# Tree Failure Casebook History

Informing Tree Management in Newcastle

2000 - 2011

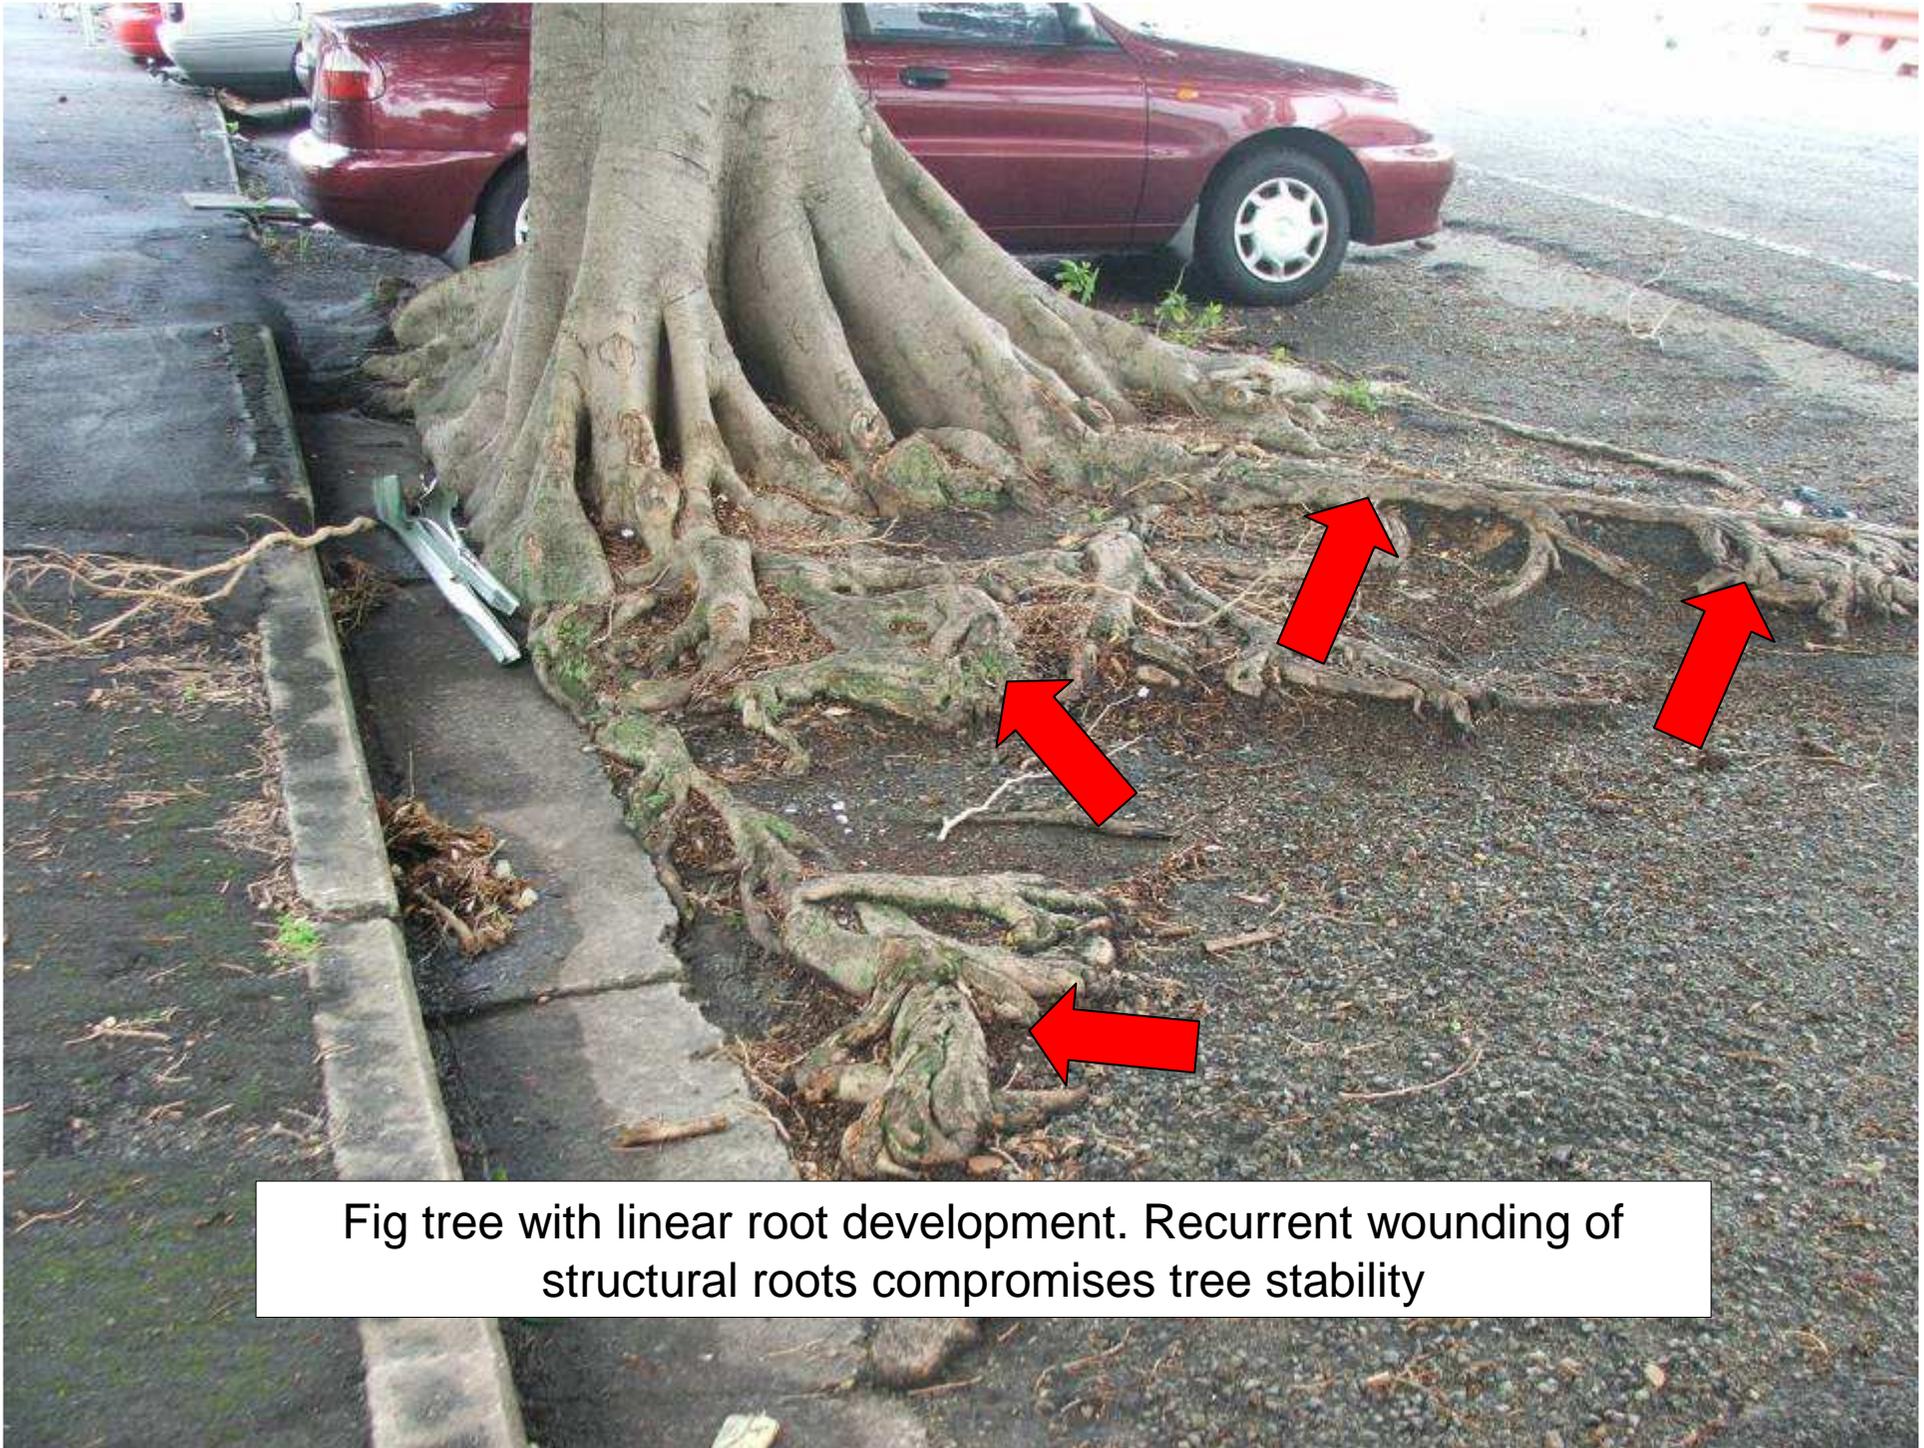
Fig tree with linear root development. Recurrent wounding of structural roots compromises tree stability

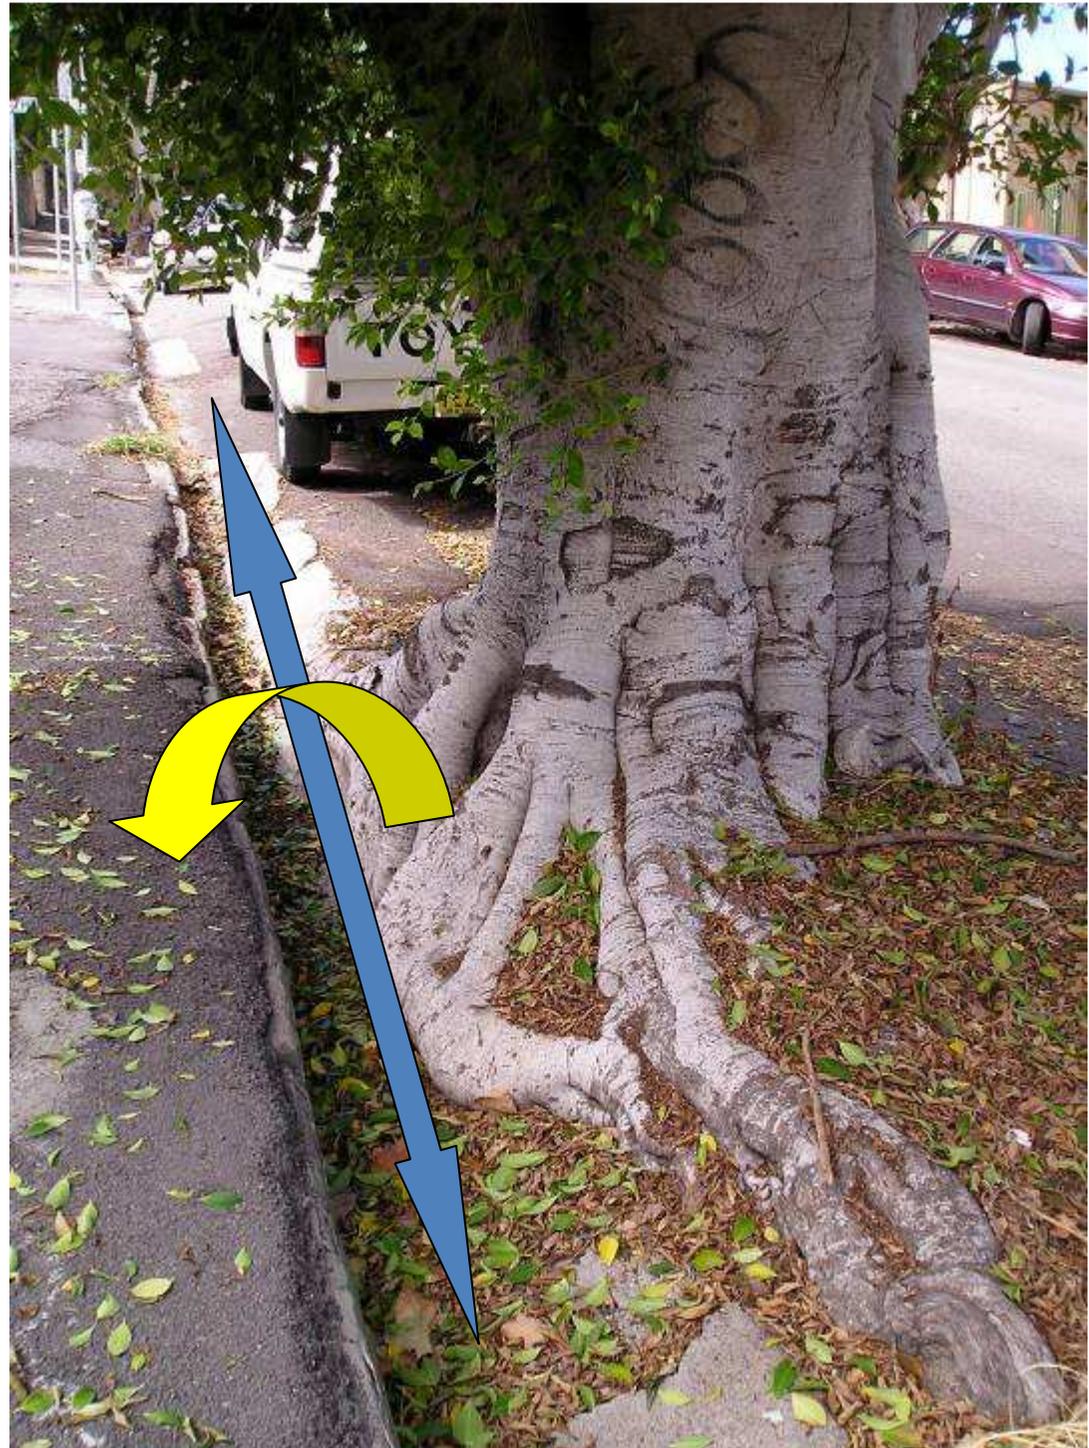
## Tyrrell St 2003

Linear (eccentric) root development with the kerb acting as a potential pivot point increasing the potential for whole tree failure

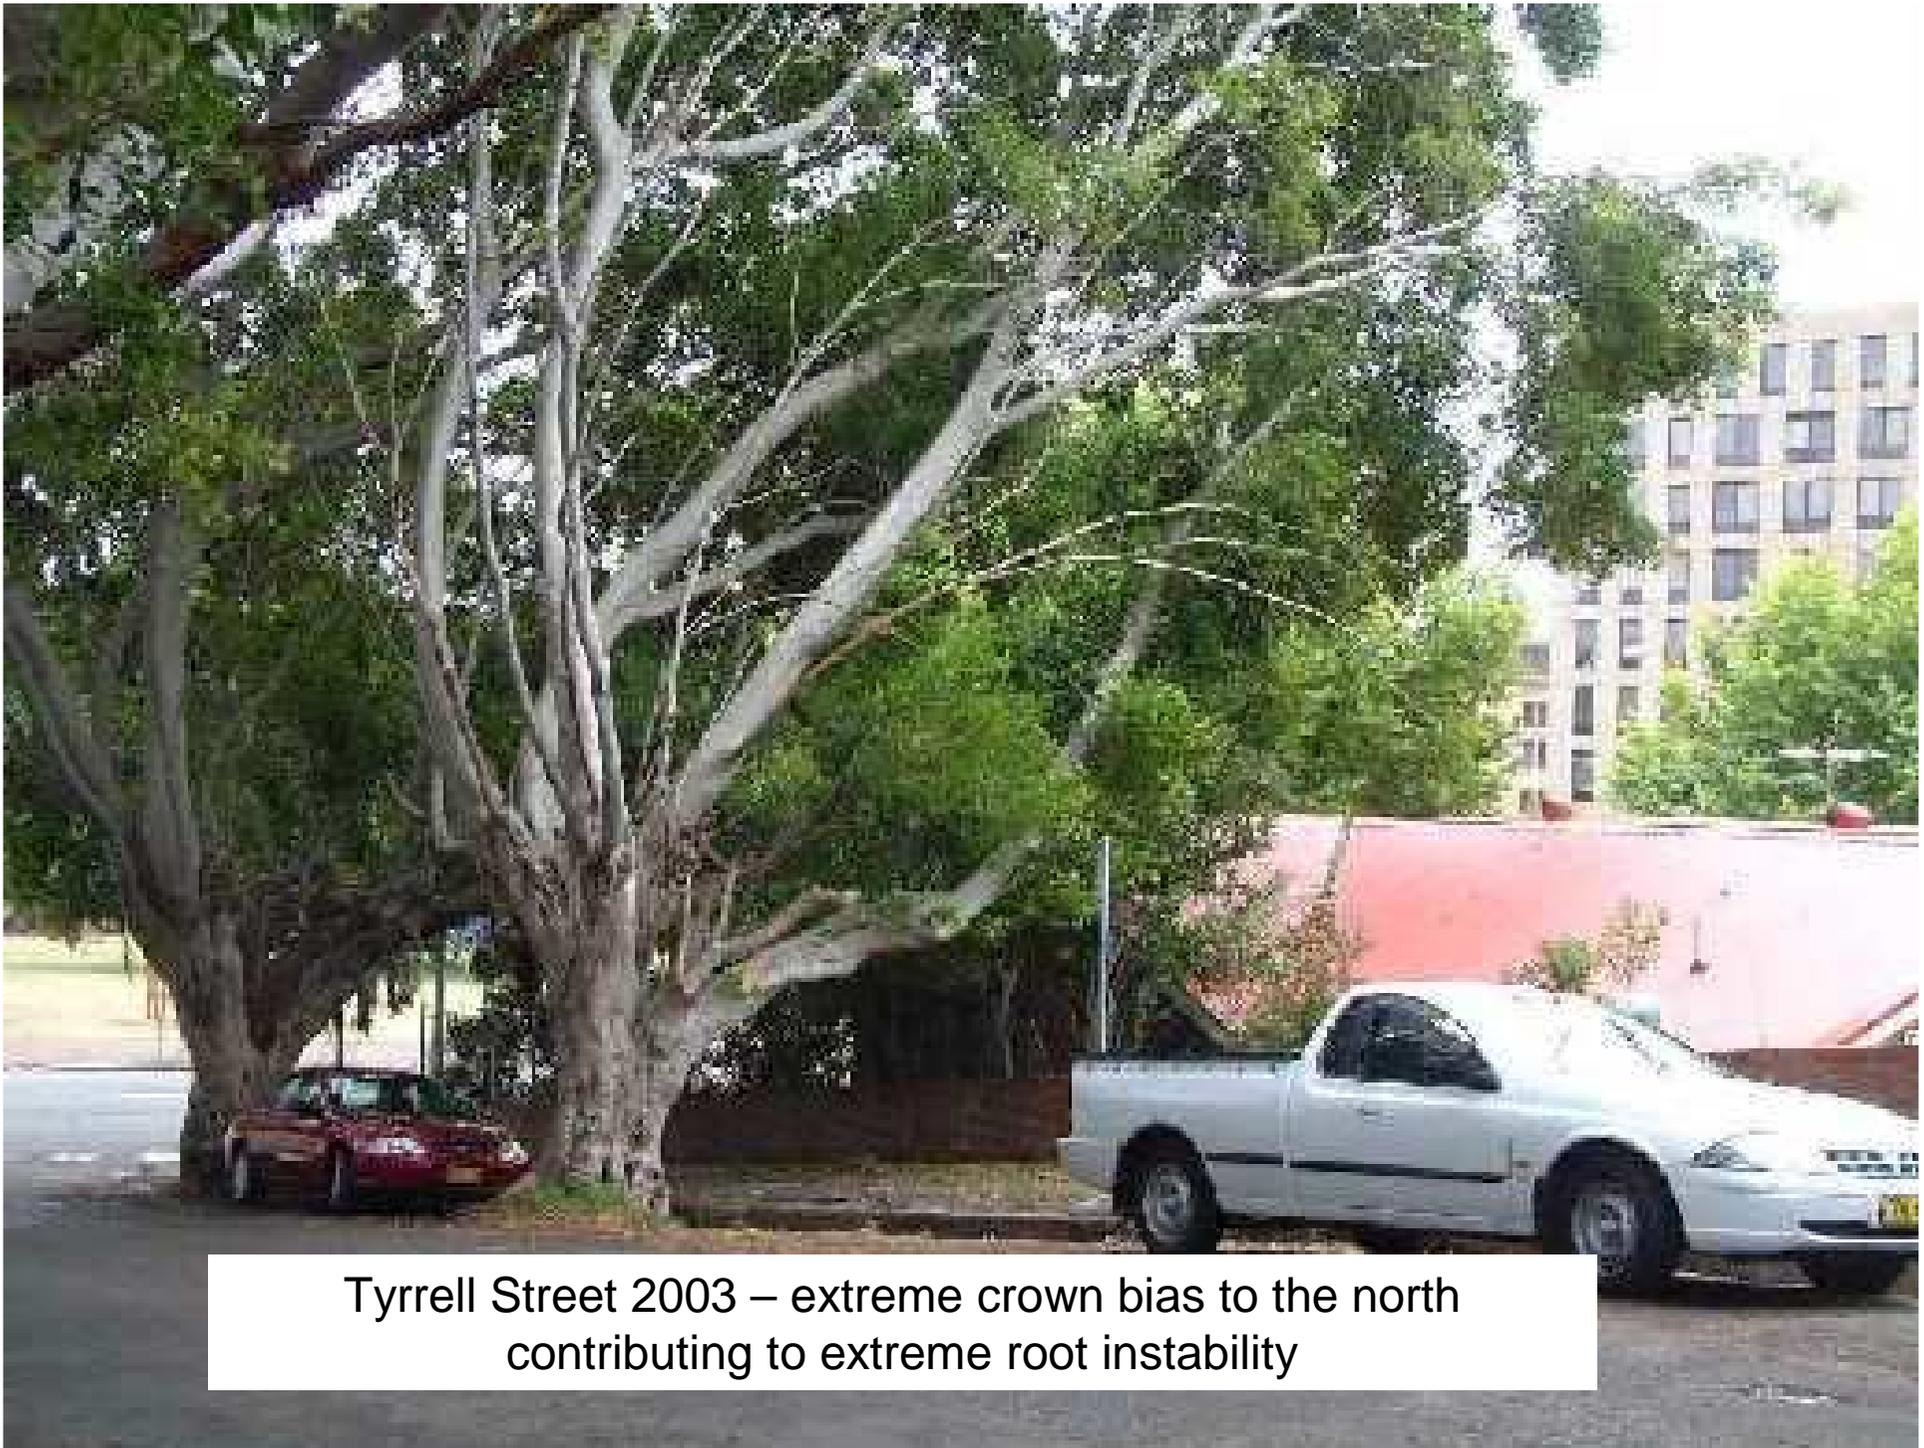
Tyrrell Street 2003 – extreme crown bias to the north contributing to extreme root instability

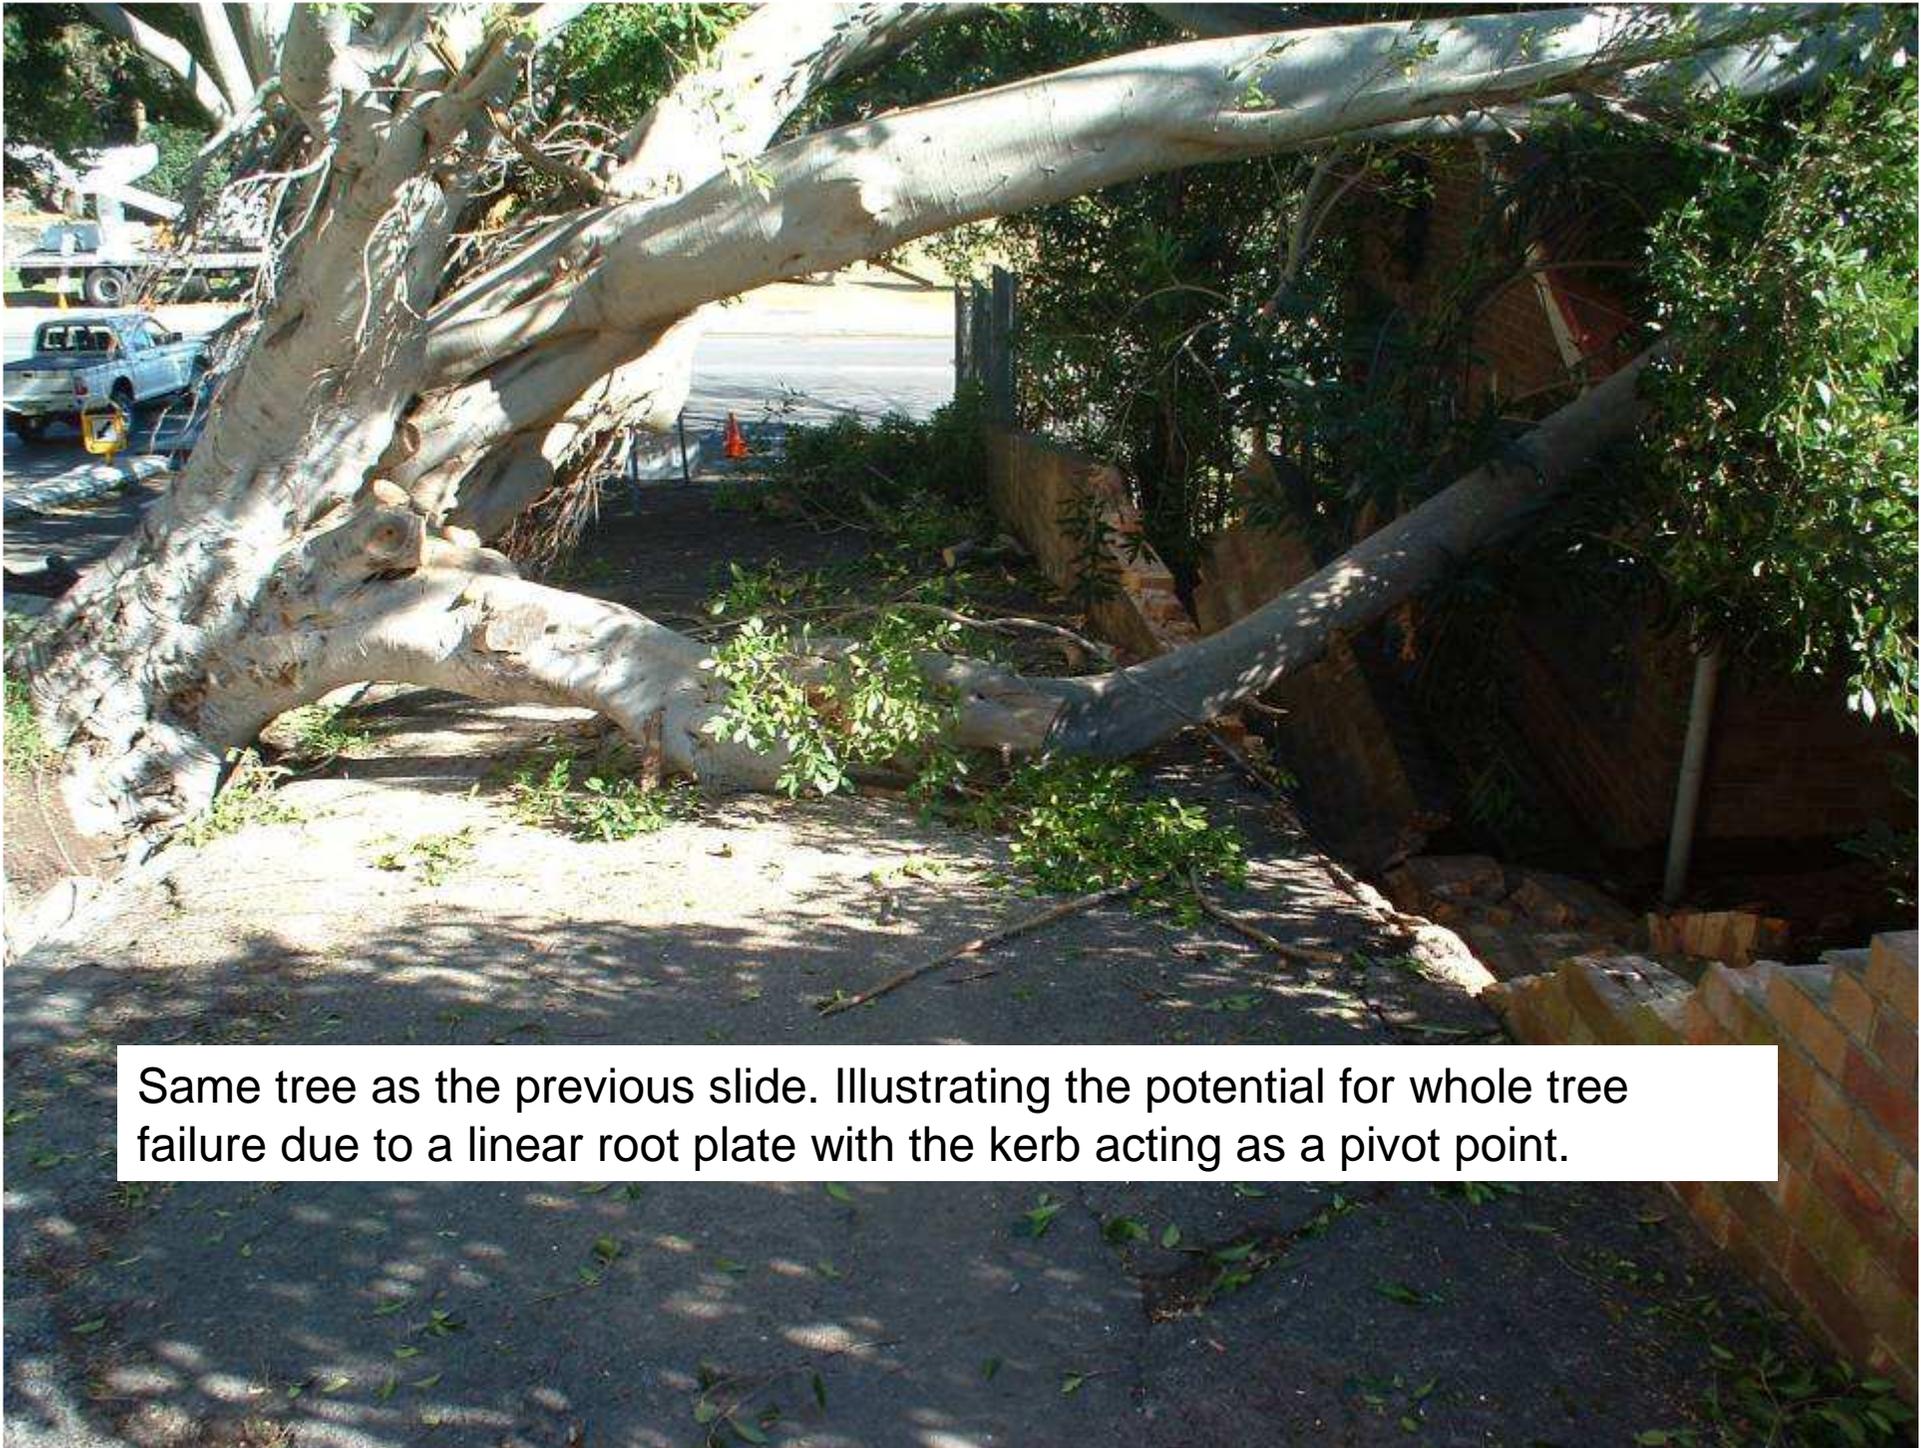
**Tyrrell Street 2003**

Whole tree failed when a 70mm diameter root was cut. The root was found to have been 'anchored' under a steel water main. Note the absence of structural roots

Same tree as the previous slide. Illustrating the potential for whole tree failure due to a linear root plate with the kerb acting as a pivot point.

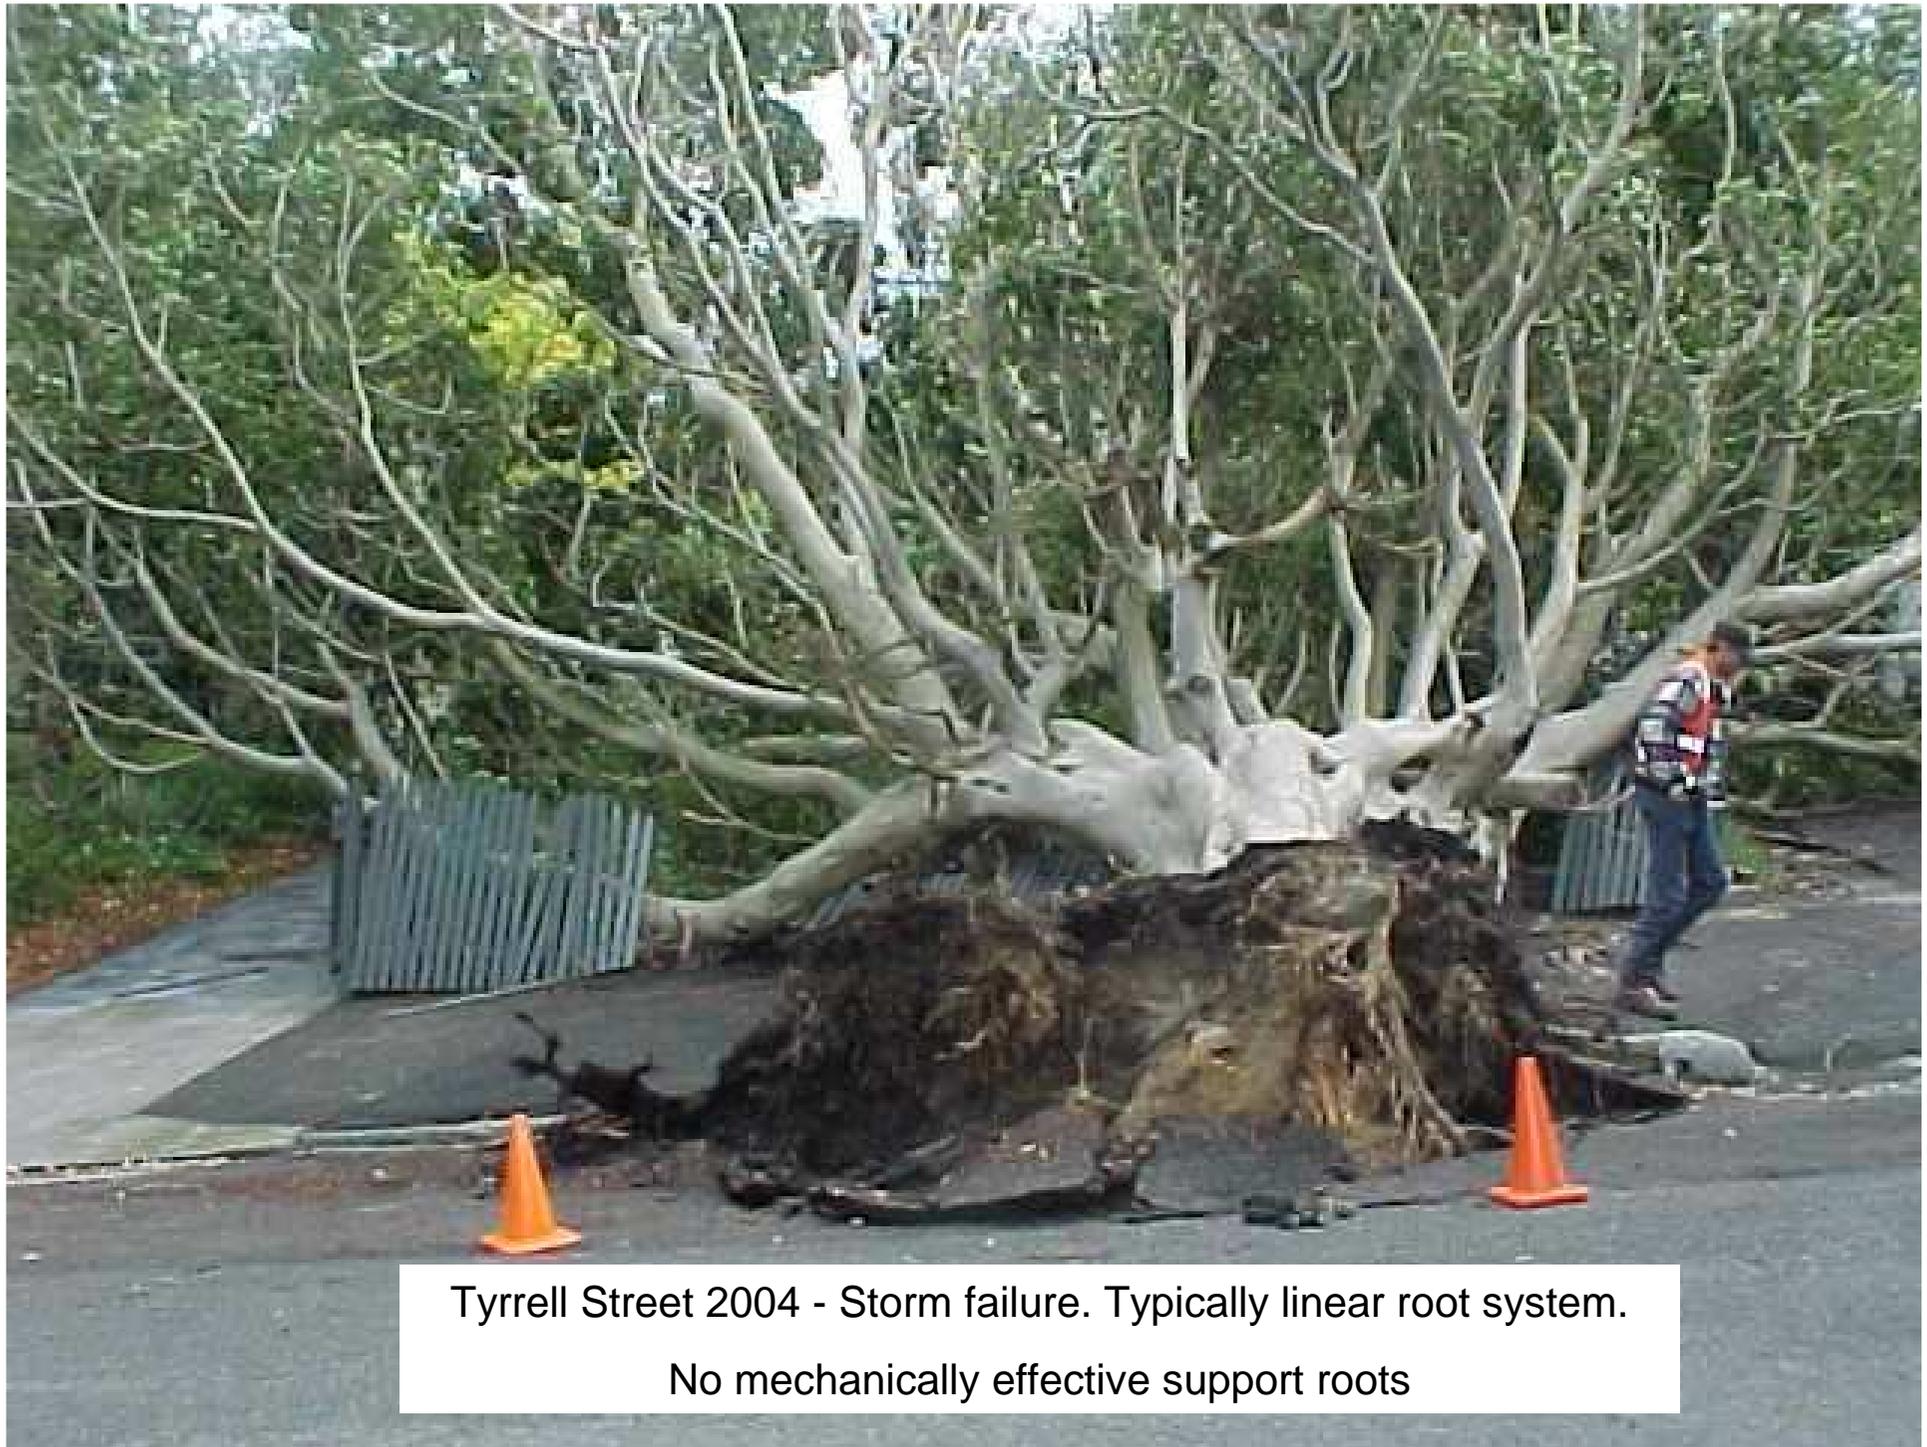
Tyrrell Street 2004 - Storm failure. Typically linear root system.  
No mechanically effective support roots

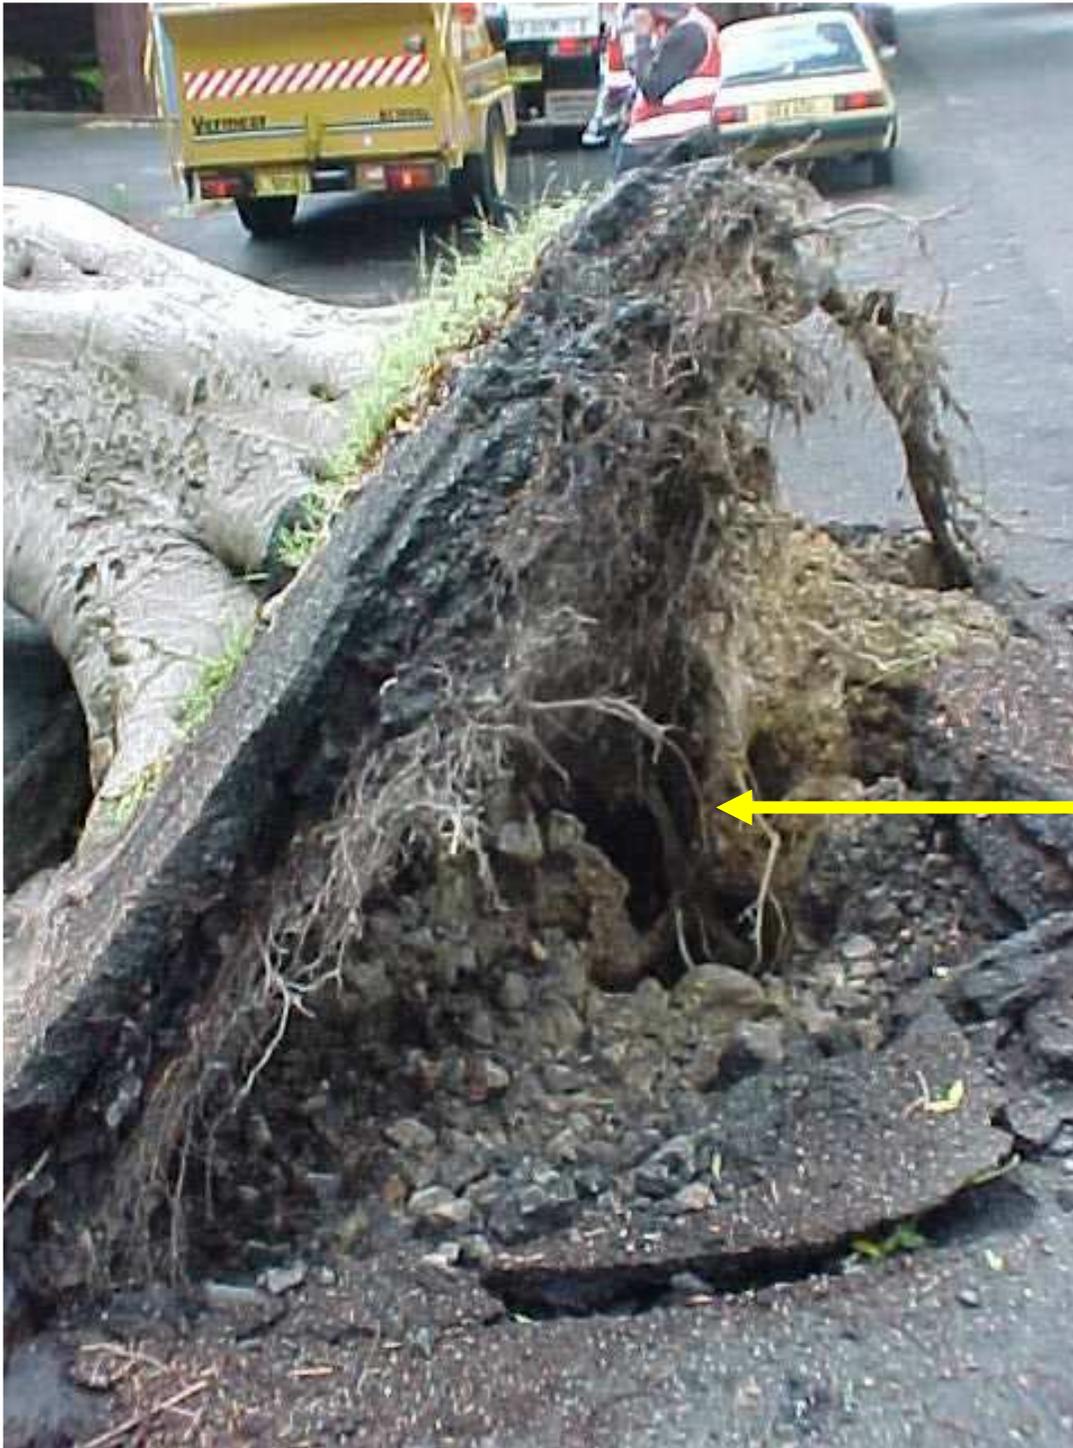
Same tree as previous slide.

Whole-tree failure due to linear (eccentric) root plate and absence of mechanically effective structural roots

Sinker roots directly beneath trunk did not provide the necessary tensile support

Sinker roots contributed to stability under benign conditions but under storm loading they were not a substitute for the lack of tensile support roots

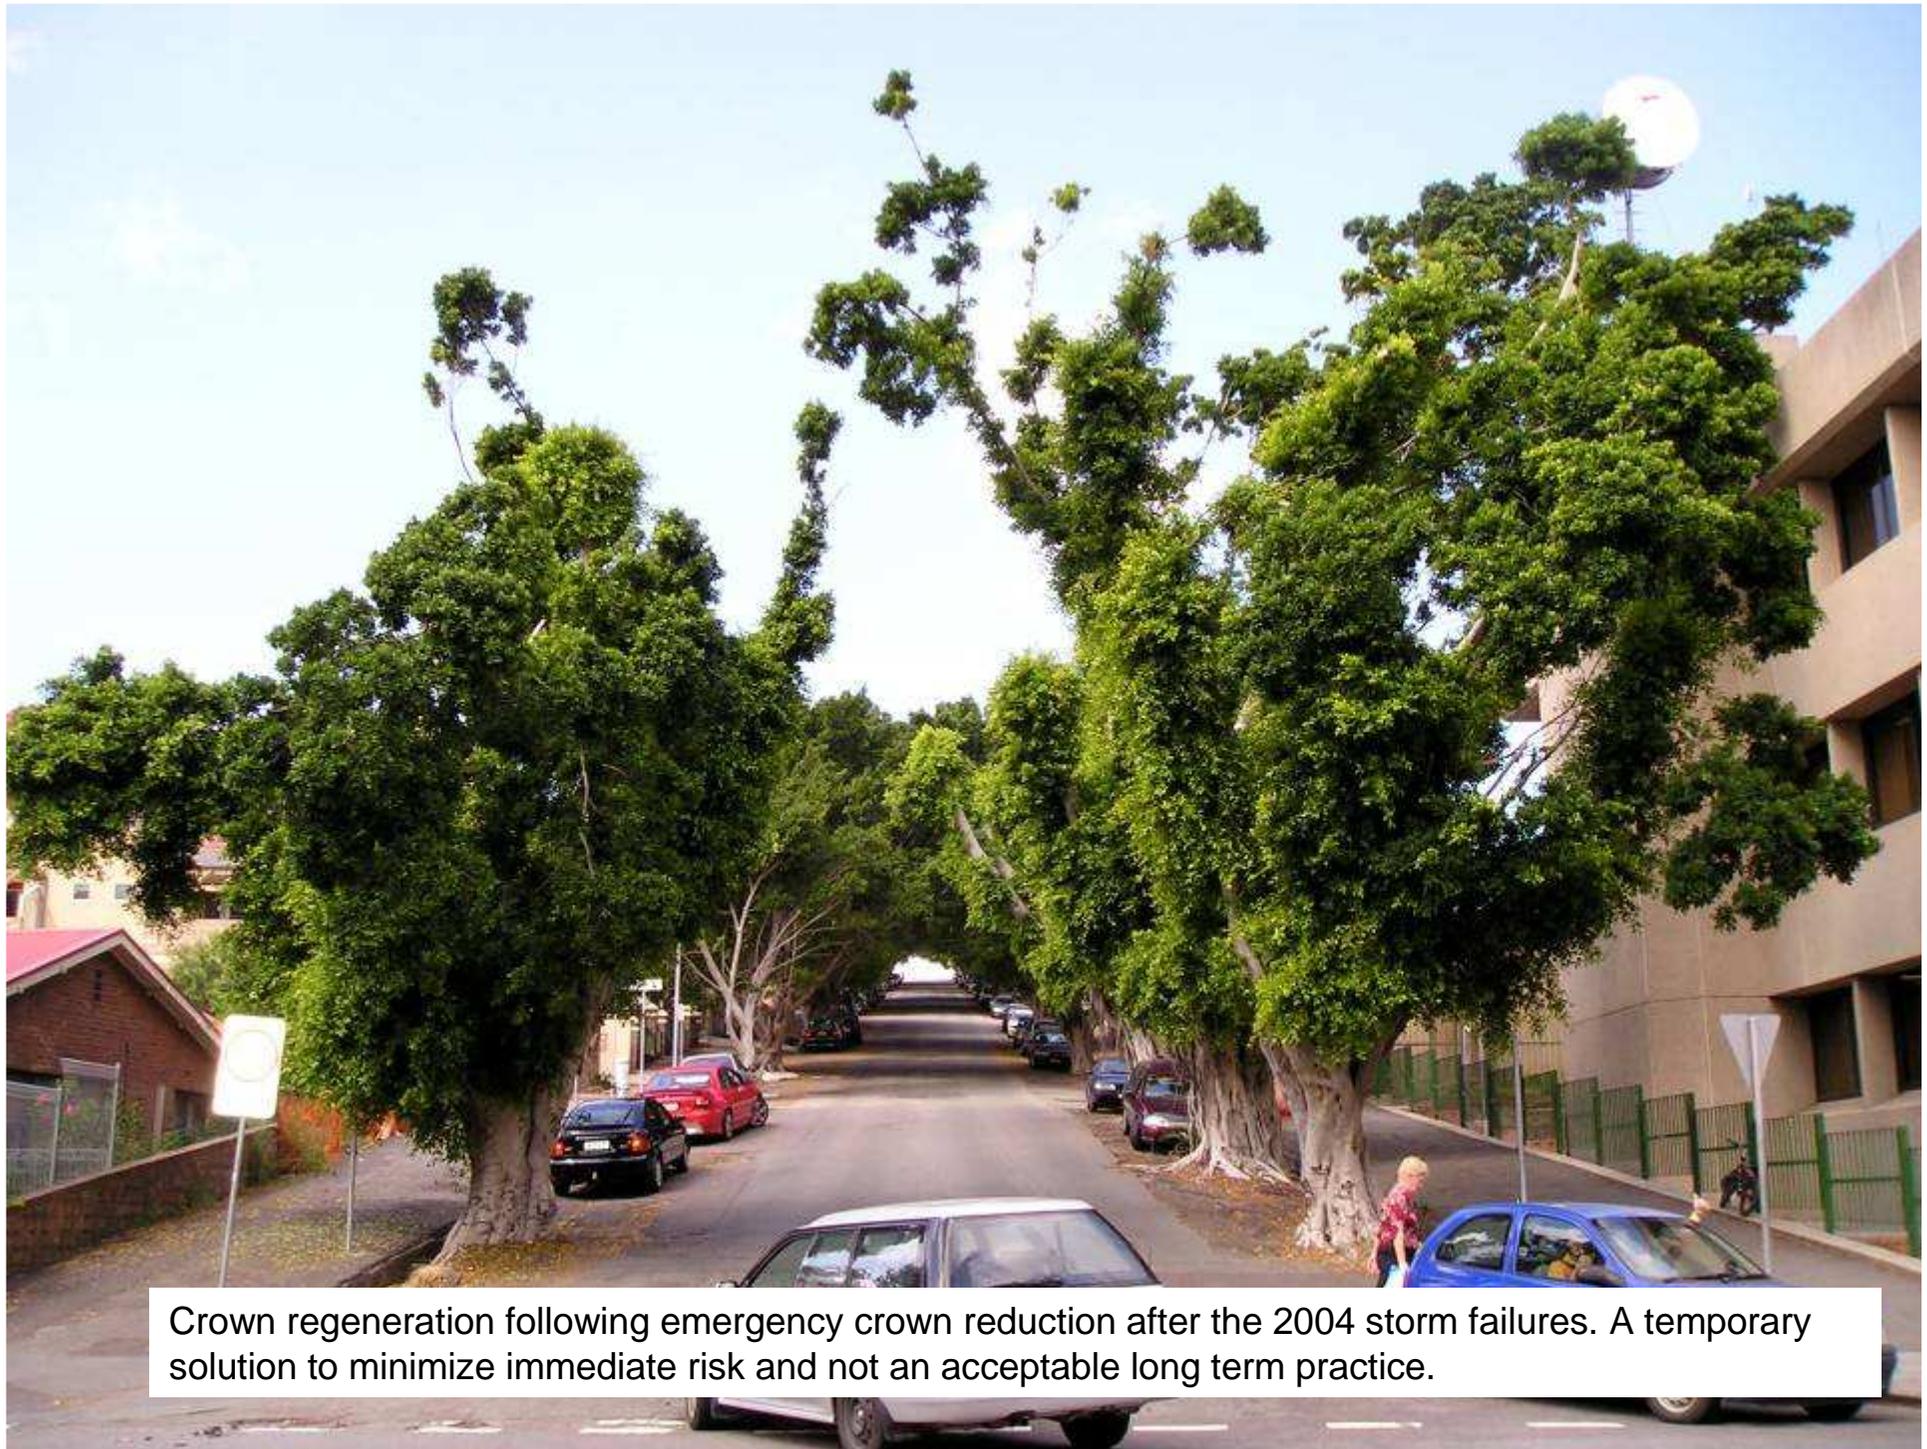
Crown regeneration following emergency crown reduction after the 2004 storm failures. A temporary solution to minimize immediate risk and not an acceptable long term practice.

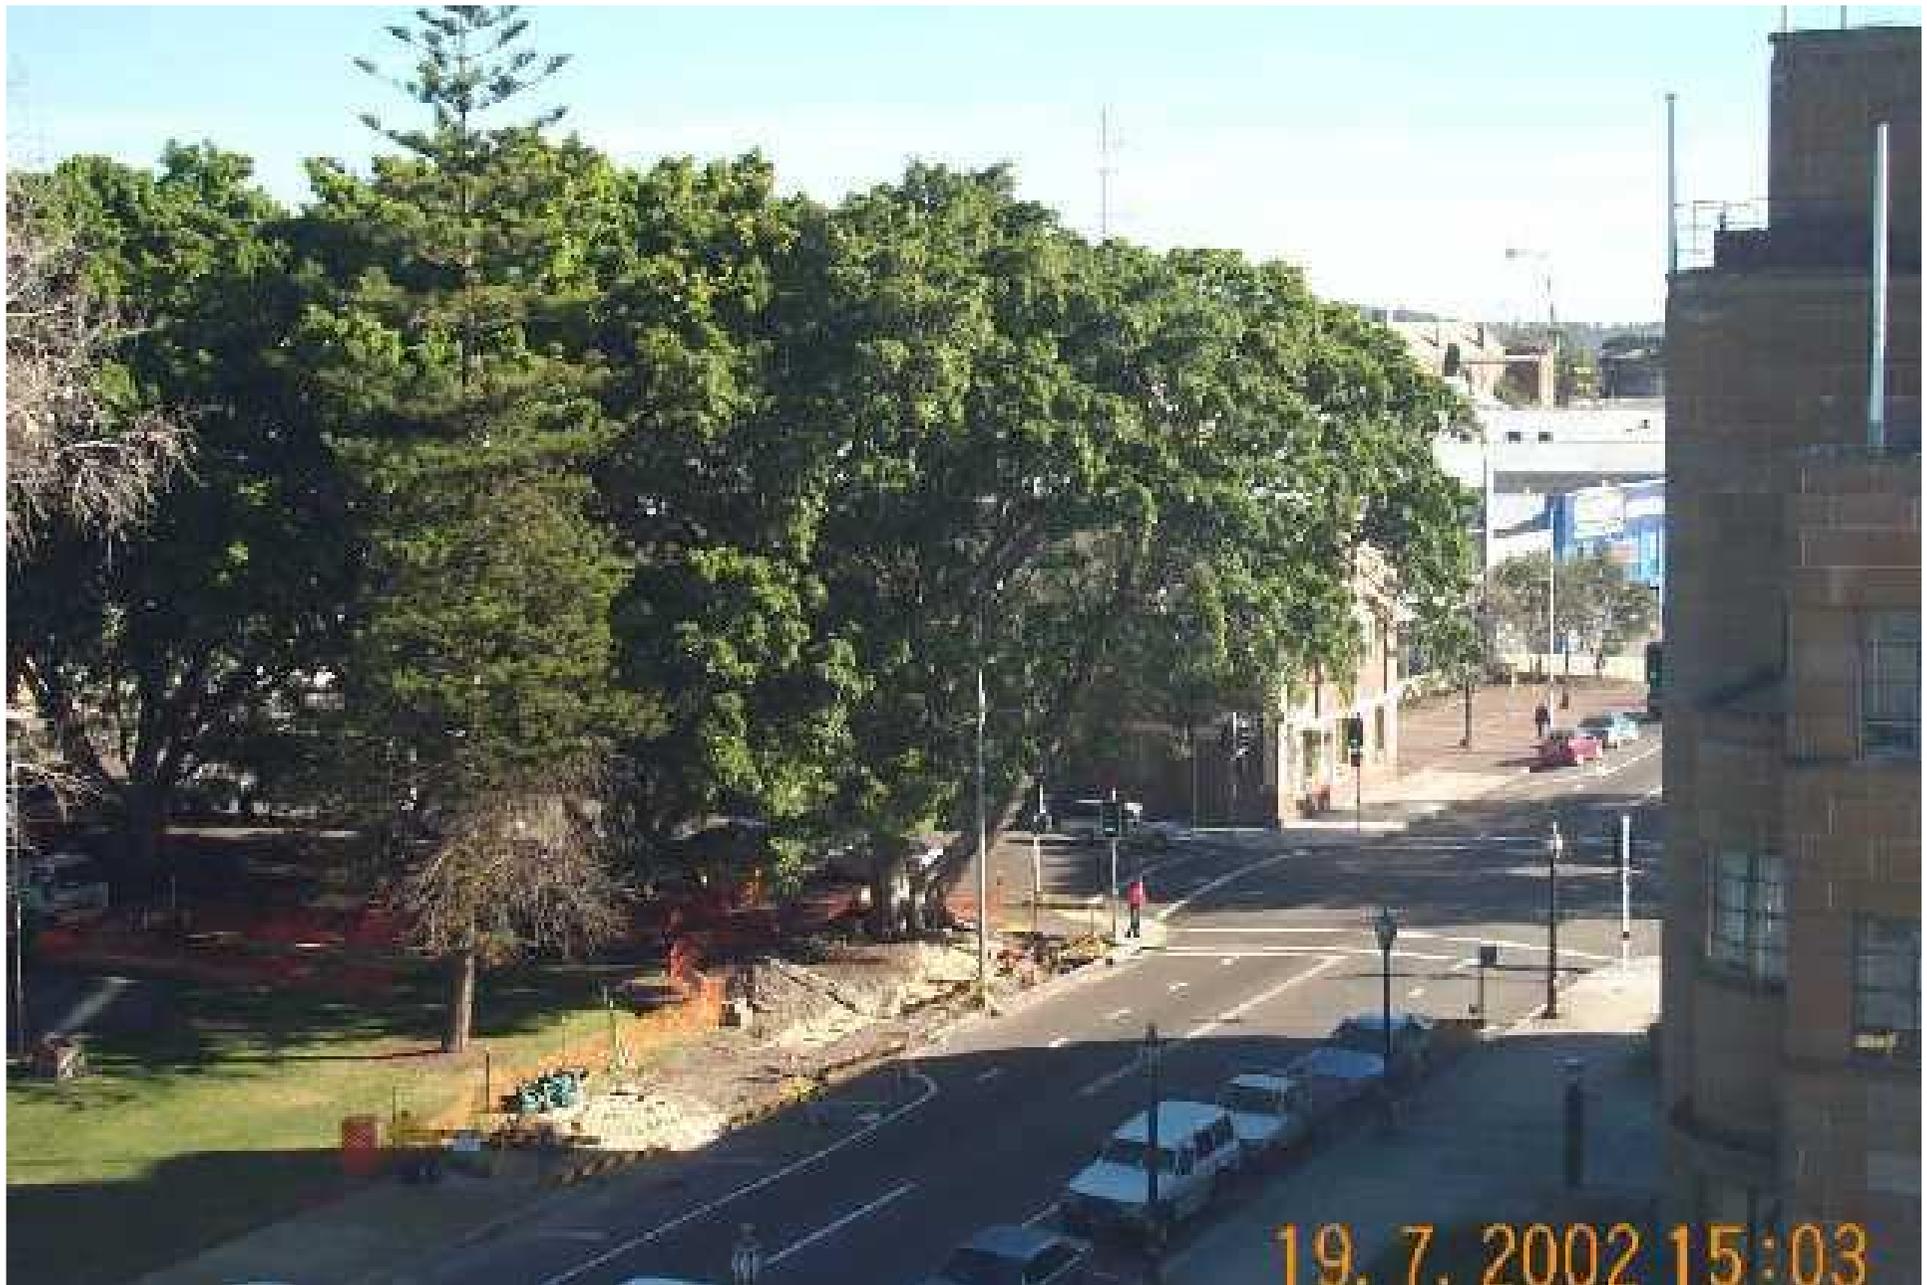
11 kv Cables stretched  
by fig roots

Utility trenches may  
provide conditions  
suited to  
opportunistic root  
development ie  
oxygen and water

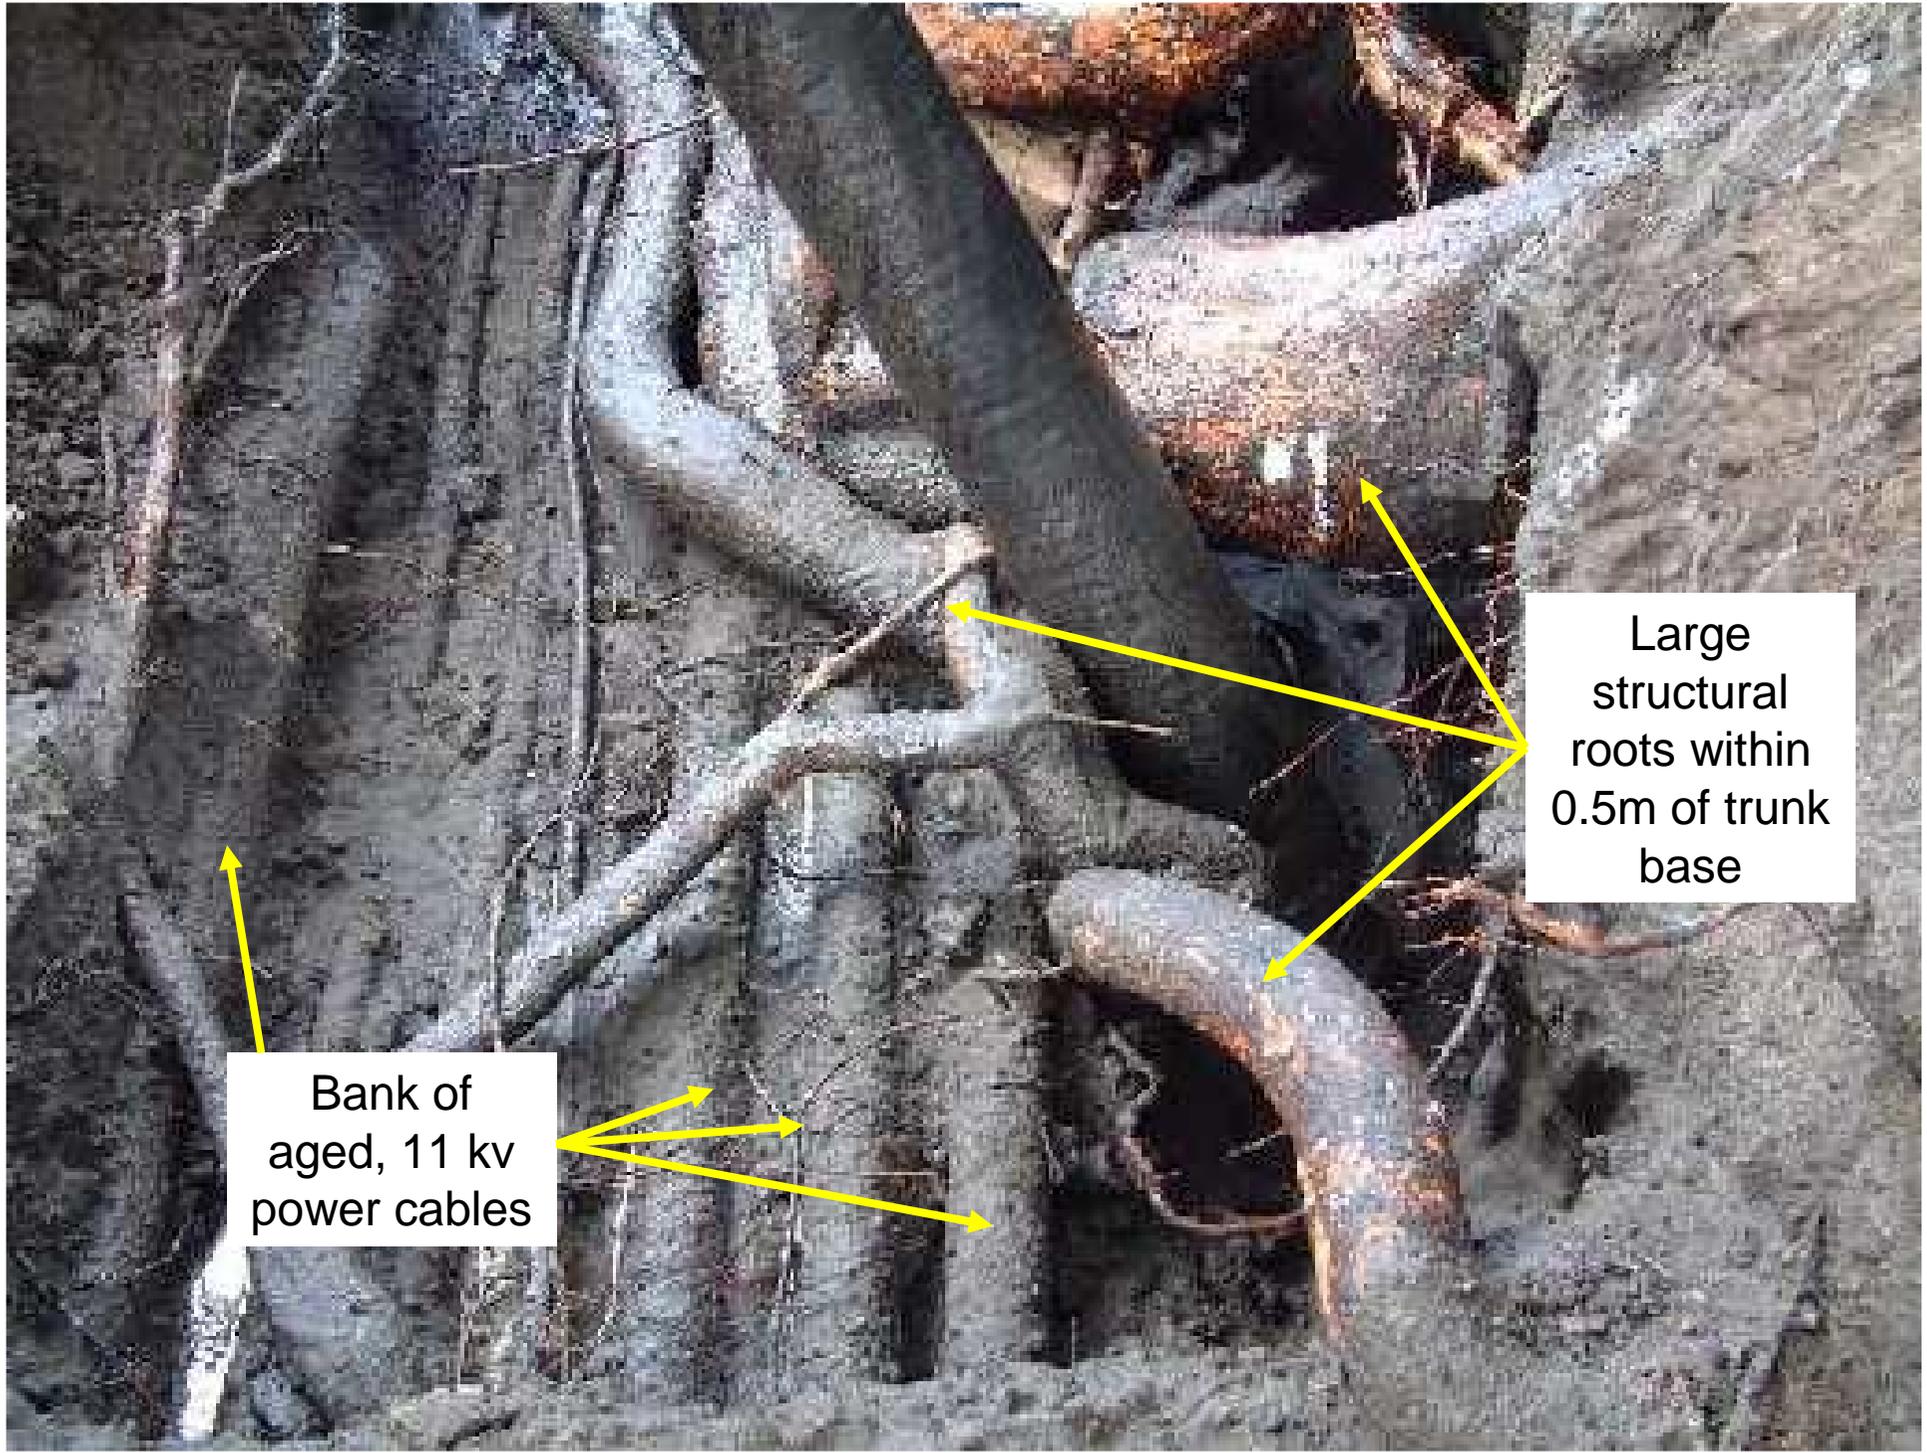
Bank of aged, 11 kv power cables

Large structural roots within 0.5m of trunk base
