# Tree Failure Casebook History

Informing Tree Management in Newcastle

2000 - 2011

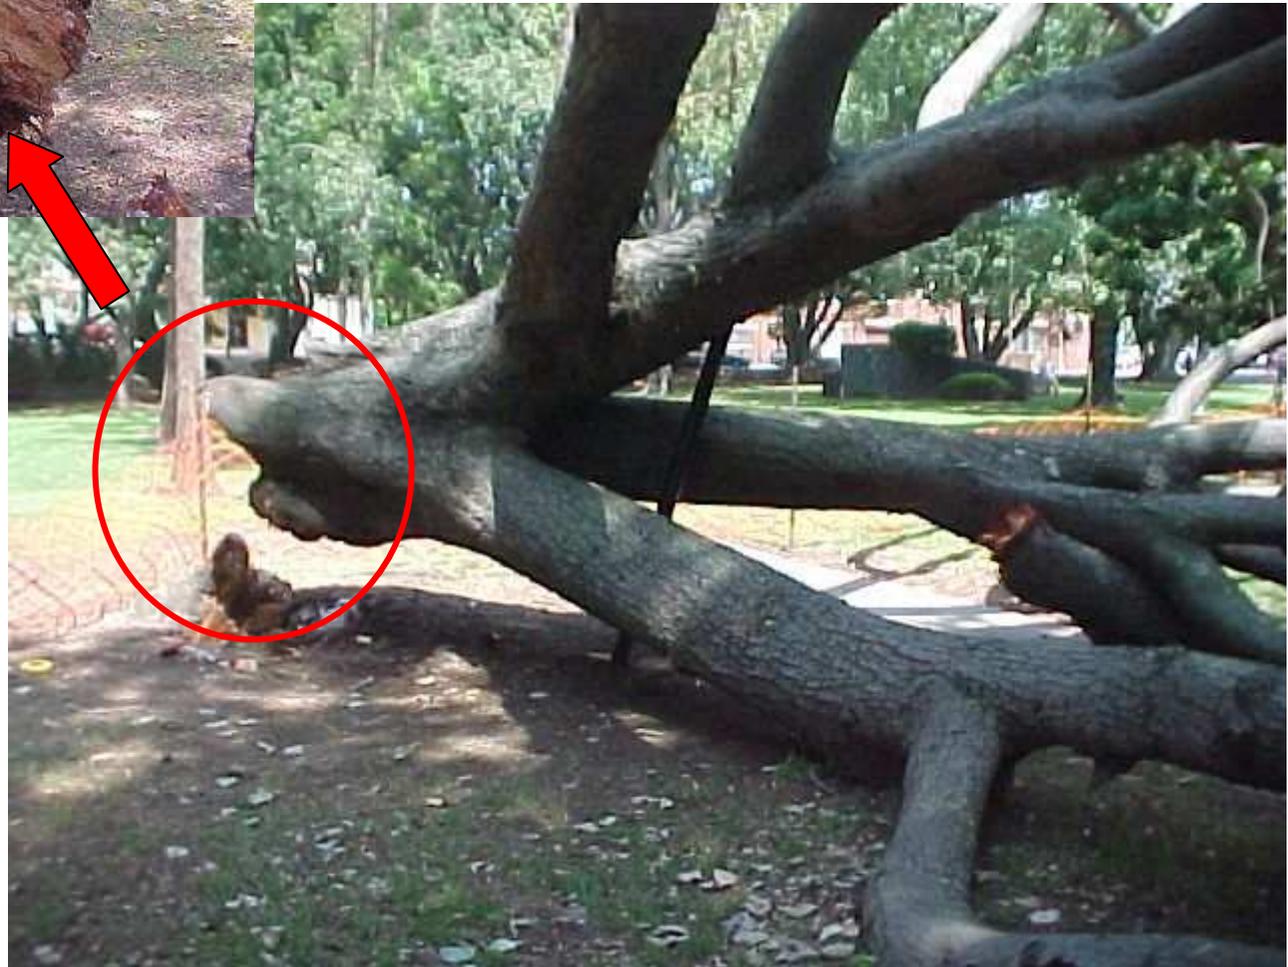
## Failure of Kaffir Plum Civic Park 2000

Brown Rot in the stem base and root crown. Failure occurred at night time under calm conditions

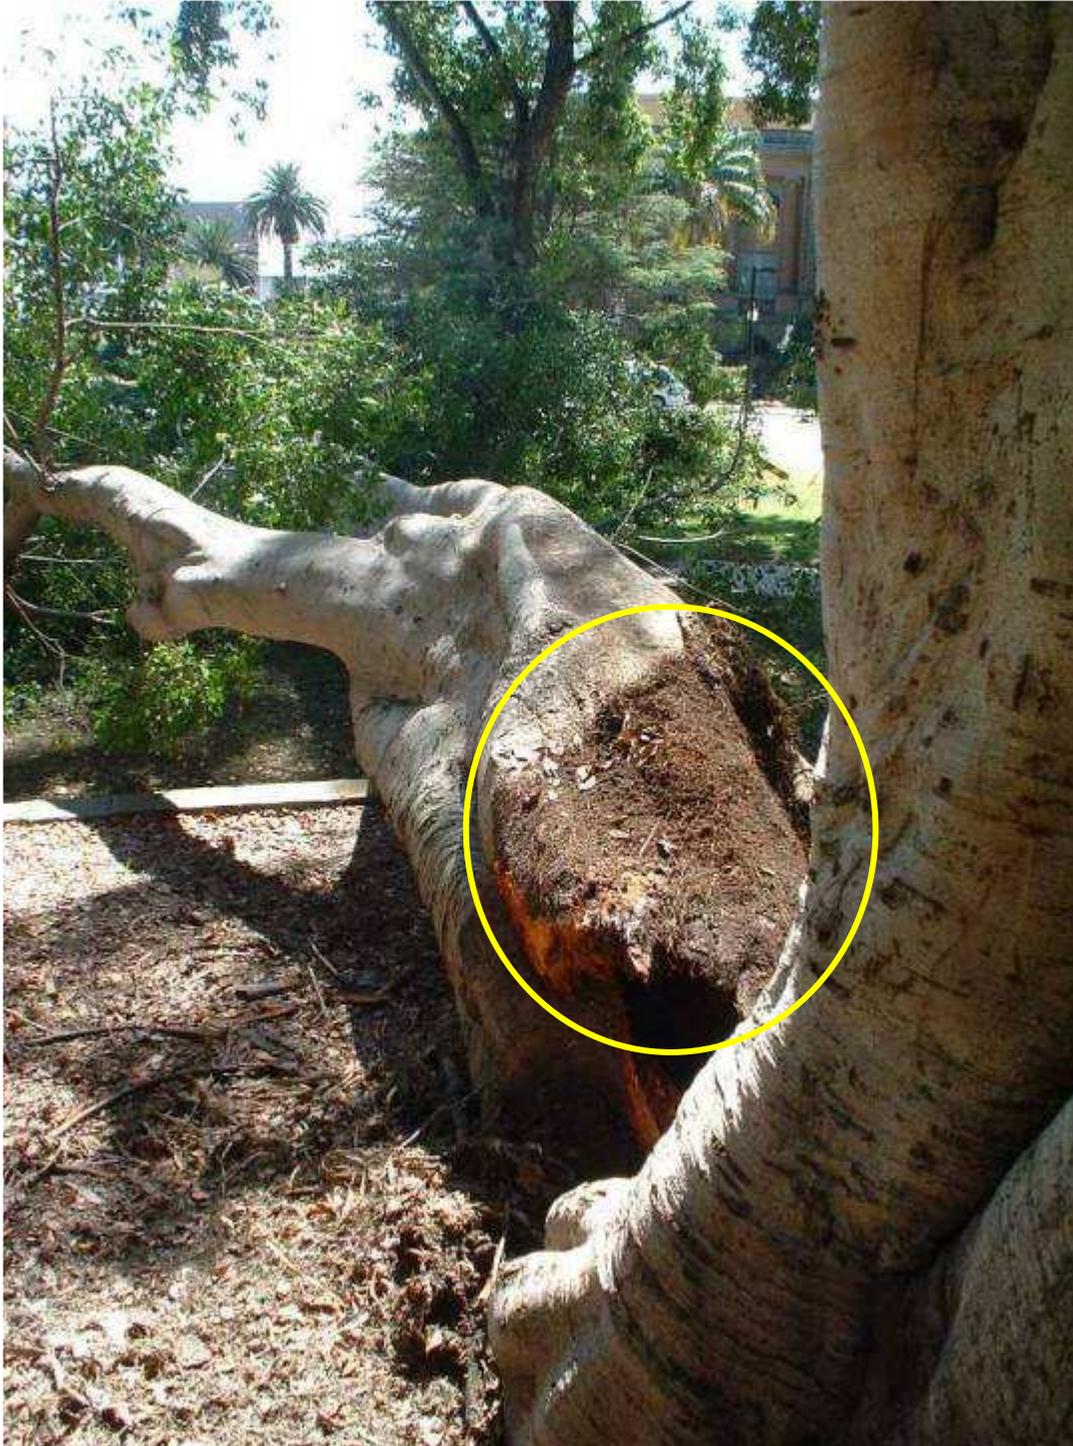
Civic Park 2006

Failure due to severe inclusion defect. This trunk and branch inclusion defect is a relatively common characteristic of Hills Fig. The natural growth of Fig trunks makes assessment of such defects problematic

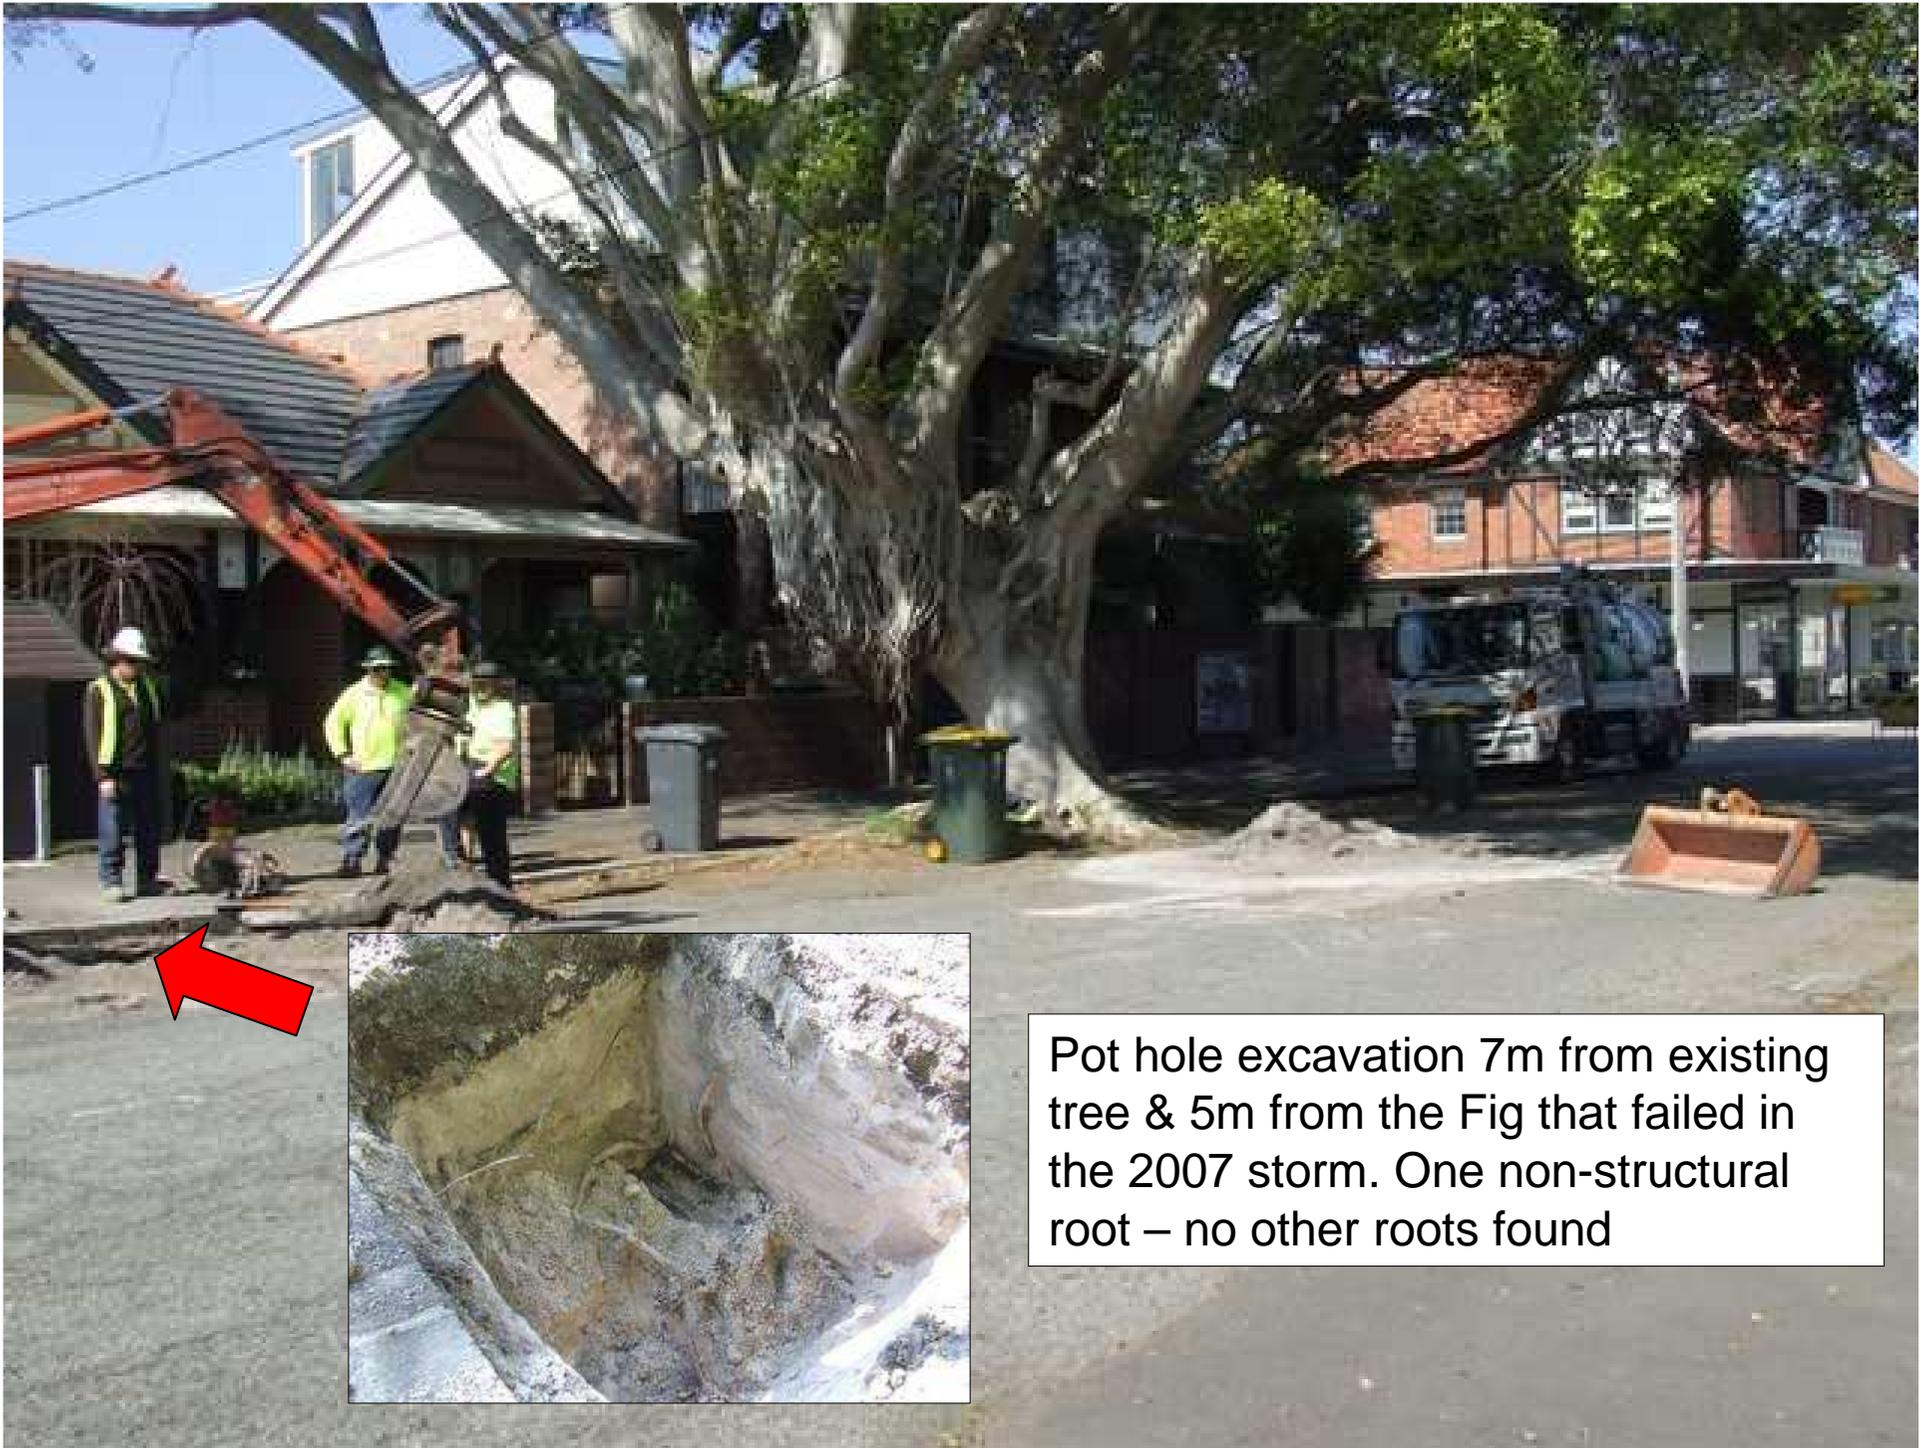
Pot hole excavation 7m from existing tree & 5m from the Fig that failed in the 2007 storm. One non-structural root – no other roots found

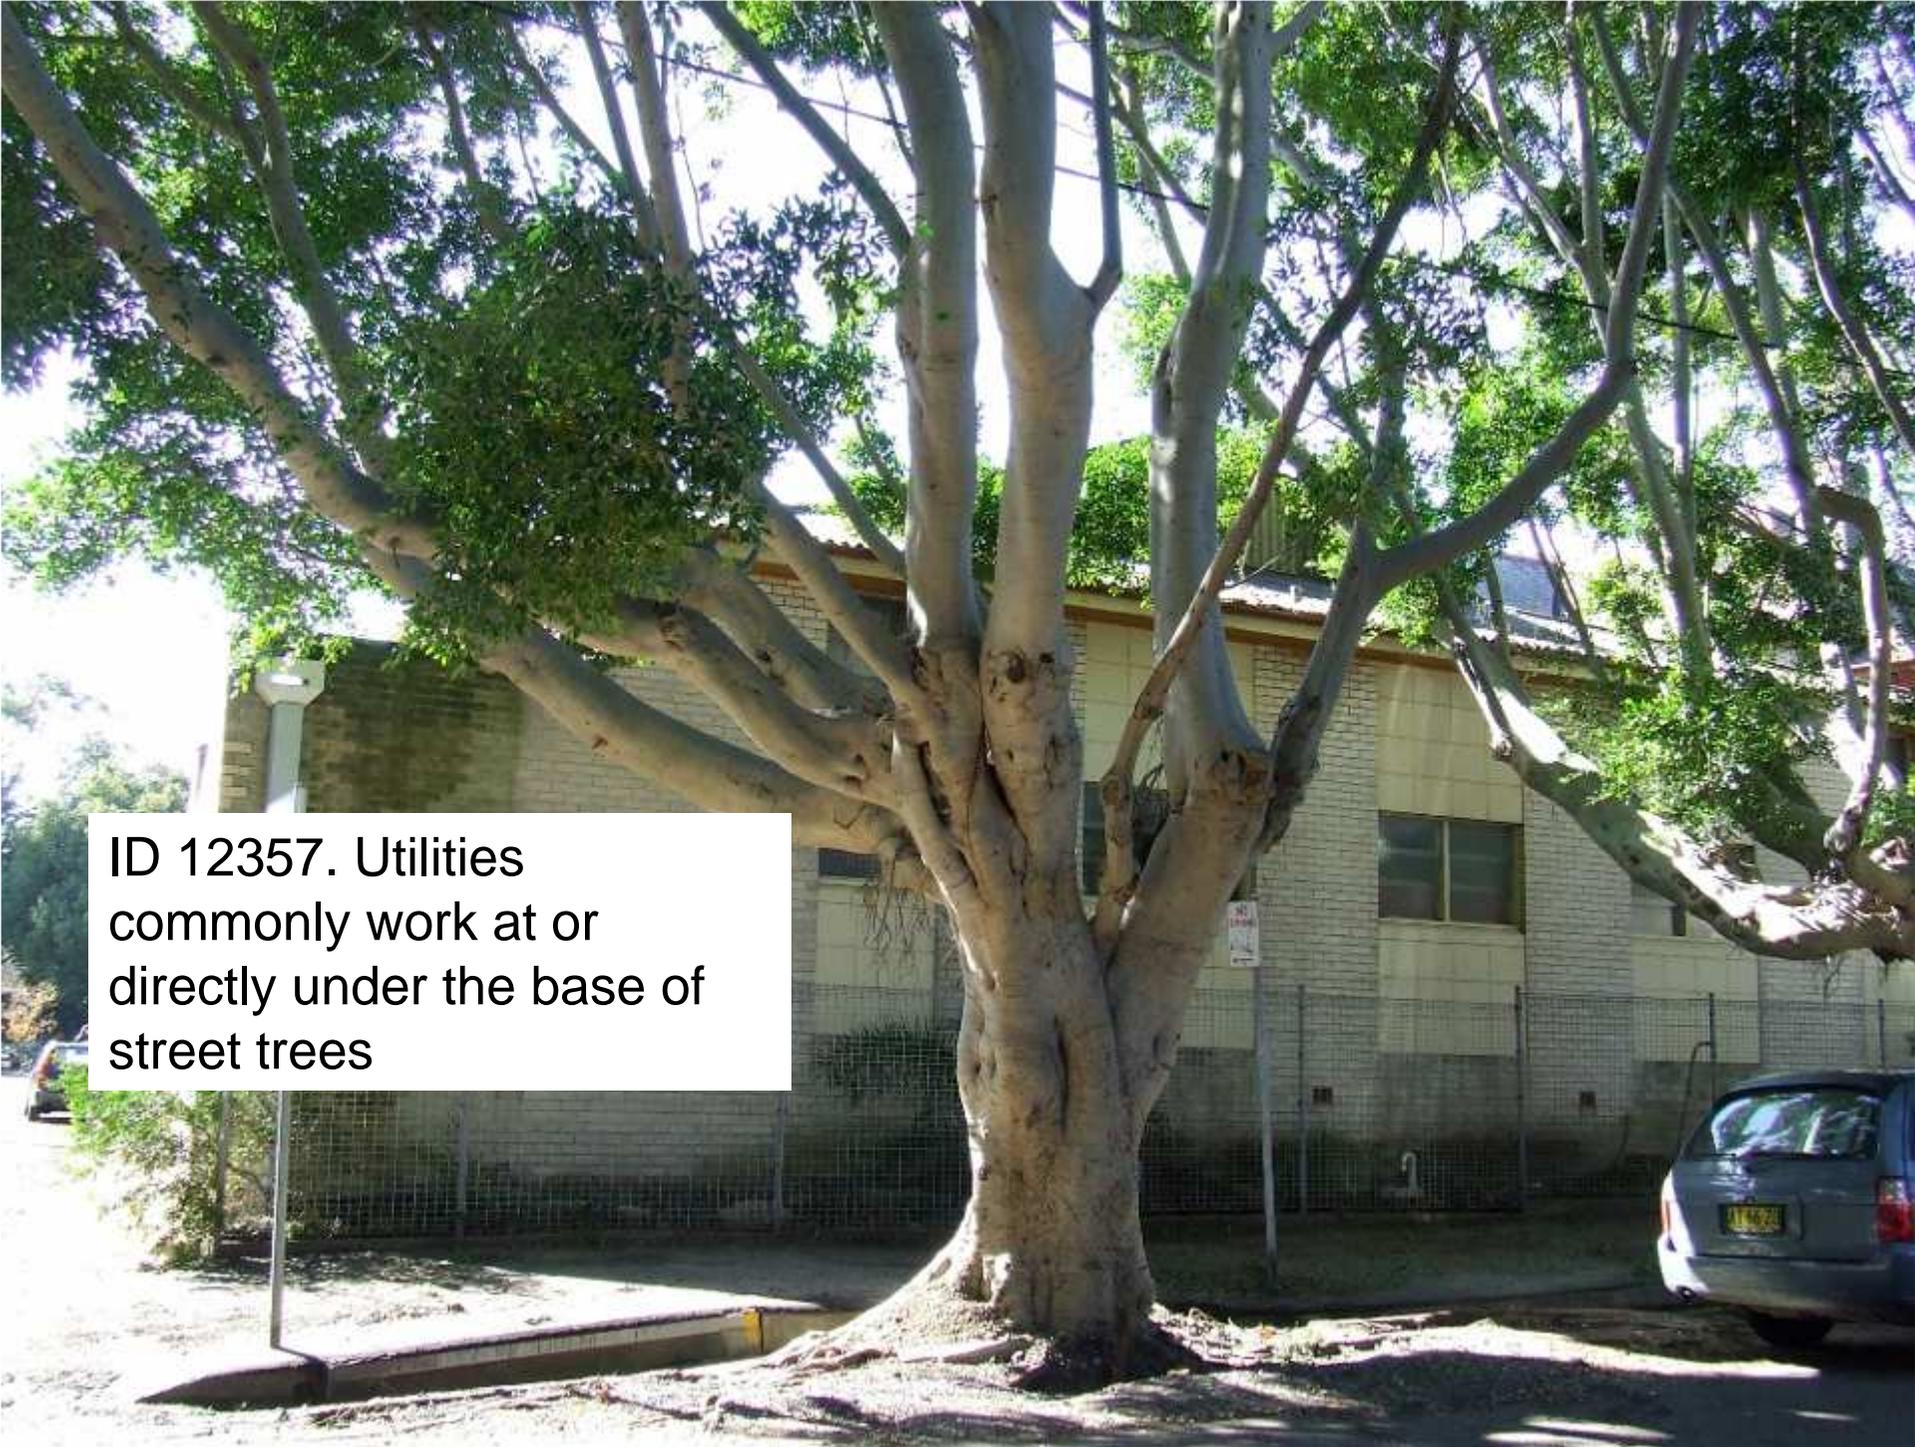
ID 12357. Utilities commonly work at or directly under the base of street trees

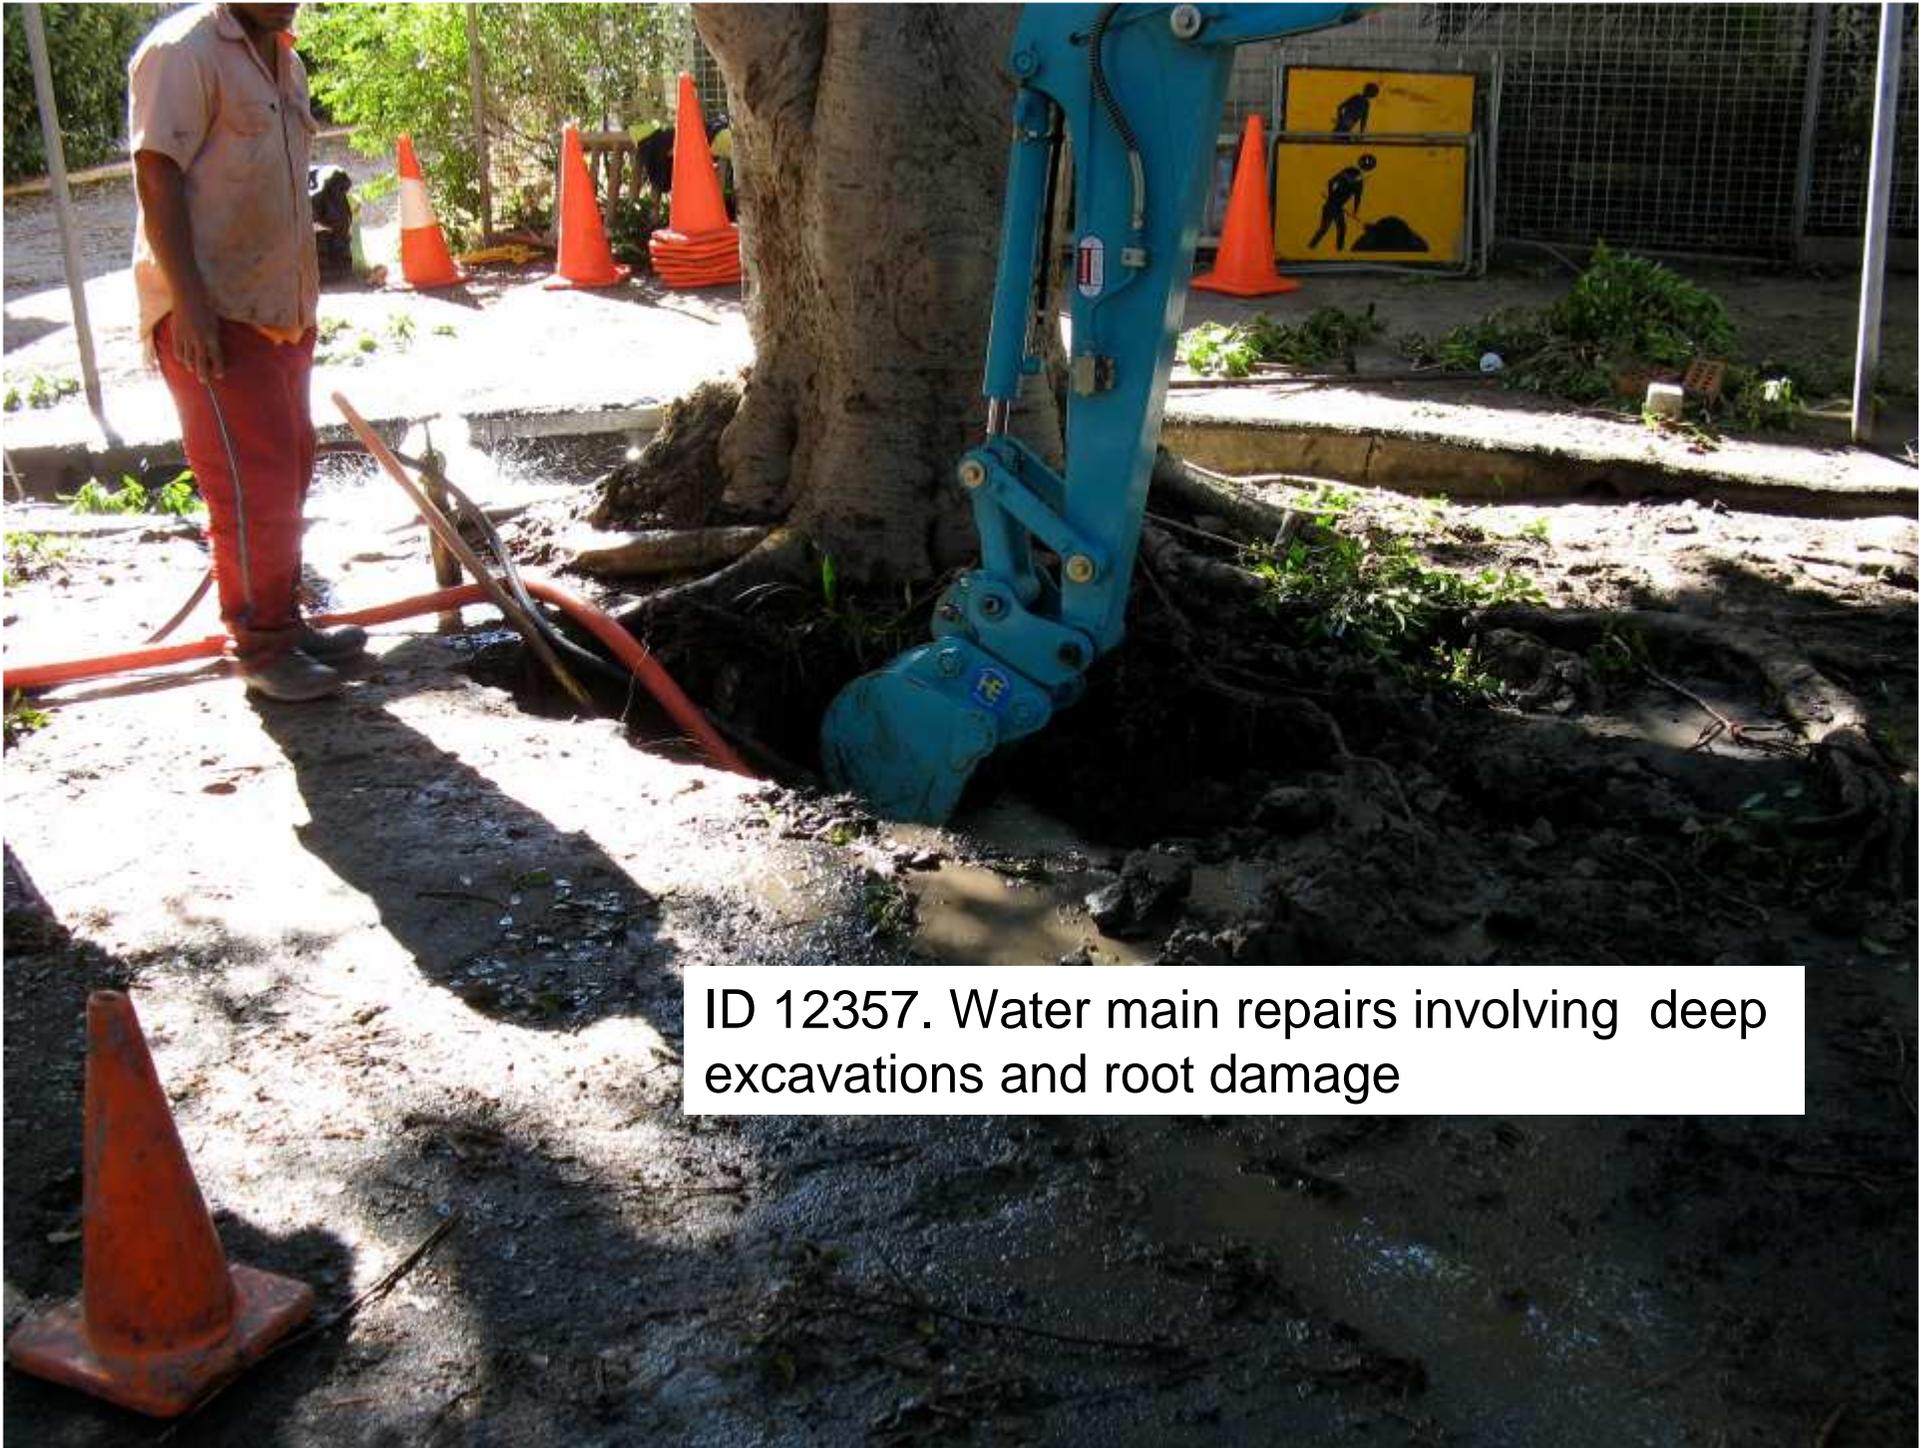
ID 12357. Water main repairs involving deep excavations and root damage

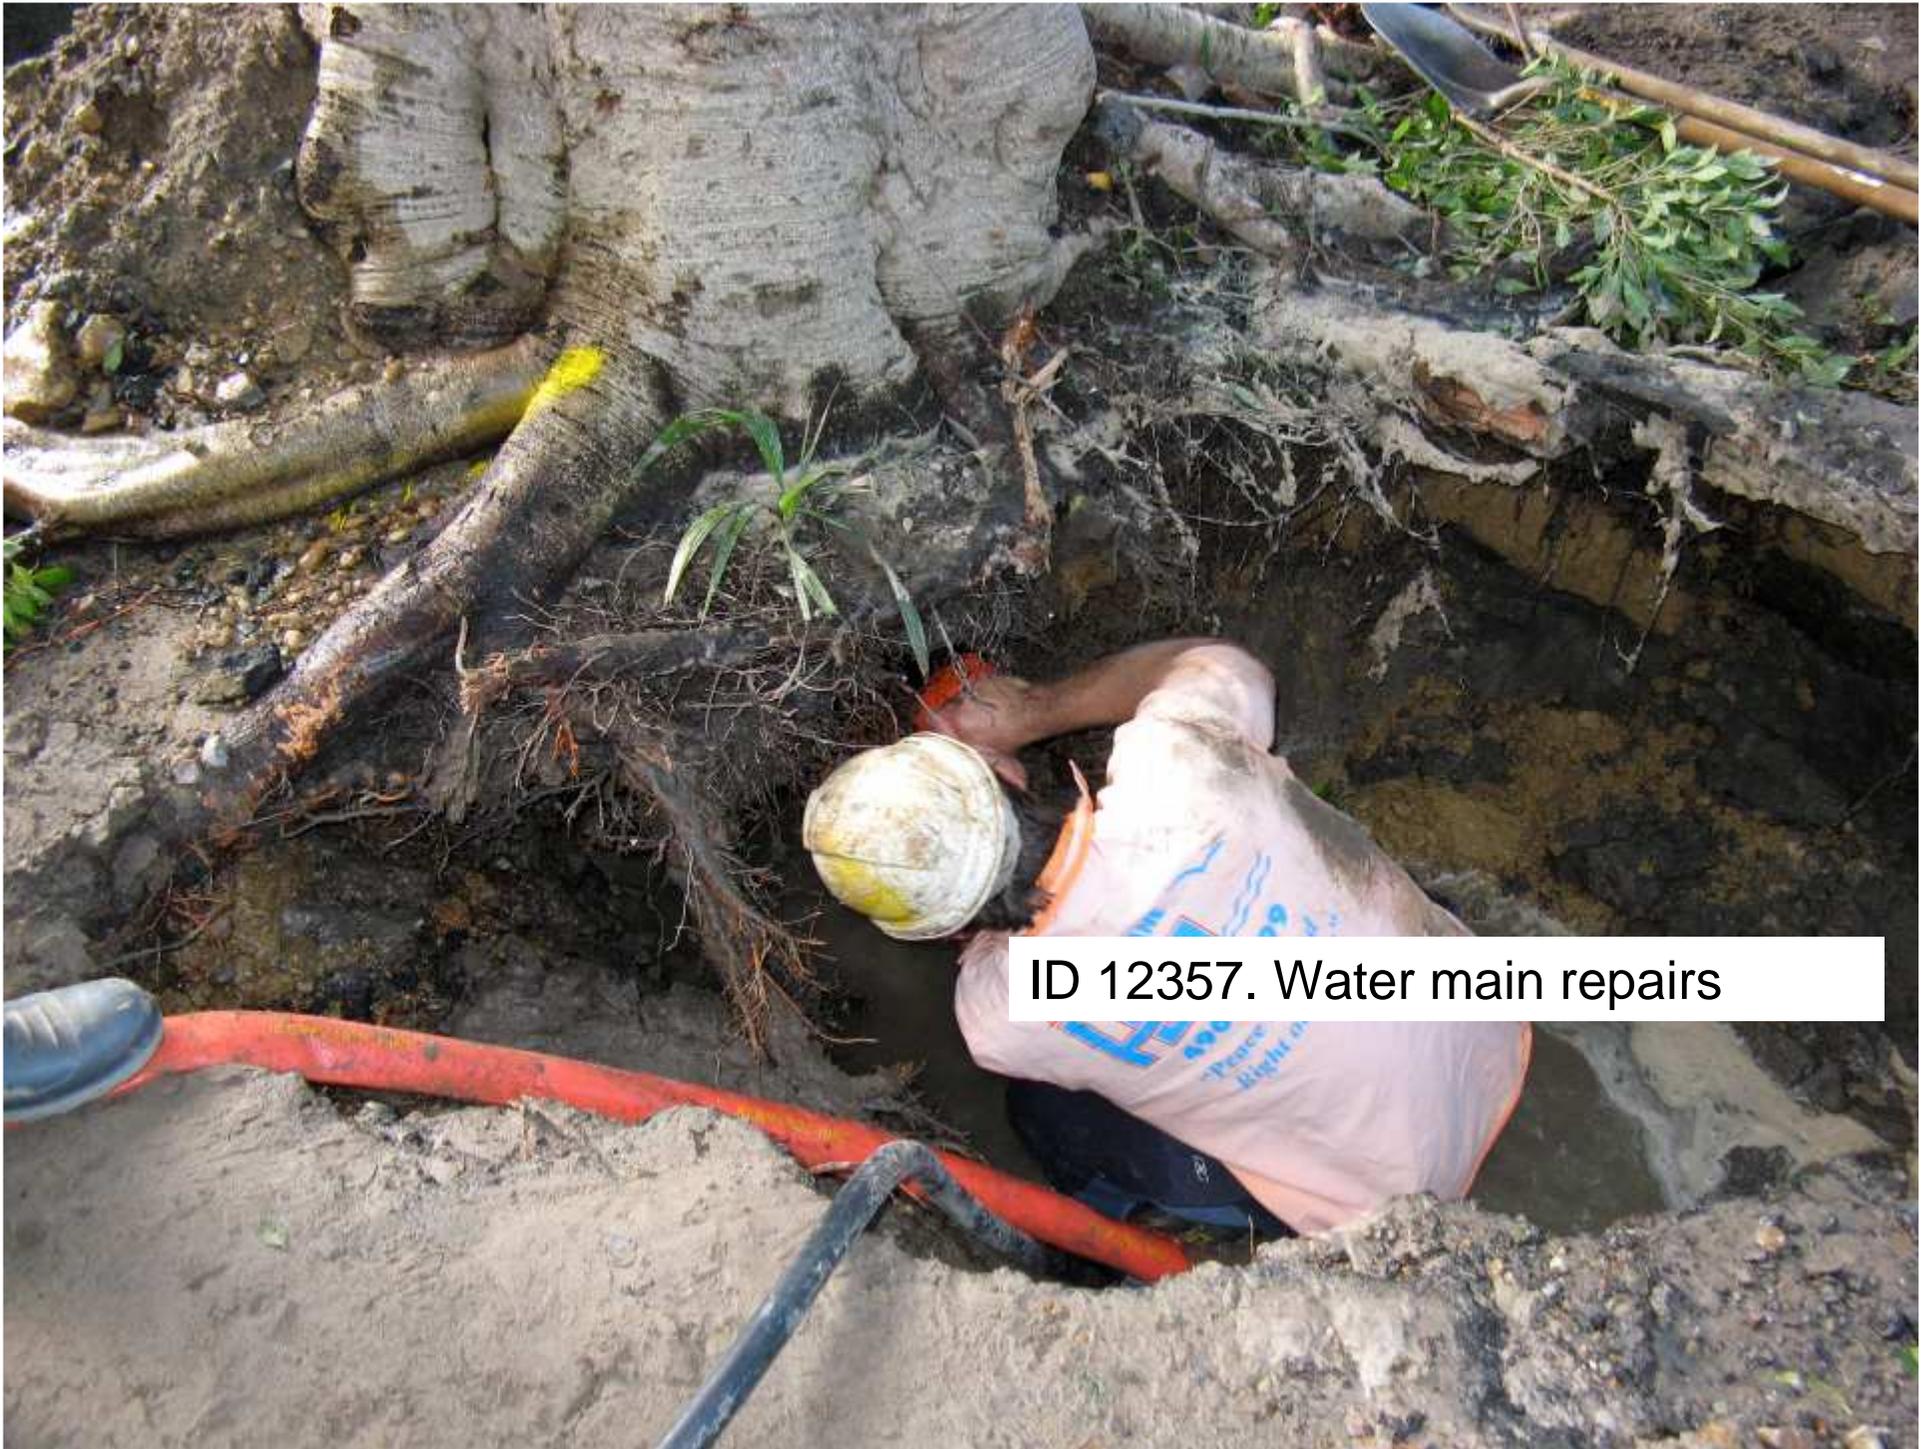
ID 12357. Water main repairs

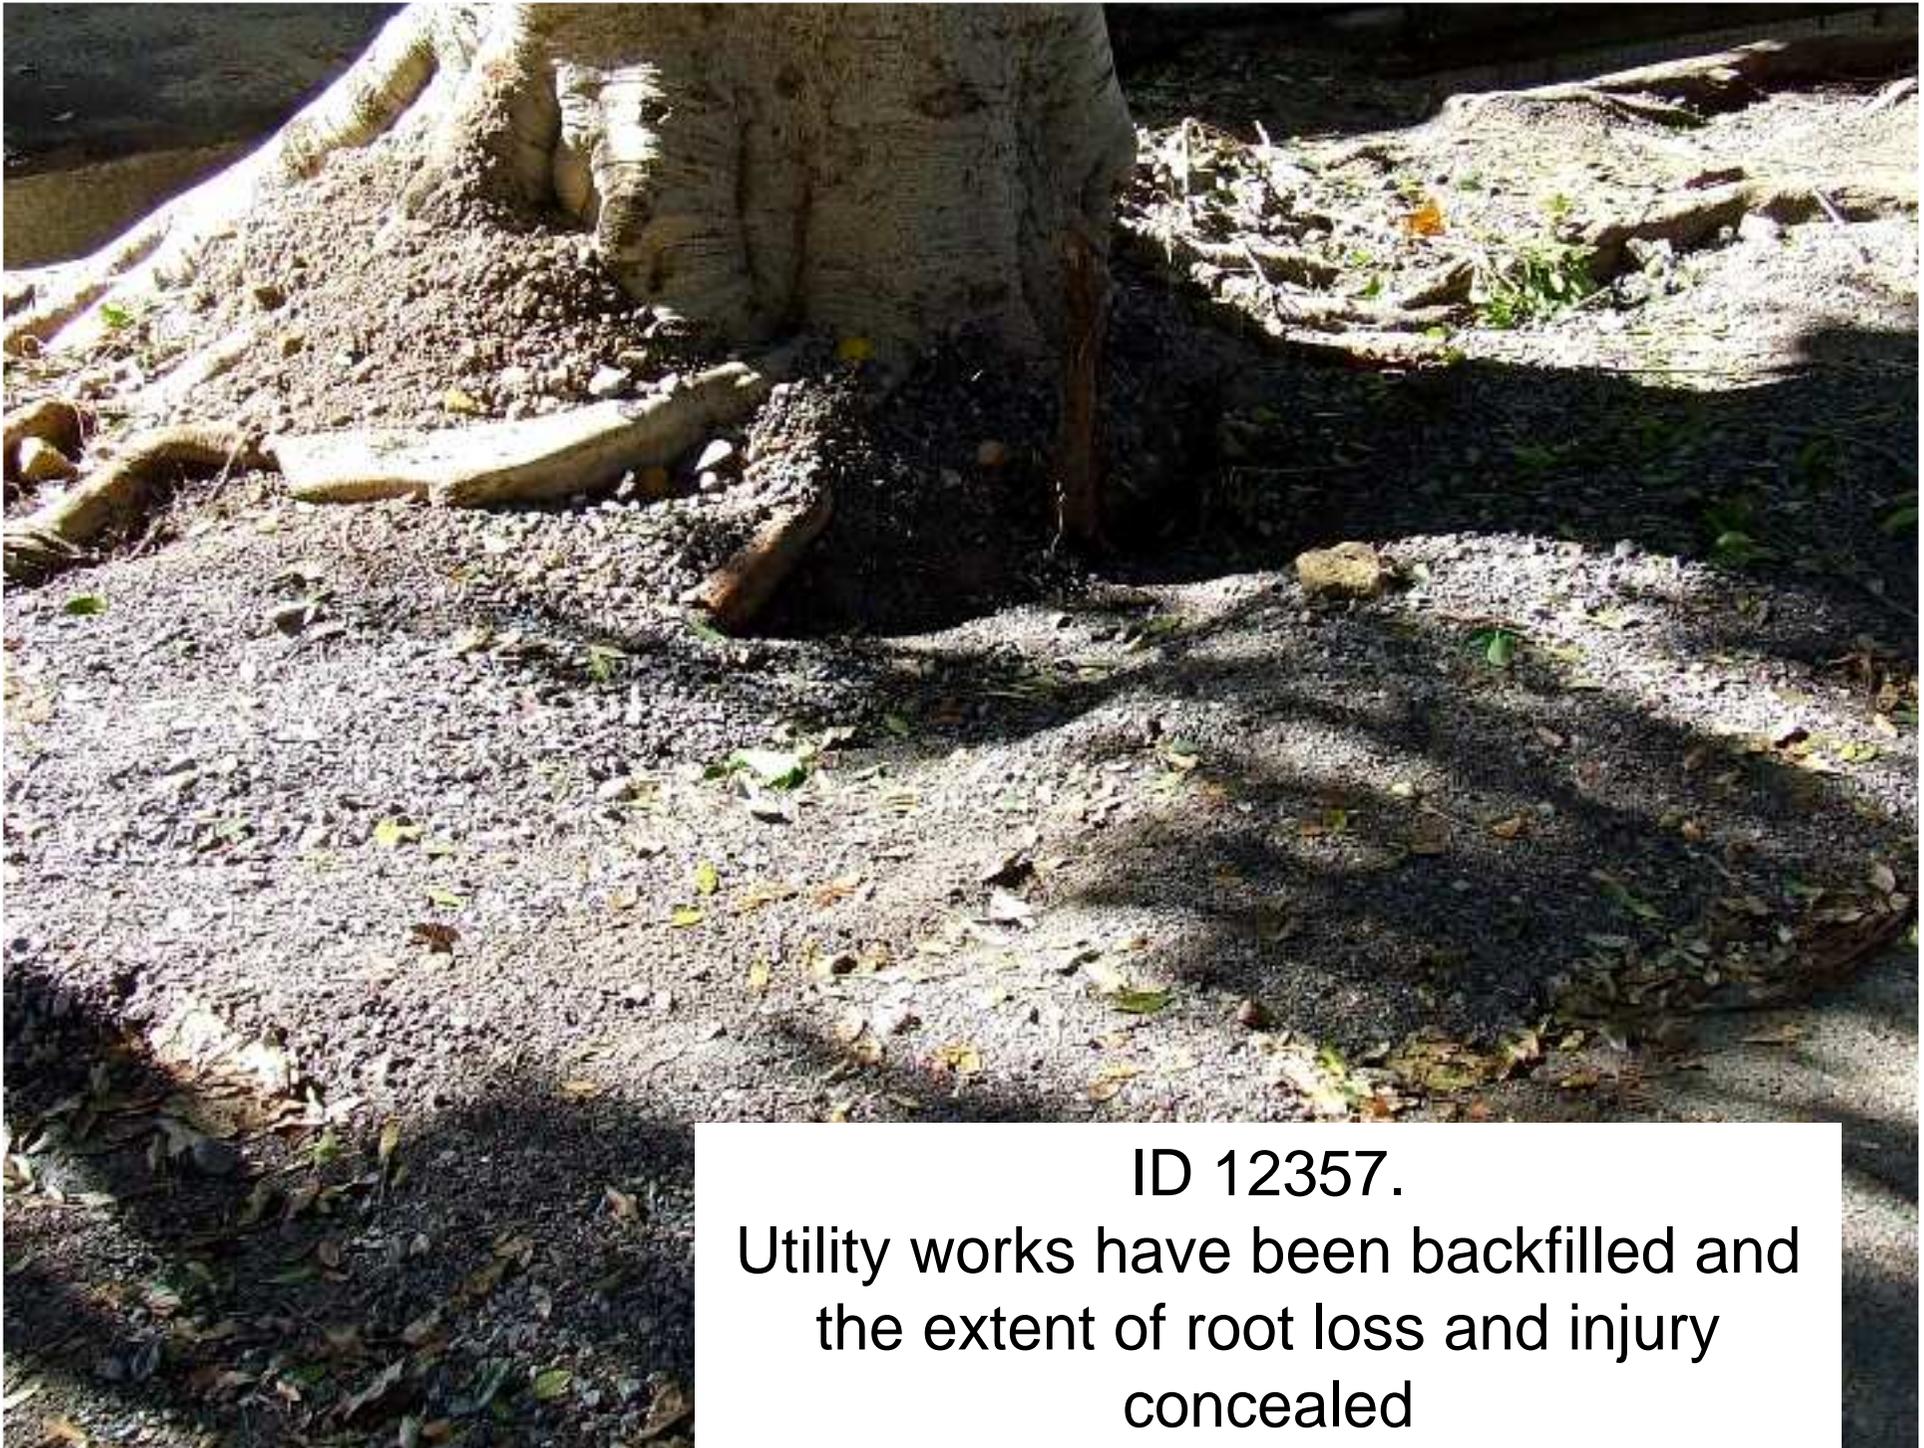
ID 12357.

Utility works have been backfilled and  
the extent of root loss and injury  
concealed

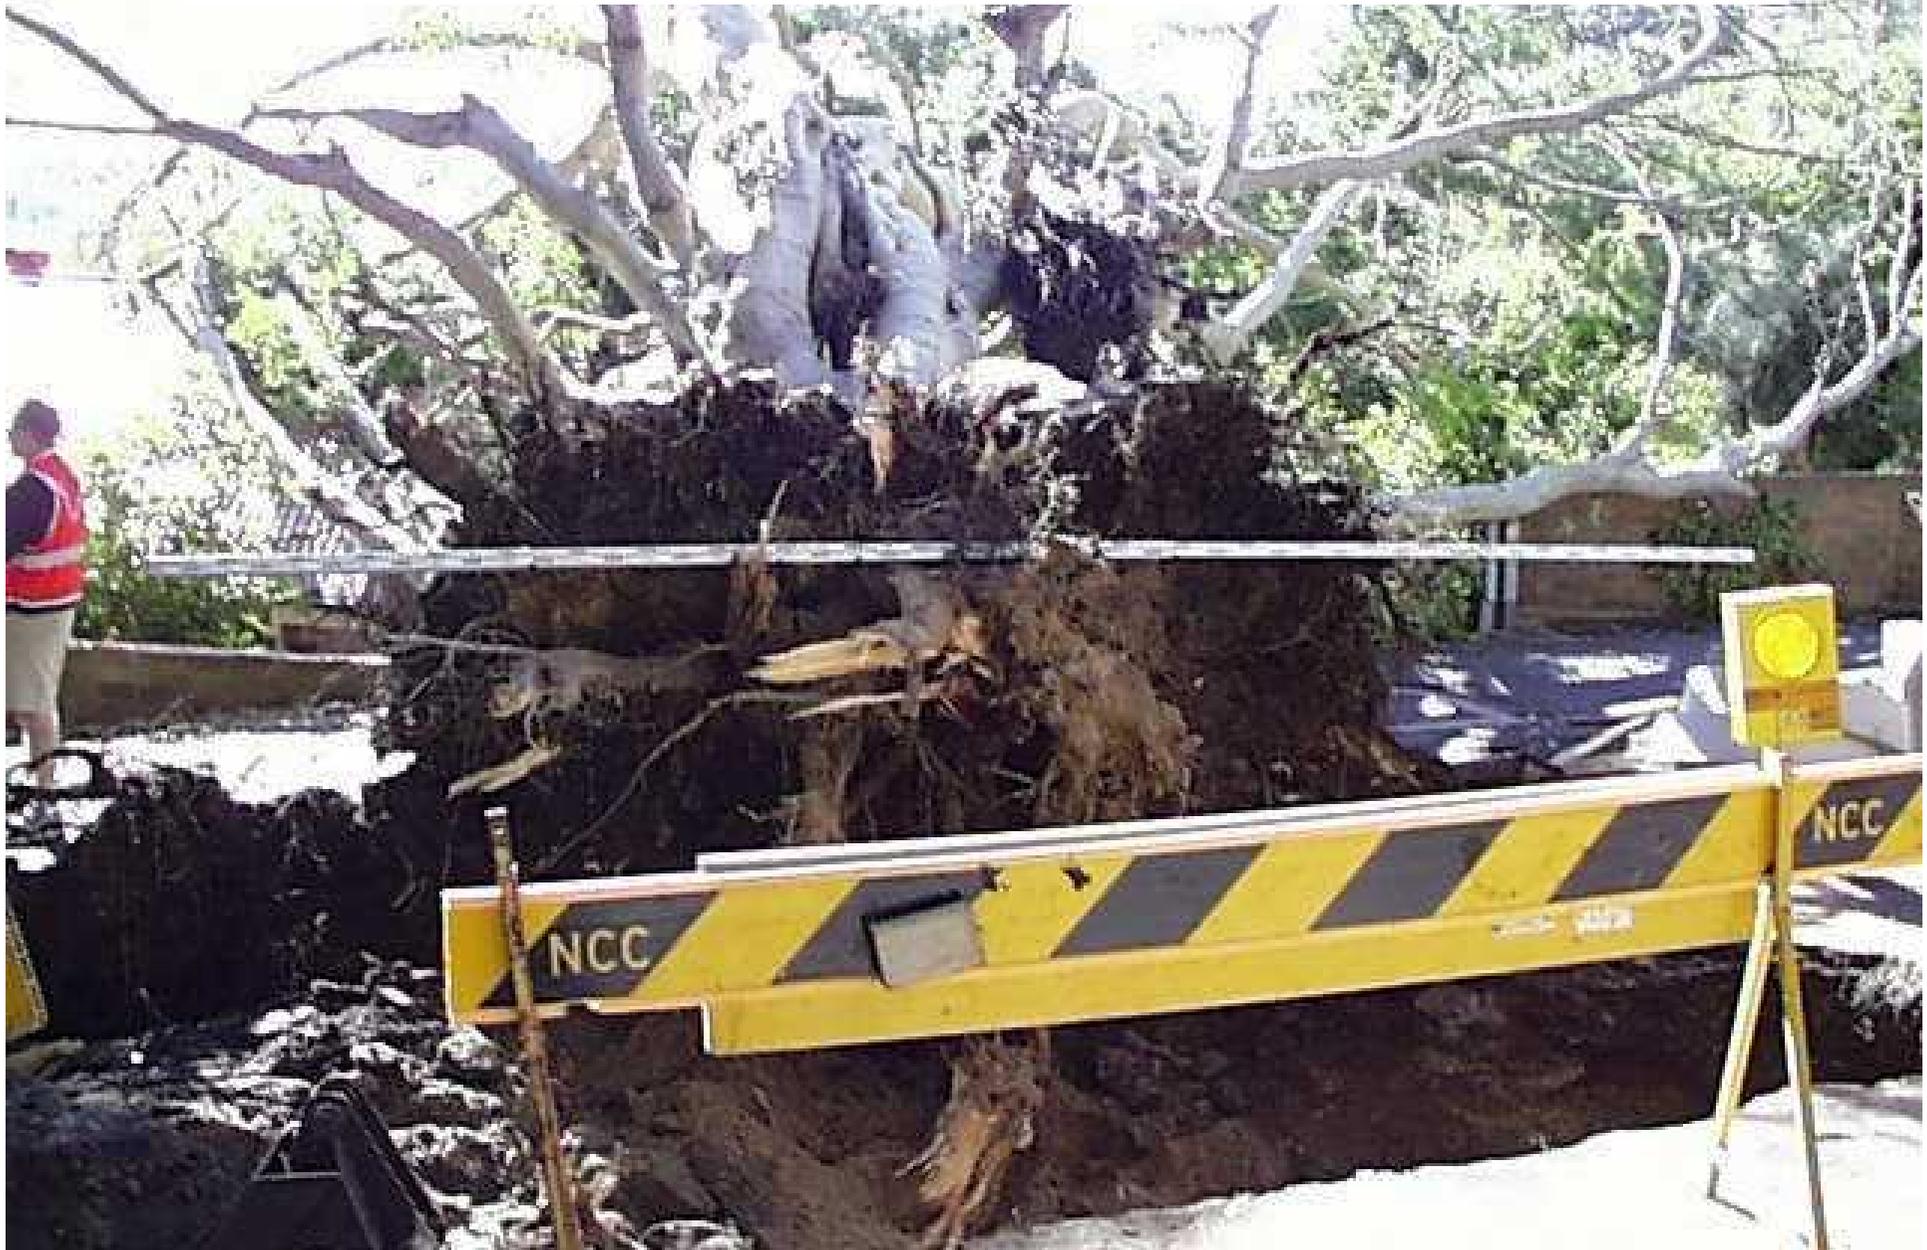
Gregson Park 2002 - Port Jackson Fig. Failure due to root decay and restricted root development

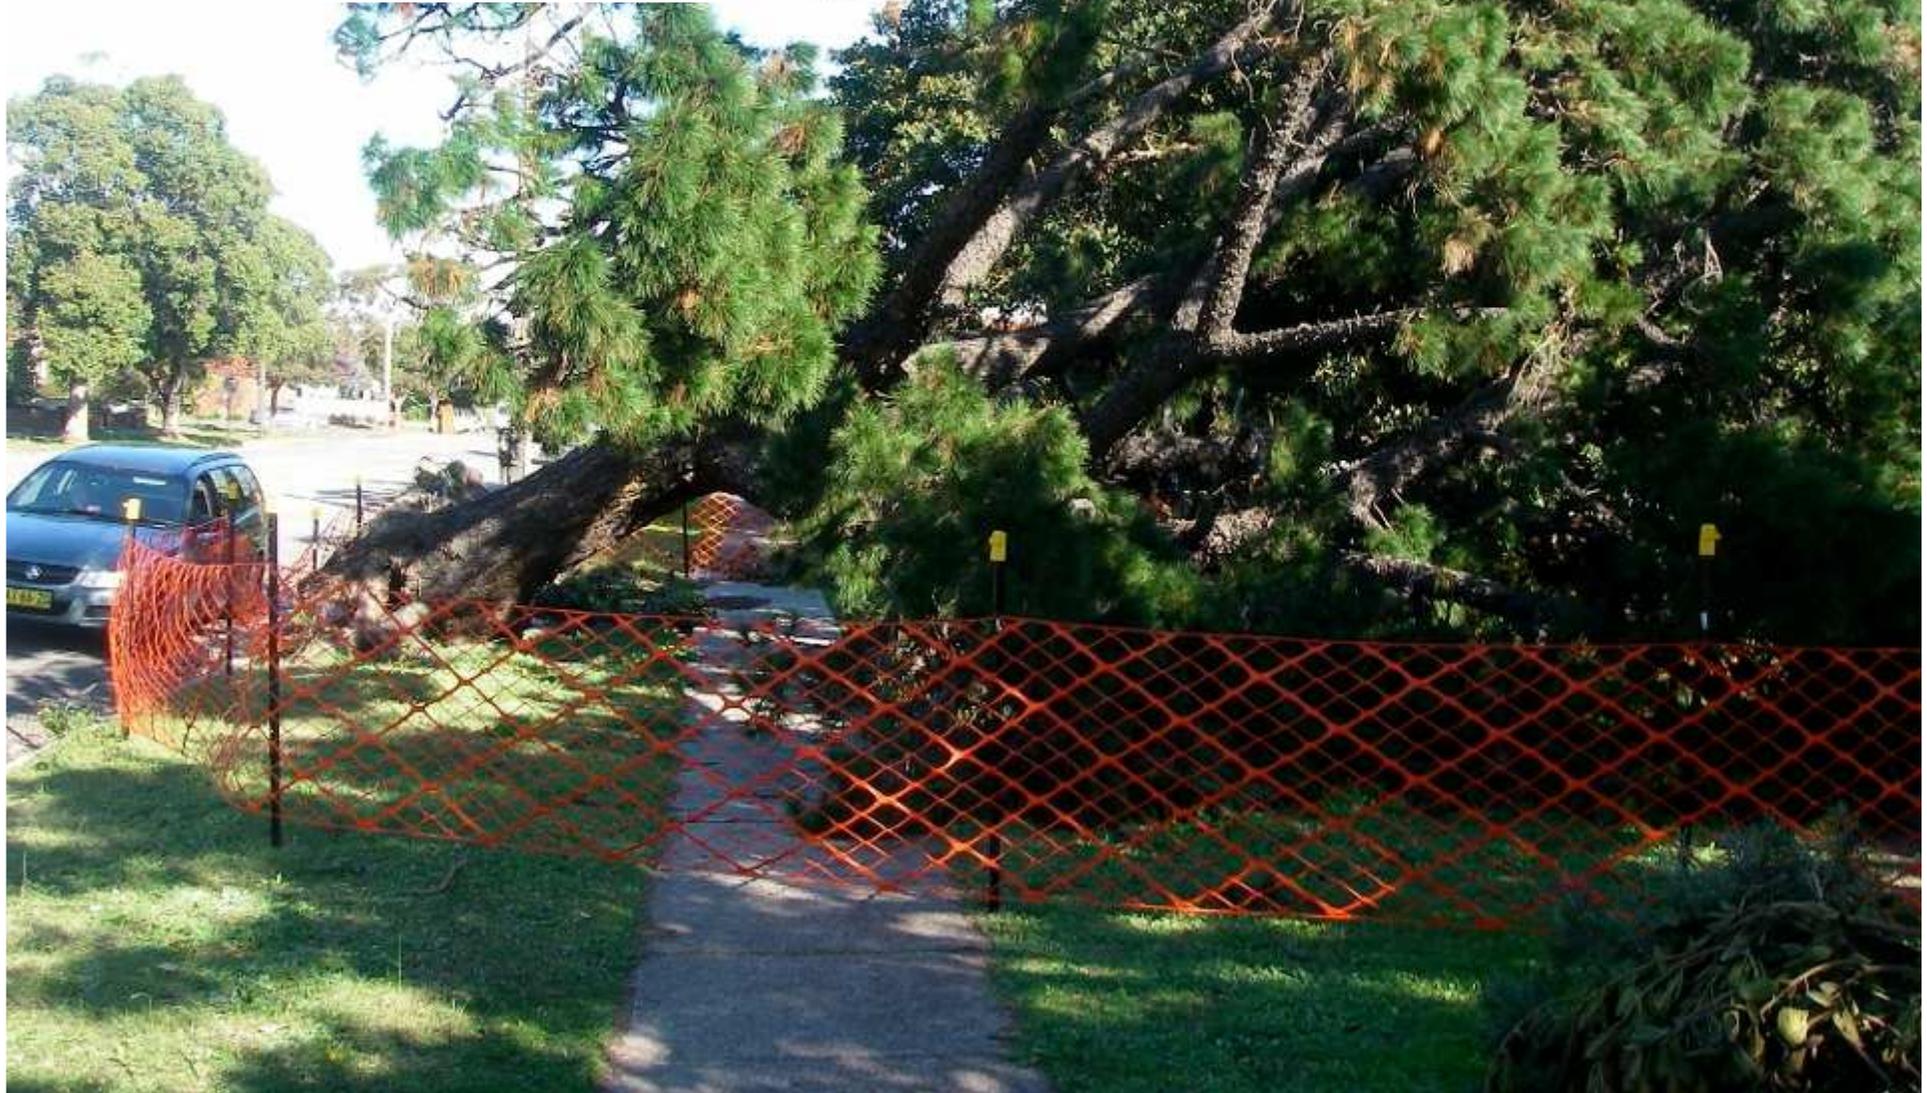
# Gordon Avenue 2007

Radiata Pine root failure due to  
linear root development

Linear (eccentric) root development in a large kerb-side tree requires further examination
