# Tree Failure Casebook History

Informing Tree Management in Newcastle

2000 - 2011

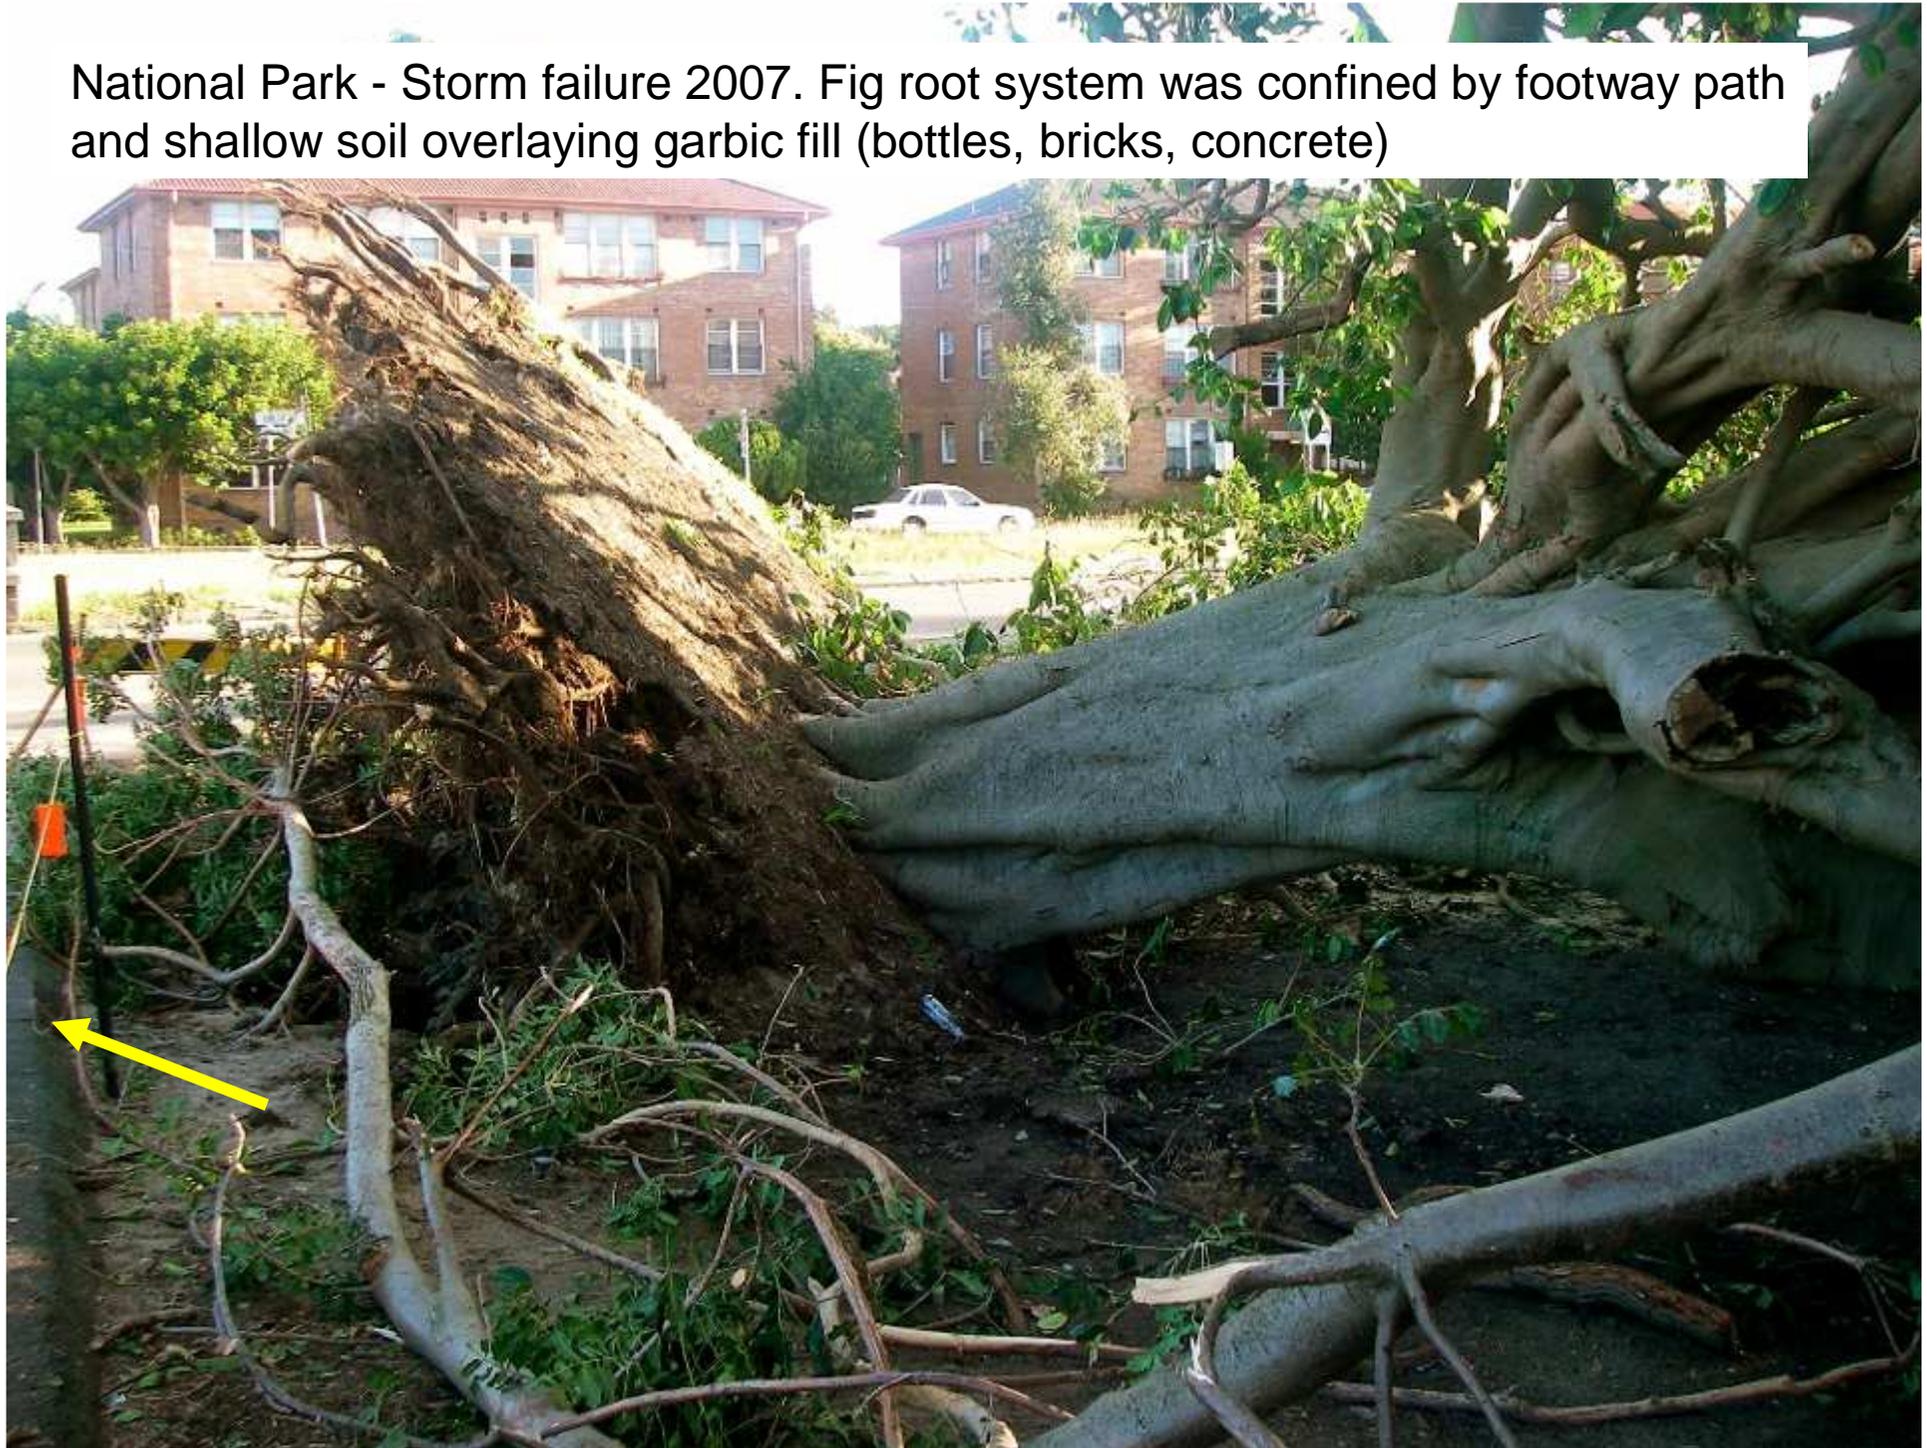
National Park - Storm failure 2007. Fig root system was confined by footway path and shallow soil overlaying garbic fill (bottles, bricks, concrete)

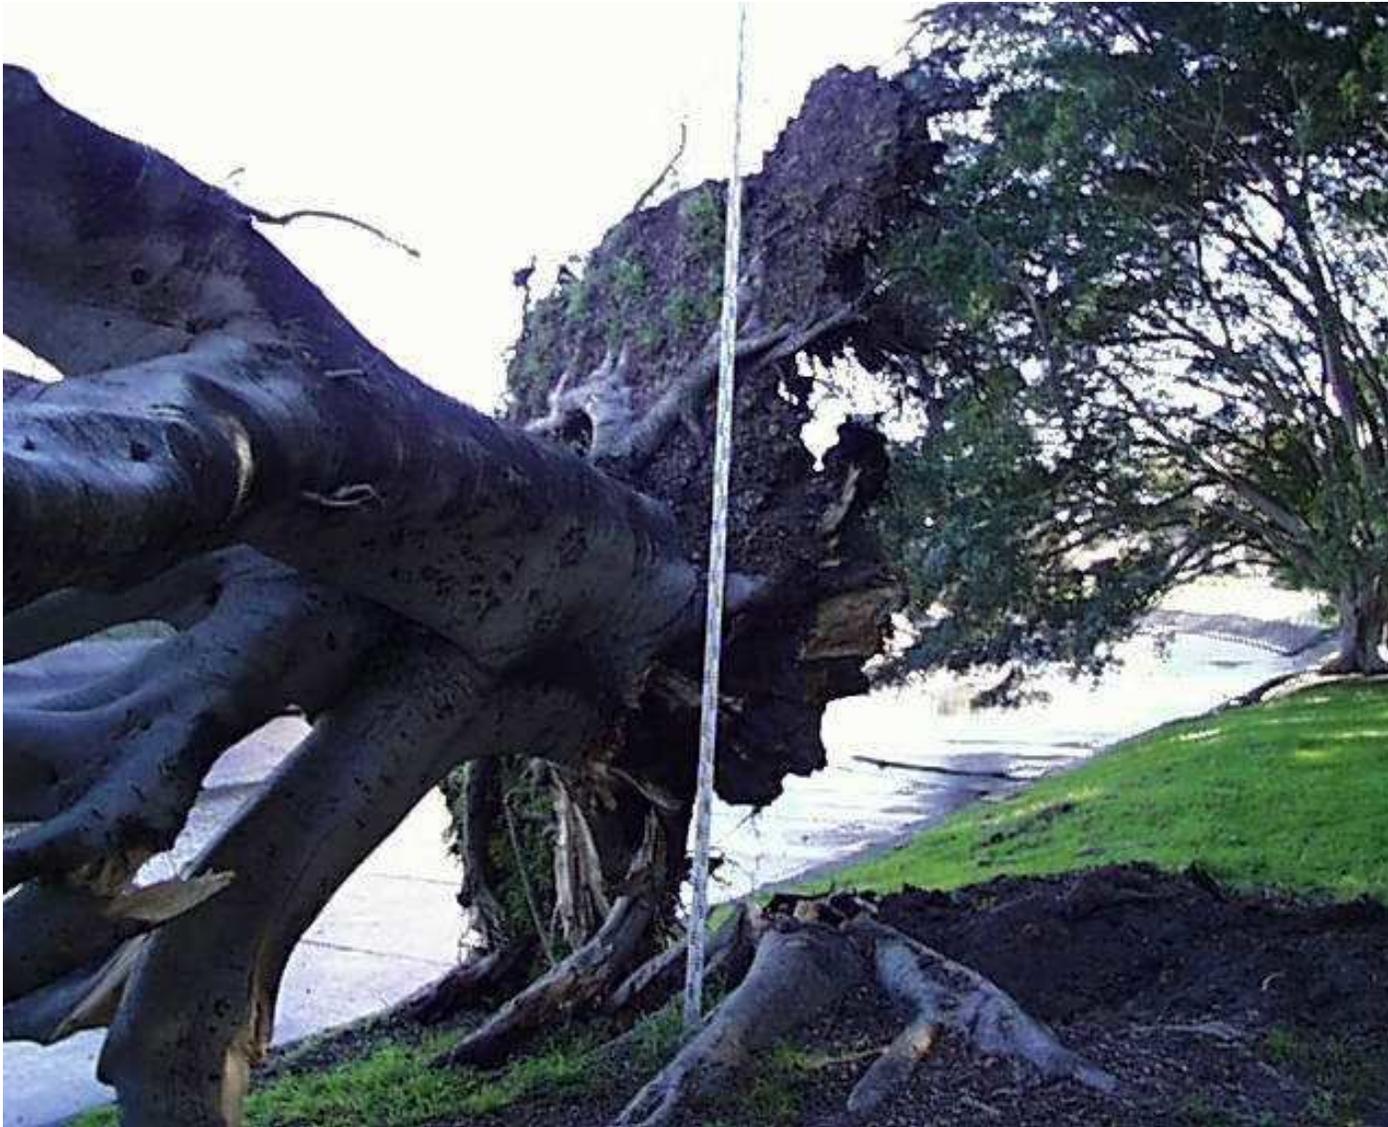
TAFE Campus, Tighes Hill. Failure due to decayed buttress roots

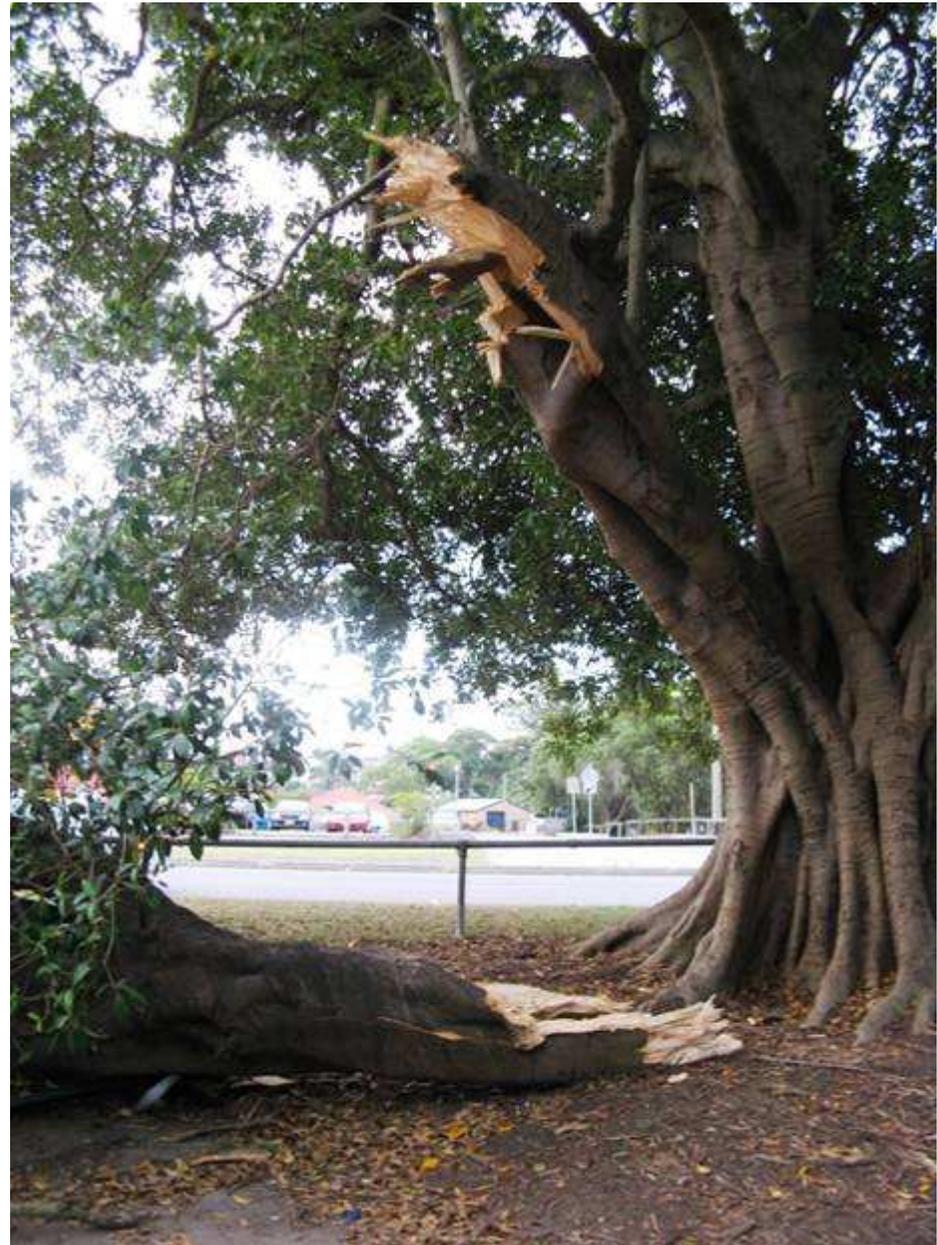
Port Jackson Fig at  
Wallsend Park.

Second branch failure  
incident

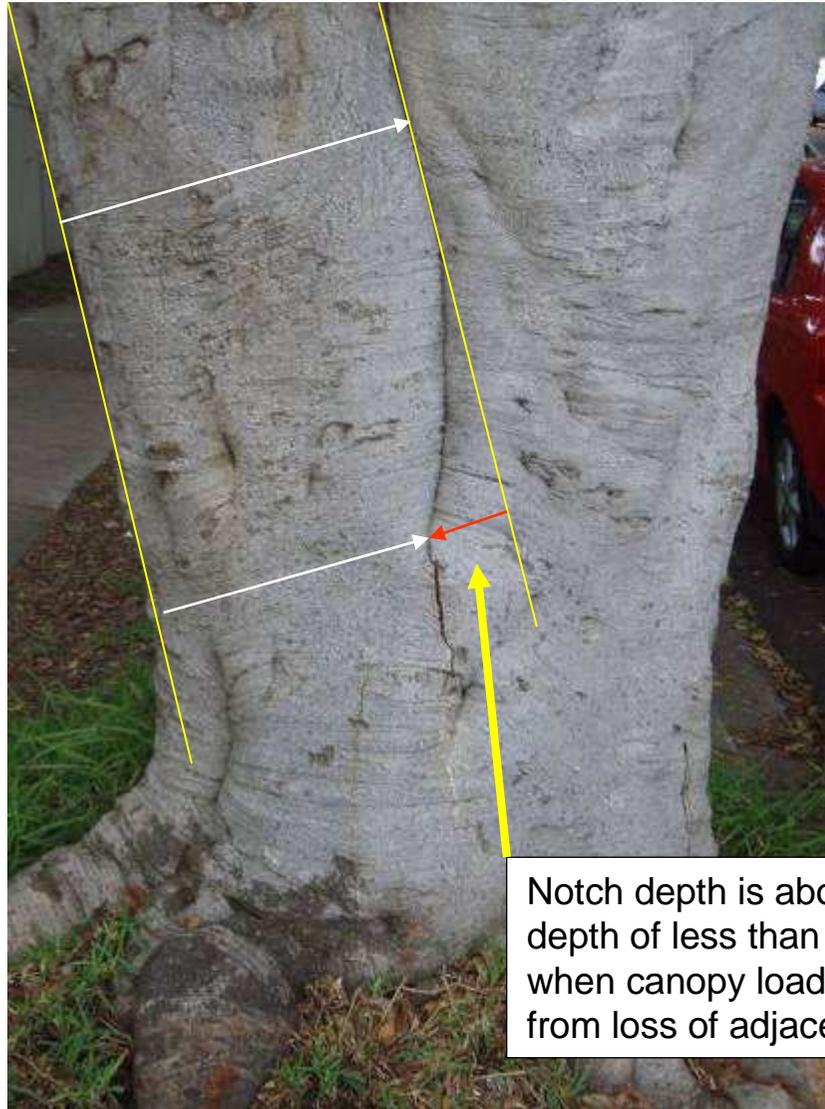
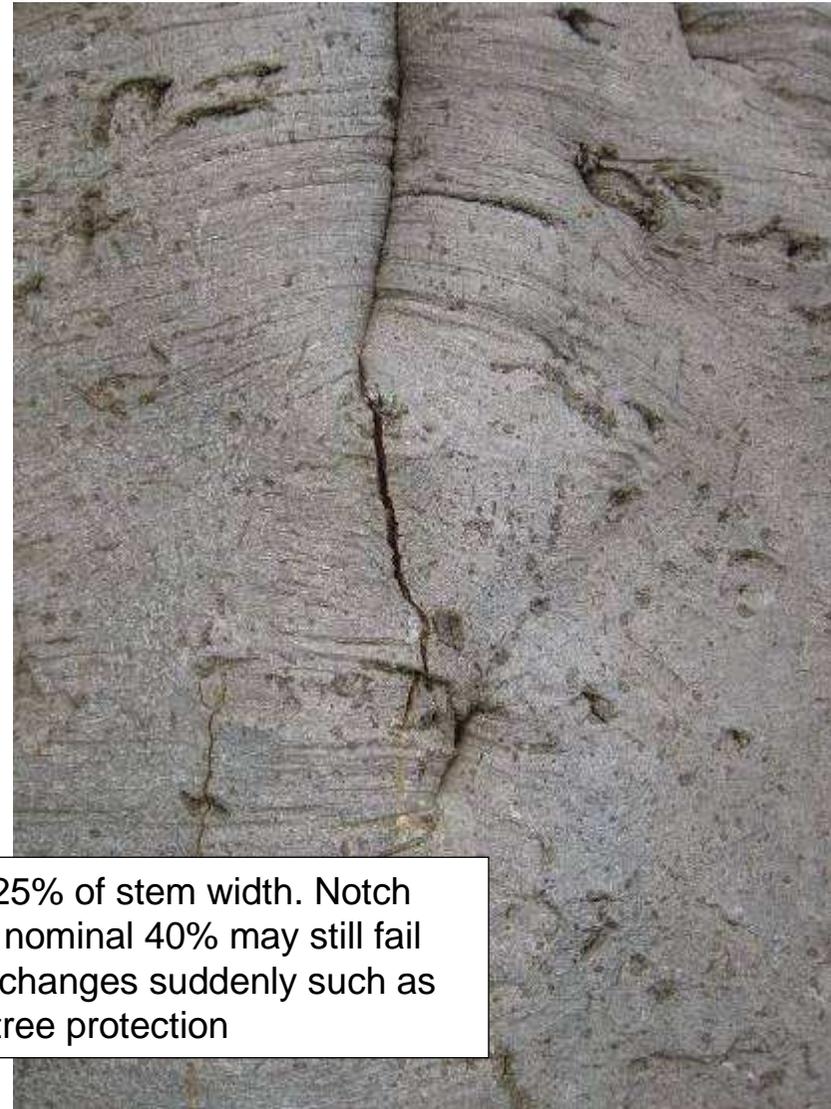
## Branch inclusion failure in Swan Street

Notch depth is about 25% of stem width. Notch depth of less than the nominal 40% may still fail when canopy loading changes suddenly such as from loss of adjacent tree protection

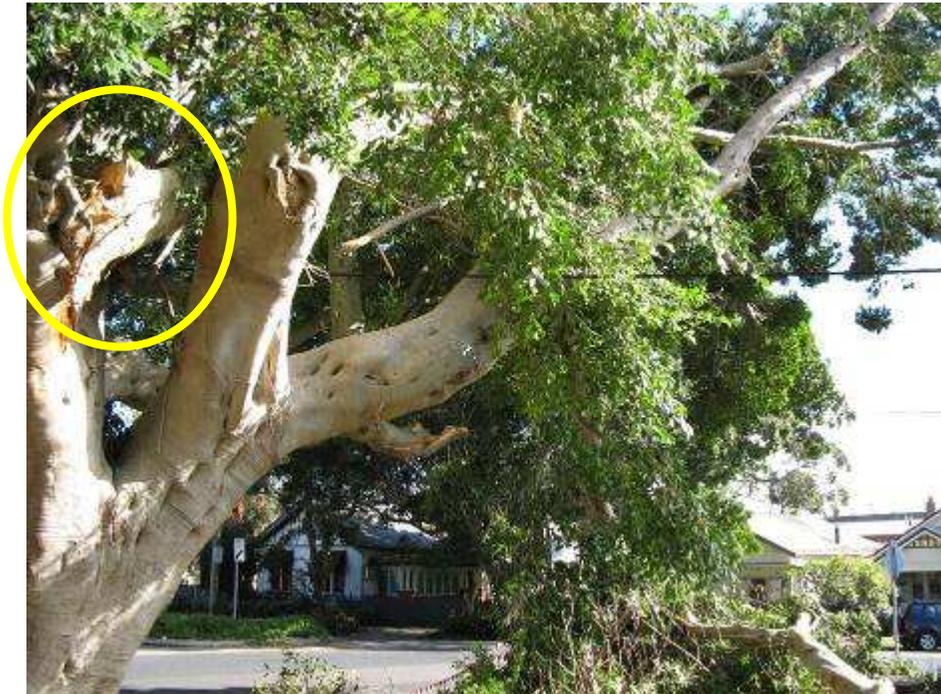
## Branch failure of Hills Fig in Swan Street 20 June 2007

Branch failure occurred at the weakened re-growth junction resulting from past lopping

The 'Pasha Bulka' storm that occurred on 7 June 2007 is likely to have fractured the branch which then totally failed on 20 June 2007. The tree was assessed and found to be at significant risk of further branch failures. Due to the high pedestrian use and built assets the only responsible risk mitigation option was tree removal.

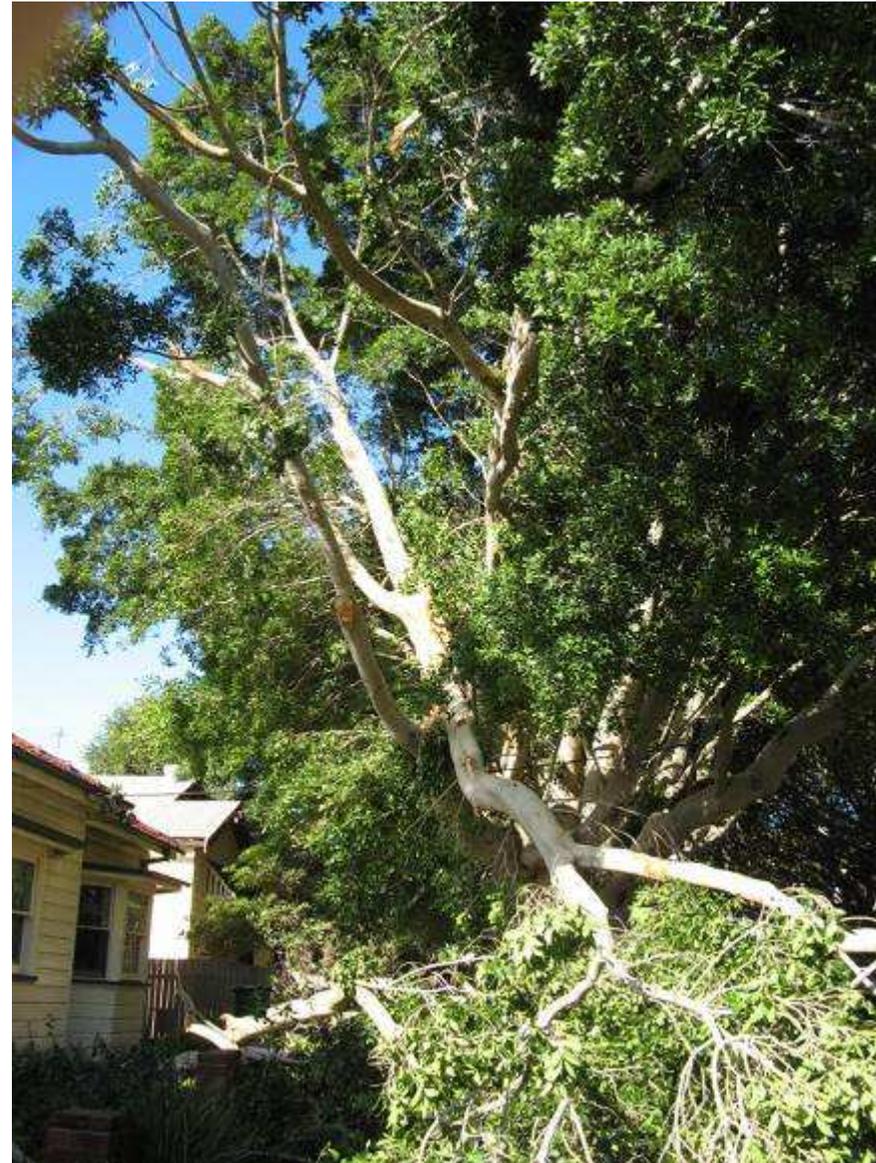
Trunk/branch inclusion failure (2009) at corner of  
Brooks Street and Swan Street

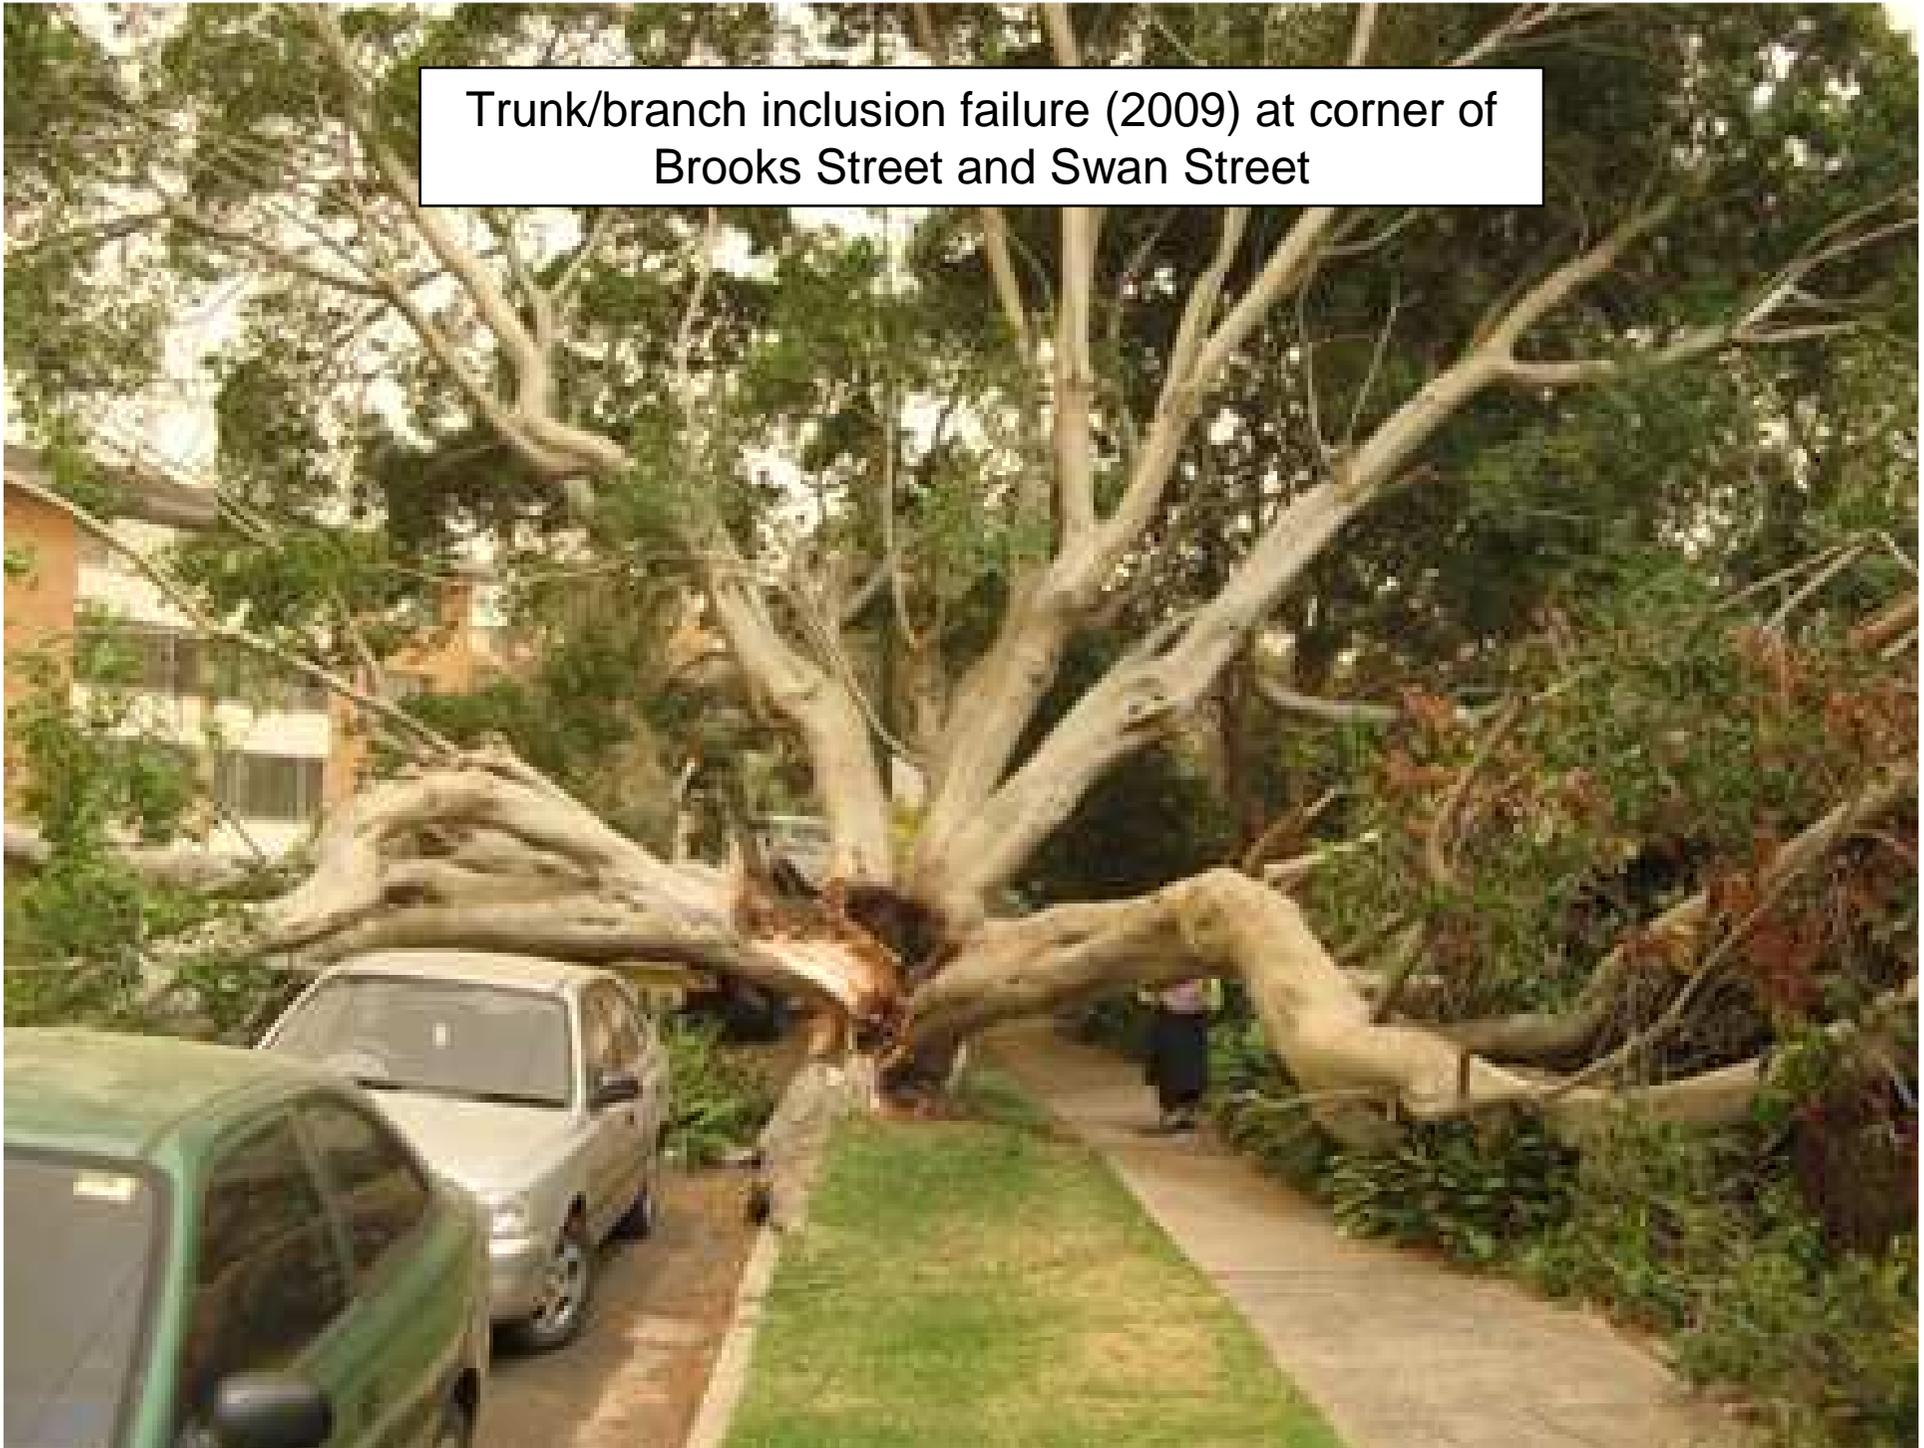
## Corner Brooks and Swan Street 2009

The typical form of multiple compression forks, here creating a 'cluster wedge' stem configuration. Each stem exerts pressure on the adjacent stem. As the stems increase in length and weight, wood growth in the compression area at the stem base acts like a wedge, leveraging the stems apart until failure.

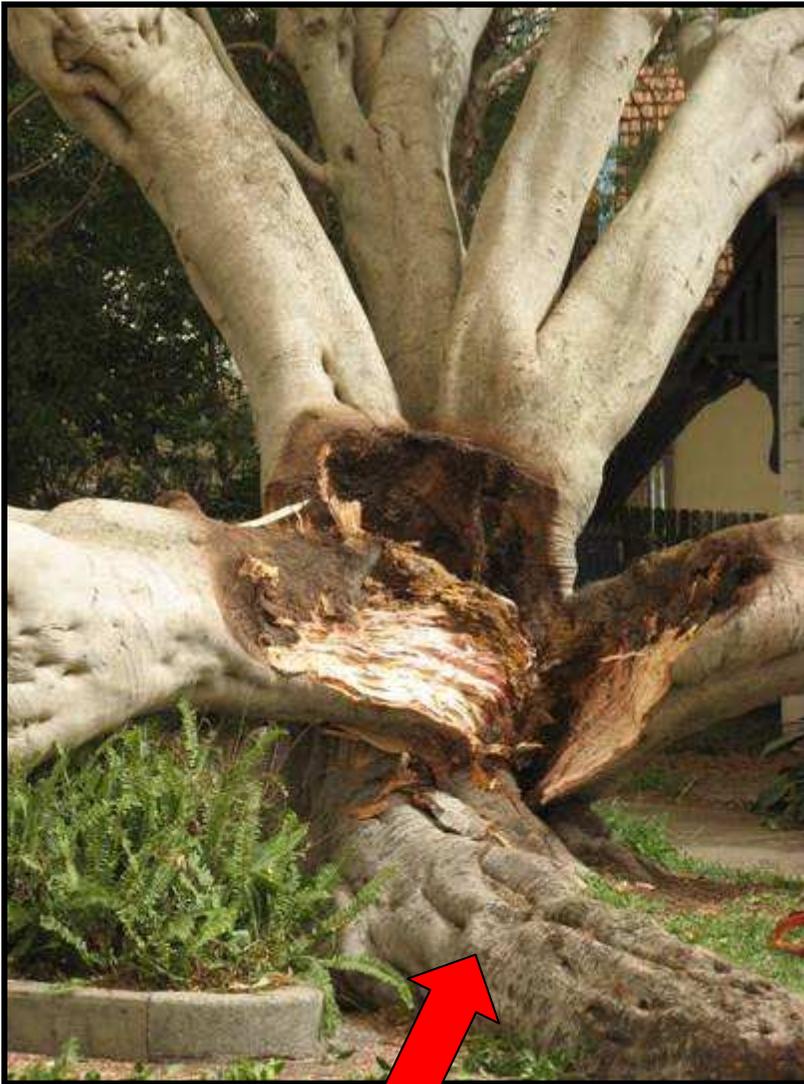
Single massive linear root aligned with kerb direction

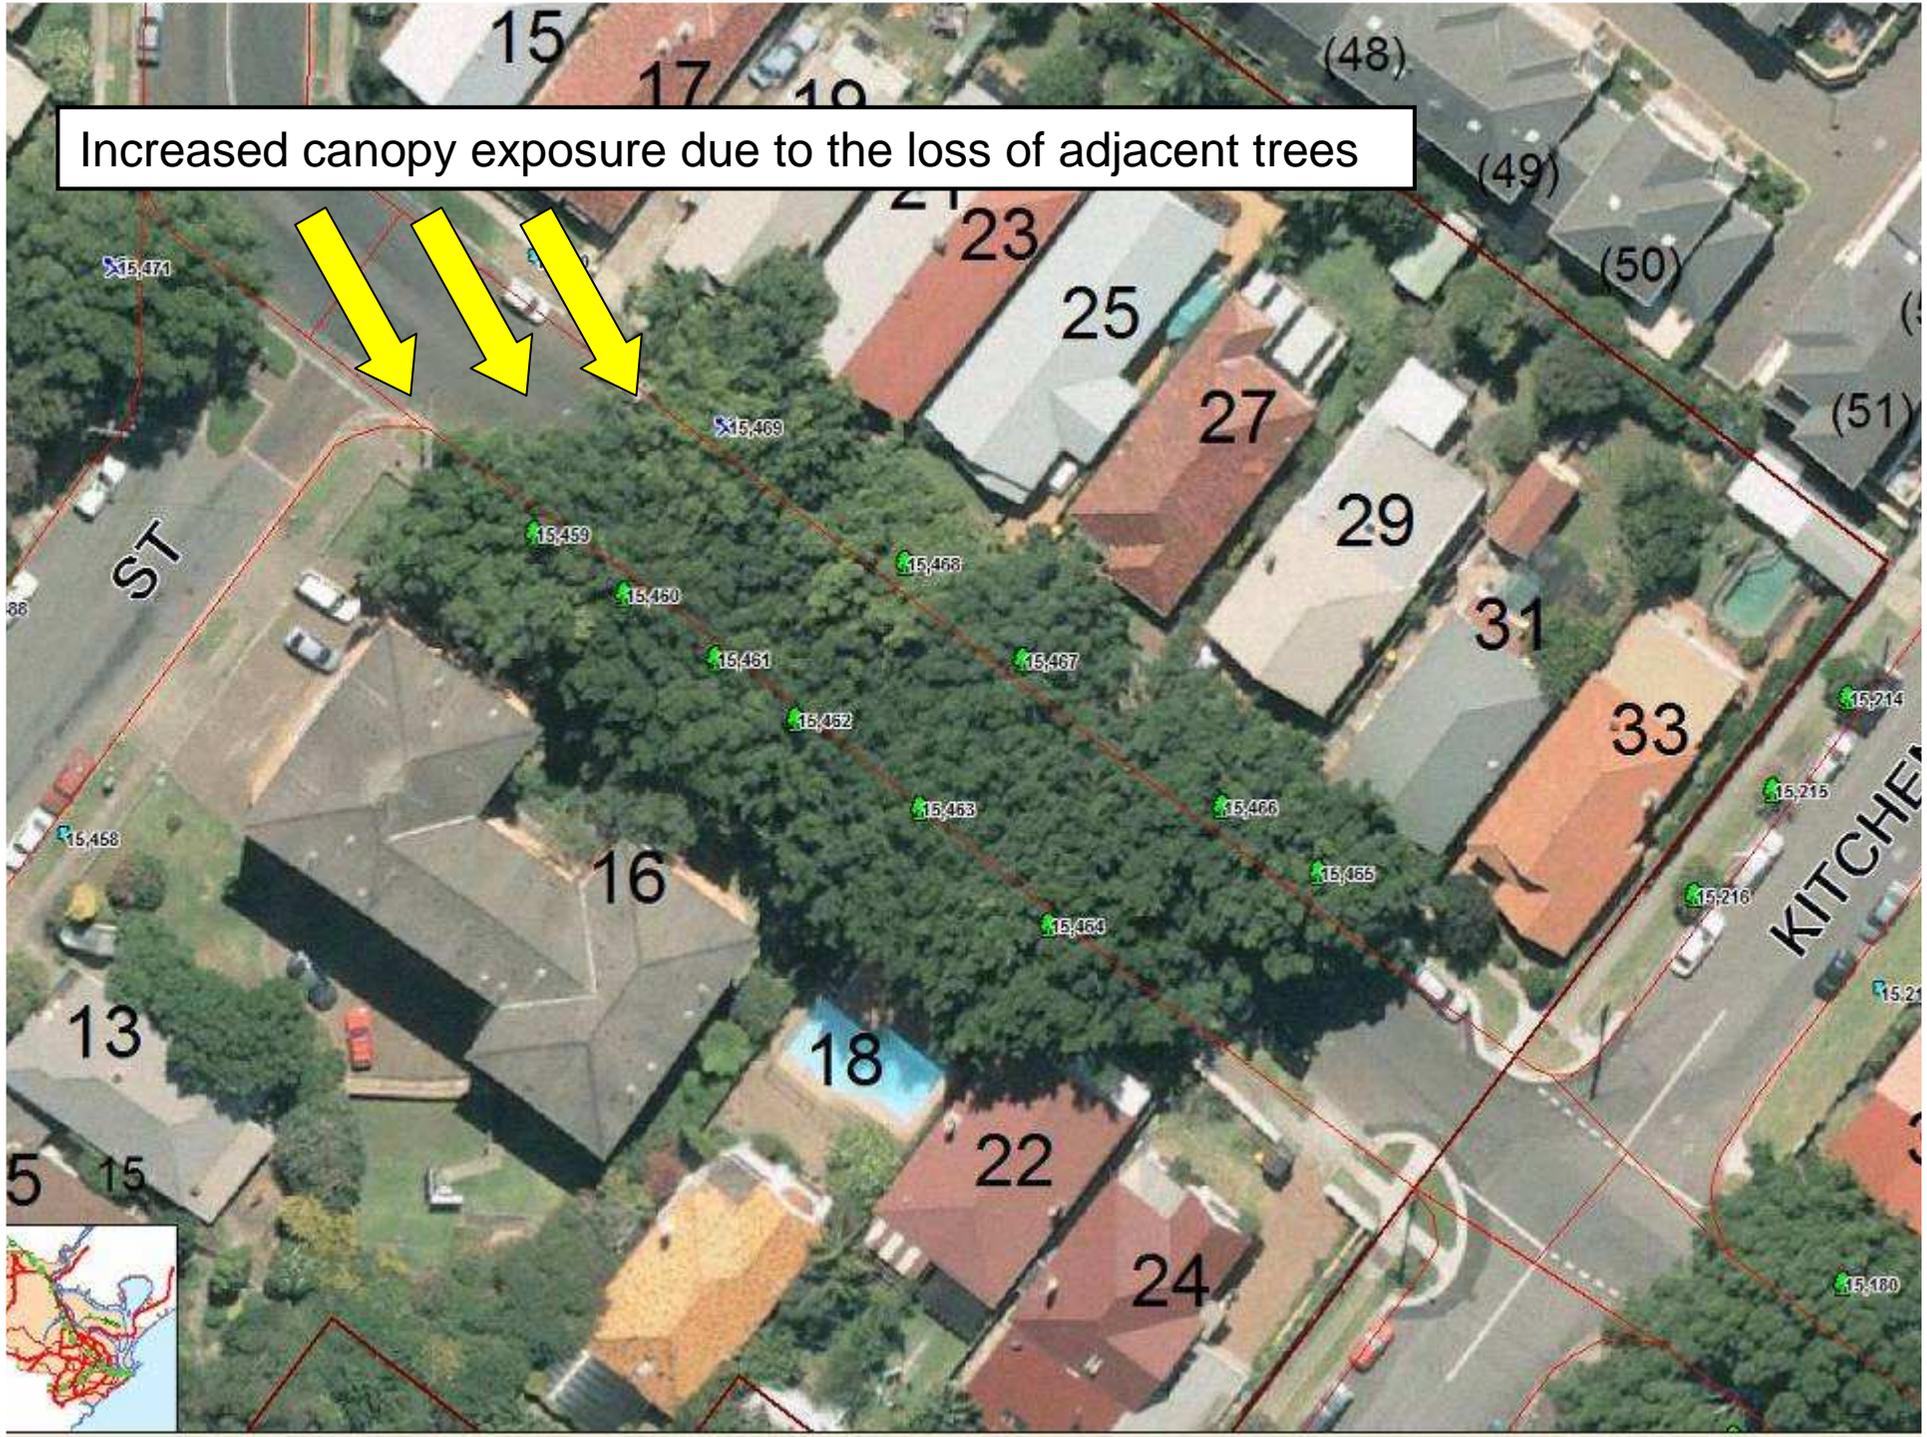
Increased canopy exposure due to the loss of adjacent trees

Increased wind loading after the removal of the adjacent tree contributed to the failure at the branch inclusion defect.

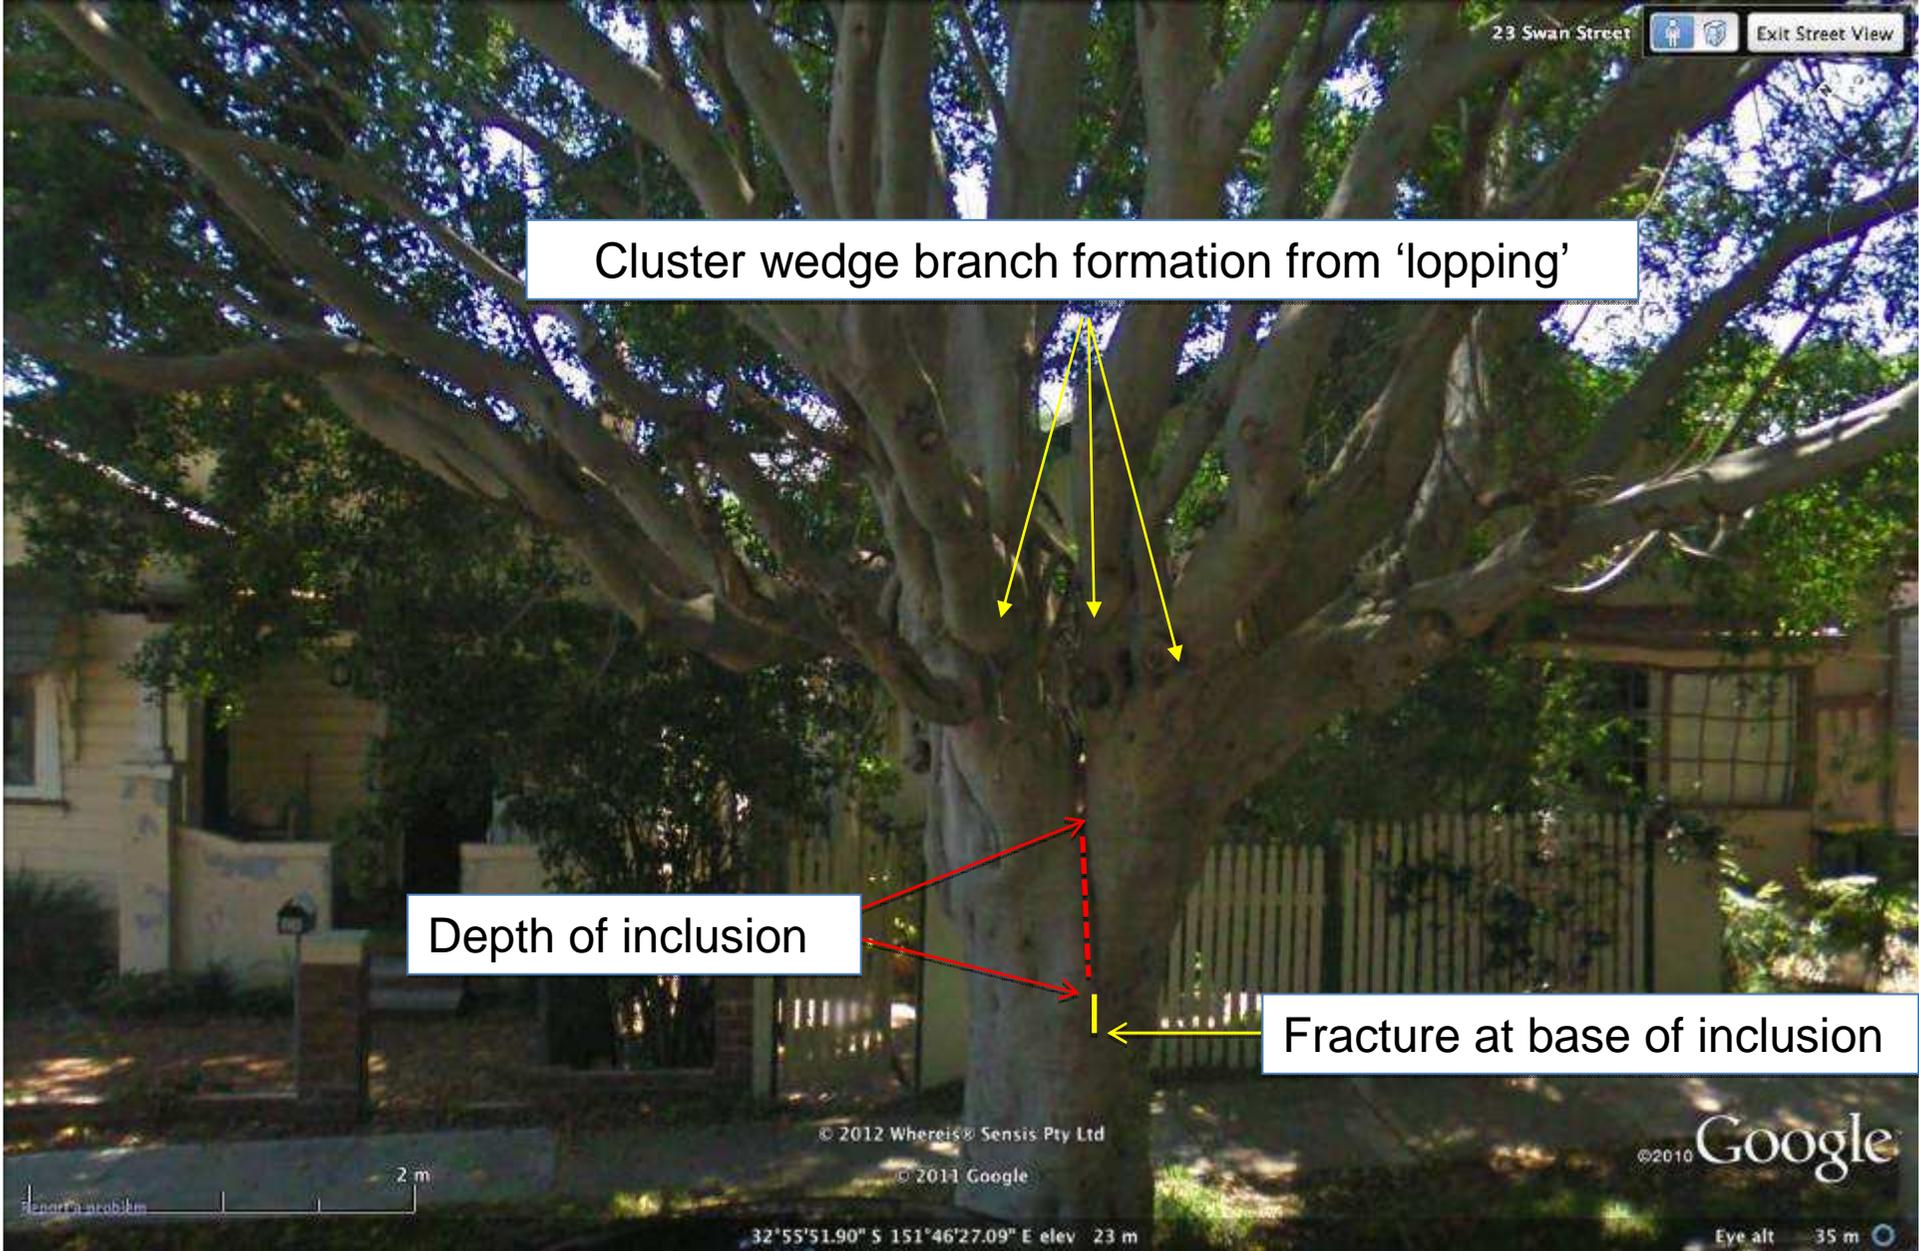
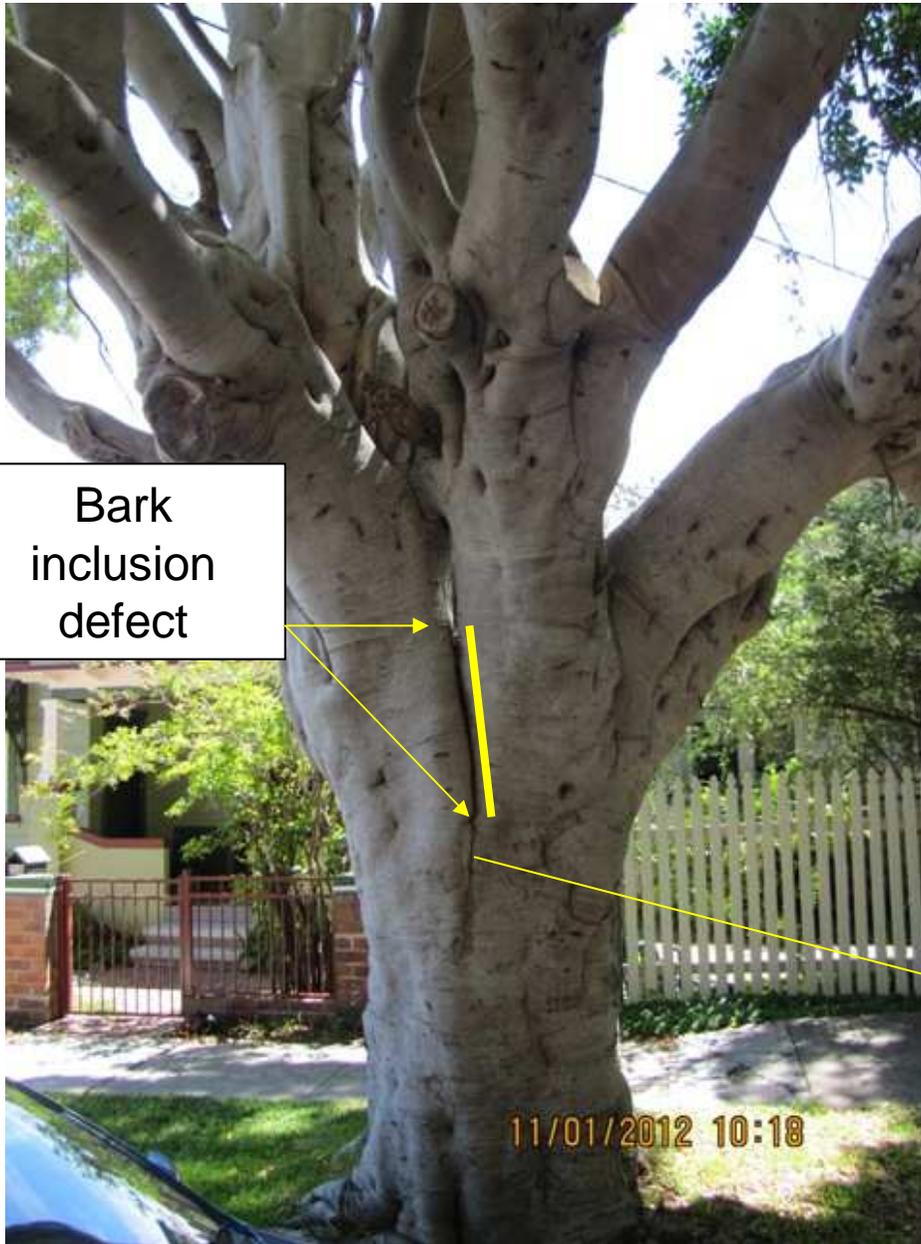
Tree ID 15469 (21 Swan St )

Bark inclusion defect

Stem separation as a consequence of bark inclusion

Tensile fracture at the base of the branch inclusion

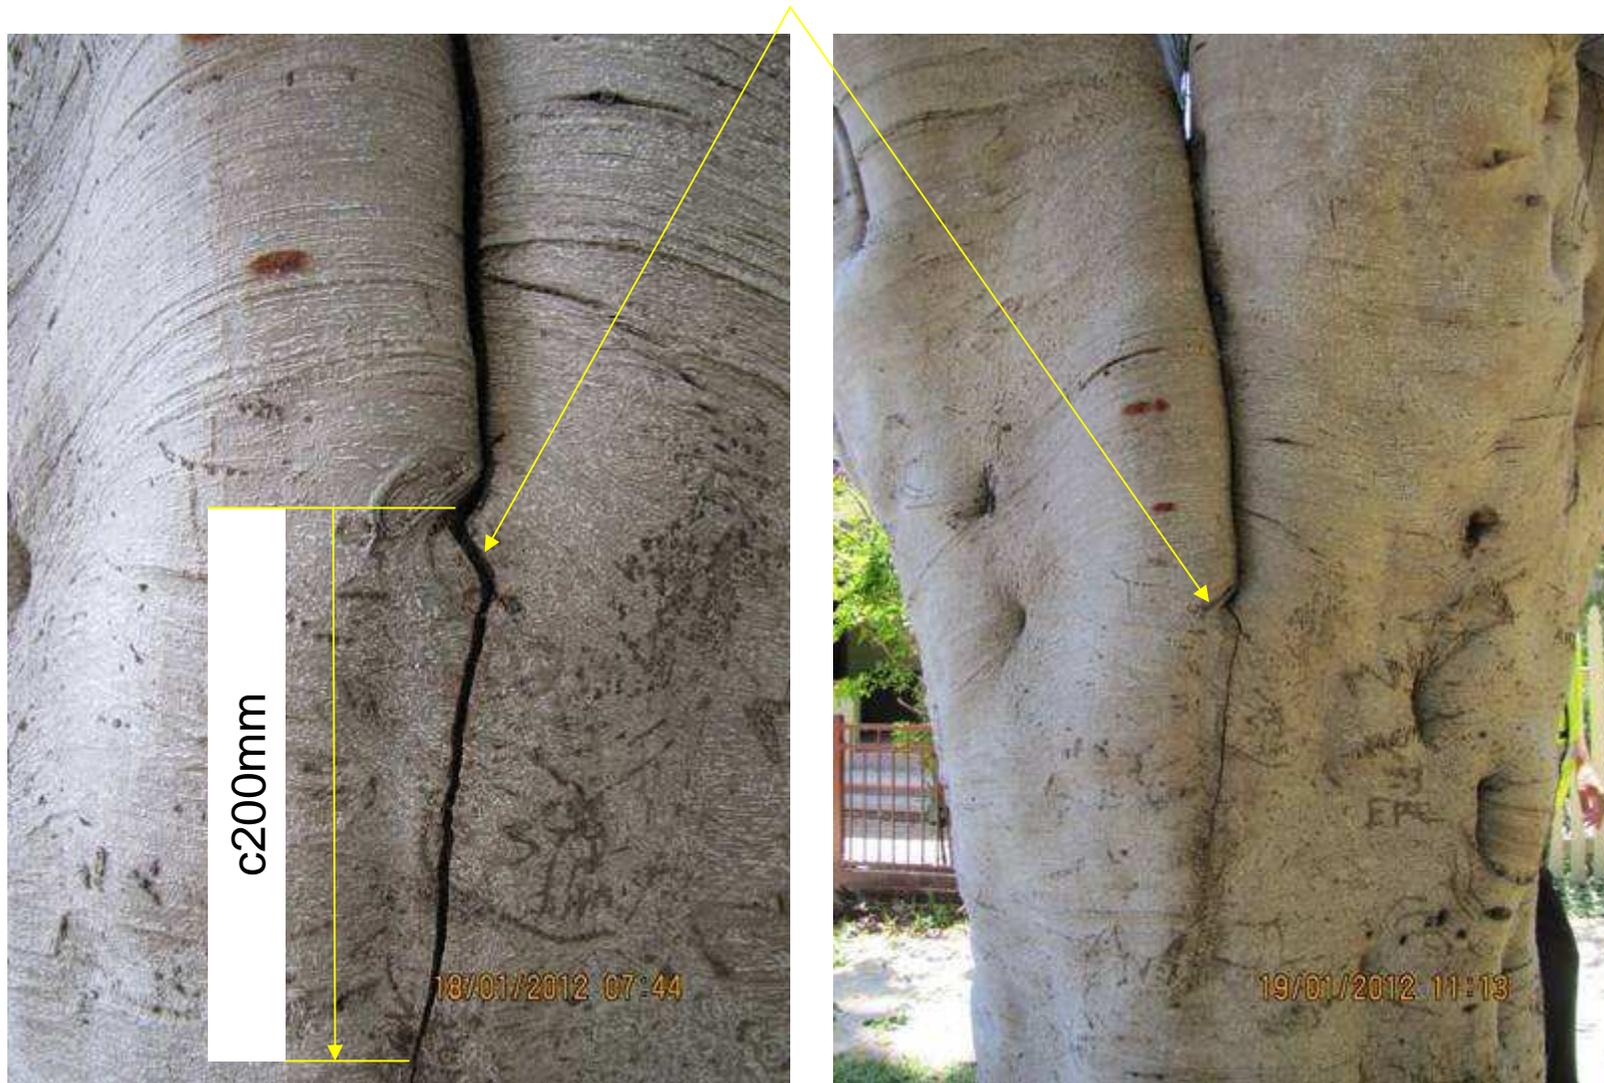
Road side crack & stem closure after the tensile load was reduced during felling

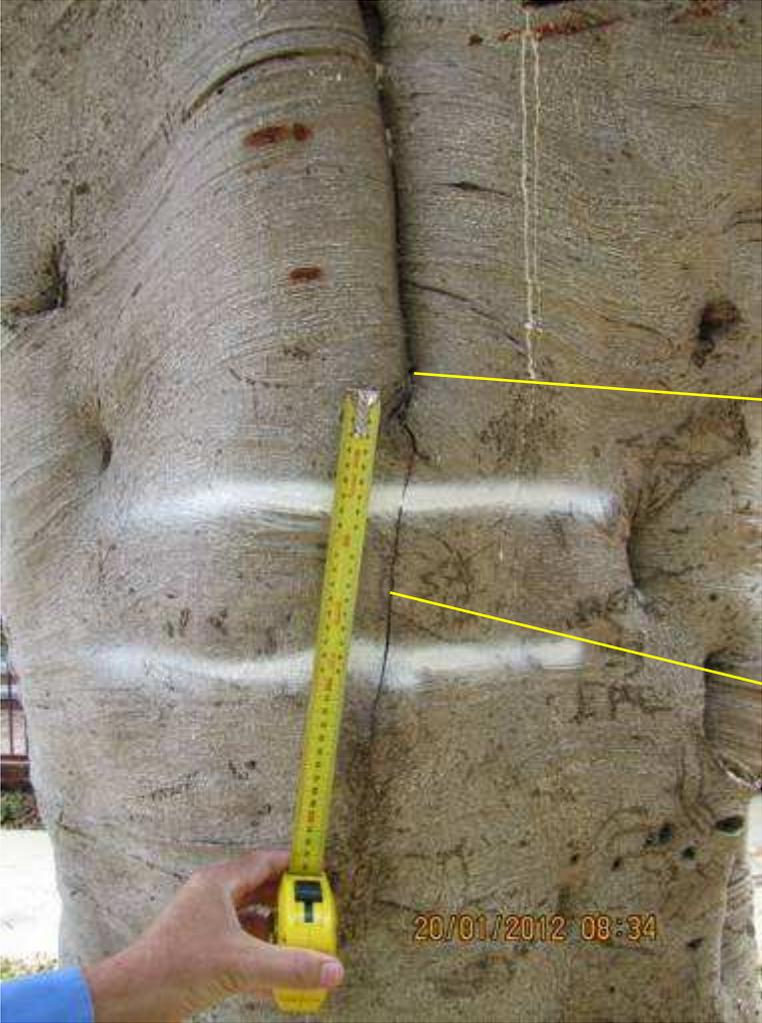
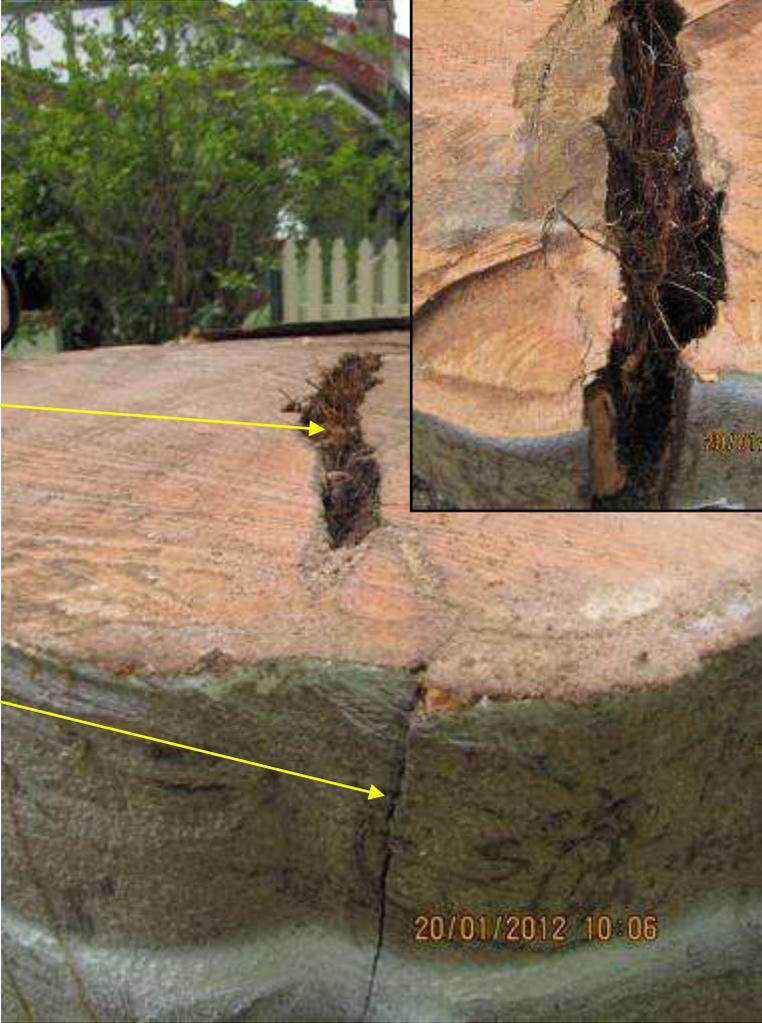
Road side compression fork with branch inclusion as an internal structural defect
