# Tree Failure Casebook History

Informing Tree Management in Newcastle

2000 - 2011

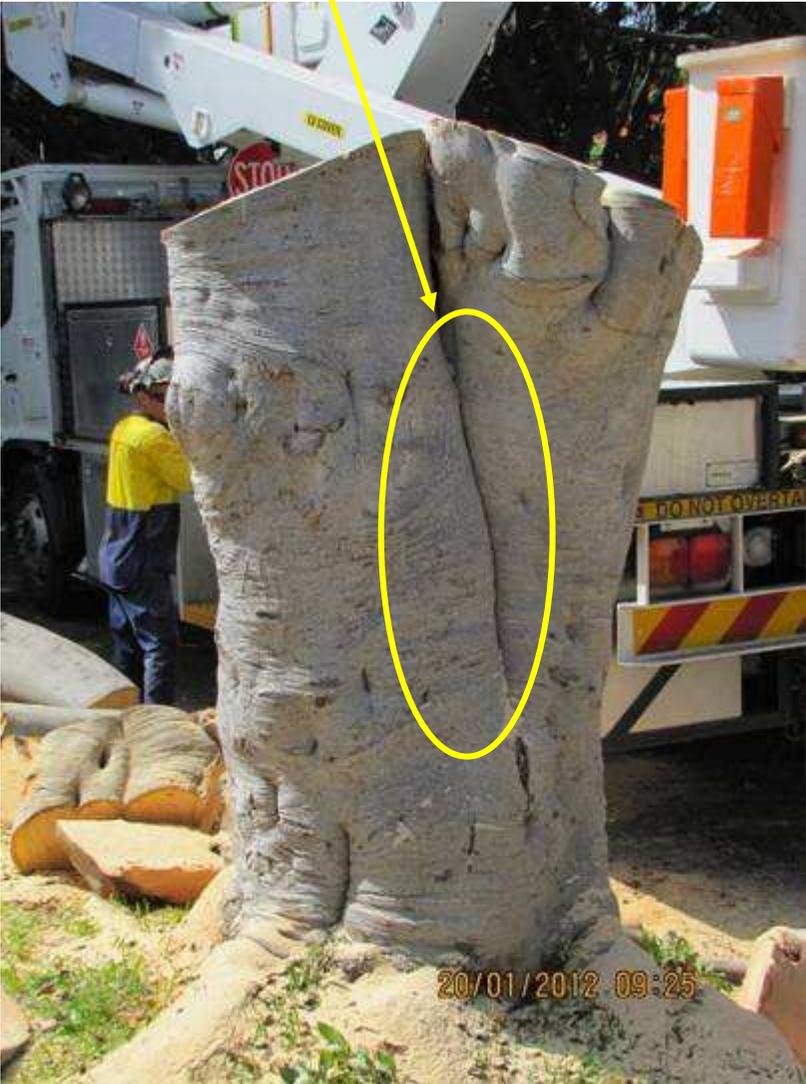
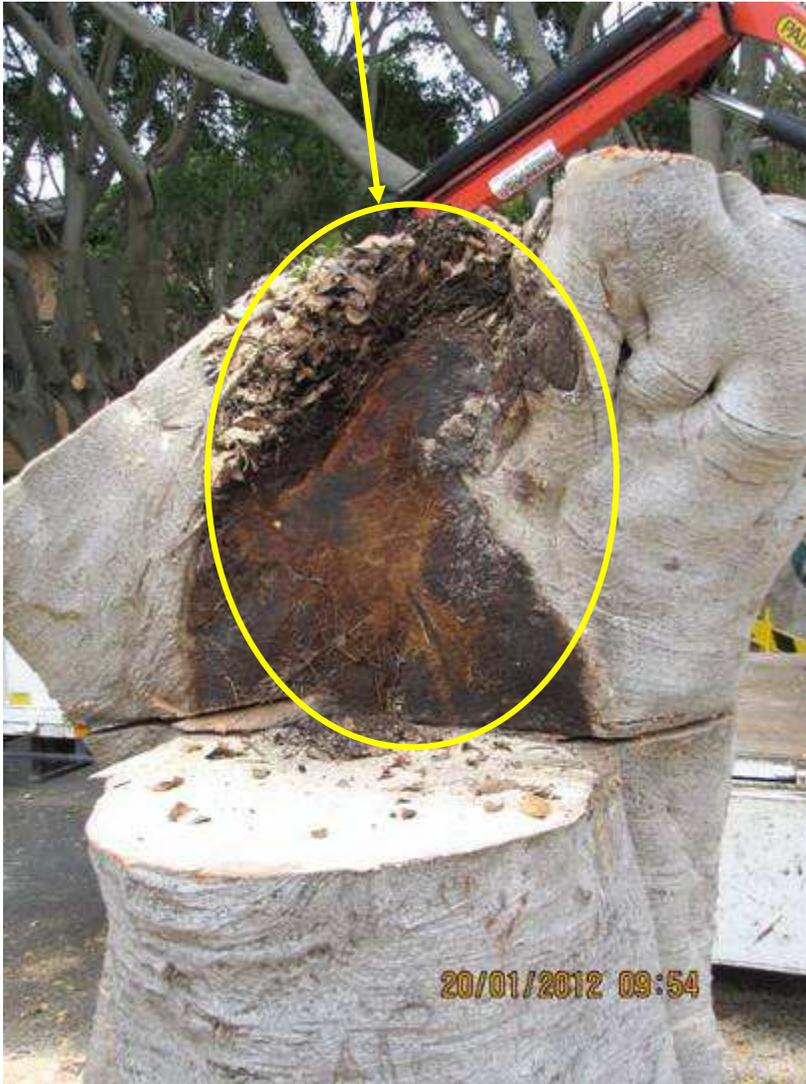
# Footway Stem inclusion defect – a compression fork

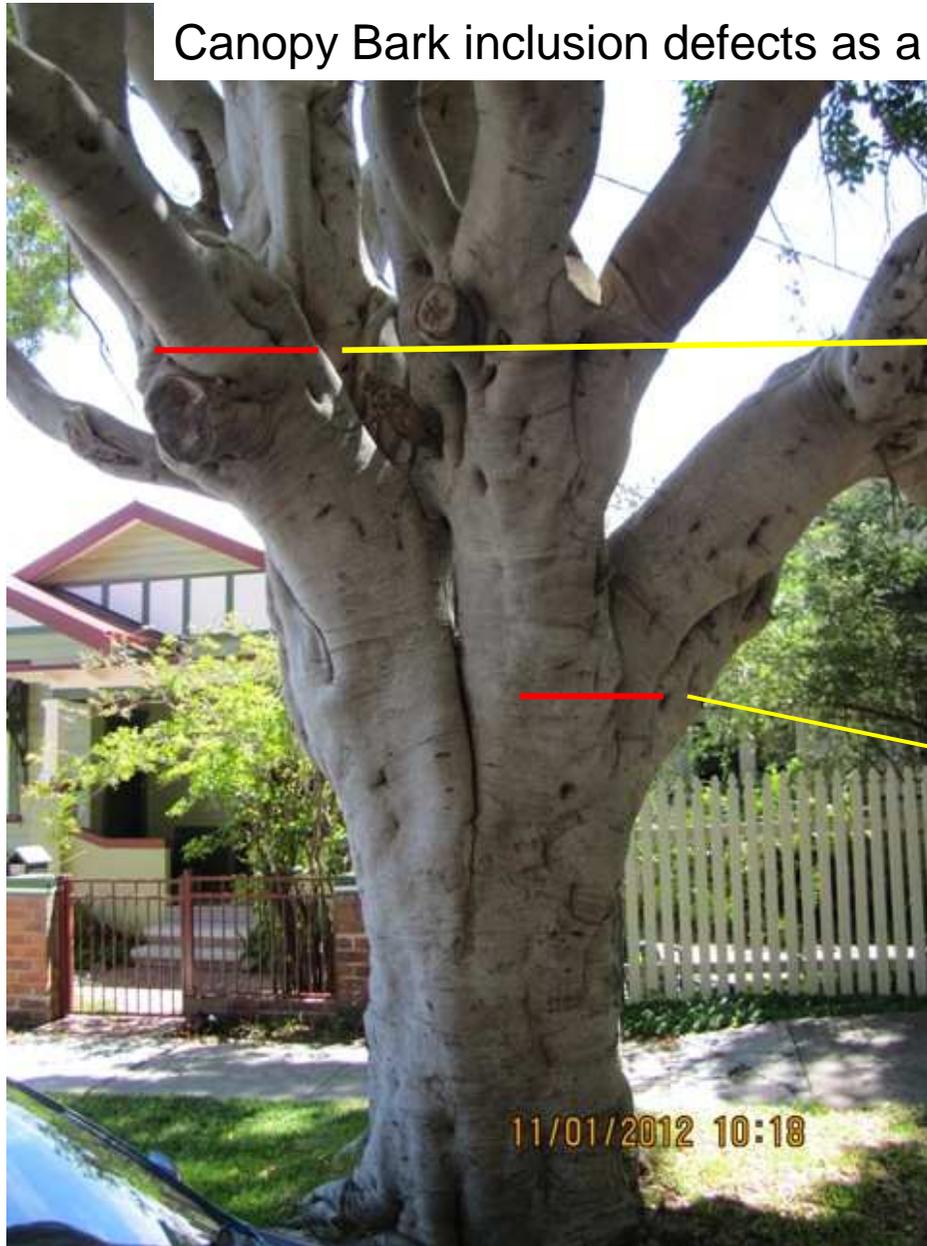
# Canopy Bark inclusion defects as a result of lopping

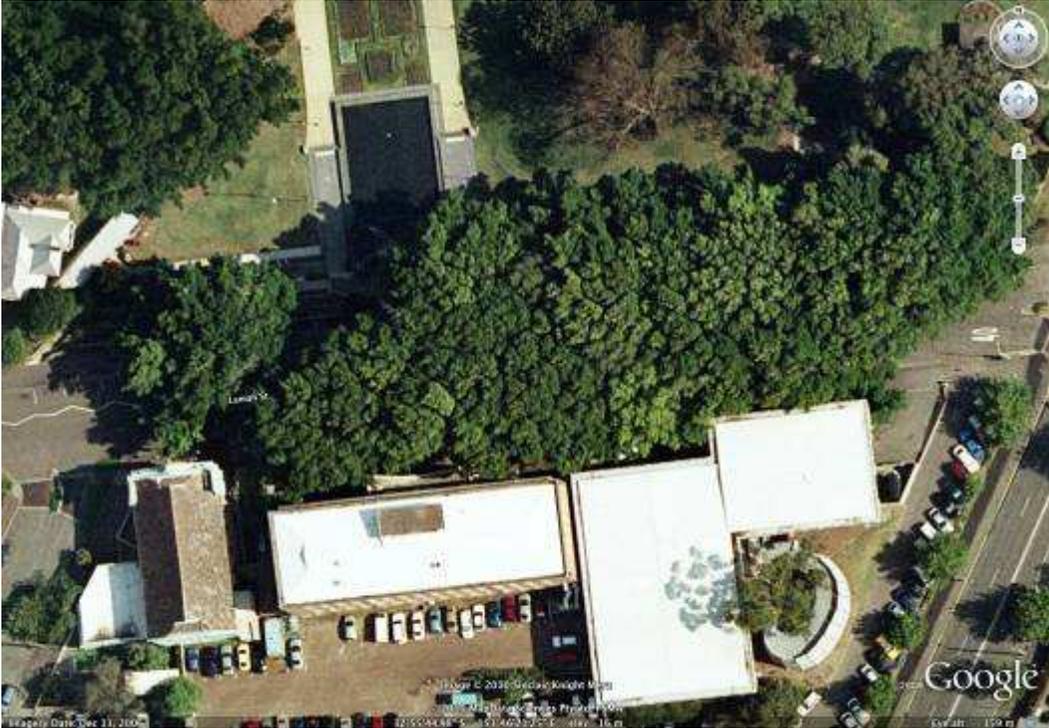
Laman Street Fig canopy after June 2007 - three trees removed due to root plate failure

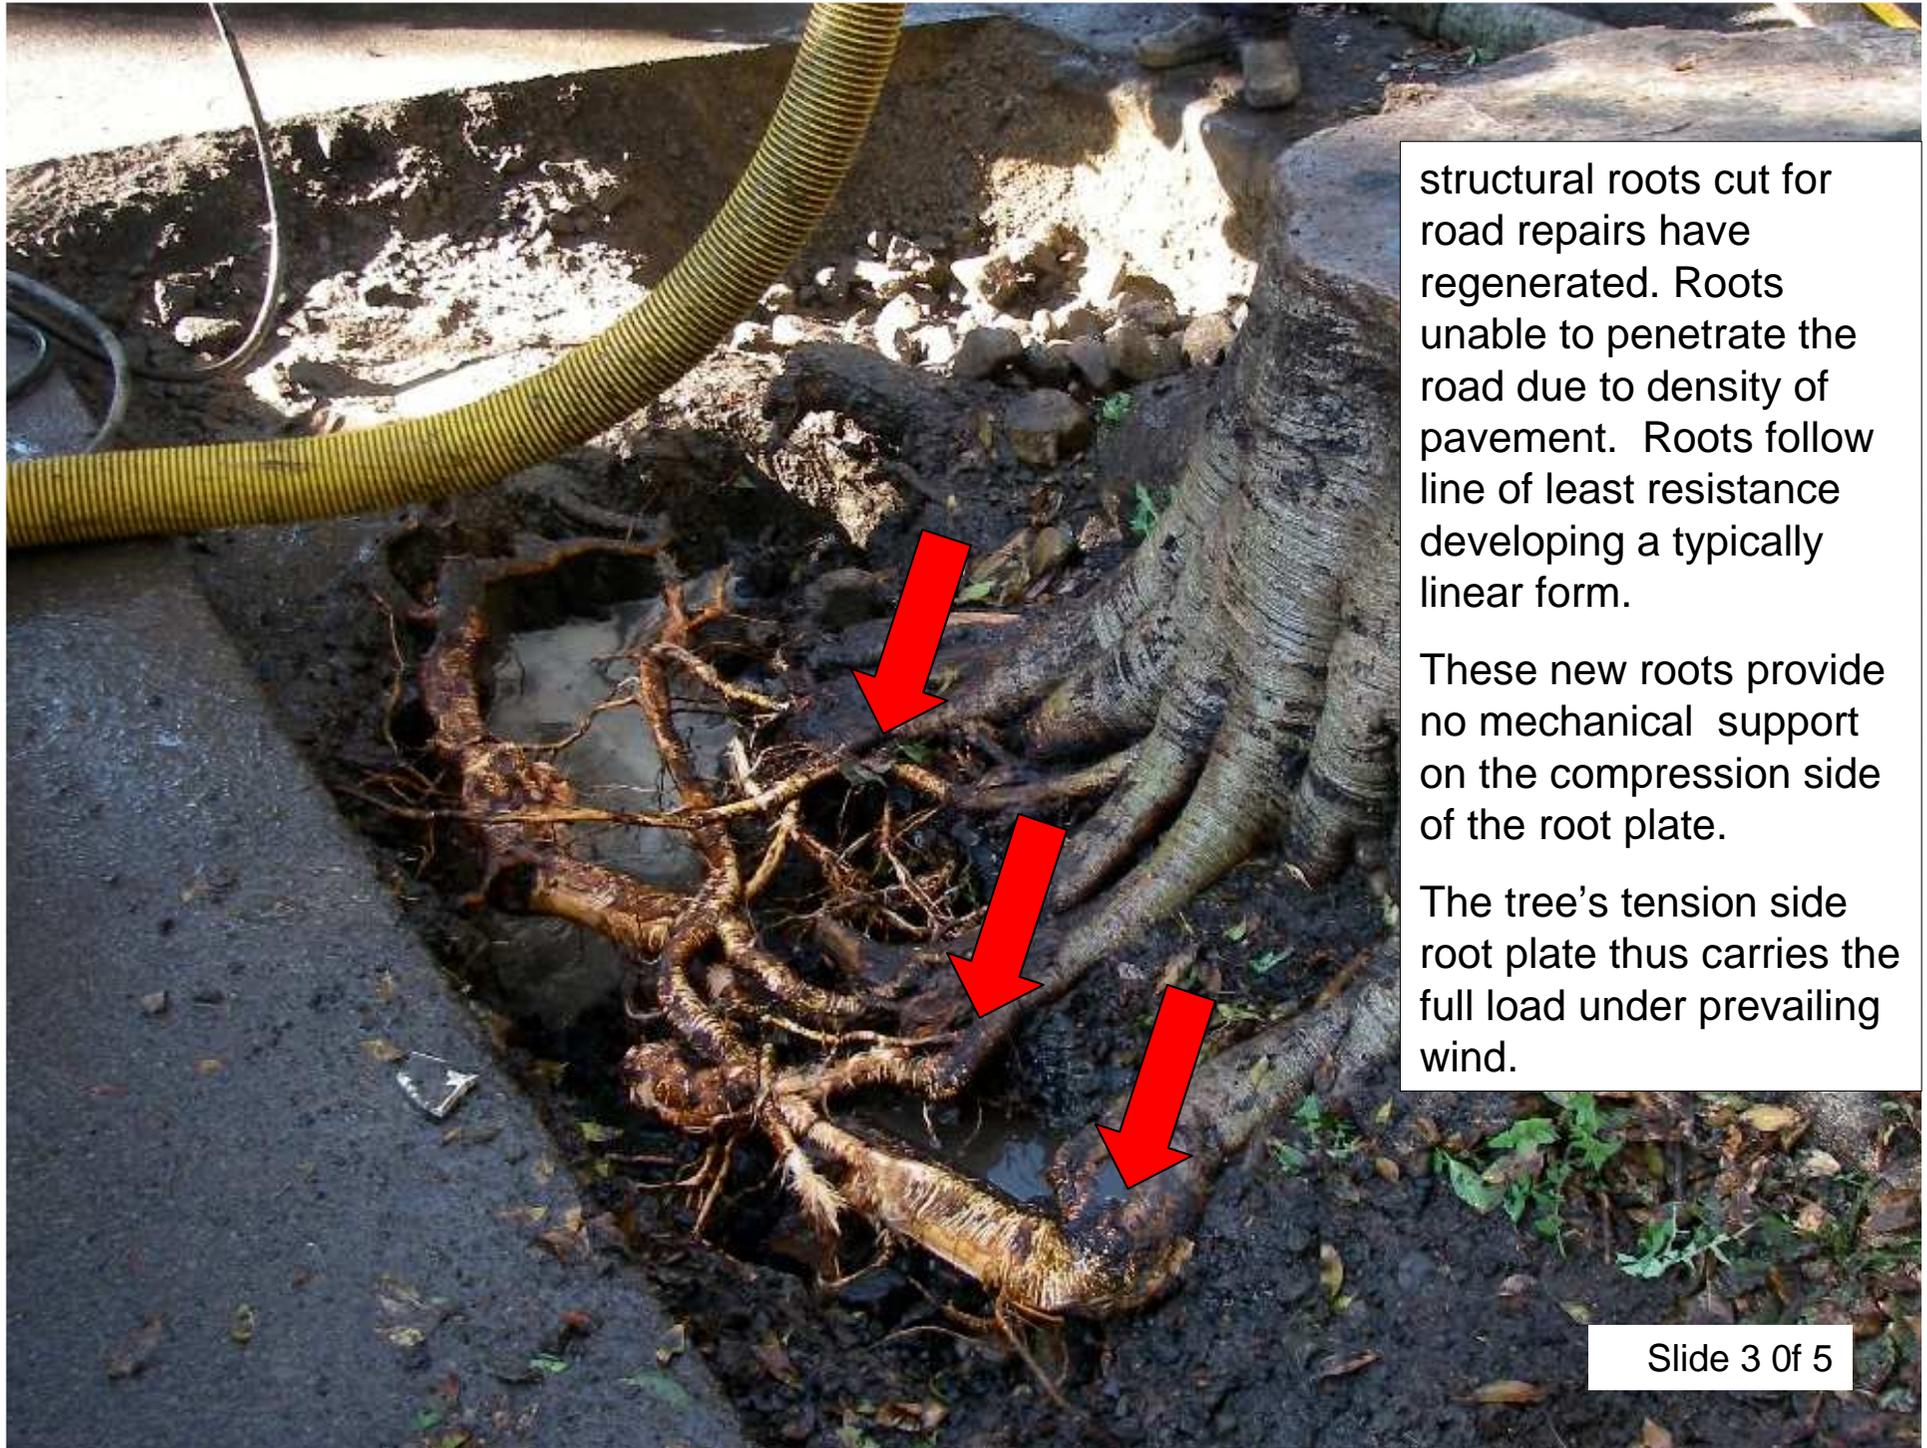
structural roots cut for road repairs have regenerated. Roots unable to penetrate the road due to density of pavement. Roots follow line of least resistance developing a typically linear form.

These new roots provide no mechanical support on the compression side of the root plate.

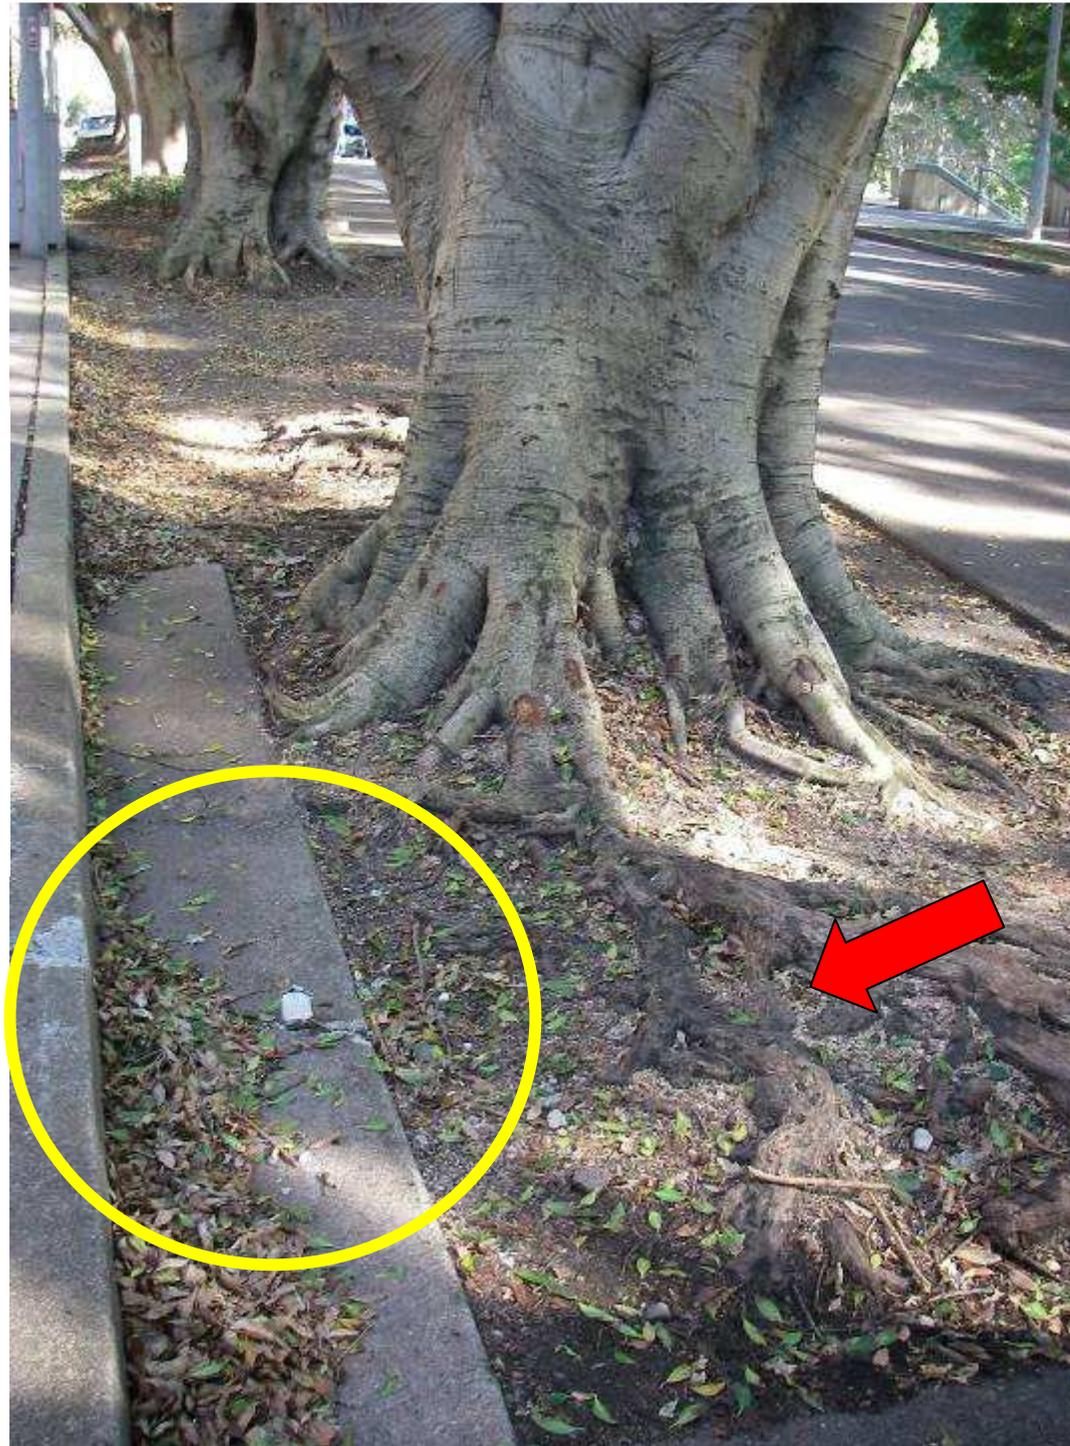
Tree 4805

The extent of the root plate on the northern side of the Laman Street trees i.e. the trees on south side, is defined by the edge of the parking lane.

Critical damage. Typically wounded buttress roots that form the tree's primary mechanical support.

Fractured  
kerb and  
channel  
caused by  
flexing of  
tensile  
loaded roots

A 25m high  
tree with  
wounded and  
weakened  
structural roots  
is a  
mechanically  
compromised  
structure

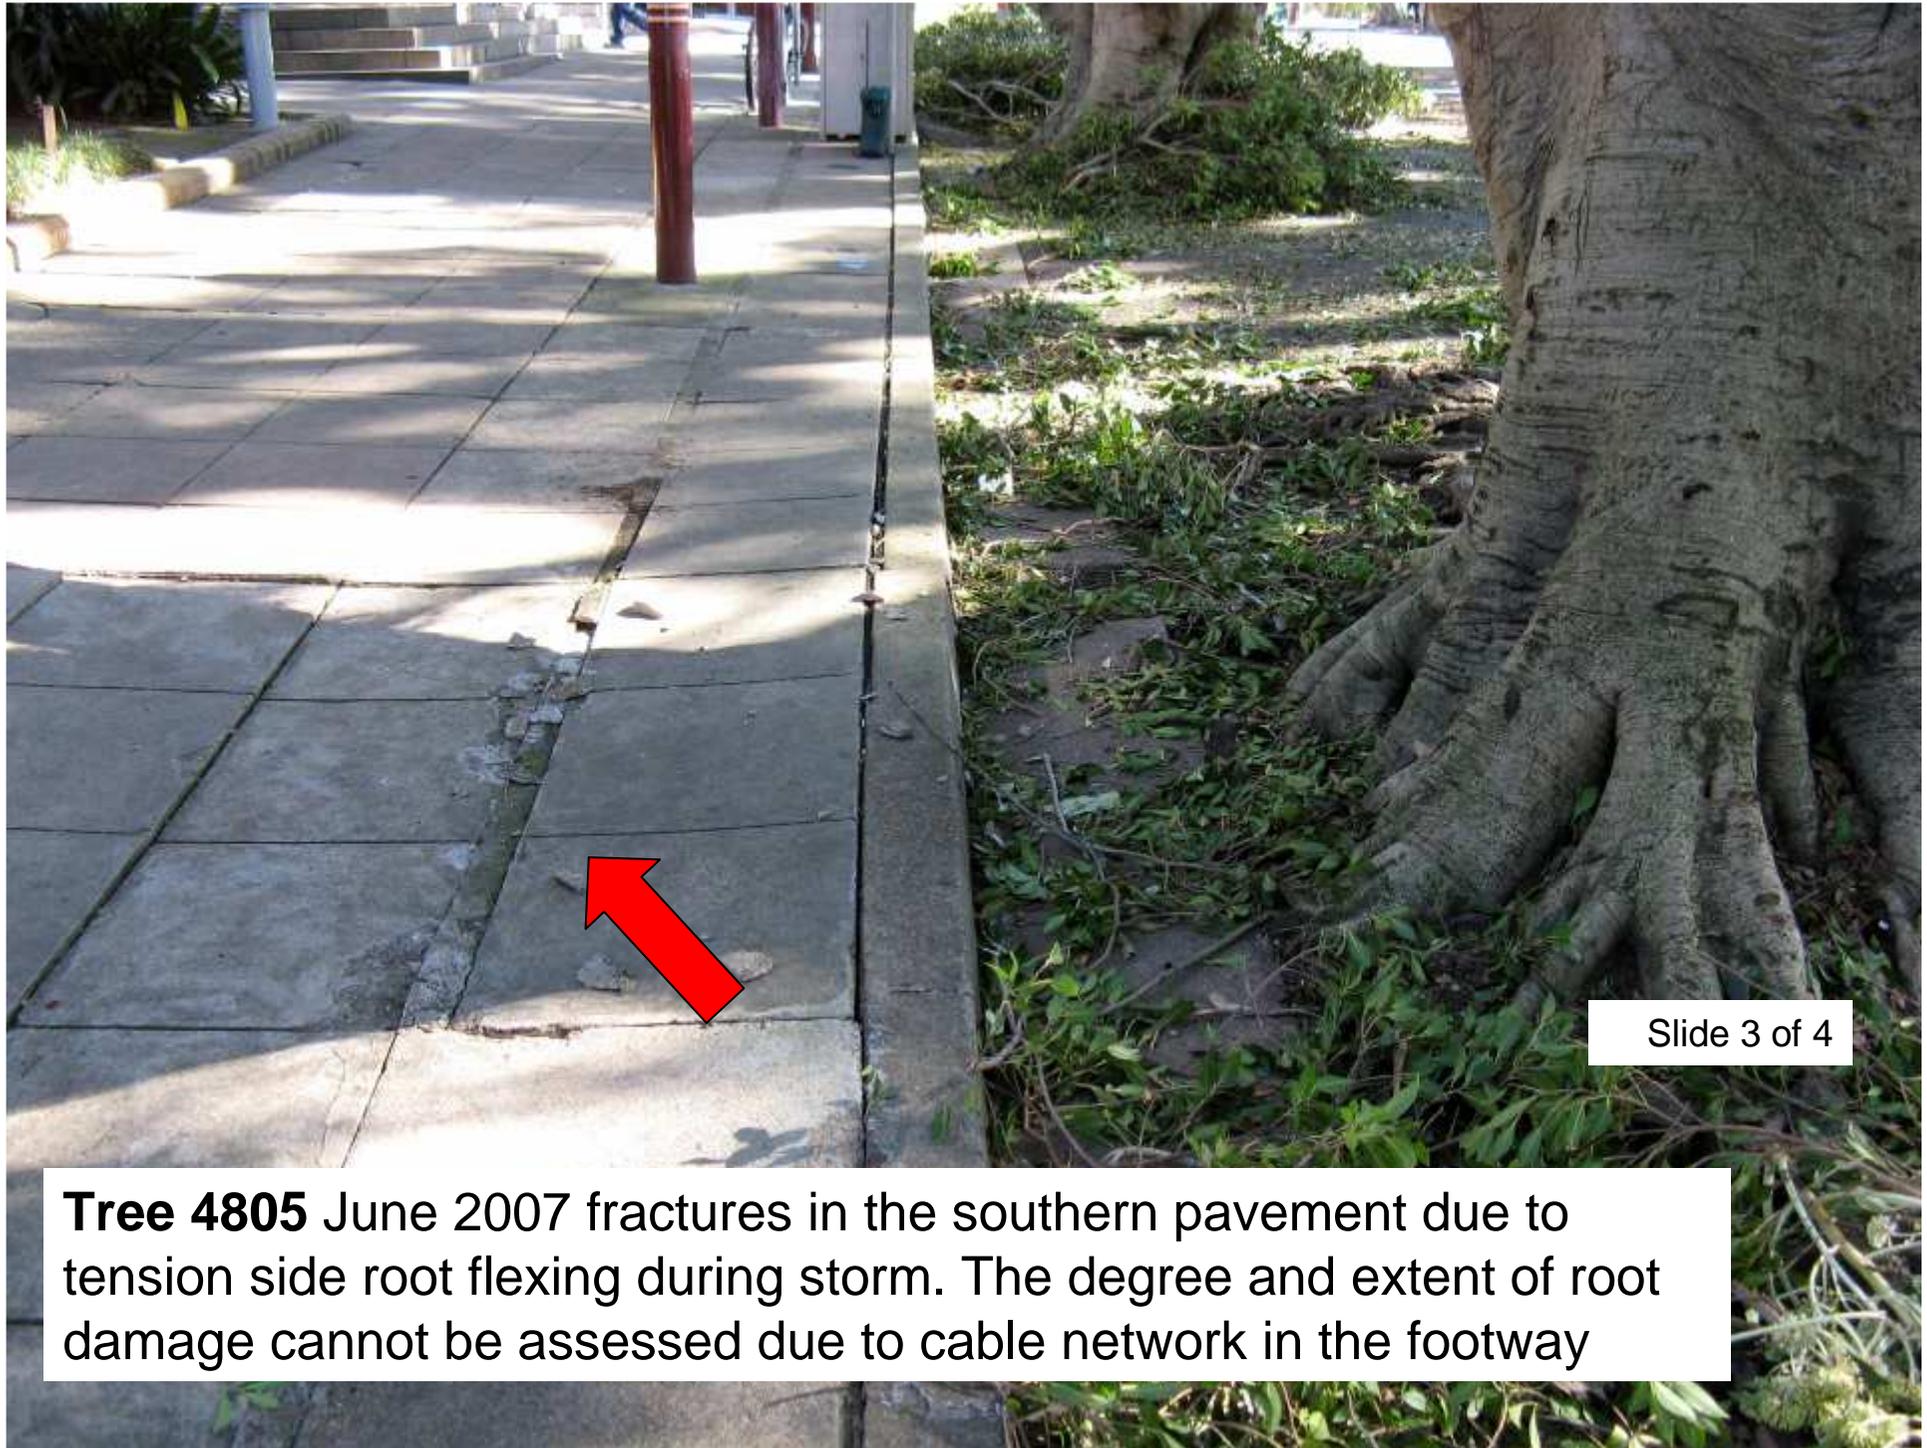
**Tree 4805** June 2007 fractures in the southern pavement due to tension side root flexing during storm. The degree and extent of root damage cannot be assessed due to cable network in the footway

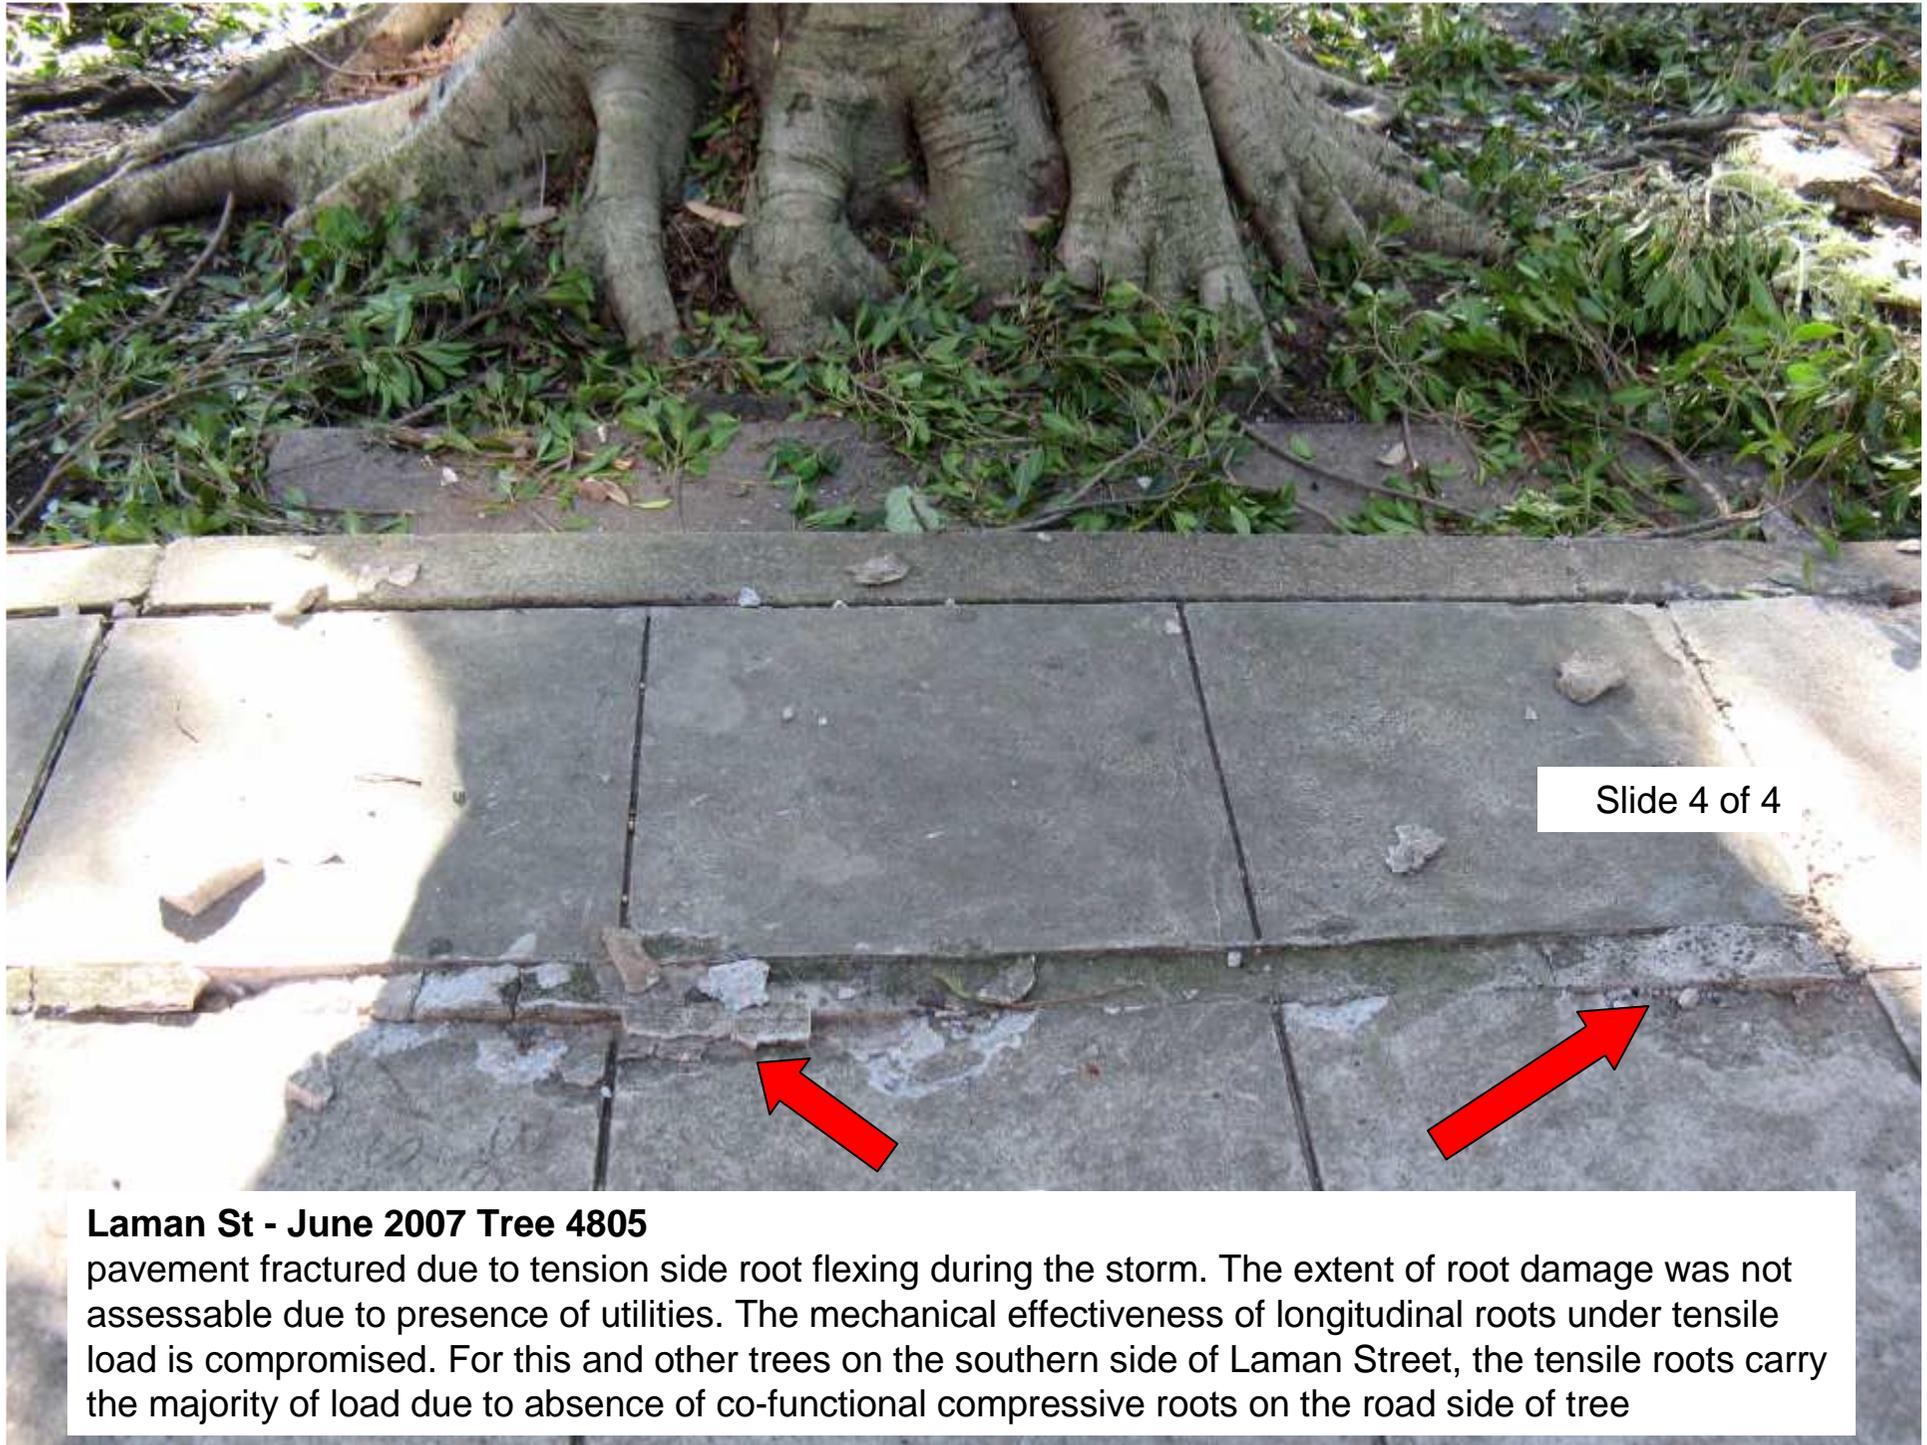
**Laman St - June 2007 Tree 4805**

pavement fractured due to tension side root flexing during the storm. The extent of root damage was not assessable due to presence of utilities. The mechanical effectiveness of longitudinal roots under tensile load is compromised. For this and other trees on the southern side of Laman Street, the tensile roots carry the majority of load due to absence of co-functional compressive roots on the road side of tree

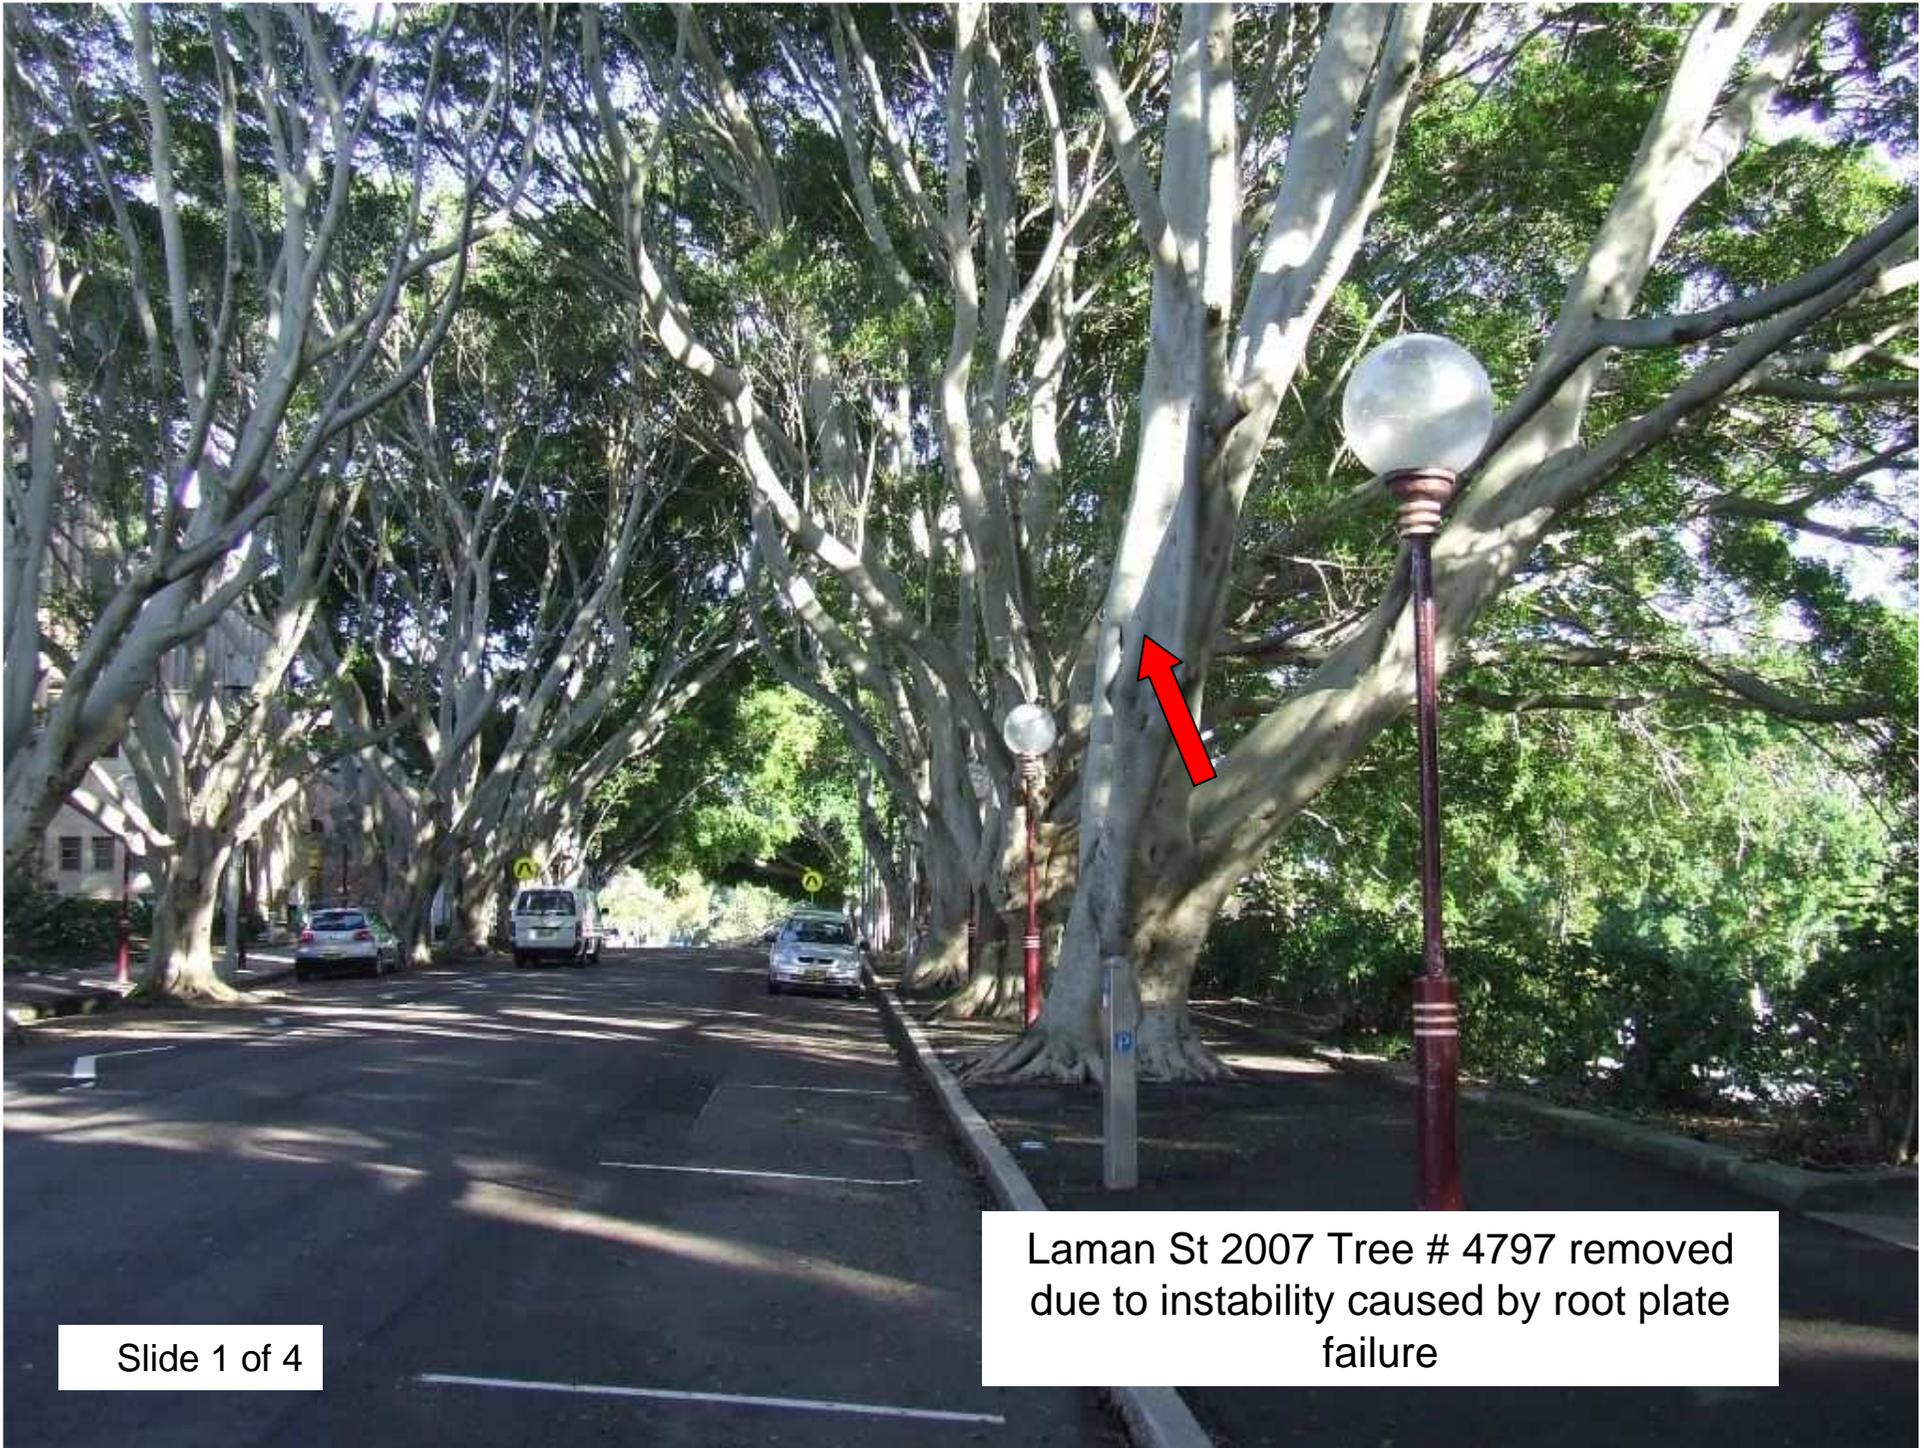
Laman St 2007 Tree # 4797 removed due to instability caused by root plate failure

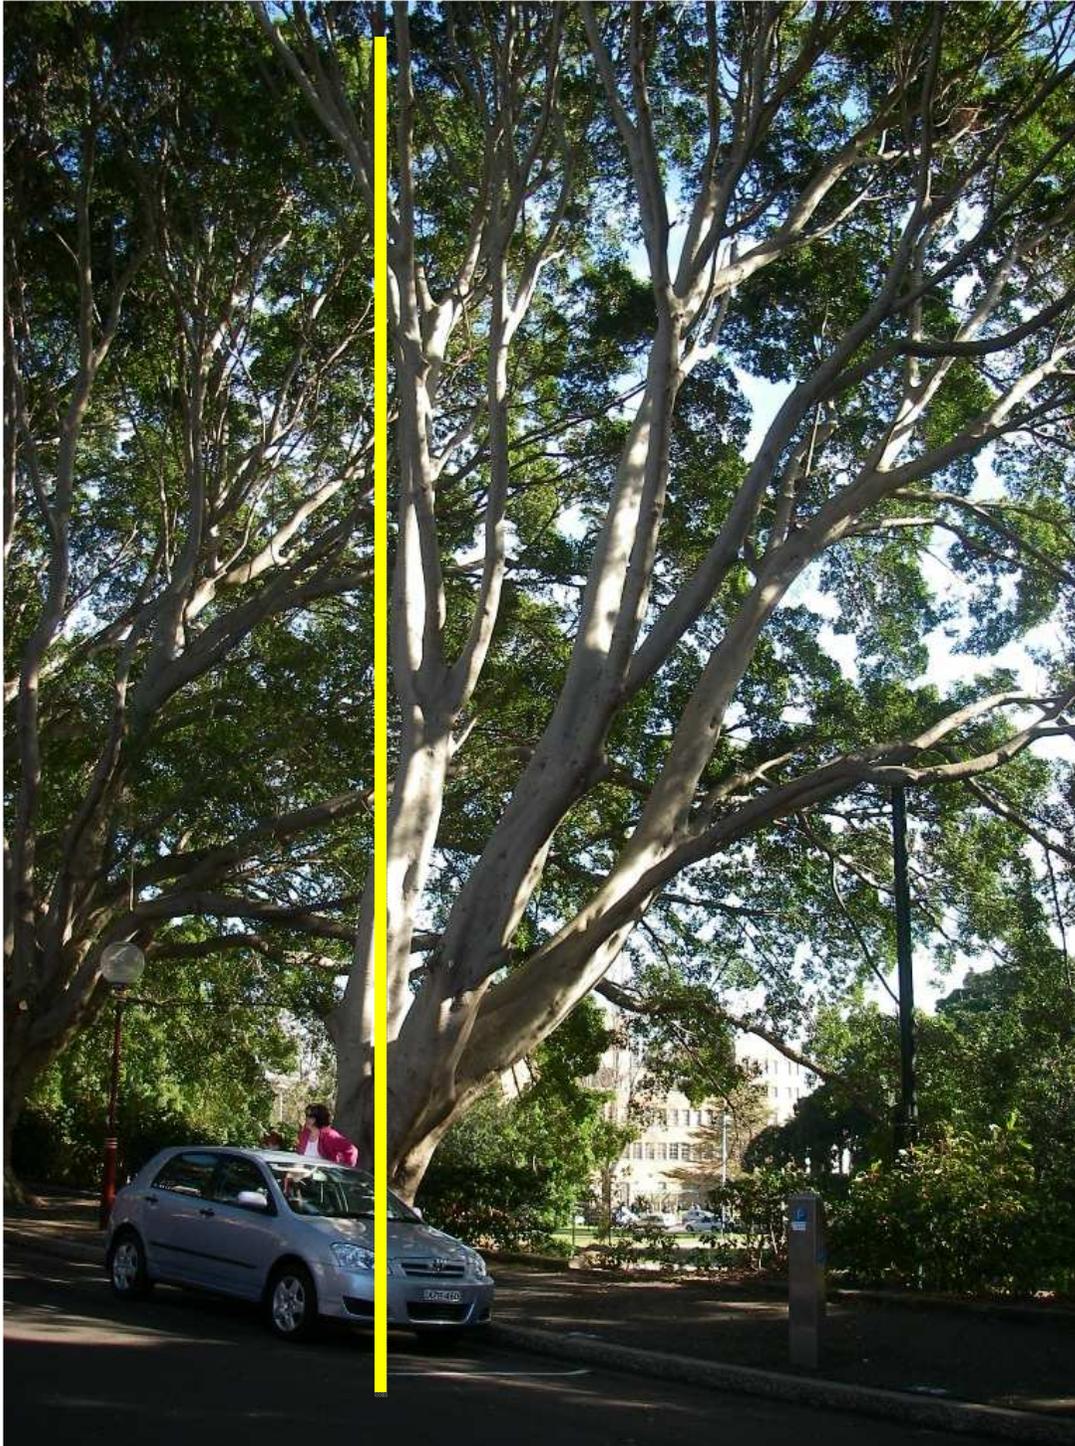
Tree 4797

Severe crown  
asymmetry in 2006

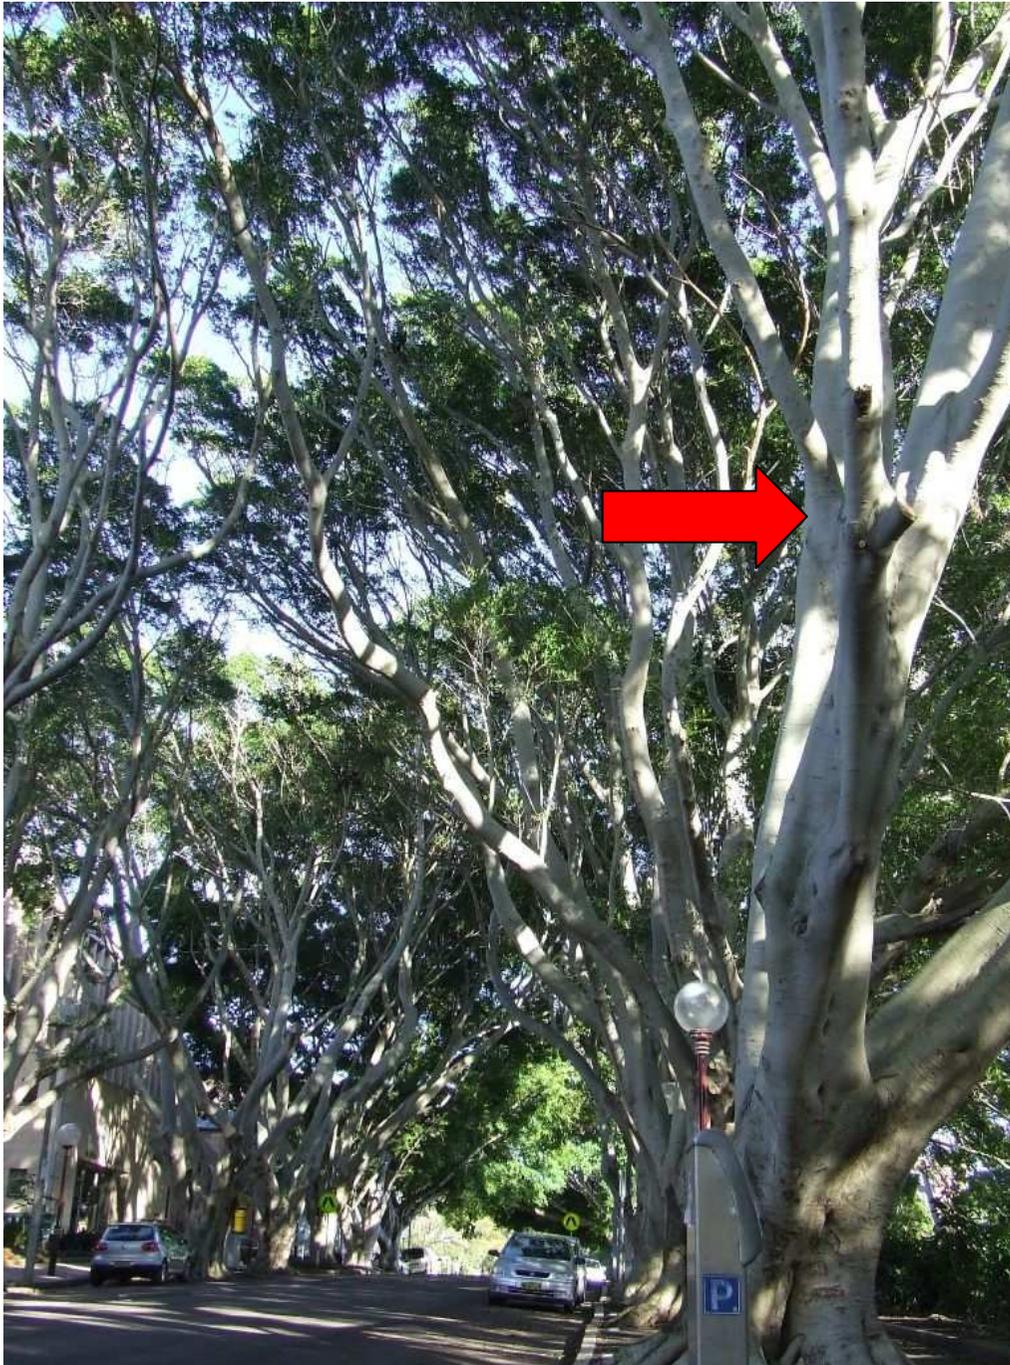
Tree 12018 on the northern footpath at the eastern end of Laman Street was wind rocked in the June 2007 storm.

The tree was assessed and a determination made to retain the tree as it had a more symmetrical form than adjacent trees and no evidence of root movement or root/crown fractures in on the compression side.

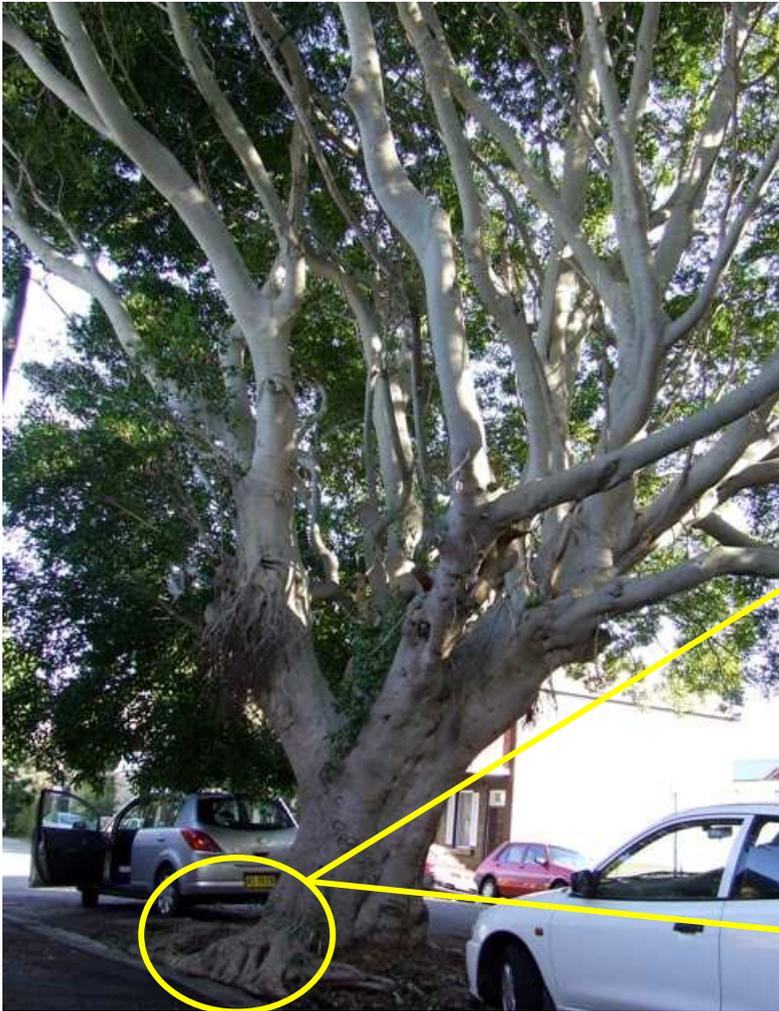
Hills Fig tree removed at 41 Laman Street due to tensile root failure in June 2007 storm. Resident advised that foliage previously above vehicle was now touching roof of parked car.

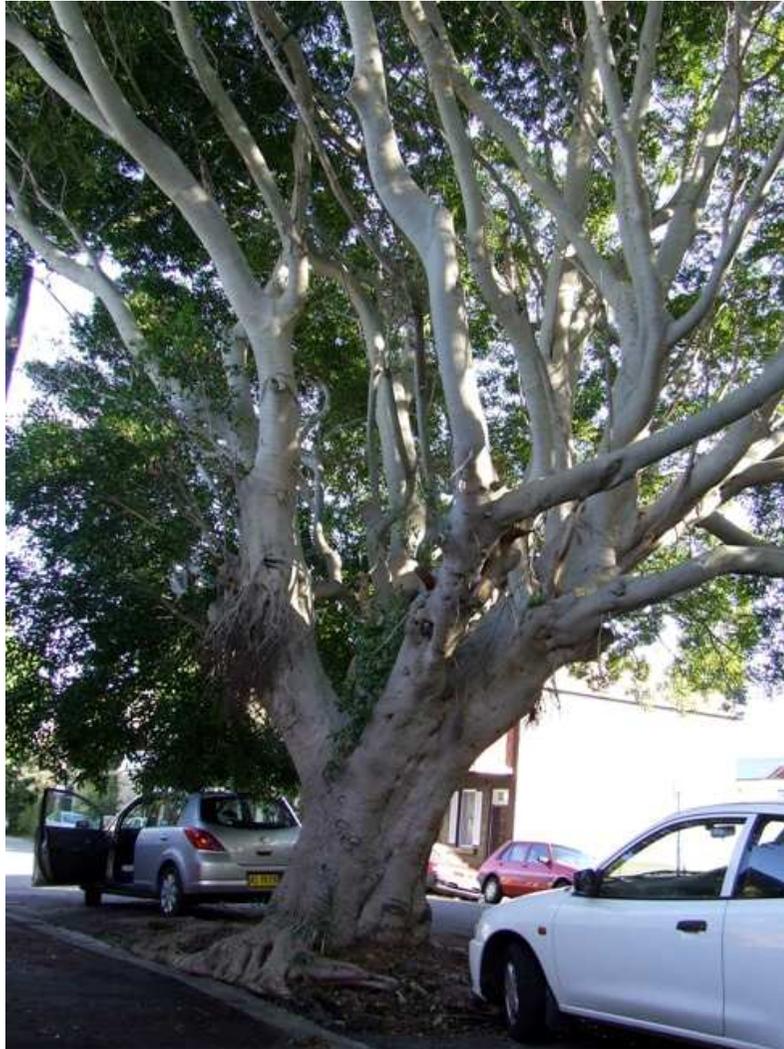
Compression stress cracks on road pavement side

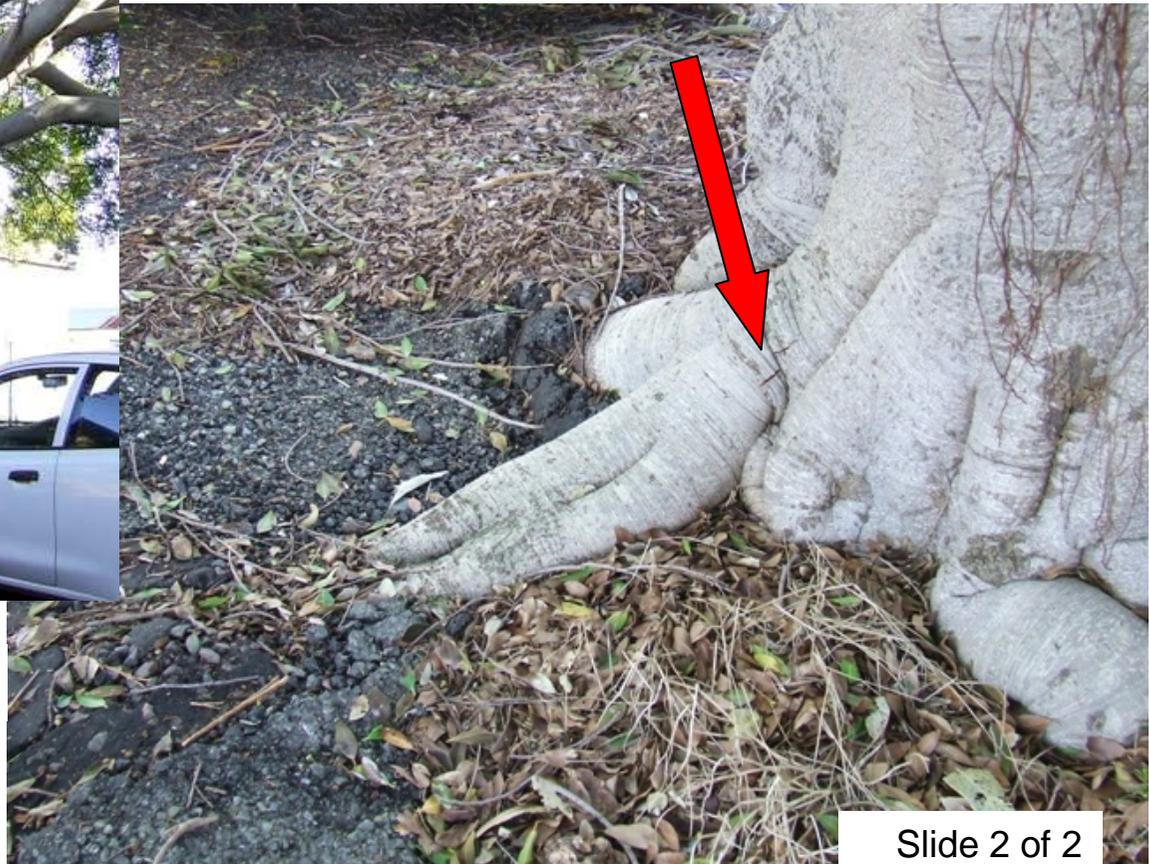
41 Laman St root plate failure
