# Tree Failure Casebook History

Informing Tree Management in Newcastle

2000 - 2011

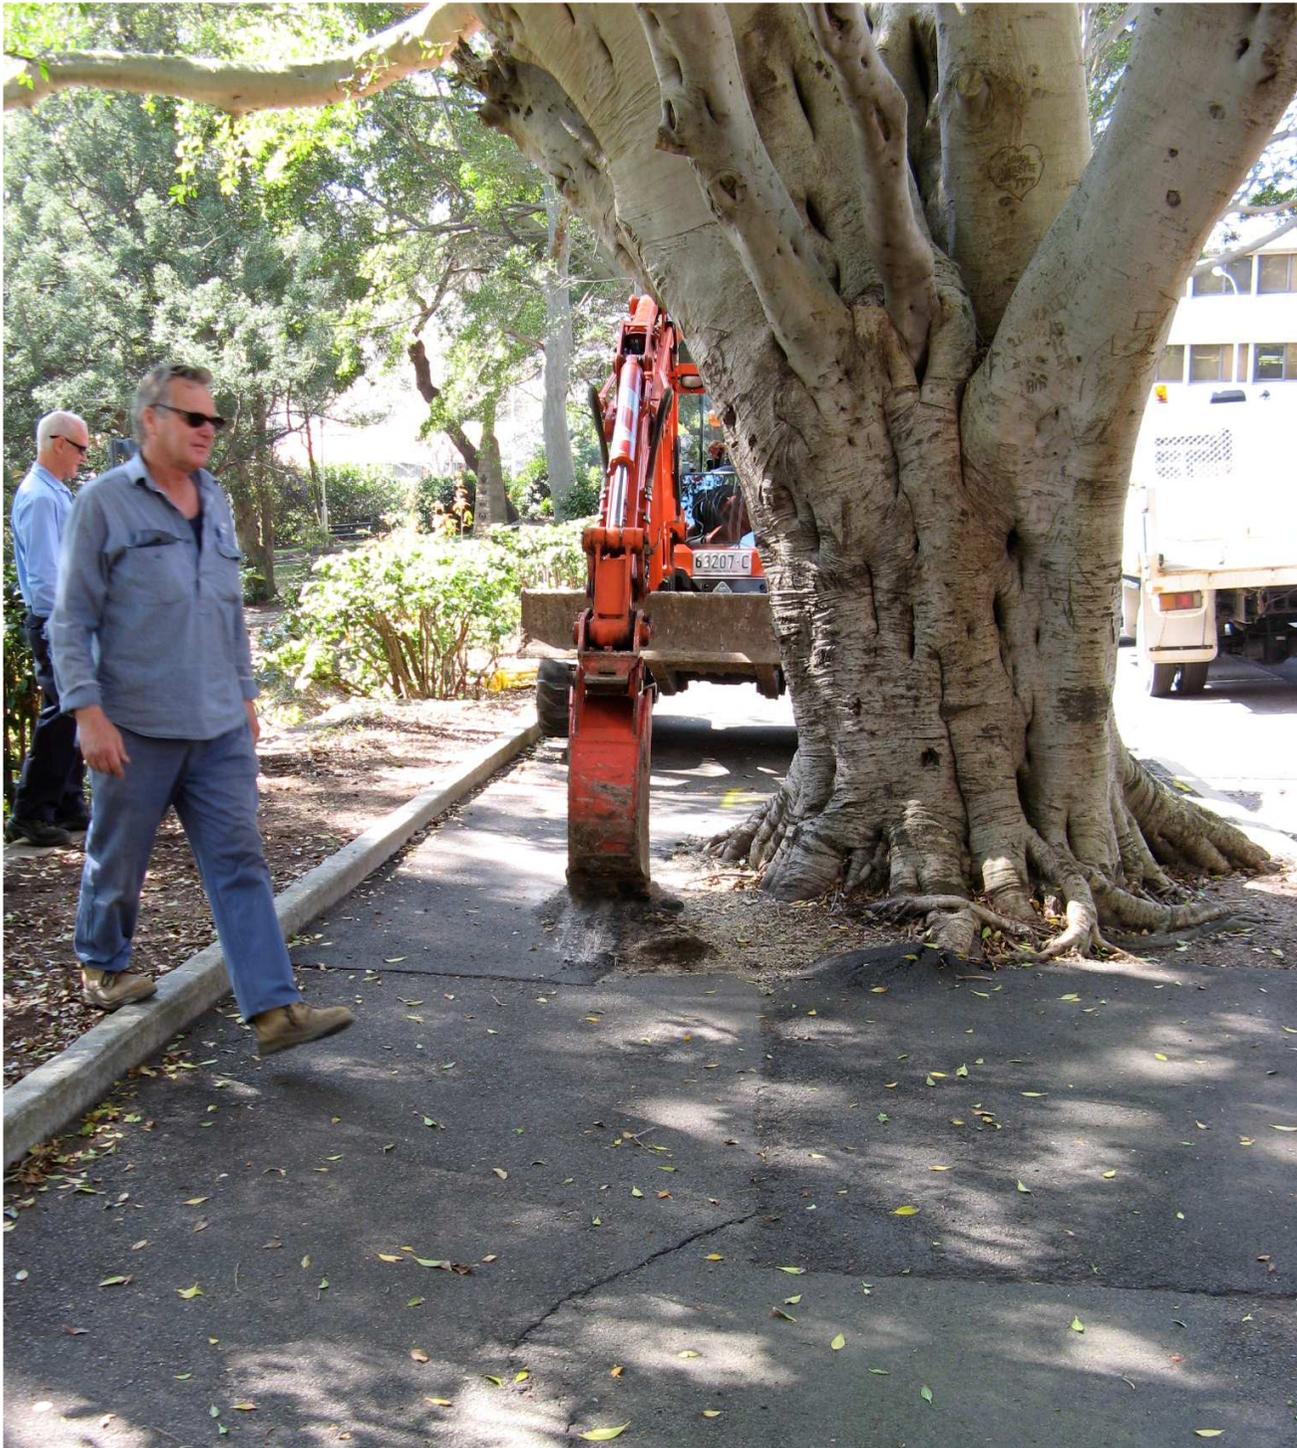
Laman Street  
northern  
footpath

Excavations  
commence for  
high voltage  
power cable  
failure in 2009

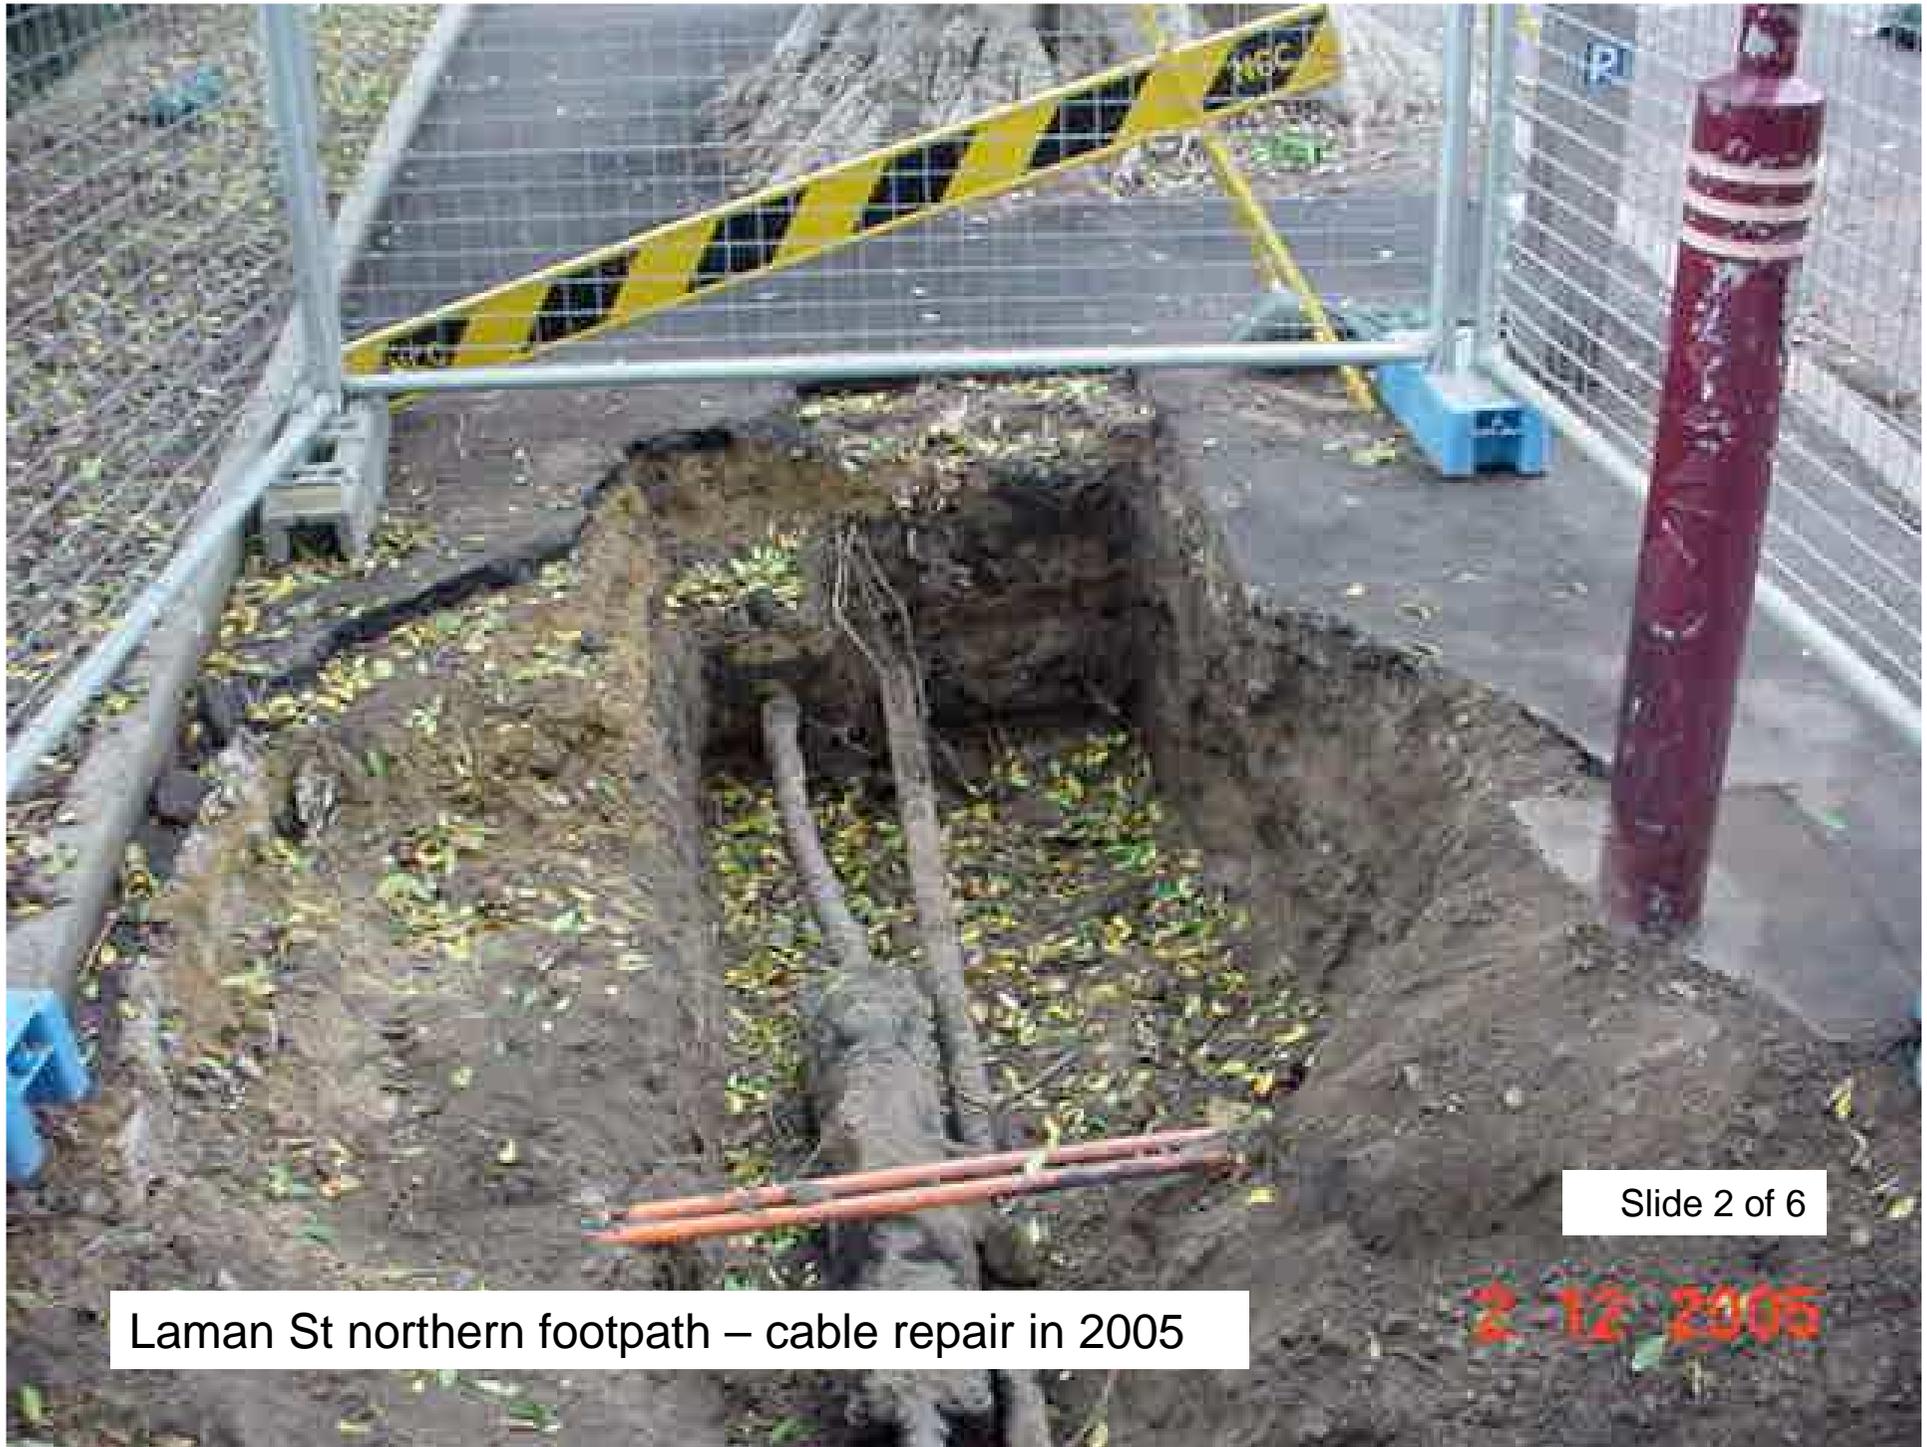
Laman St northern footpath – cable repair in 2005

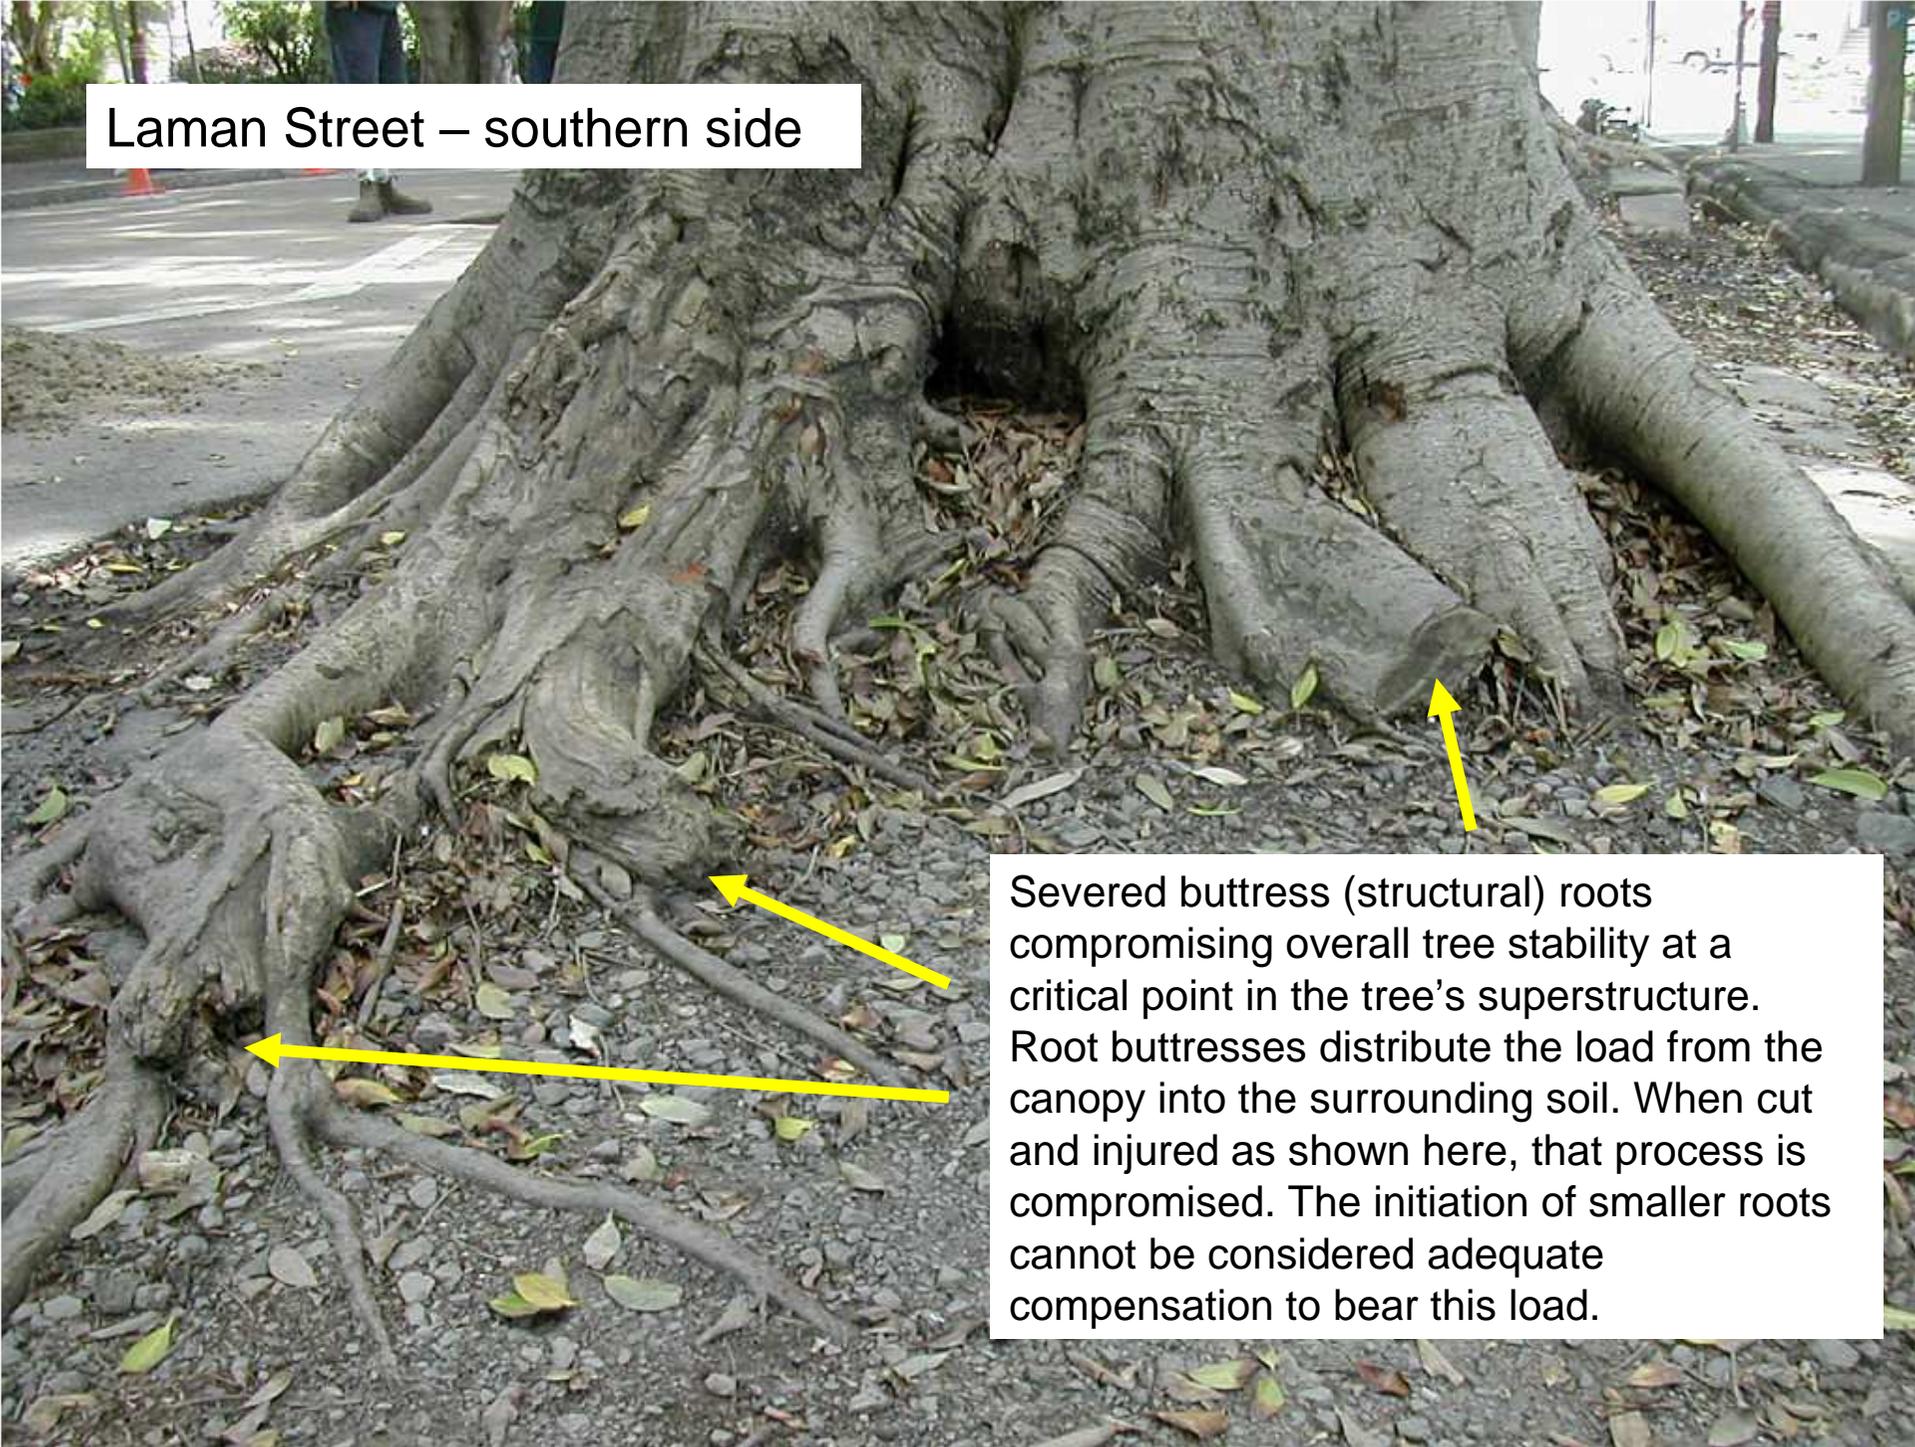
Laman Street – southern side

Severed buttress (structural) roots compromising overall tree stability at a critical point in the tree's superstructure. Root buttresses distribute the load from the canopy into the surrounding soil. When cut and injured as shown here, that process is compromised. The initiation of smaller roots cannot be considered adequate compensation to bear this load.
