Investigation into Stability of three Hill's Weeping Figs Along Laman Street Newcastle

City of Newcastle

Dennis Marsden, MAIH, MISA, MNAAA
Consulting Arborist

11 July 2007

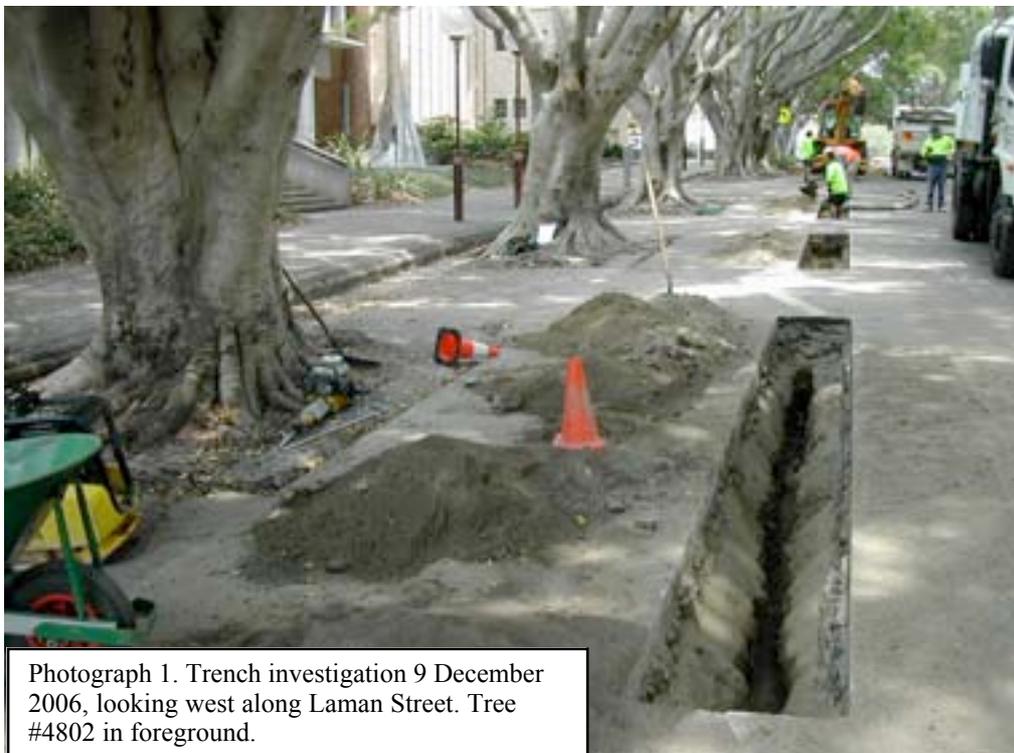
Photograph 1. Trench investigation 9 December 2006, looking west along Laman Street. Tree #4802 in foreground.

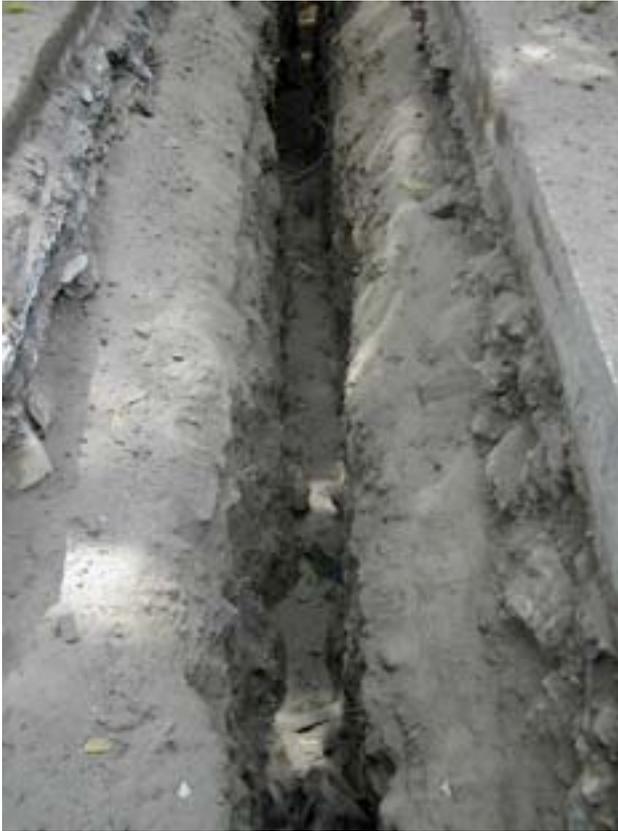
The investigation found that no primary woody roots were present in any trench. The majority of trenches contained only a few woody roots, generally less than about 10mm in diameter, and few fibrous roots.

Photograph 2 (left) shows a typical completed trench.

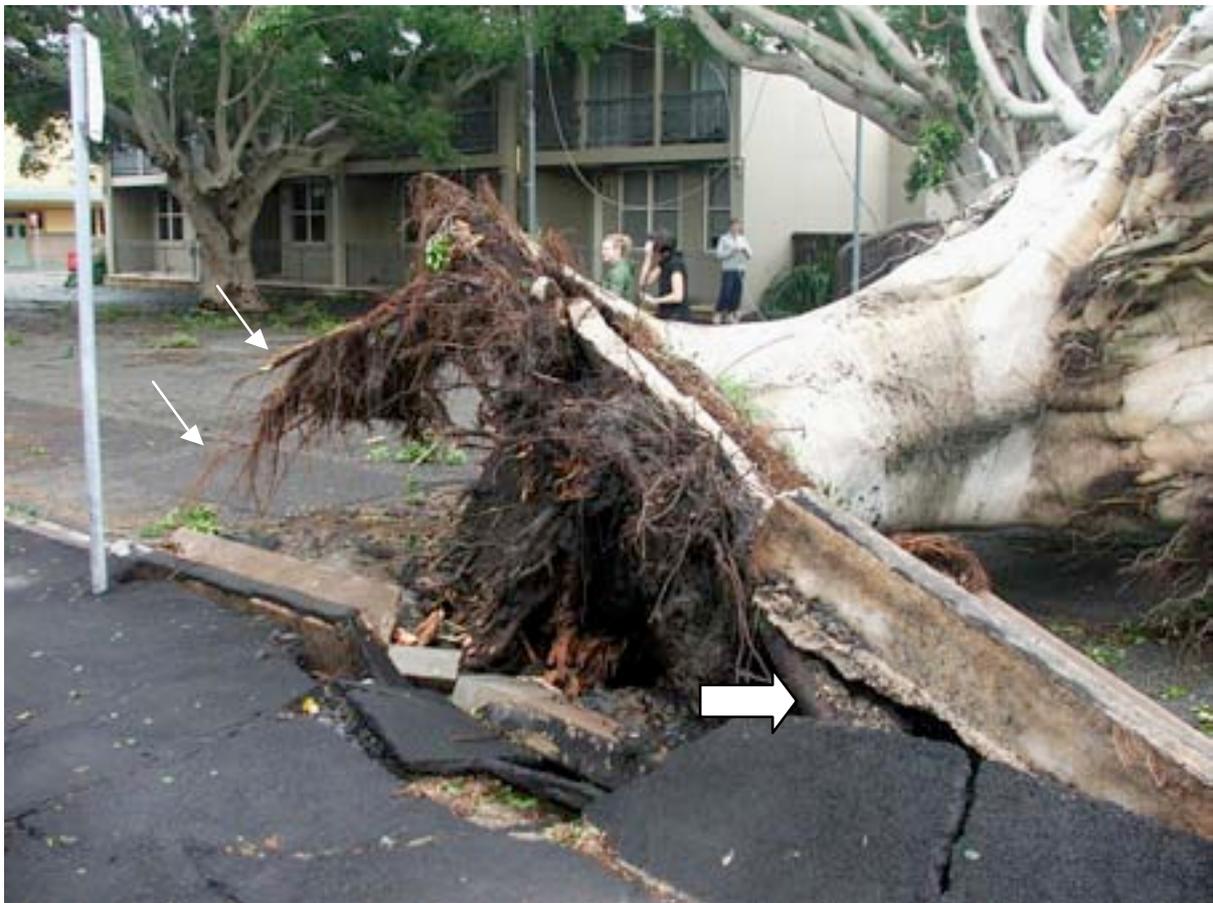
Photograph 3, above. This Hill's Fig on Bruce Street had been planted in the footpath, with the kerb acting as a barrier to the development of the root-plate, preventing the extension of structural support roots on the 'tension' side. This mirrors the conditions on the northern side of Laman Street. What appears to be a large primary root has developed in a lineal direction, running along the inside edge of the kerb (large arrow). Note the lateral development of secondary woody roots (small arrows). Note also the diameter of the stem and the relatively small size of the root-plate tilted out of the ground.

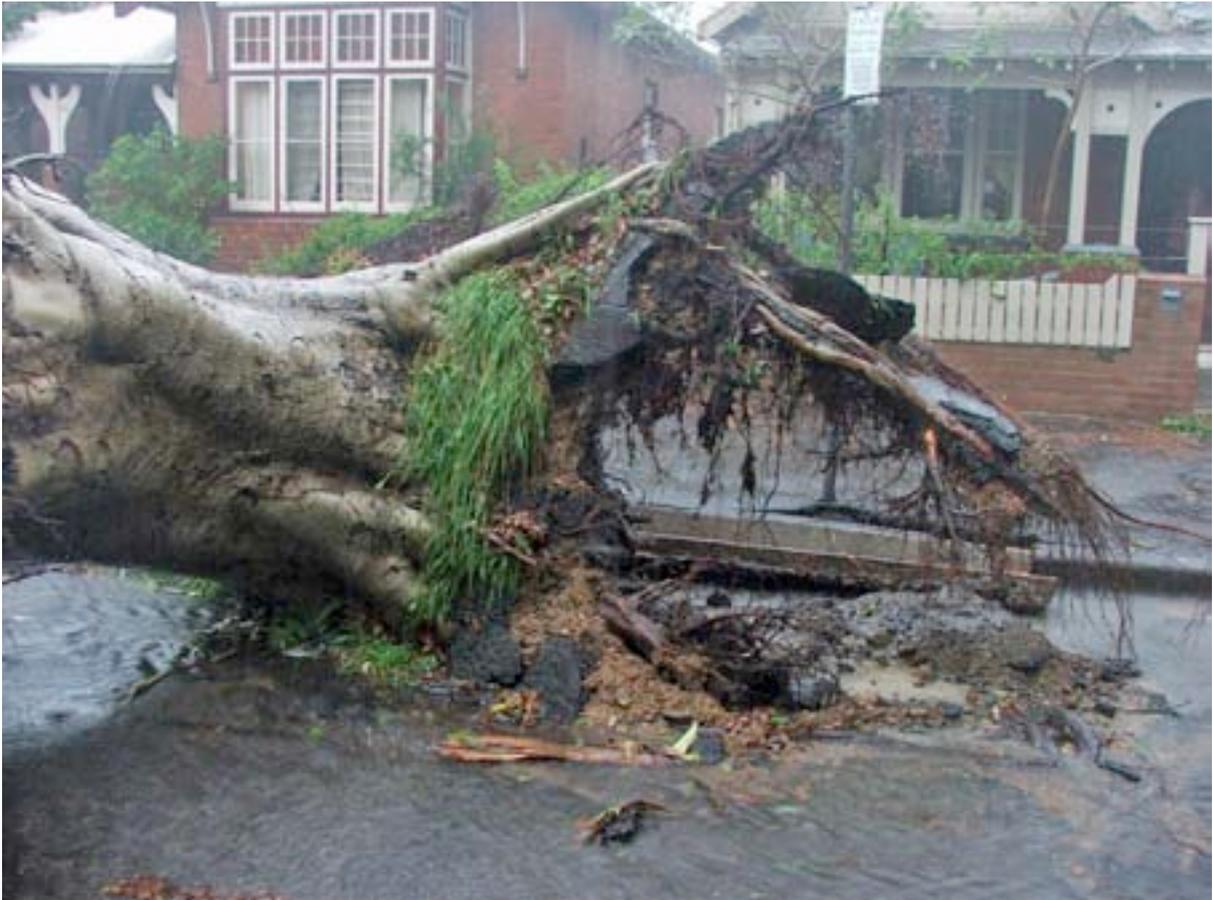
Photograph 4, above. Another of the Bruce Street figs. This tree had been planted within the street, which is identical to the situation on the southern side of Laman Street. Again, the kerb has acted as a barrier preventing the development of roots on the ‘tension’ side.

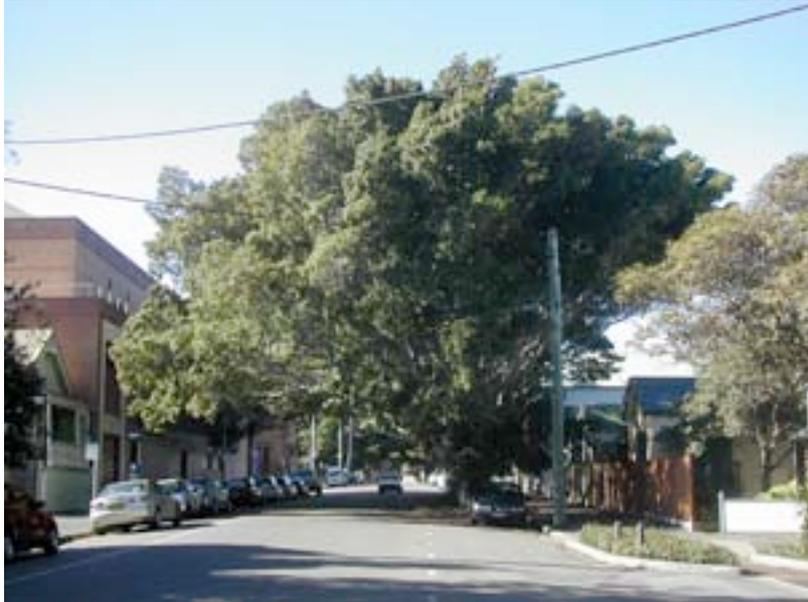
This tree is located outside 41 & 43 Laman Street (photograph 5, below) and has not been the subject of previous investigations by the author.

The tree has a fairly symmetrical crown spread although under-pruning to provide clearances of residences has left the crown with a pronounced bias to the north.

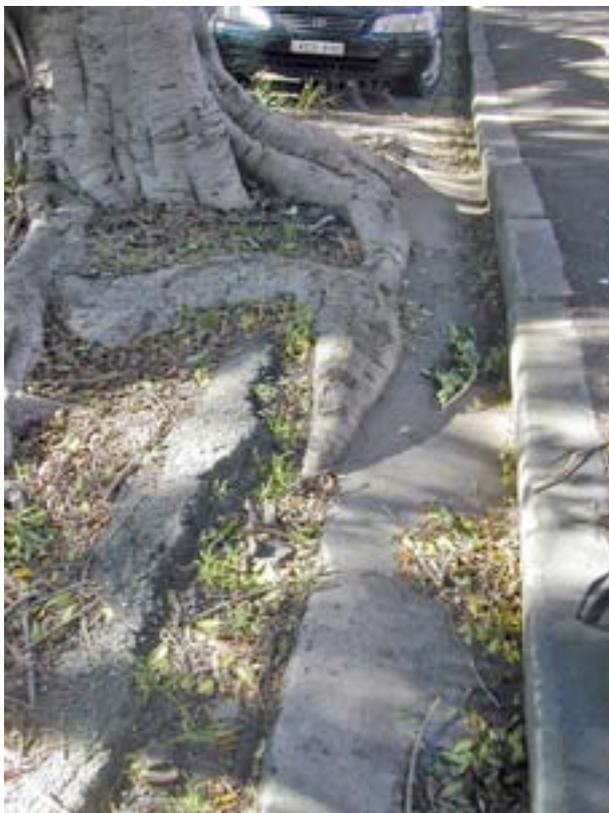
The primary roots have buttressed along the gutter (photograph 6, left). Most of the surface roots across the remaining sides have been severed some years ago, no doubt to mitigate damage to the roadway.

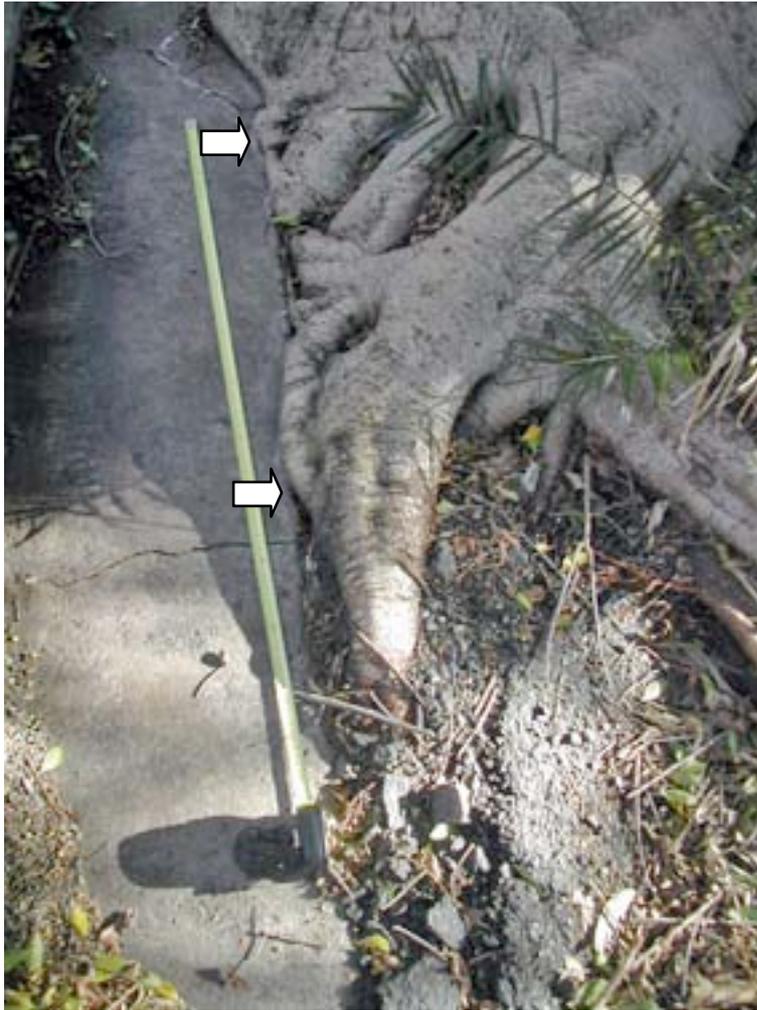
It was noted that a section of buttress on the southeast side of the tree had shifted up and away from the gutter, opening up a gap over a lineal distance of approximately one metre (photograph 7, left).

Tree #4818 was found to have been destabilised by the storm and in the process of gradual whole-tree failure. The recommendation was made at the conclusion of the site inspection that the removal of the tree be prioritised, with the removal subsequently being carried out on 6 and 9 July.

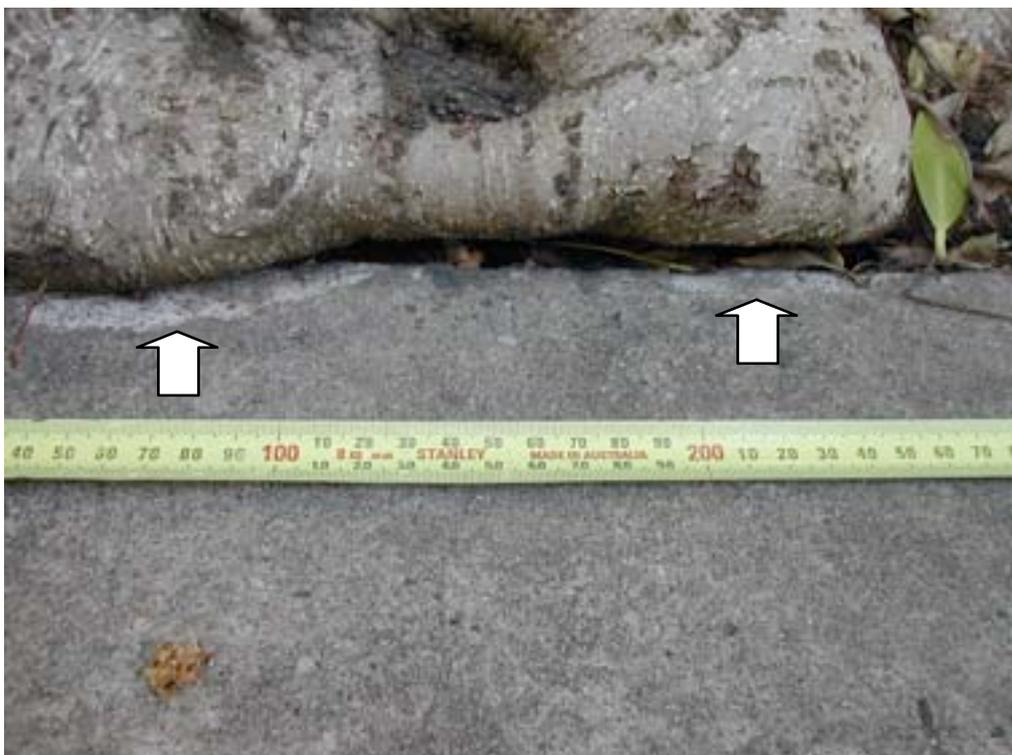
The gap along this section was 12 to 15mm wide (photograph 8, below). Note the light coloured patches on the concrete where the buttresses had previously rested (arrows).

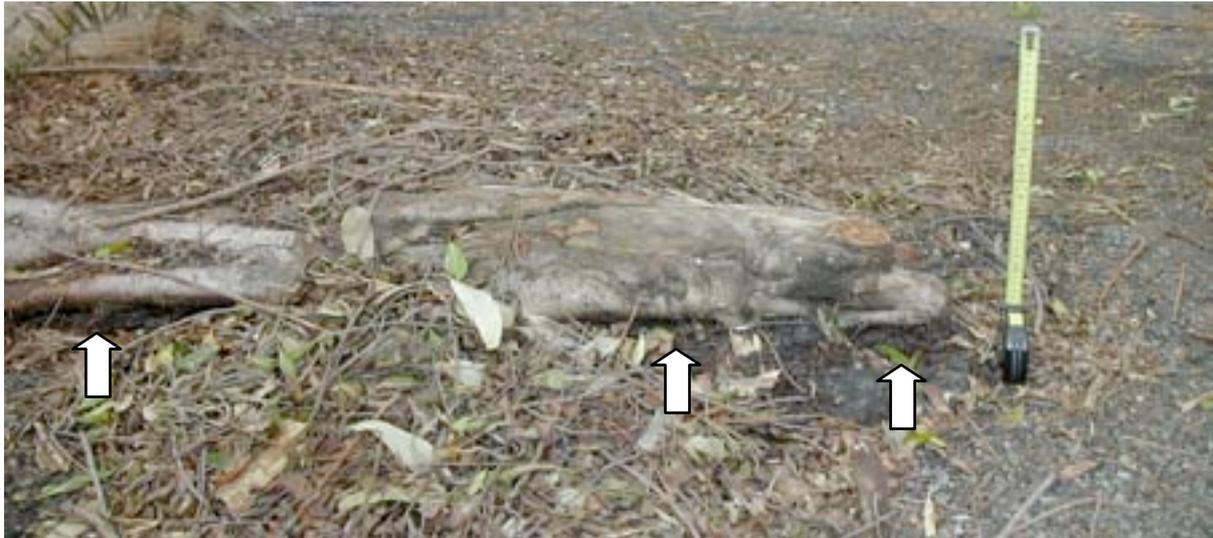
Photograph 9, above. A surface root extending to the east had lifted by 50mm at the end nearest the tape. Freshly exposed soil was evident under the edge of the root. We understand from City Arborist Mr Phil Hewett that the lift was first measured as being around 20mm; hence, the tree has been gradually subsiding to the northwest since the time of the storm. A resident also noticed this gap.

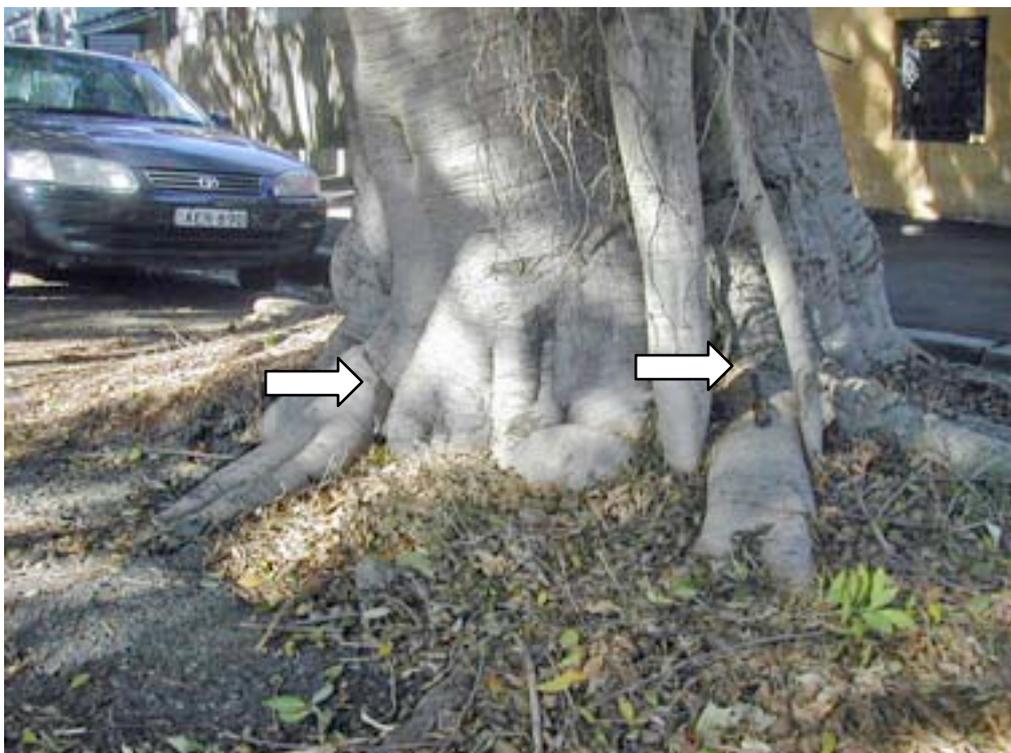
Photograph 10, above. Fractures had developed on the sides of the stem under compression, i.e. the side opposite to the section that had separated from the gutter, and the side opposite the raised root. The gap and the fractures indicate a wind-load from the southeast.

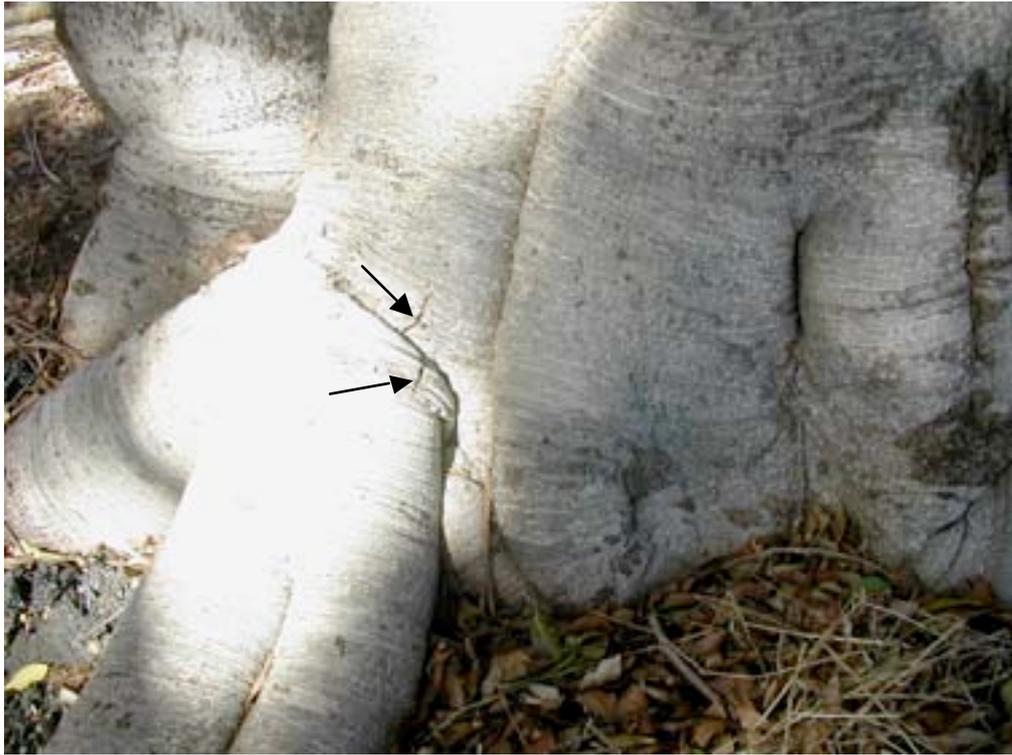
Photograph 11. 'Zigzag' Fracture at base on north.

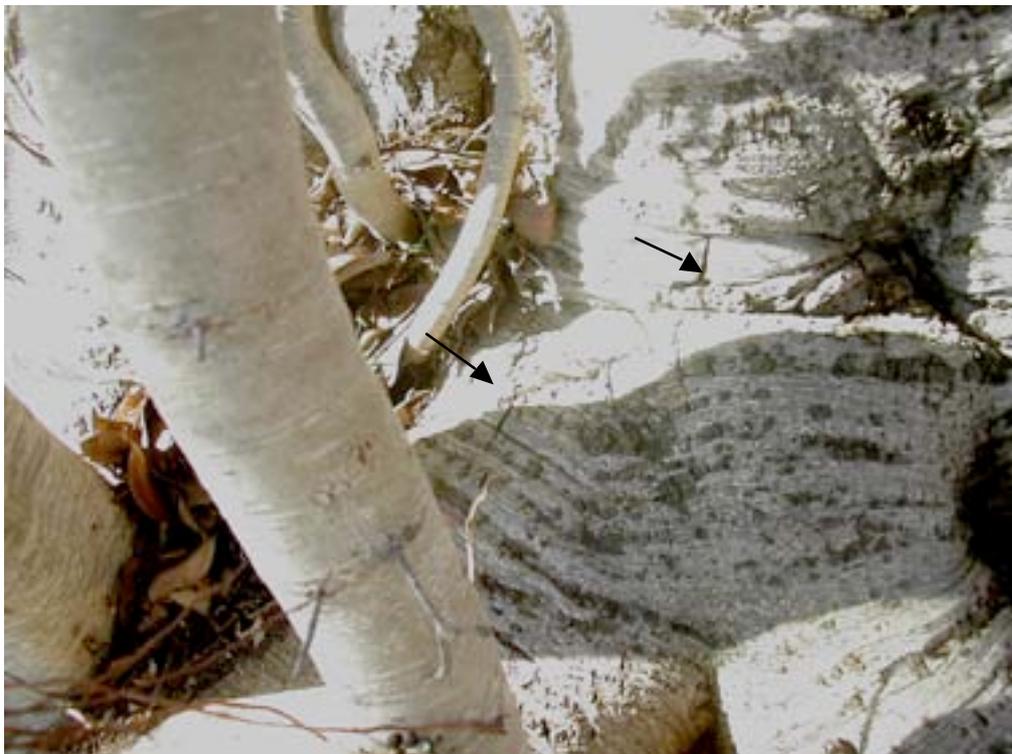
Photograph 12. Fractures at base on west.

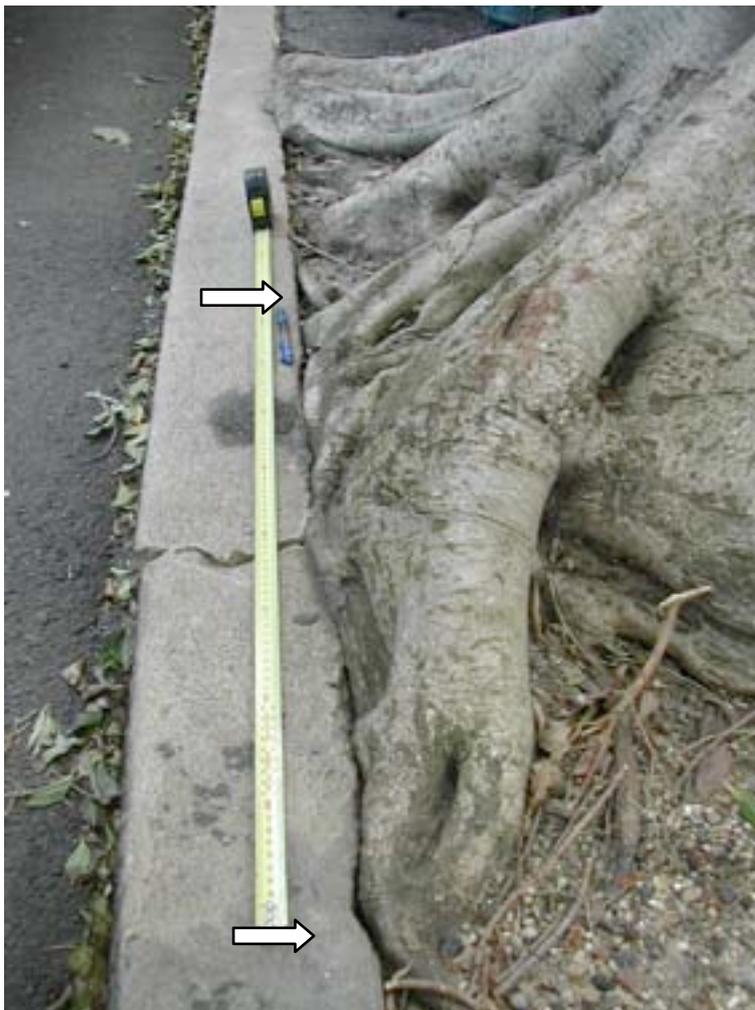
A gap has recently opened up between the kerb and the buttressed roots, extending east from the approximate middle of the base (photograph 13, below). The gap is some 1 metre long and up to 5mm wide. Fractures are present in the kerb although the fractures are not fresh, predating the storm, and were presumably caused by the pressure of the roots expanding against the kerb. The kerb is displaced by 15mm. The gap indicates a wind-load from the southeast.

The reasons for the formation of the gap along the kerb are not clear. The base of the tree and the infrastructure on the ‘compression’ side showed no signs of fracture or subsidence, and there were no signs of roots having lifted. This tends to suggest that movement of the roots displaced the kerb during the storm.

Tree #4796 was not conclusively found on the available evidence to have been destabilised. The tree does carry deadwood and stubs, which should be promptly removed. Branch unions should be checked for fractures and such like during the course of pruning works and defective branches removed. The base of the tree and its surrounds should be checked for movement and the development of fractures at least once per week over an eight-week period commencing mid-July, or configured as necessary to include the traditional 'windy' season that occurs in or around August/September. It is further recommended that Council put in place a system that ensures that the inspections are carried out. Data including photographs from the inspections is to be recorded and retained in Council files. At the end of the inspection period if no signs of movement or fractures *etc* are found, it can be concluded that the tree has not been destabilised. If signs of movement or fracturing are found at any time during the inspections the tree is to be re-evaluated.

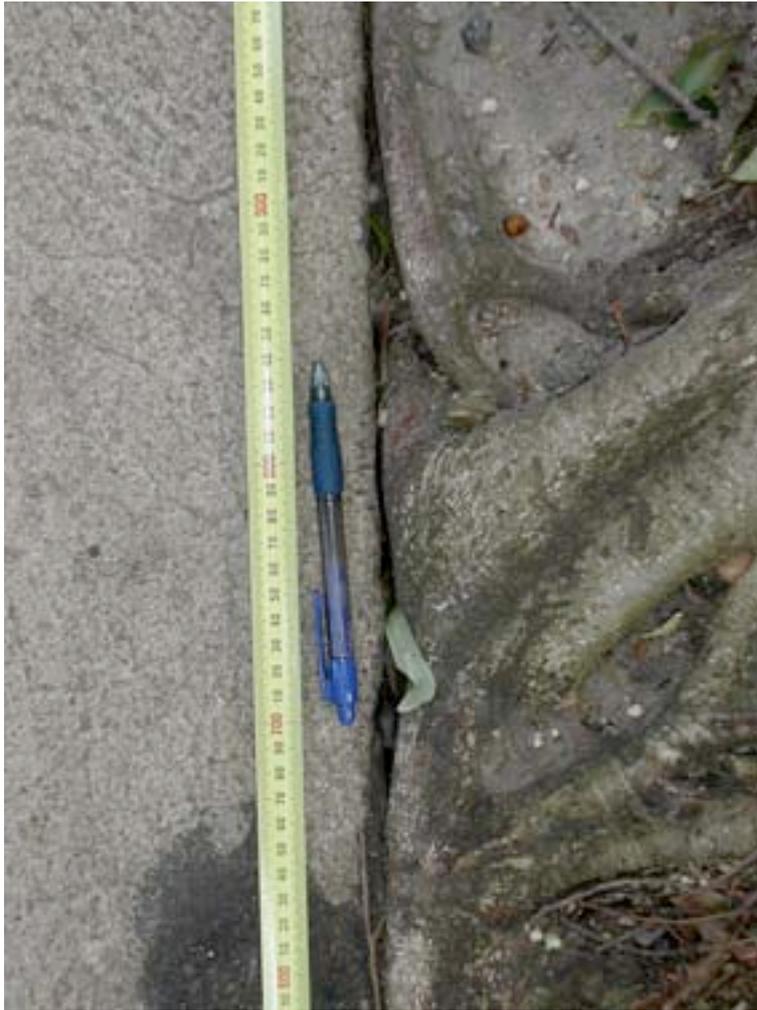
Photograph 14. The gap is up to 5mm wide.

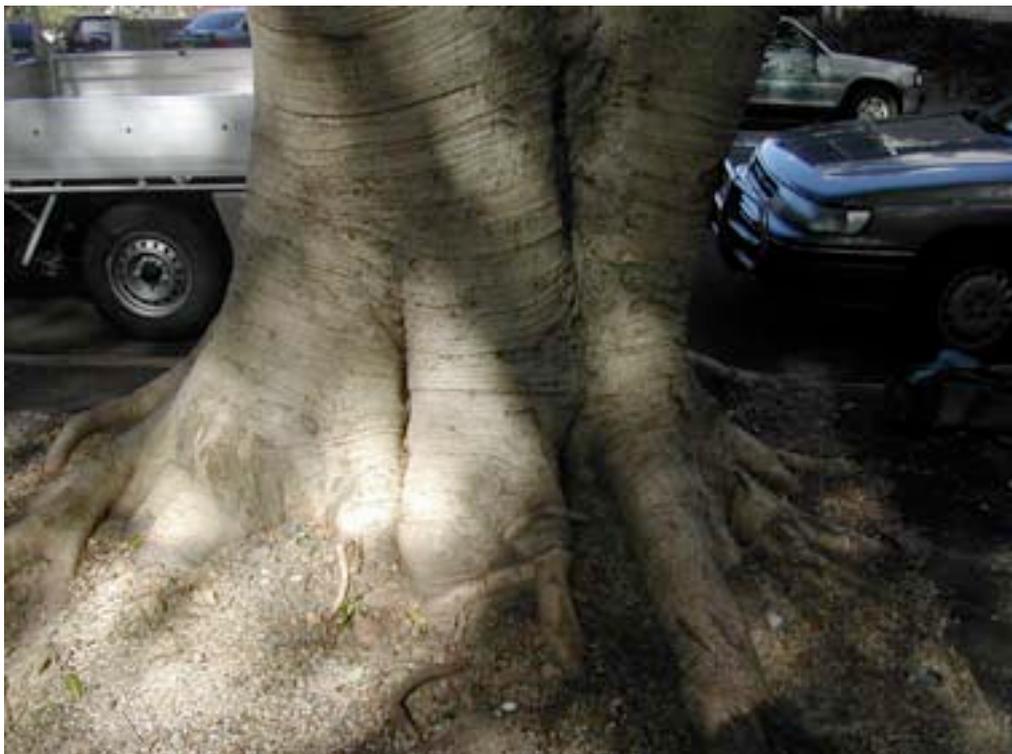
Photograph 15, below. The ‘compression’ side of the stem displayed no fractures or folds. Surface roots showed no signs of having been lifted by the wind. There were no signs of soil subsidence on the compressions side.

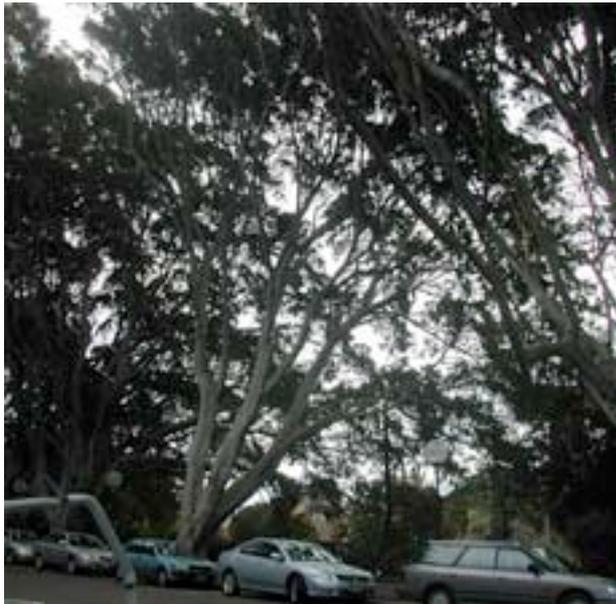
The crown of the tree is asymmetric and has a strong bias towards the north (photograph 16, left). The crown spread was physically measured at the time of the December 2006 inspection, with the axes being 15.5m (north), 6.3m (south), 9.3m (east), and 5.6m (west).

However, there are two crucial differences with this particular tree: the crown is extremely asymmetric with a pronounced bias to the north (a consequence of competition for light from nearby trees), and 'buffer' trees across the street have failed and been removed.

Tree #4797 was also not conclusively found to have been destabilised but was found to be at increased risk of failure due to severe crown imbalance and an increased exposure to wind loads. We recommend that the removal of this tree be prioritised.

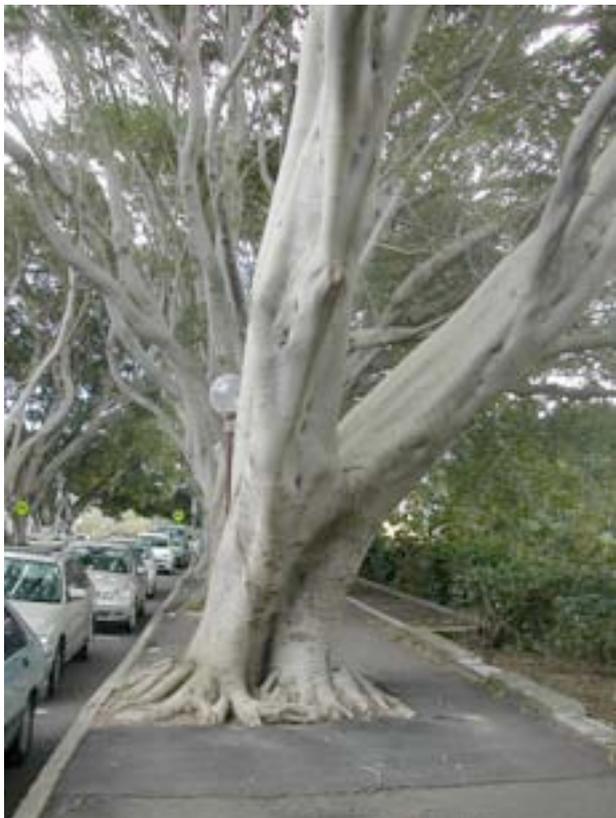
Photograph 17. The crown of the tree is carried on two vertical stems and one other stem growing on a lean of around 60° to the north.

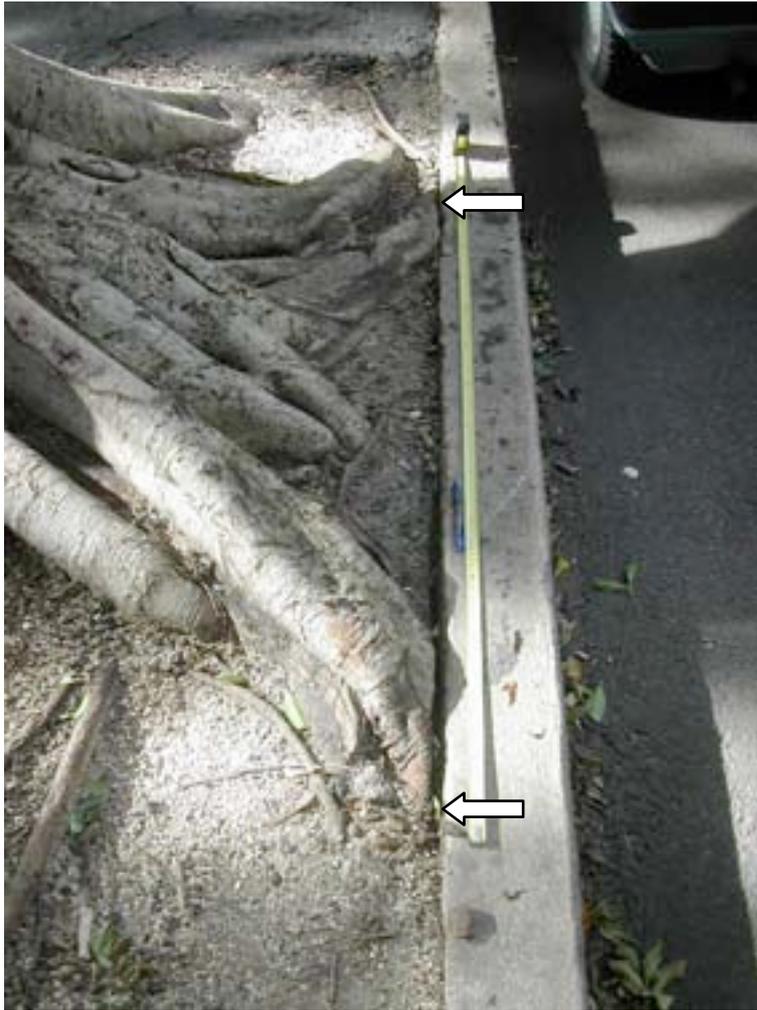
Photograph 18. A gap had recently opened along the edge of the kerb. The gap extended for 1.5m and indicates a wind-load from the south or southeast. Fractures were present in the kerb although these did not appear fresh.

Like Tree #4796, the gap that opened up along the kerb was not accompanied by any signs of lifting at the buttresses on the tensile side, or any signs of subsidence or fracturing on the compression side. Again, it is probable that the gap was caused by the flexing of roots while under a tensile load, displacing the kerb. A conclusion that the tree was destabilised by the storm cannot be supported.

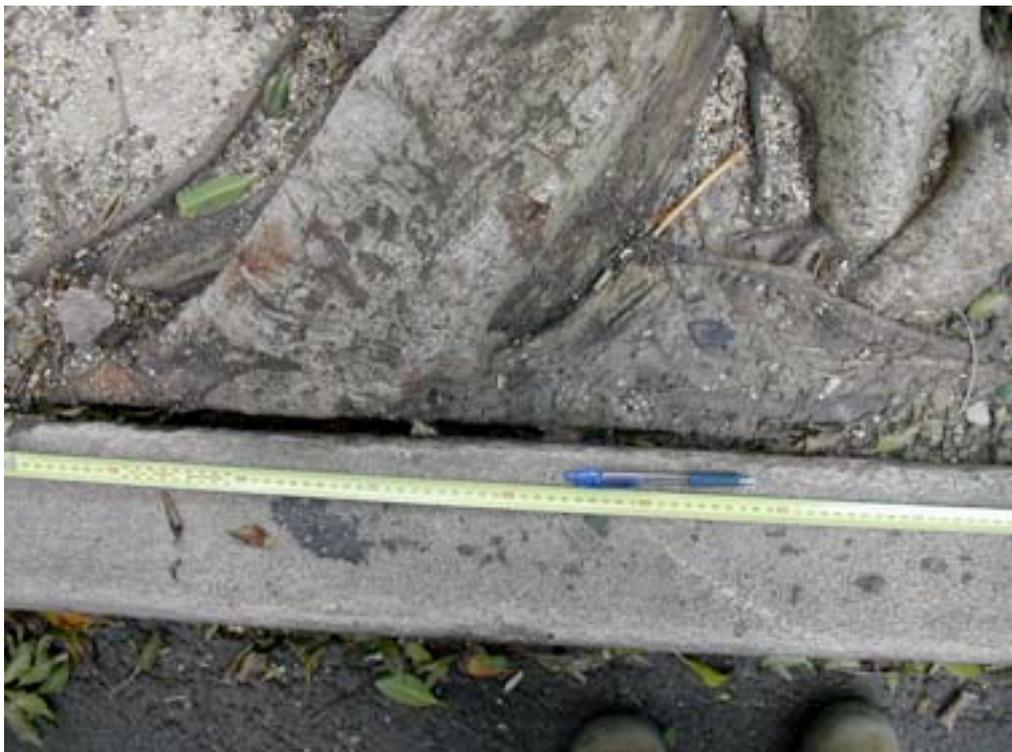
Photograph 19, below. The gap was up to 15mm wide.

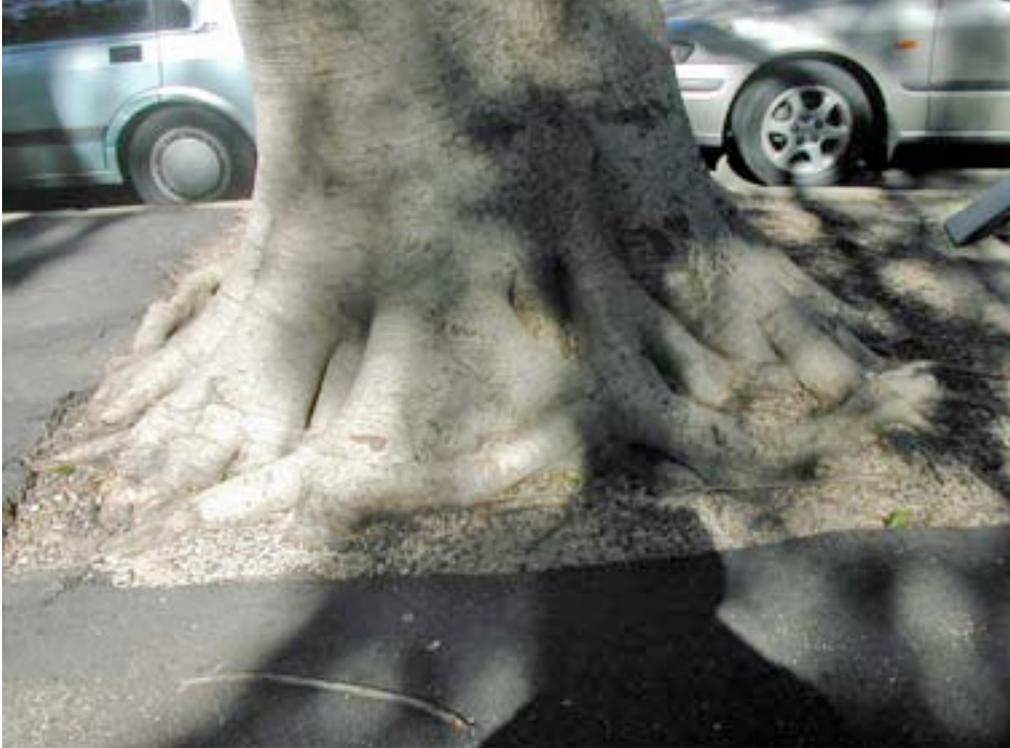
Photograph 20. The 'compression' side of the stem displayed no fracturing or sudden fibre-buckling. Surface roots showed no signs of having been lifted when under wind load. There were no signs of soil subsidence on the compressions side.

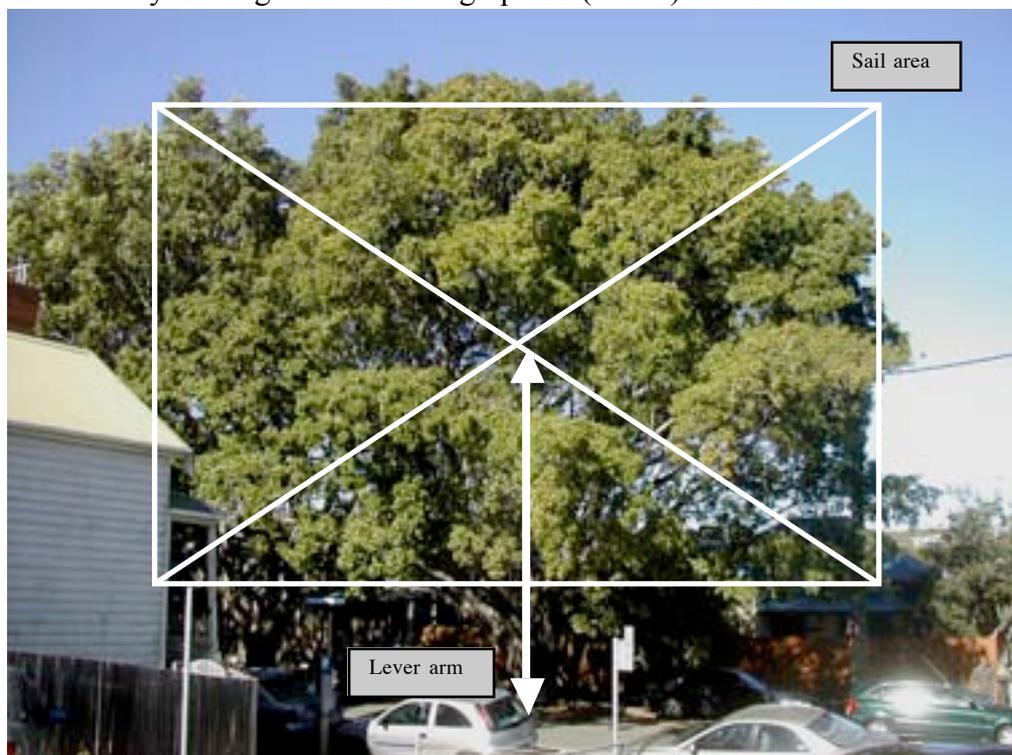
The tree has suffered a partial wind-throw and now that the crown is imbalanced, the weight of the crown is gradually dragging the tree downwards to the north. Lonsdale states that trees that suffered partial windthrow can sometimes generate new roots over several years that will stabilise the tree^{viii}, although in this instance this is not an option that we would put forward to Council. Given that the root on the east of the tree has continued to lift, it can be argued that the tree is in the process of whole-tree failure and as such the options for retention are much more limited.

The centre of the crown can be found by drawing a box around the perimeter of the crown when viewed in elevation, and joining up the diagonals. The crown centre is where the diagonals intersect^{ix}. The sail area is simply the exposed side of the crown. The lever arm is indicated by the large arrow. Photograph 21 (below) illustrates this.

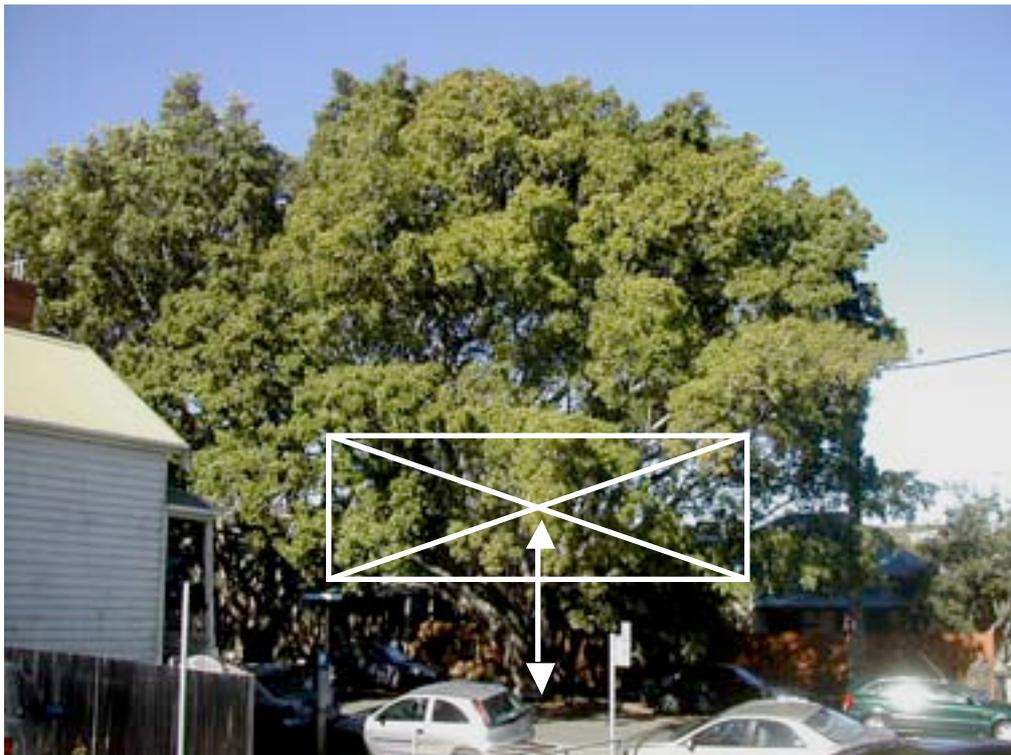
In order to avert failure the lever arm and crown-sail area would then of necessity have to be reduced from the top of the crown downwards to the point where no or only very little leverage was exerted on the root-plate. Mathematically, this equates to a crown of roughly 35m², or about 4m tall by 9m wide (photograph 22, below). Around 85% of the live crown area would be removed.

This would only be a short-term option to prevent the failure of the tree; it is not an acceptable treatment as a method of tree retention in other than exceptional circumstances, e.g. if the tree were especially valuable for reasons of culture, heritage, rarity, etc. Broadly speaking, it would involve lopping the tree back to a stump and then managing the regrowth. At best, this would result in an accelerated decline and at worst it could kill the tree outright.
