Stage 2 Reports - Sediment Transport
Study and Probabilistic Hazard
Assessment Summary (Bluecoast, 2020a)

Sediment transport study within Stockton Bight

Report #: P19028_PartA-StocktonBightStudy_TN0.00

Stockton Beach coastal erosion hazard assessment

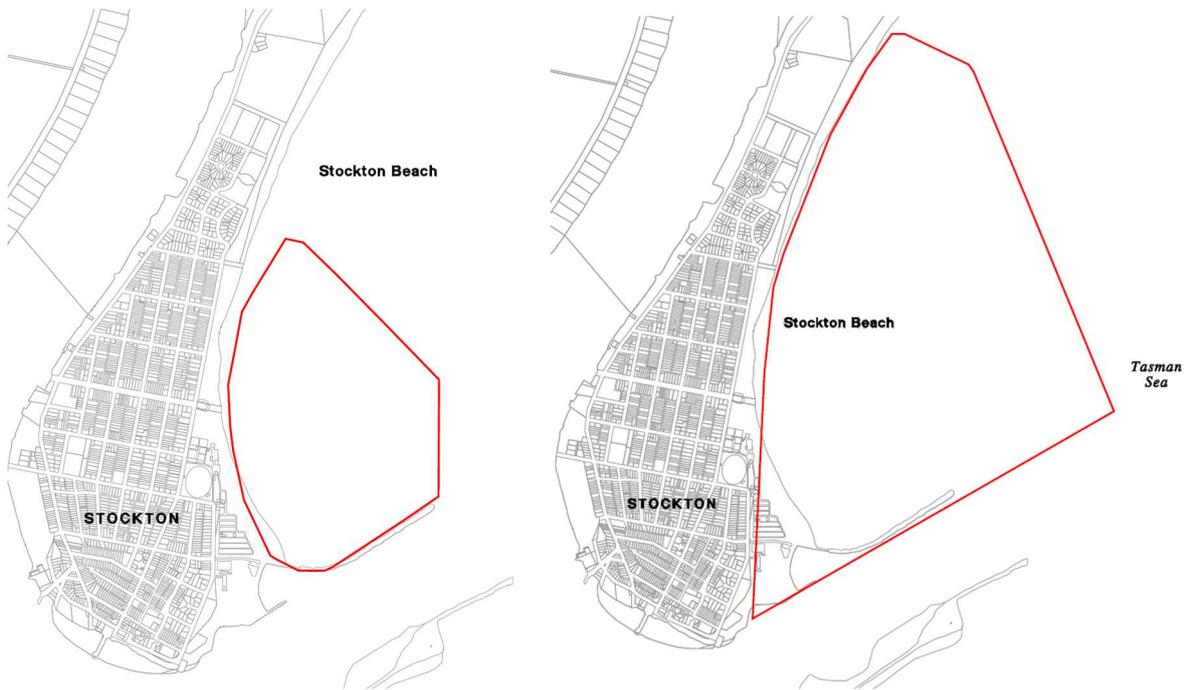
Figure 3: Sand loss analysis areas used in the Umwelt (2002) report – (left) Area 1 and (right) Area 2.

The long-term loss rate calculated by Umwelt for Area 2 is consistent with the sand loss rate from 1866 to 1988 calculated herein (70,000m³/yr). However, the rate of 370,000m³/yr given for the period from 1988 to 2000 is much higher than the rate of 100,000m³/yr estimated herein for the period between 1988 and 2018. It is noted that the lower rate presented herein does not discount the beach nourishment quantities. However, when these are included (i.e. equivalent loss rates of 133,000m³/yr) the rates are still lower than Umwelt's 1998 to 2000 rate and the difference is likely due to the shorter period of the analysis using the data available at the time of Umwelt's 2002 report.

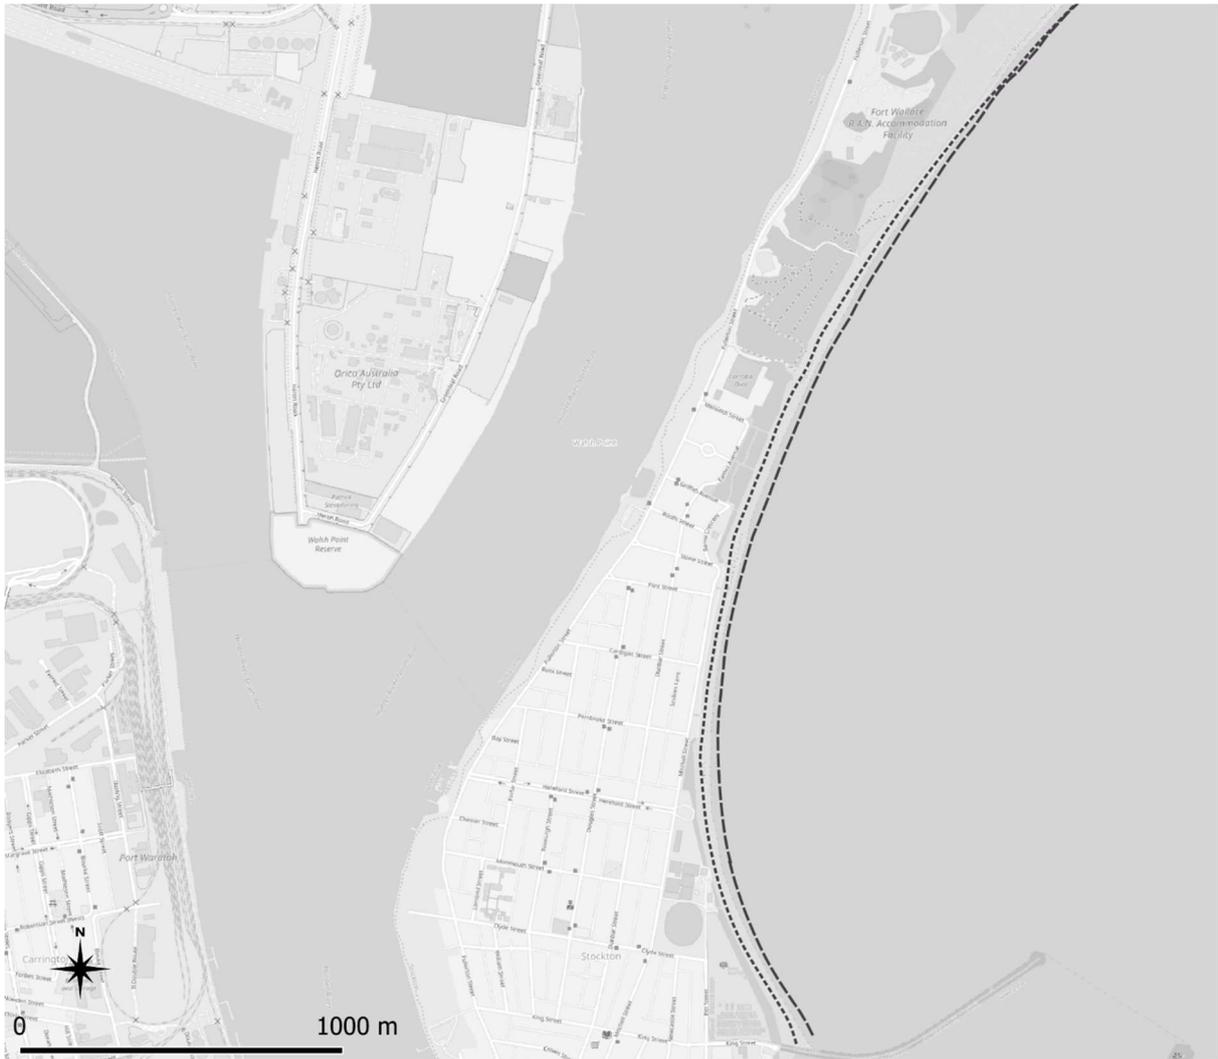
Figure 12: Mean sea level (0m AHD) shorelines from 2018 (inner) and 1994 (outer) showing realignment of the southern embayment.

- Erosion of the inner surf zone is still observed in compartment 4 inshore of the dispersed sand nourishment, this may be due to the response of the shoreline to erosion occurring to the north (i.e. realignment of the zeta shaped embayment in response to lack of sediment supply), see Figure 12.

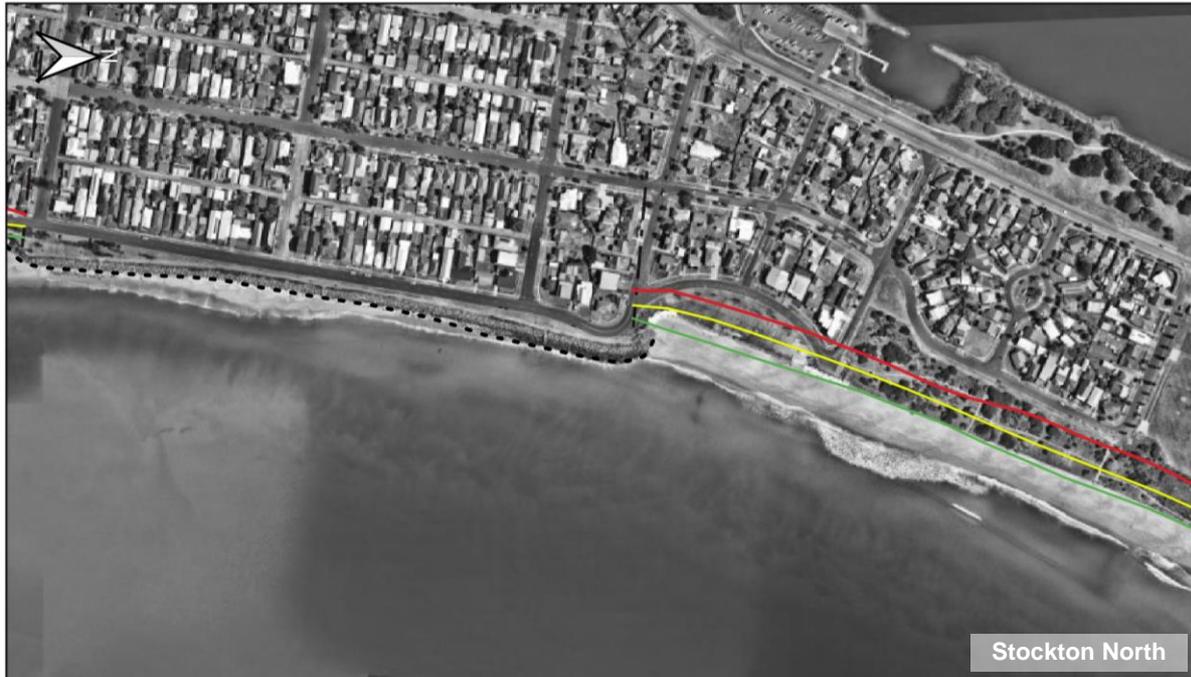
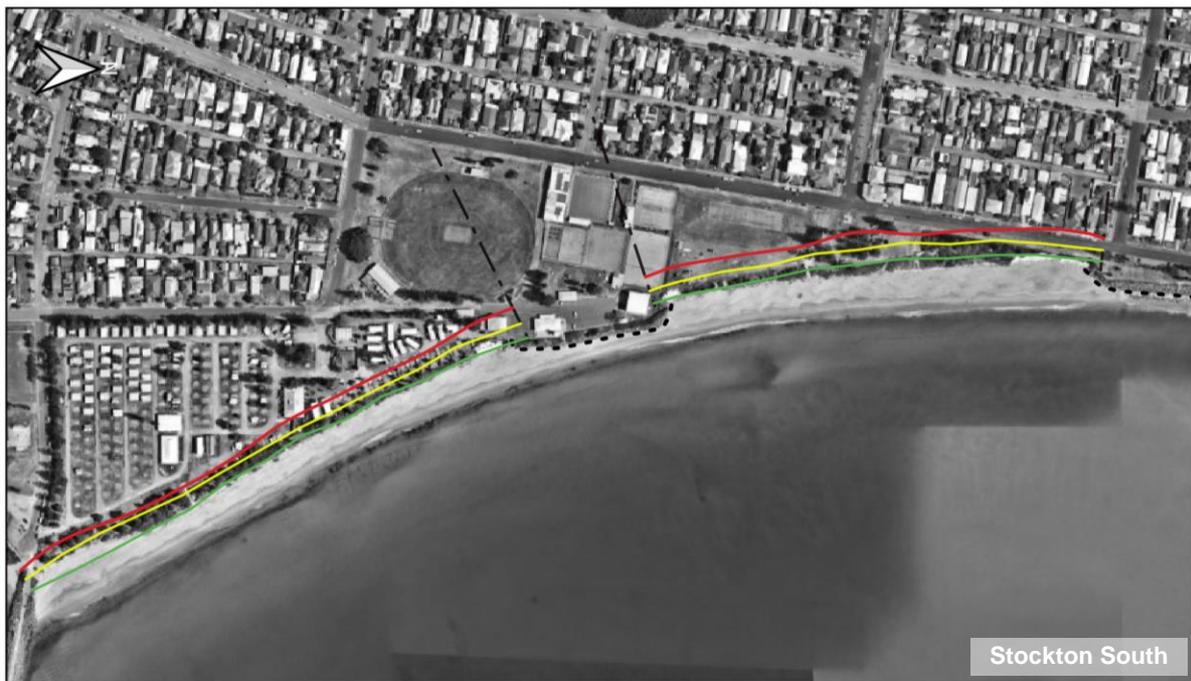
Figure 11: Hazard lines for the erosion hazard in year 2020.

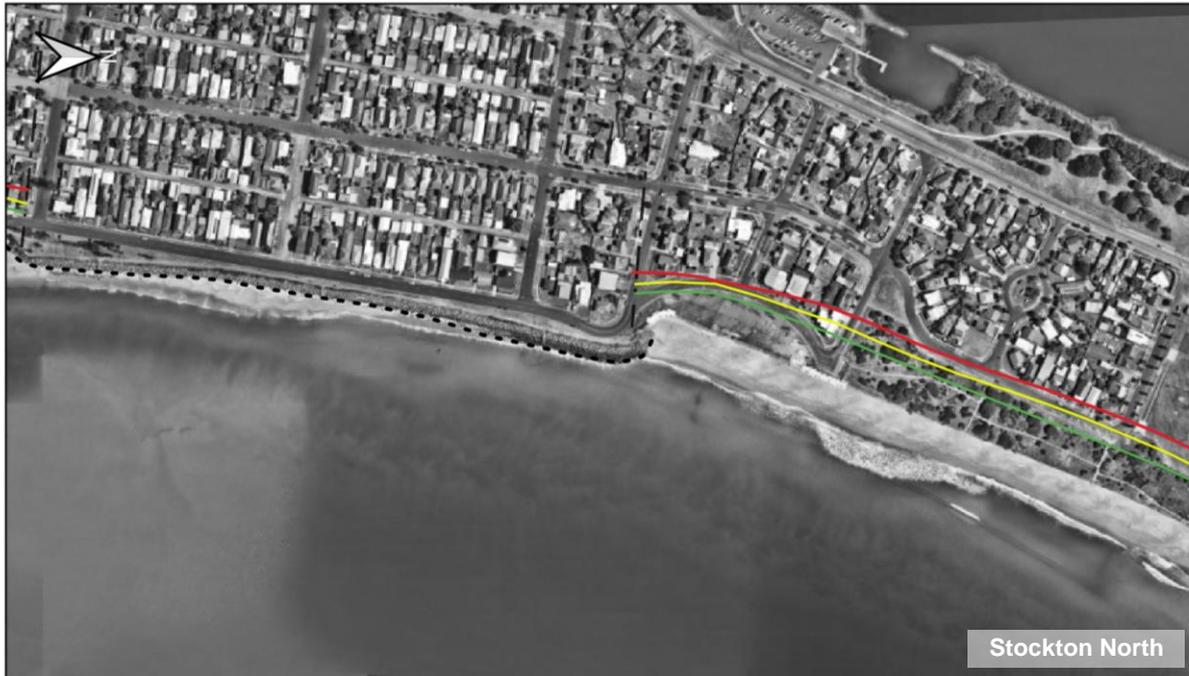
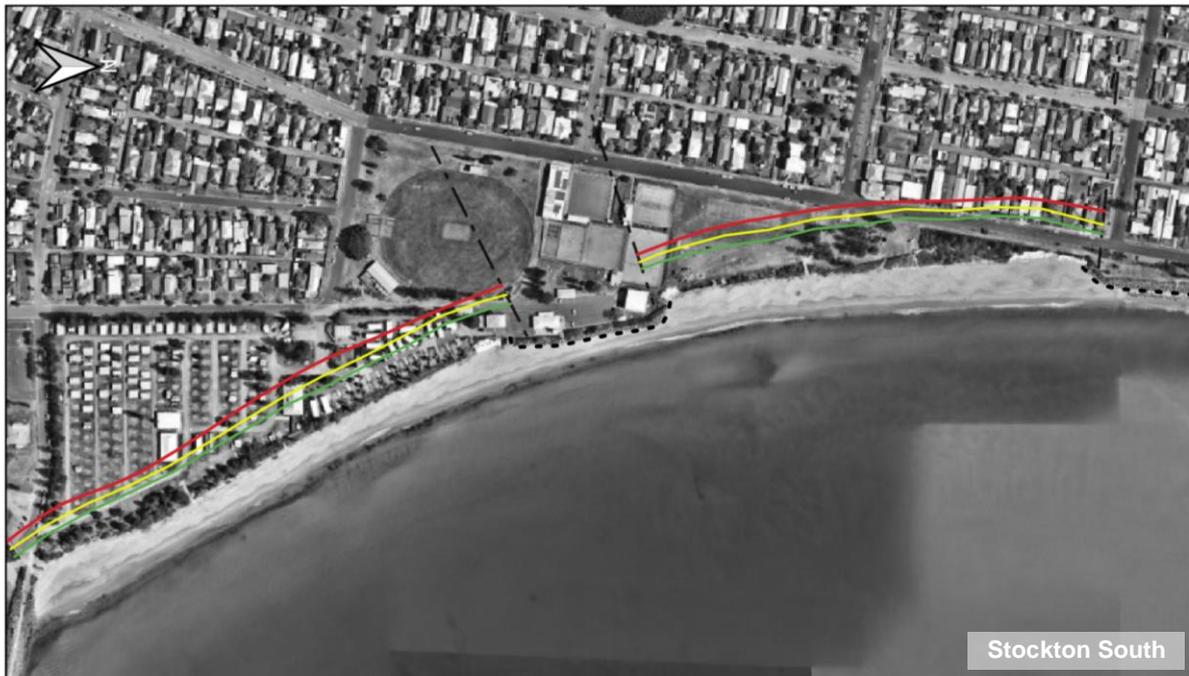
Figure 12: Hazard lines for the erosion hazard in year 2040.

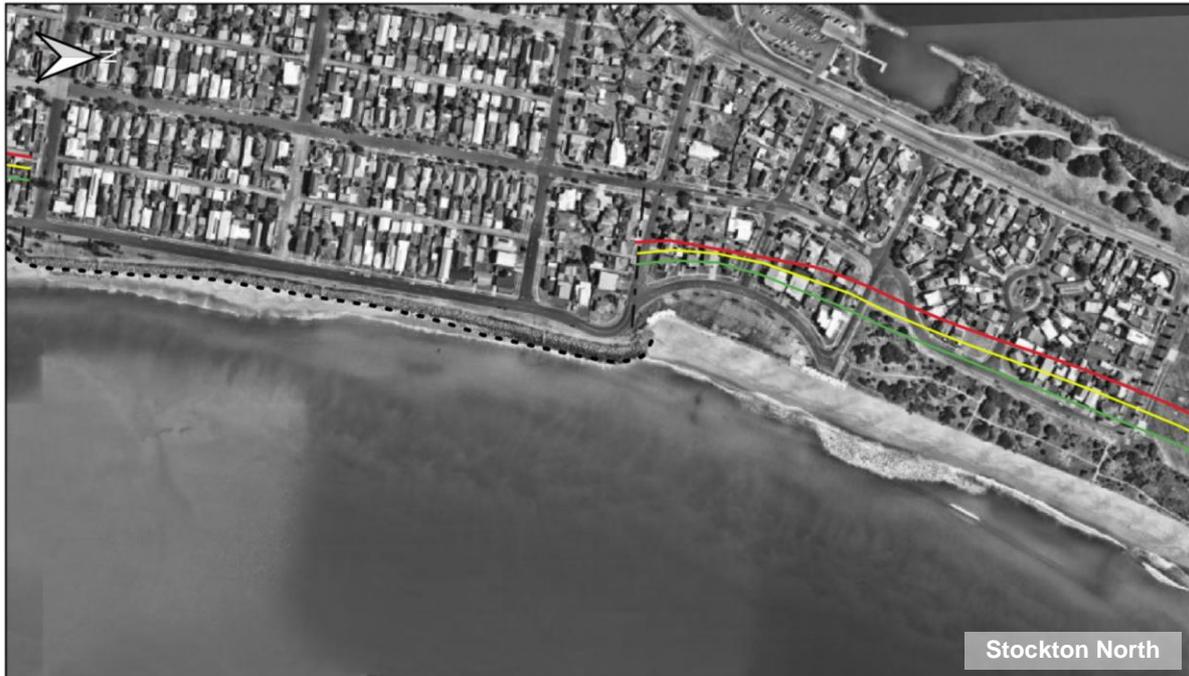
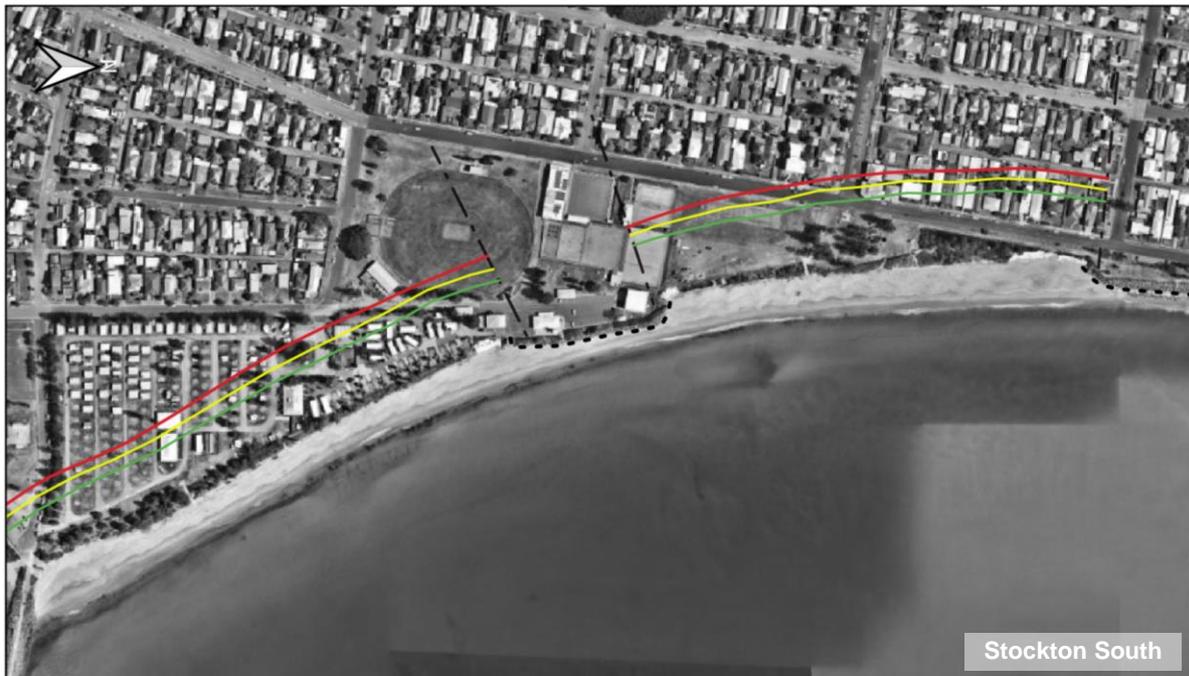
Figure 13: Hazard lines for the erosion hazard in year 2060.

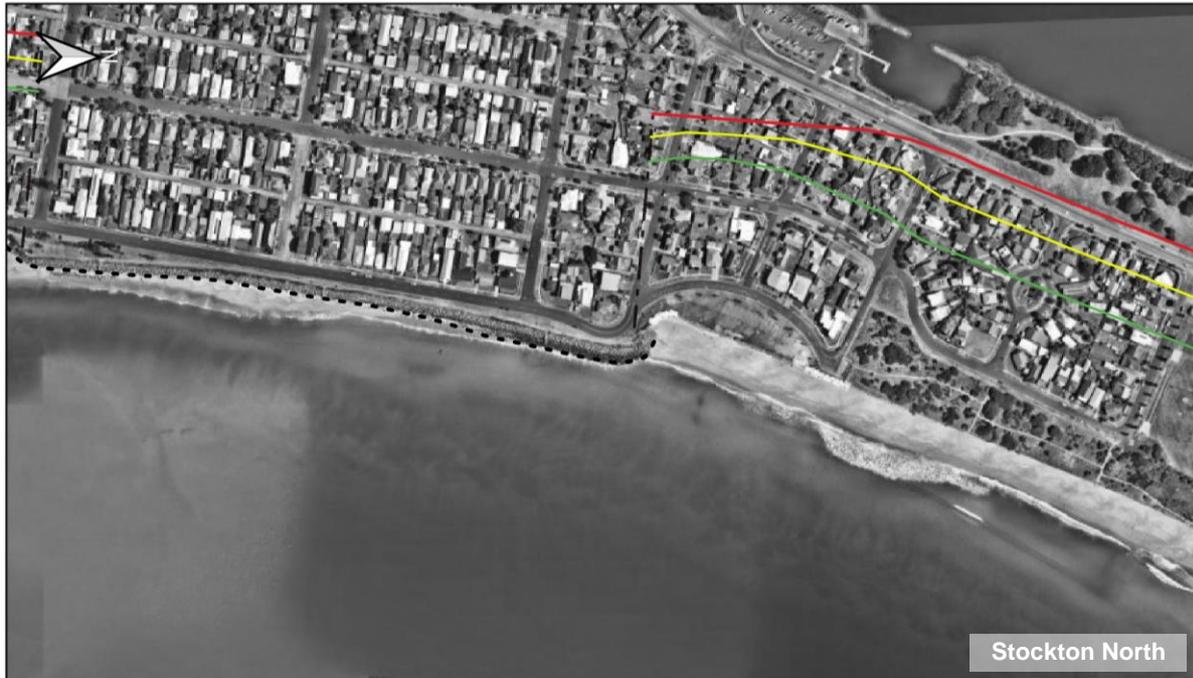
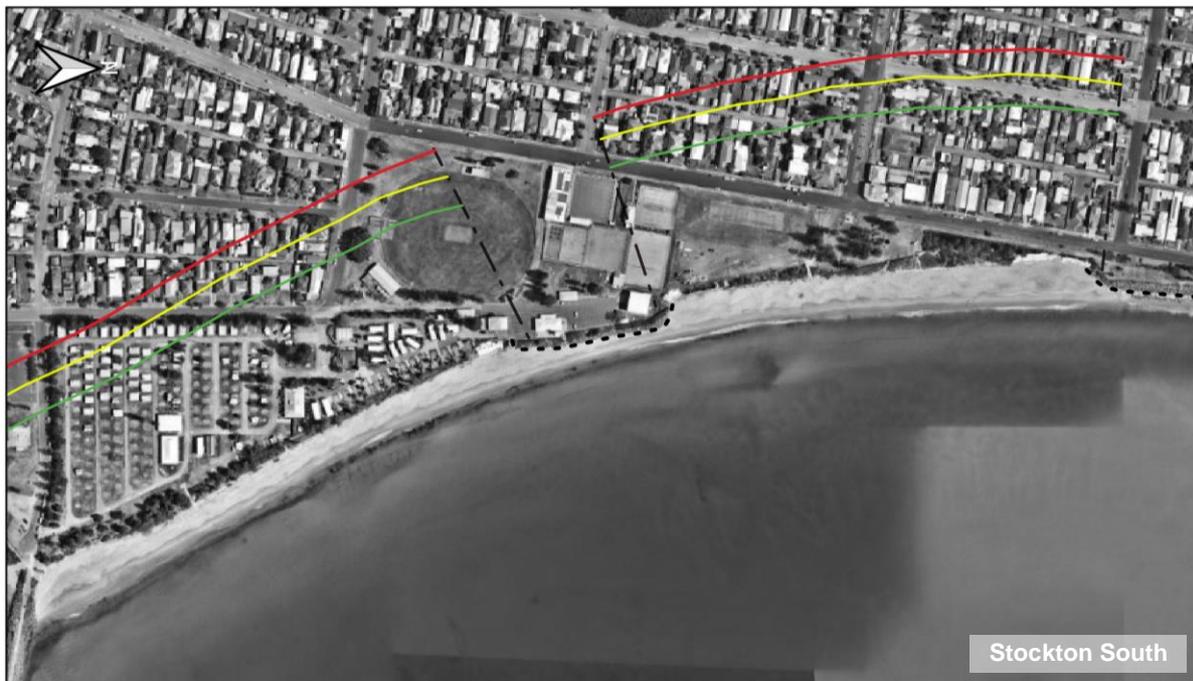
Figure 14: Hazard lines for the erosion hazard in year 2120.

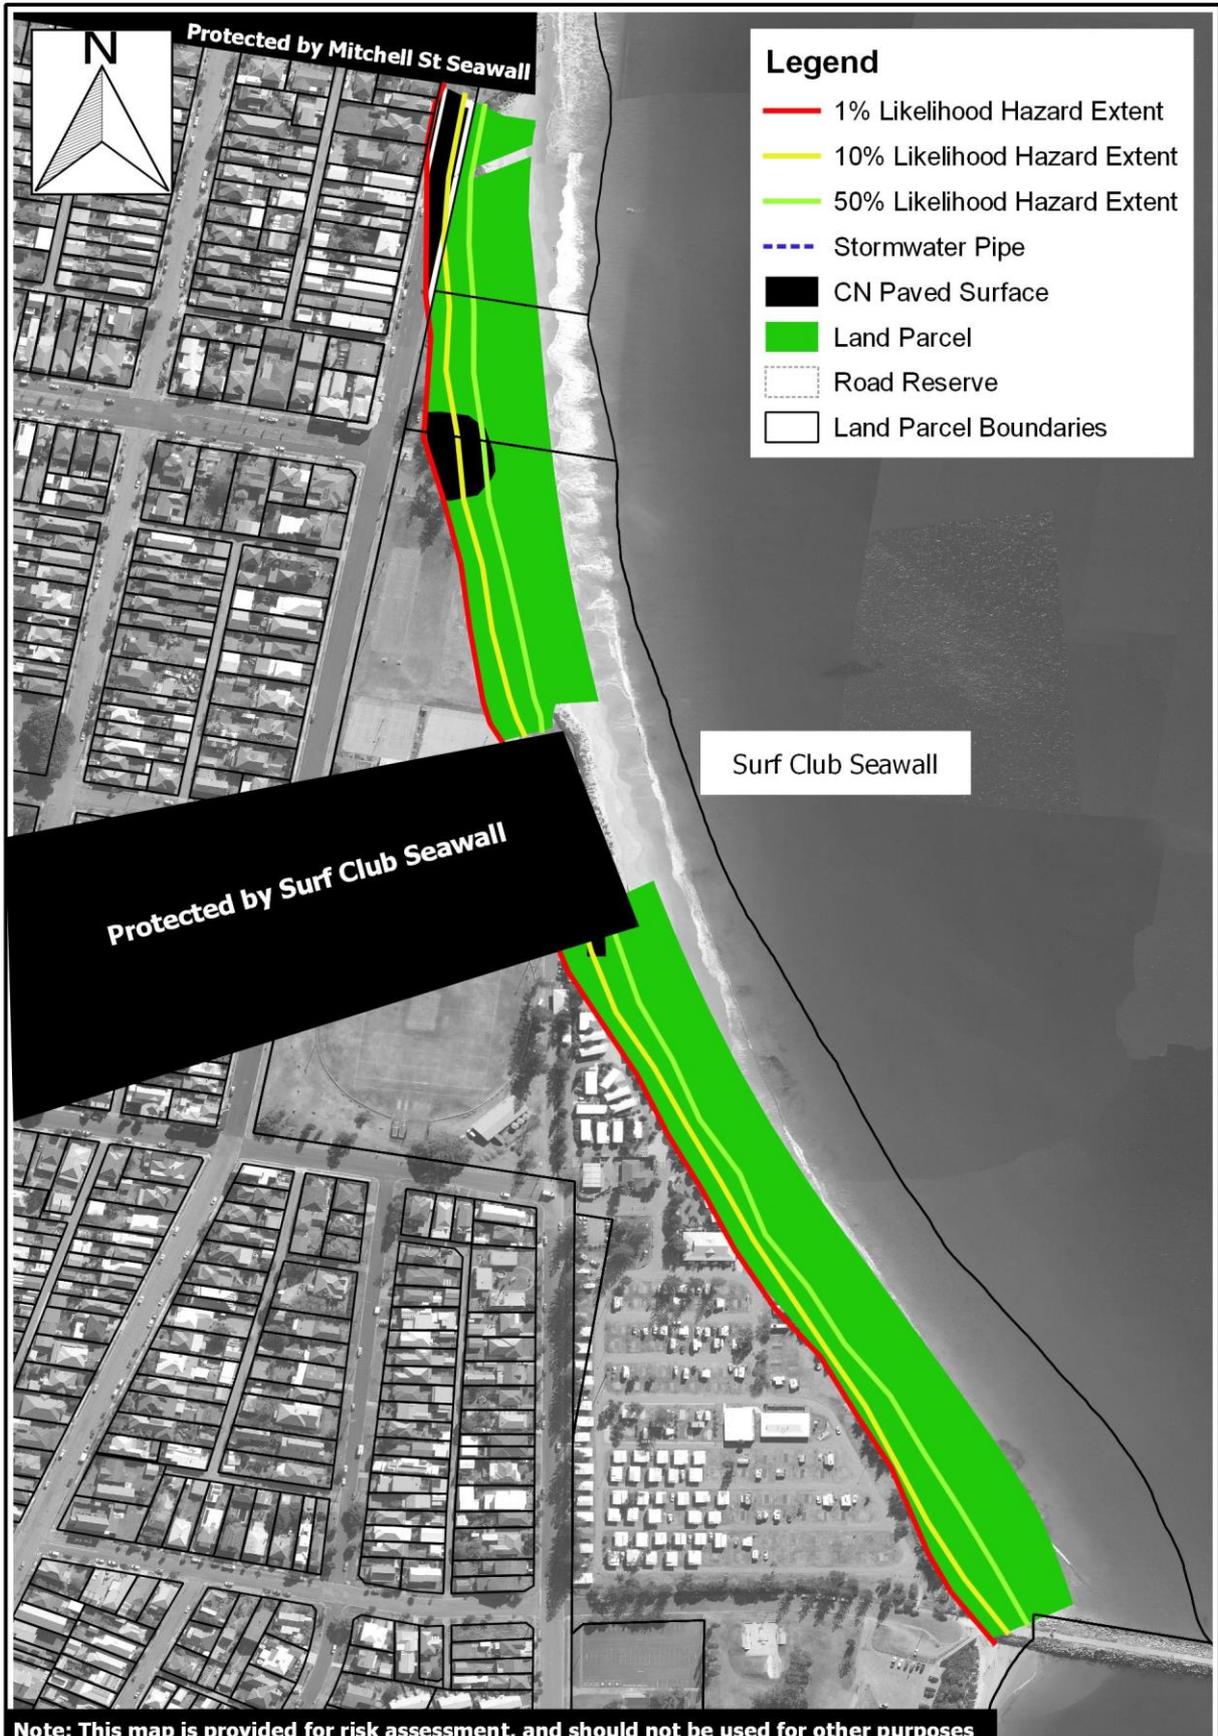
Figure 5: Affected Surface Assets for 2020 (South)

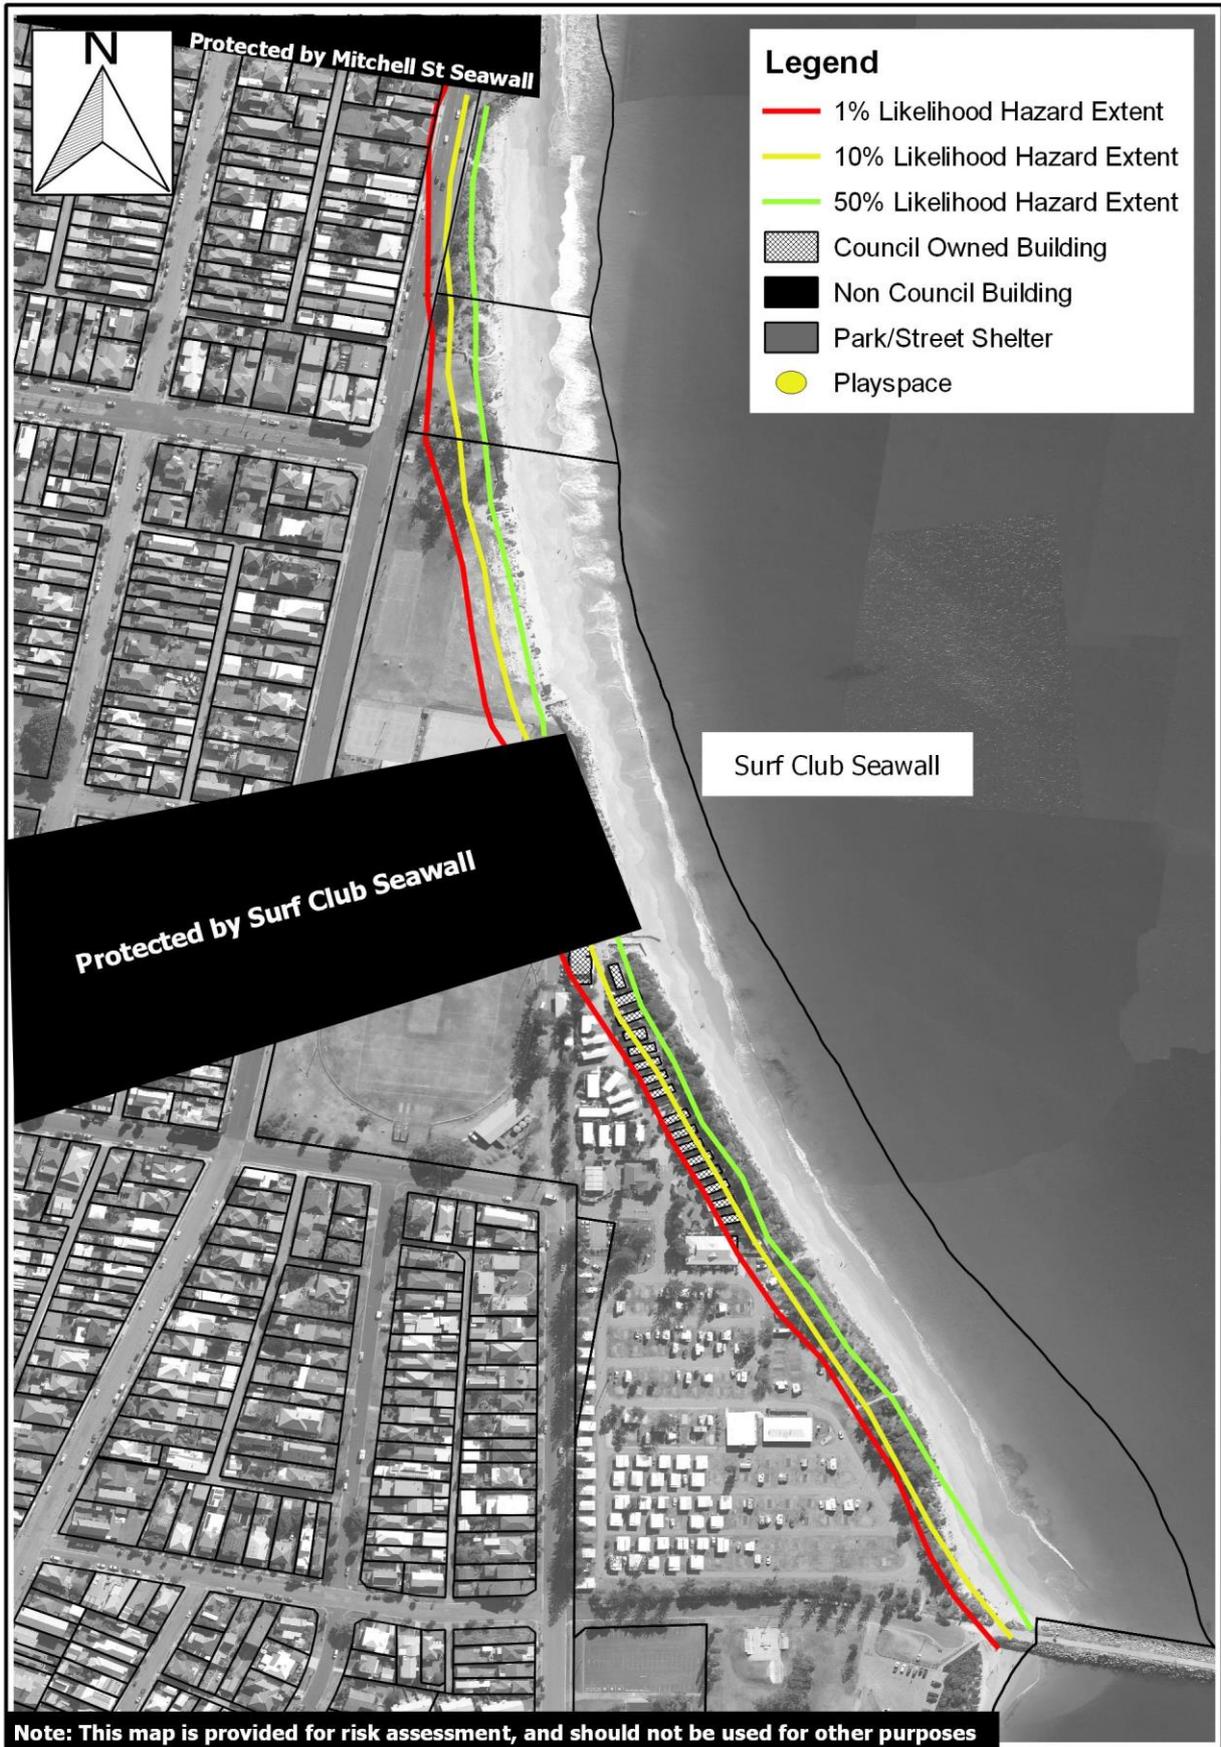
Figure 6: Affected Above Ground Assets for 2020 (South)

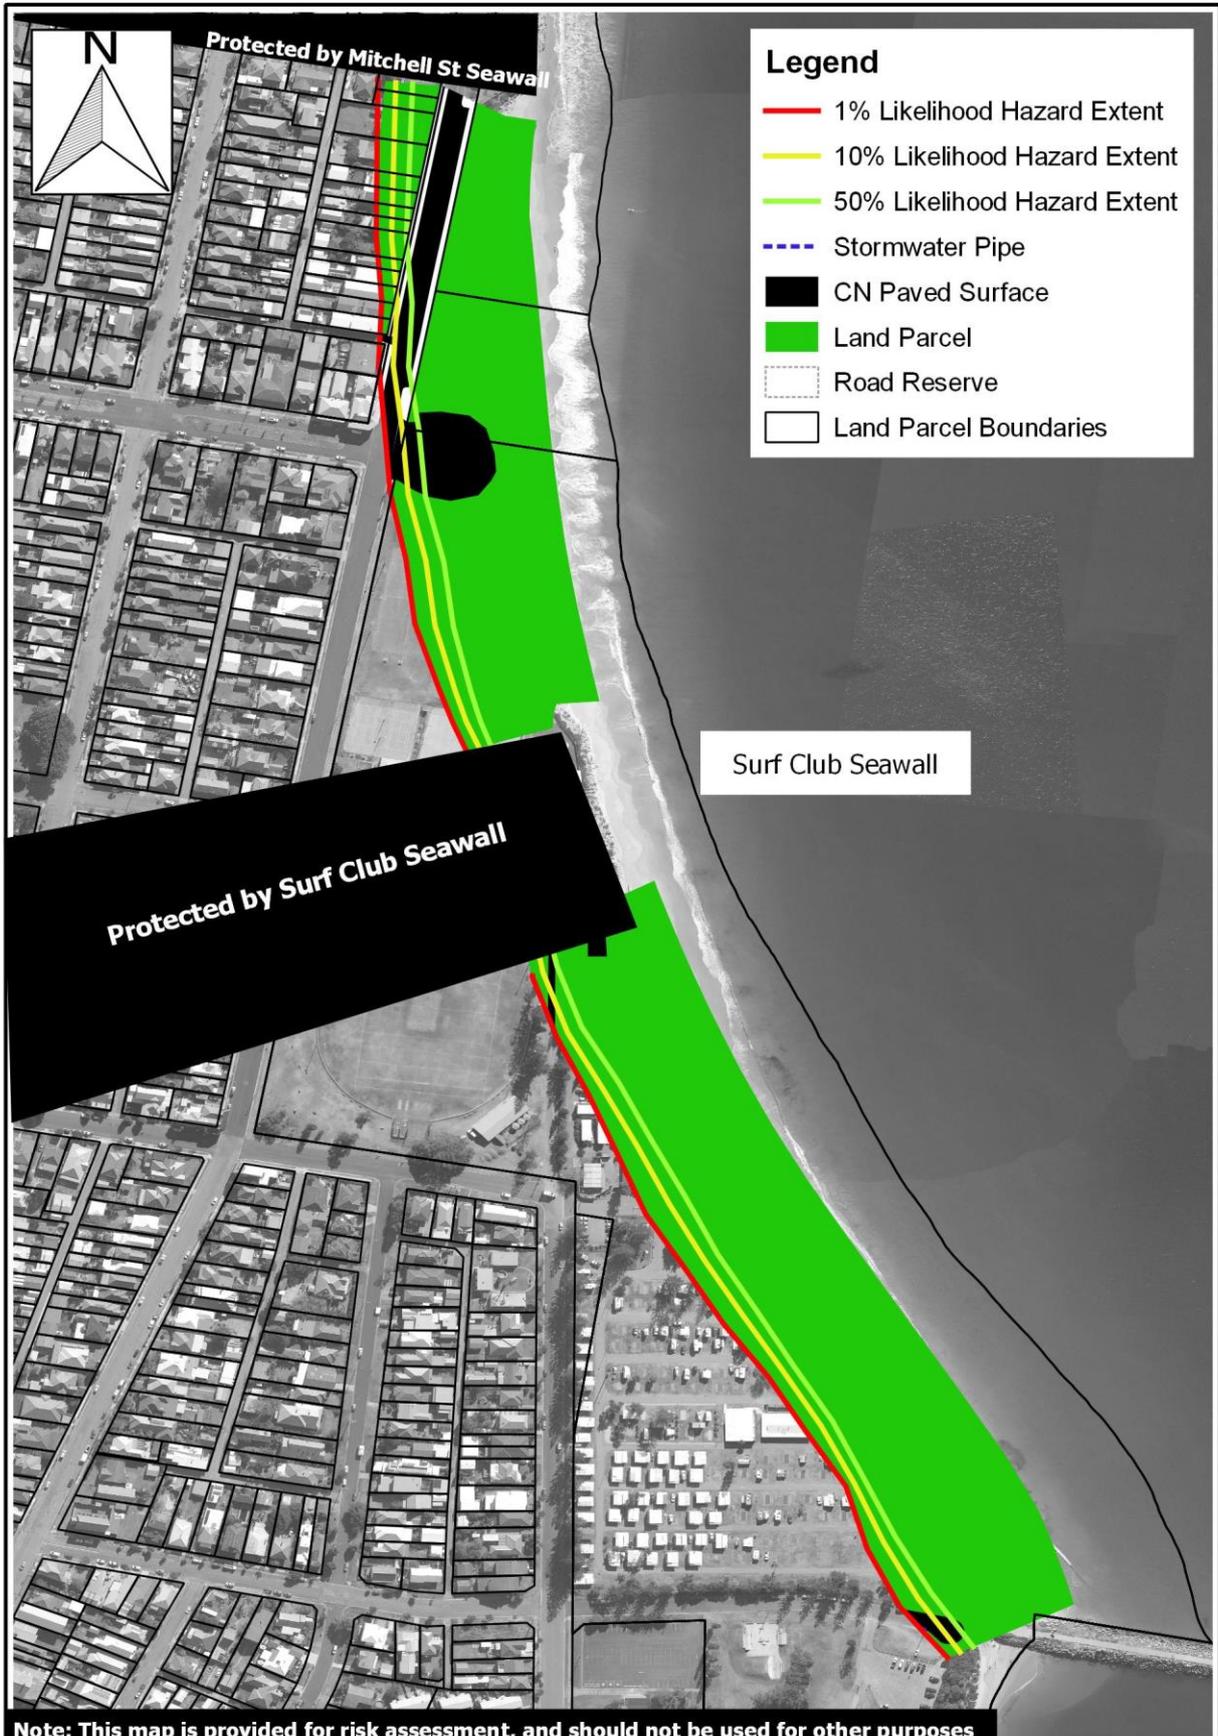
Figure 9: Affected Surface Assets for 2040 (South)
