## Conservation Management Plan

Shepherds Hill Defence Group Military Installations  
SHR # 01806

41 The Terrace, Newcastle and 65 Nesca Parade, The Hill

Submitted to the Council of the City of Newcastle

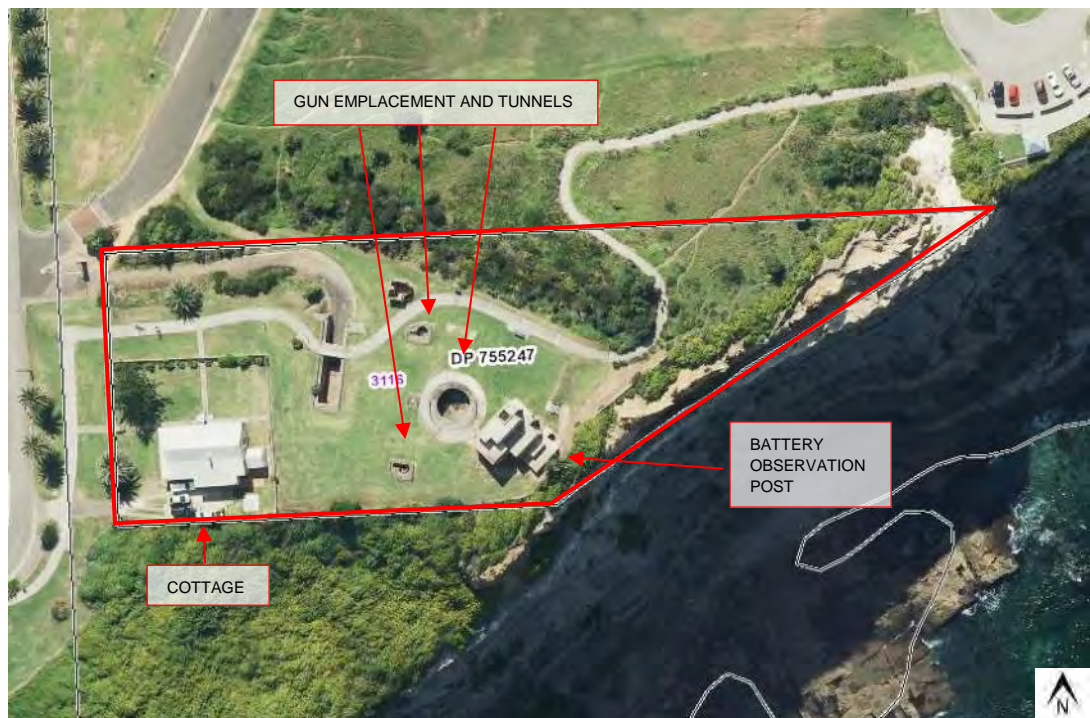
Figure 6: Detailed aerial view showing the various built elements located on the subject site. (Source: SIX Maps accessed 21 August 2017 via <https://maps.six.nsw.gov.au/>)

The block slopes slightly to the east and the cottage is built towards the western end of the site. All other built elements are located east of the cottage excluding the toilet block and the Marine Rescue aerial which are located south of the cottage. A number of built elements are underground and not visible from ground level (tunnels etc) (Figure 6).

According to the archaeological assessment undertaken by JCIS Consultants, there are a number of concrete pads within the site visible the aerial (Figure 6):<sup>3</sup>

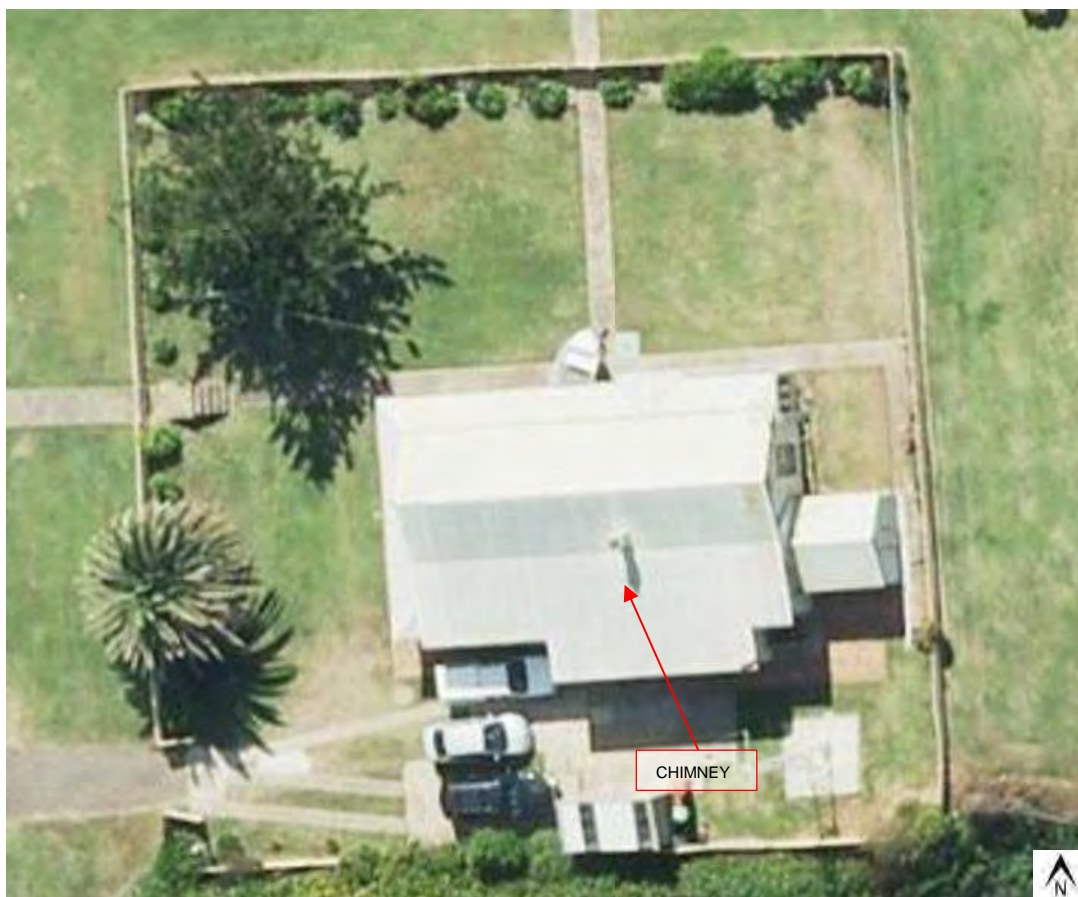
Figure 8: Aerial view showing the configuration of the roof and garden, prior to the storm of April 2015. Note the one remaining chimney present. The grounds within the boundary of the picket fence appear to have been maintained in this aerial image but were overgrown during the site inspections undertaken

The cottage previously featured 3 chimneys (centrally, to the east and to the west), of which only one remained before the cottage was damaged in the April 2015 storm, as indicated in the aerial seen in Figure 8. According to the SoHI prepared by John Carr in relation to the restoration works, the skillion roof was repaired in late 2016 temporarily to prevent further water ingress and deterioration to the interiors of the cottage. The roof to the remainder of the building remained damaged.<sup>5</sup>

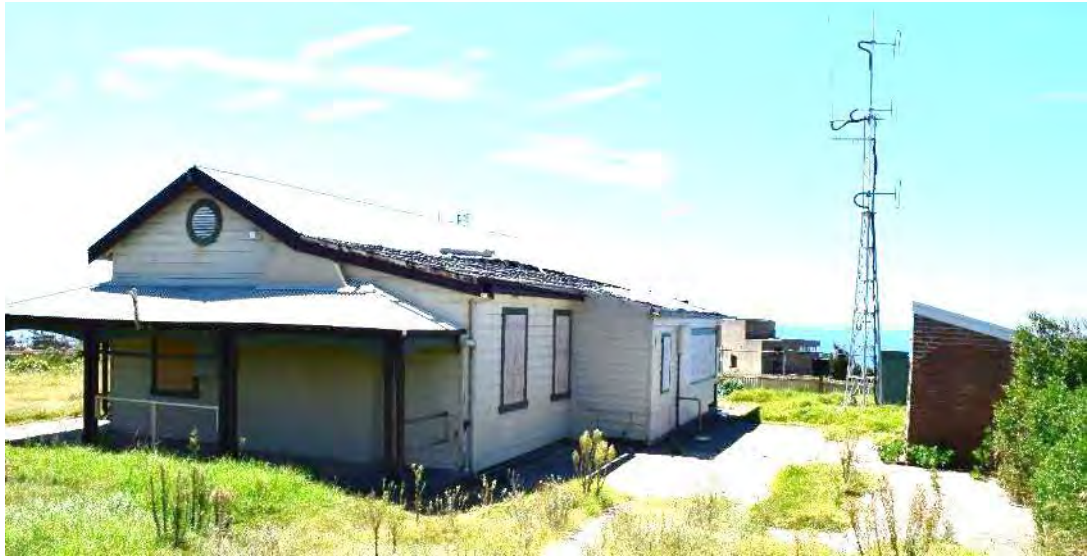
Figure 9: The cottage looking east towards the Tasman Sea and the Observation Post which is visible in the background. Note the extension to the southern elevation, damaged to the roof, concrete paving between the cottage and outbuilding and overgrown surrounding garden. The Marine Rescue aerial is also visible.

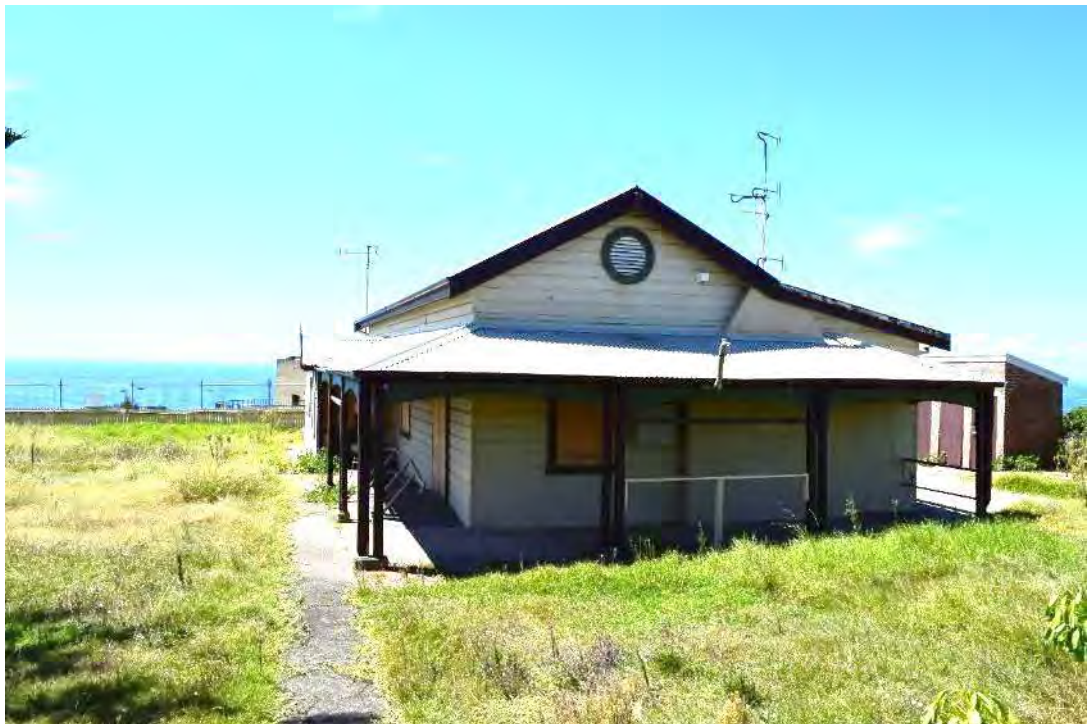
Figure 10: Cliff Street looking east towards the cottage. The wrap around veranda is clearly visible from within this elevation along with the gable end and circular vent detailing. The ground, as evident in the photo has a slight incline towards the north-east.

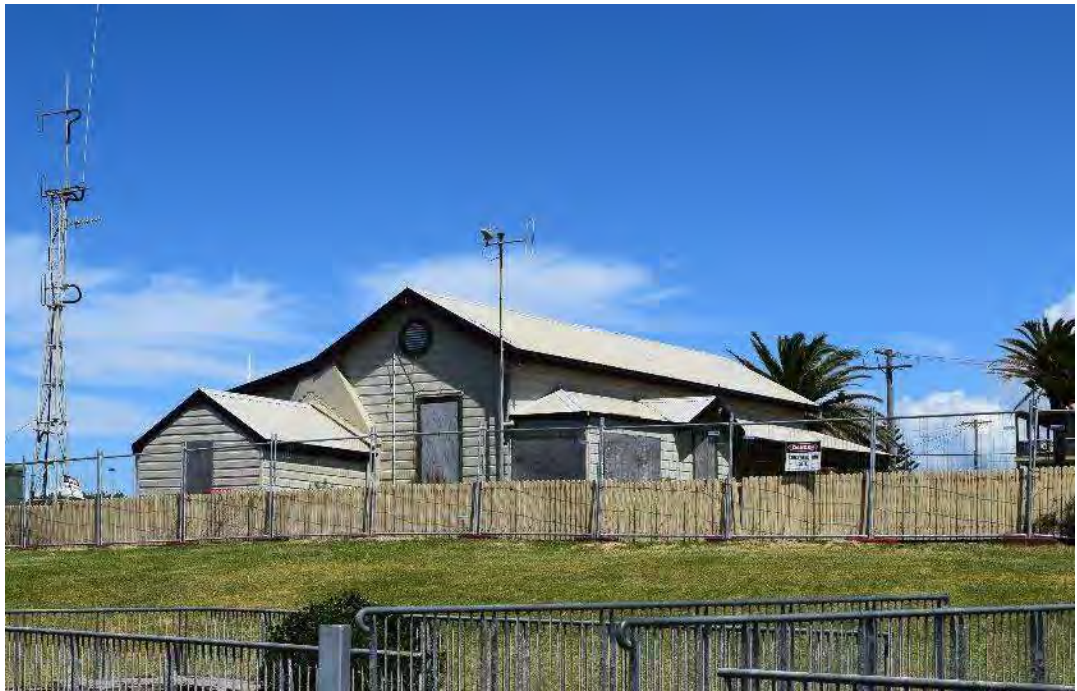
Figure 11: Eastern and northern elevations showing the gable end with circular vent, laundry extension and separate gable end to the main entrance. The infilled sunroom is also visible along with the temporary metal fence and picket fence from the 1980s.

The external eastern façade (Figure 11) features a gable end with a central circular vent (as seen in the western elevation), a boarded doorway and an attached laundry that is at a lower height to the main cottage, with a separate gable end and external entrance within the eastern elevation. The laundry is in the same timber weatherboards as the rest of the cottage. Also evident in this elevation is the skillion roof to the south, visible behind the laundry building.

Access to the cottage can be gained from within an entrance located within the north-eastern corner of the cottage, within the northern elevation (Figure 11). As previously identified the veranda and separate skillion roof extends from the western elevation, wrapping around to the north and terminating where it meets the entrance which has a separate gable end (with timber finial at the apex). Adjacent to the enclosed entrance in the north-eastern corner is an enclosed sunroom, with a separate skillion roof at the same height as the veranda roof.

It should also be noted that within Bedroom 3, Kitchen and Dining Room, the fibre plaster sheeting seen in other rooms is not present and the timber lining boards are exposed (Figure 18, Figure 19 and Figure 20). The north-eastern sunroom is also a later addition and was originally an open section of veranda. This is clearly evident in the fabric of this section of the cottage whereby wall linings have been introduced and there are small windows which are stylistically in contrast to the windows seen in other areas of the cottage (Figure 11).<sup>7</sup>

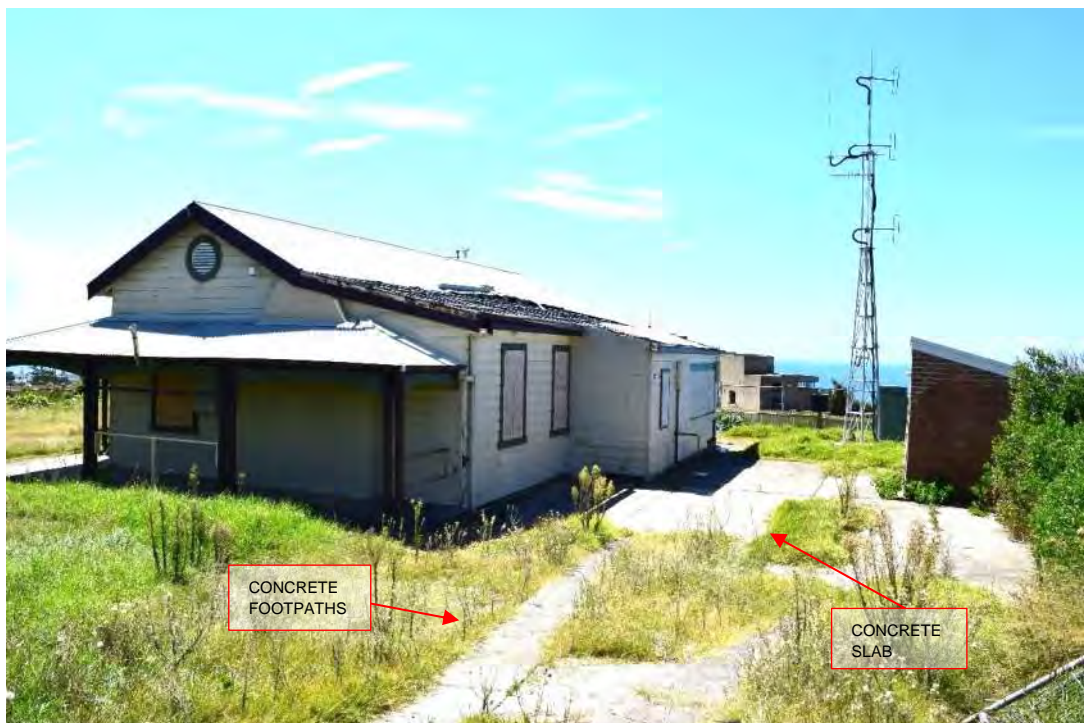
Figure 12: The western and southern elevations of the cottage. Note the concrete slab between the cottage and shed and concrete paths that lead from The Terrace.

The southern elevation (Figure 12) includes an extension to the south east, where a bathroom and sunroom were added at a later date, resulting in the extension of the main roof. The roof to this section is of a skillion design, extending south from the main gabled roof section of the cottage and extension over the south-eastern extension. There are a series of windows and doors present within this elevation, however, they have been boarded up. These windows, along with the window to the southern elevation of the kitchen, are a later addition and differ in appearance to other windows seen in the cottage. The extension is clad in rusticated weatherboards with vertical tongue and groove lining boards to the extension's eastern elevation.

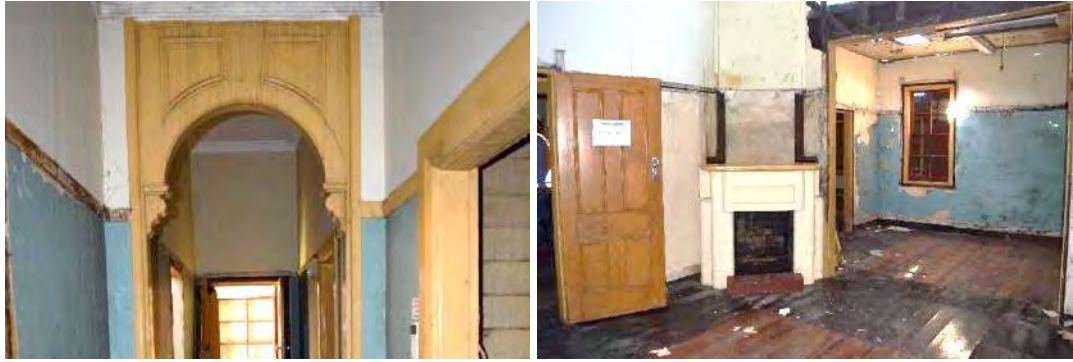
Figure 13: Entry hallway with decorative timber architraves and corbels (left) remaining fireplace and timber floors (right). The masonry fireplace was installed in the 1920s and was substantially damaged in the April 2015 storm. It is also leaning into the room and is not considered to be in a typical style from the 1920s.

Despite the damage, decorative timber architraves including timber corbels and a section of the picture rails still remain (Figure 13). In some sections the timber has been painted, while others remain unpainted. Throughout the cottage, polished timber floorboards of different timber varieties line the floor. Although both chimneys have been damaged, the brick fireplace hearths remain with little damage sustained.

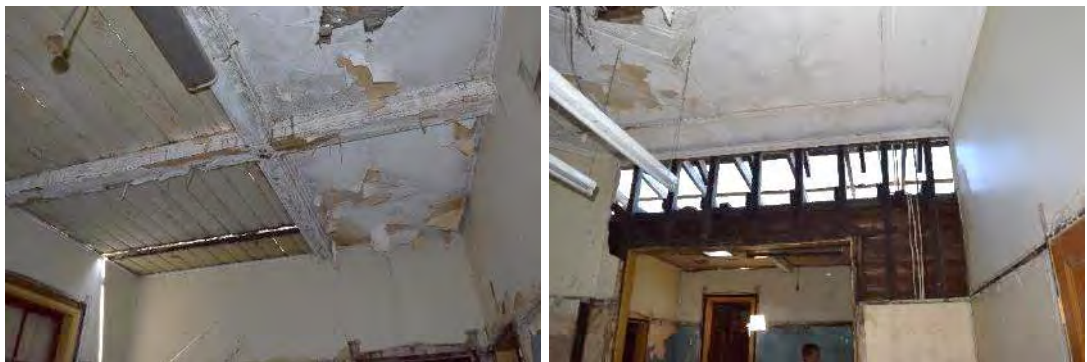
Figure 14: Weatherboard ceiling with crossed timber beams in a smaller ancillary room (left) evidence of decorative plaster moulding in the main living area (right). Note the damage incurred to the ceiling as a result of water ingress caused by openings to the roof following the April 2015 storm.

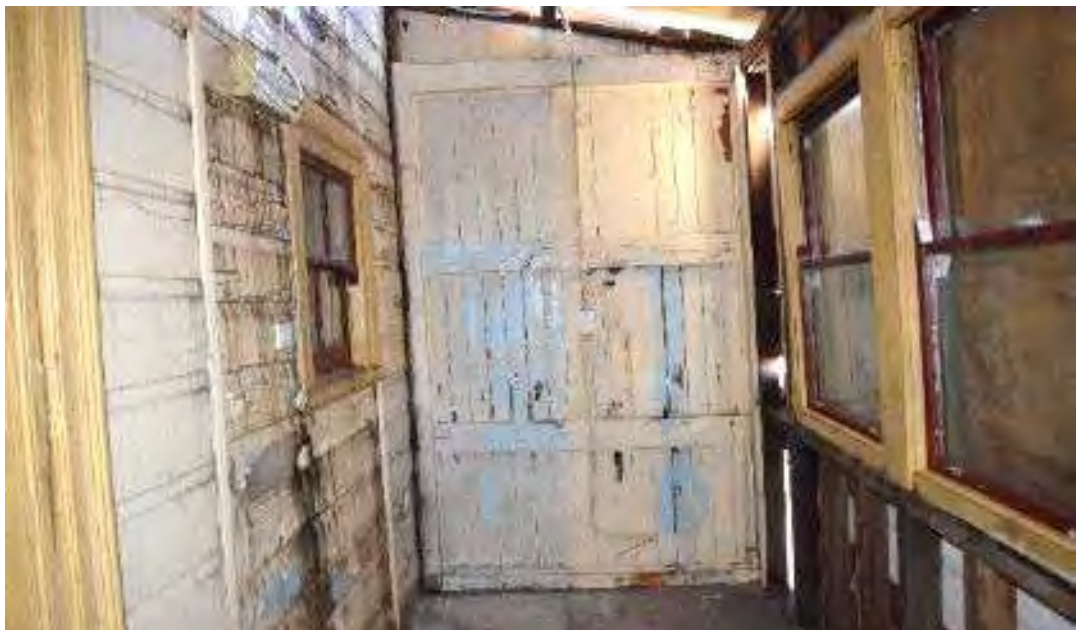
Figure 15: Infilled veranda section along the southern elevation of the house known as Sunroom 2. Evidence of the original southern façade, prior to the infilling of this section of the veranda is present including windows and external timber weatherboards.

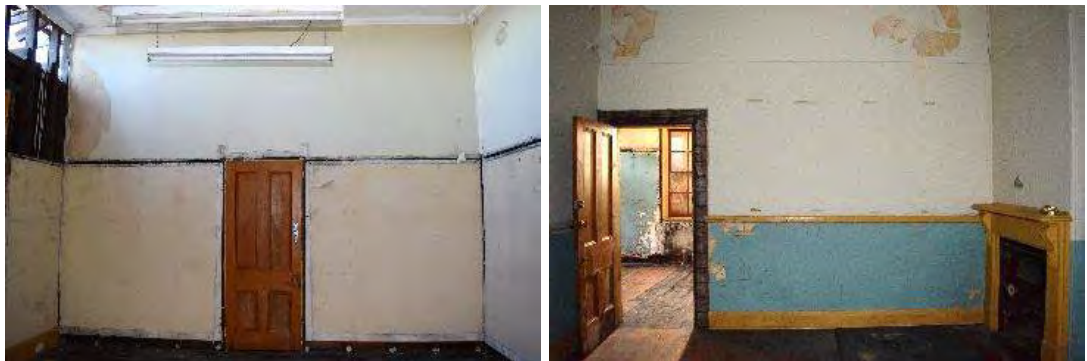
Figure 17: Internal views of the living room showing dado rails and skirting removed (left) and bedroom 1 with a decorative fireplace and timber mantle visible (right).

- Living room (Figure 17)
- Dining room (Figure 18)
- 3 bedrooms (Figure 17 and Figure 18)
- 2 sunrooms (Figure 19 and Figure 20)
- Kitchen (Figure 20)
- Bathroom (Figure 19)
- Laundry (Figure 11)

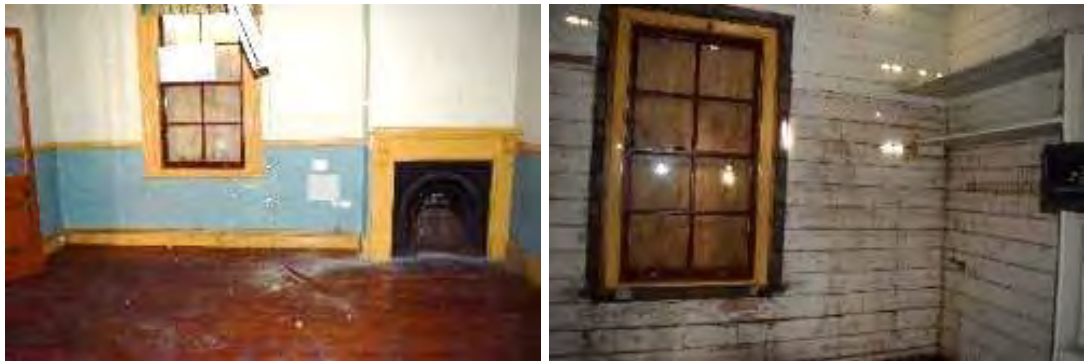
Figure 18: Internal views of Bedroom 2 with a fireplace with a timber mantle, similar to Bedroom 1 visible (left). The image on the right is of the interior of Bedroom 3 where the walls consist of timber boards.

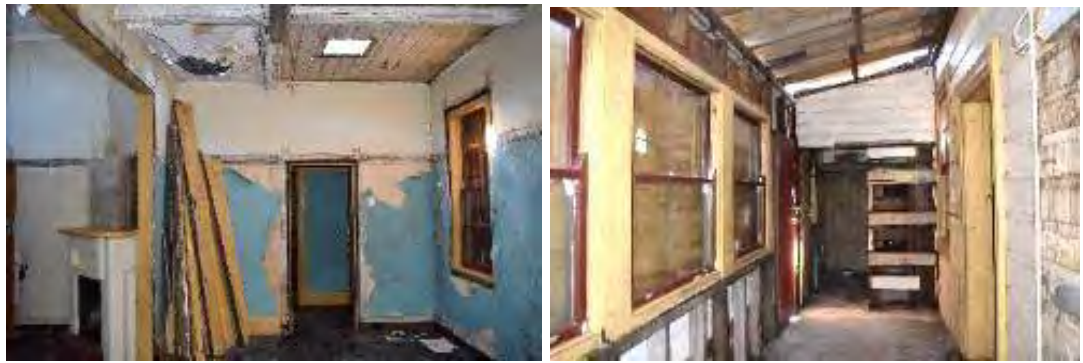
Figure 19: Internal views of the Dining Room where picture rails and skirting have been removed (left) and the former bathroom, located in Sunroom 2 (right, southern extension).

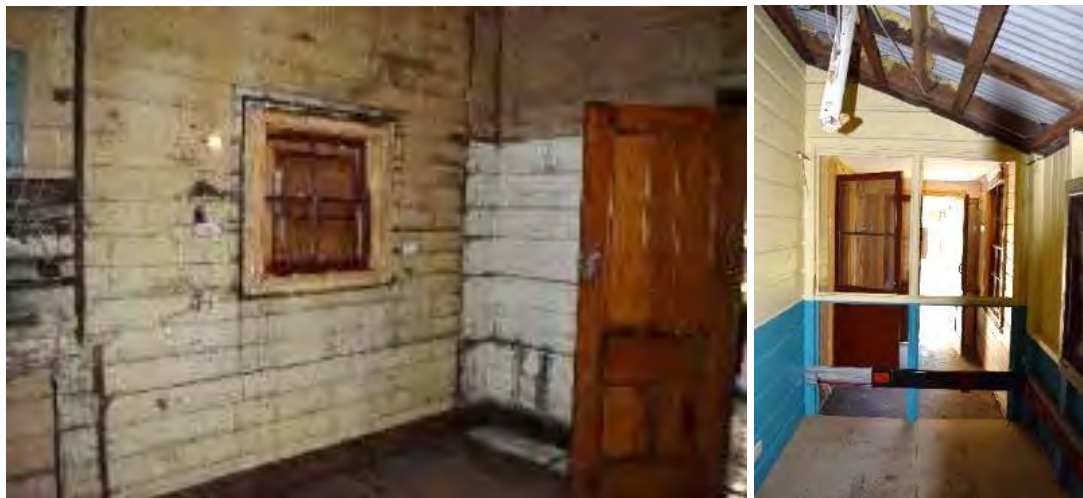
Figure 20: Internal views of the kitchen (left) and Sunroom 1 (right). Note the kitchen no longer contains fabric relating to its use and the Sunroom is clearly visible when entering from the main entrance.

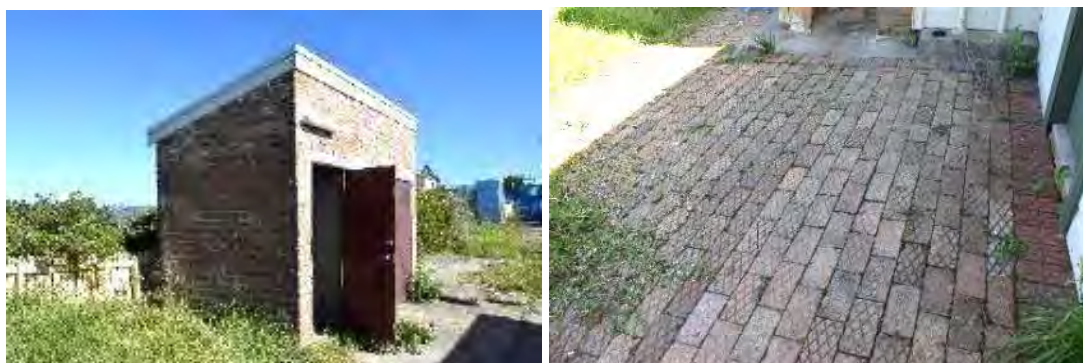
Figure 21: External view of the brick outhouse building located to the south of the cottage (left) and a detailed view of the diamond hatched paving found externally within this area (right). Recent historical research has indicated this brick paving was laid in c.1908. As the laundry is a later addition and the paving has been arranged around the structure to the south, it is most likely a later addition to the site.

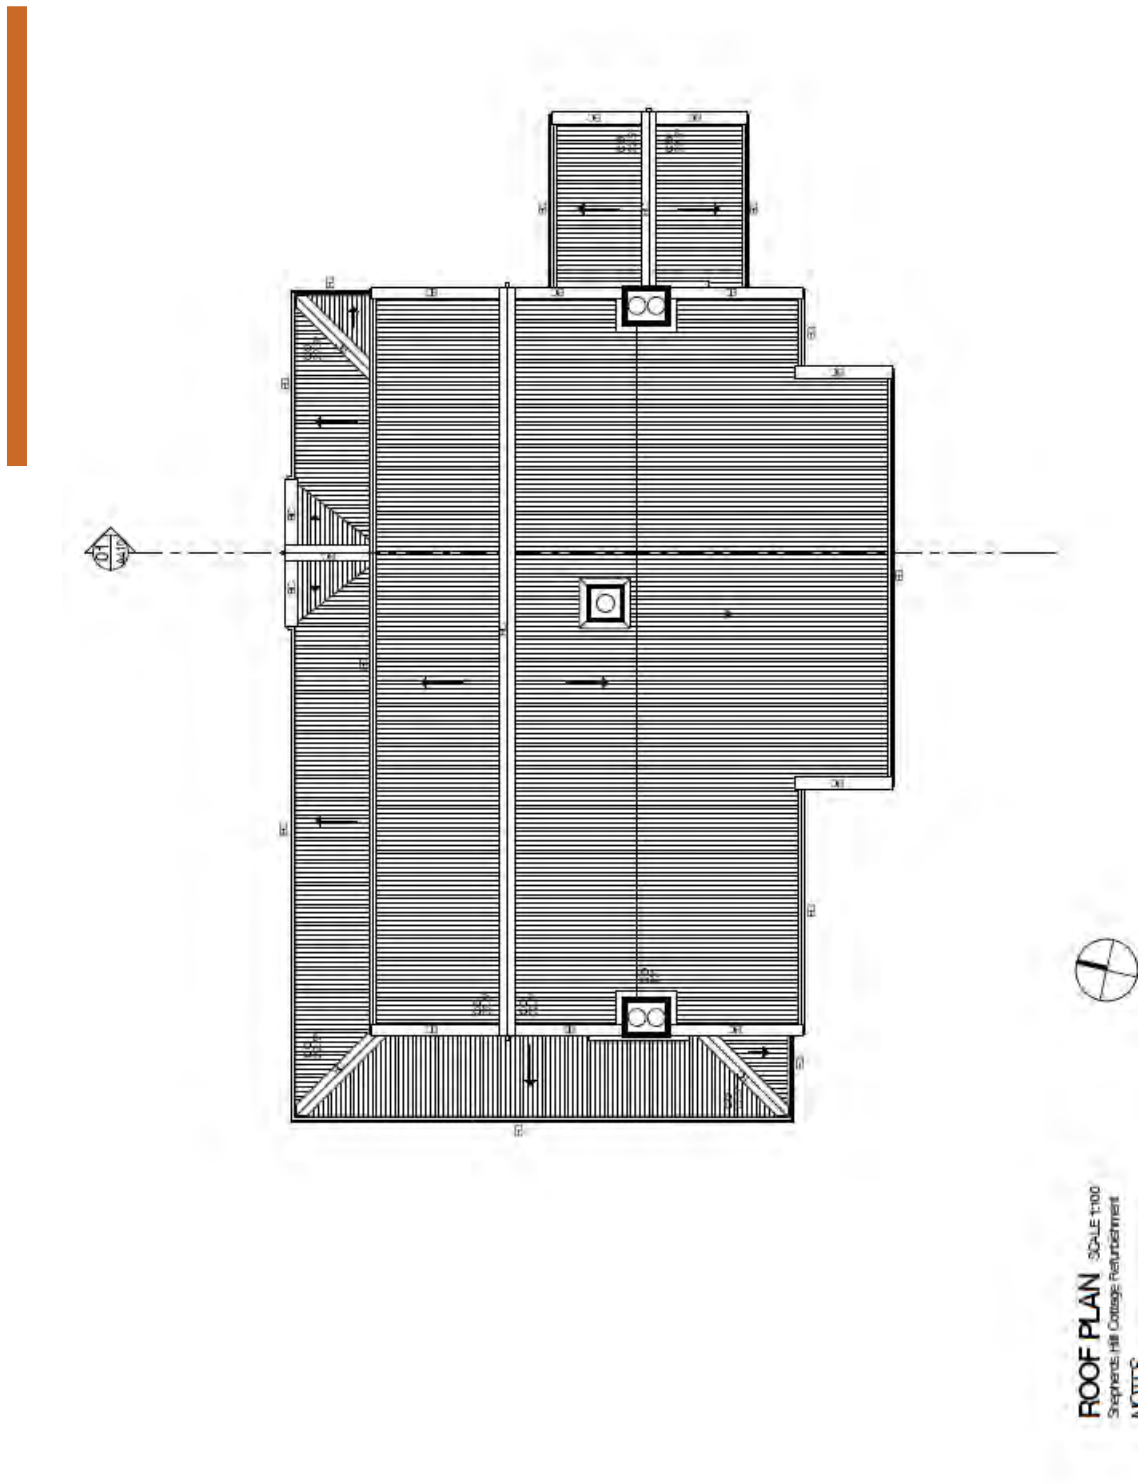
Figure 26: Anticipated roof layout of the cottage following conservation works. (Source: Curran, drawing no. A210, revision A, 2 August 2017)

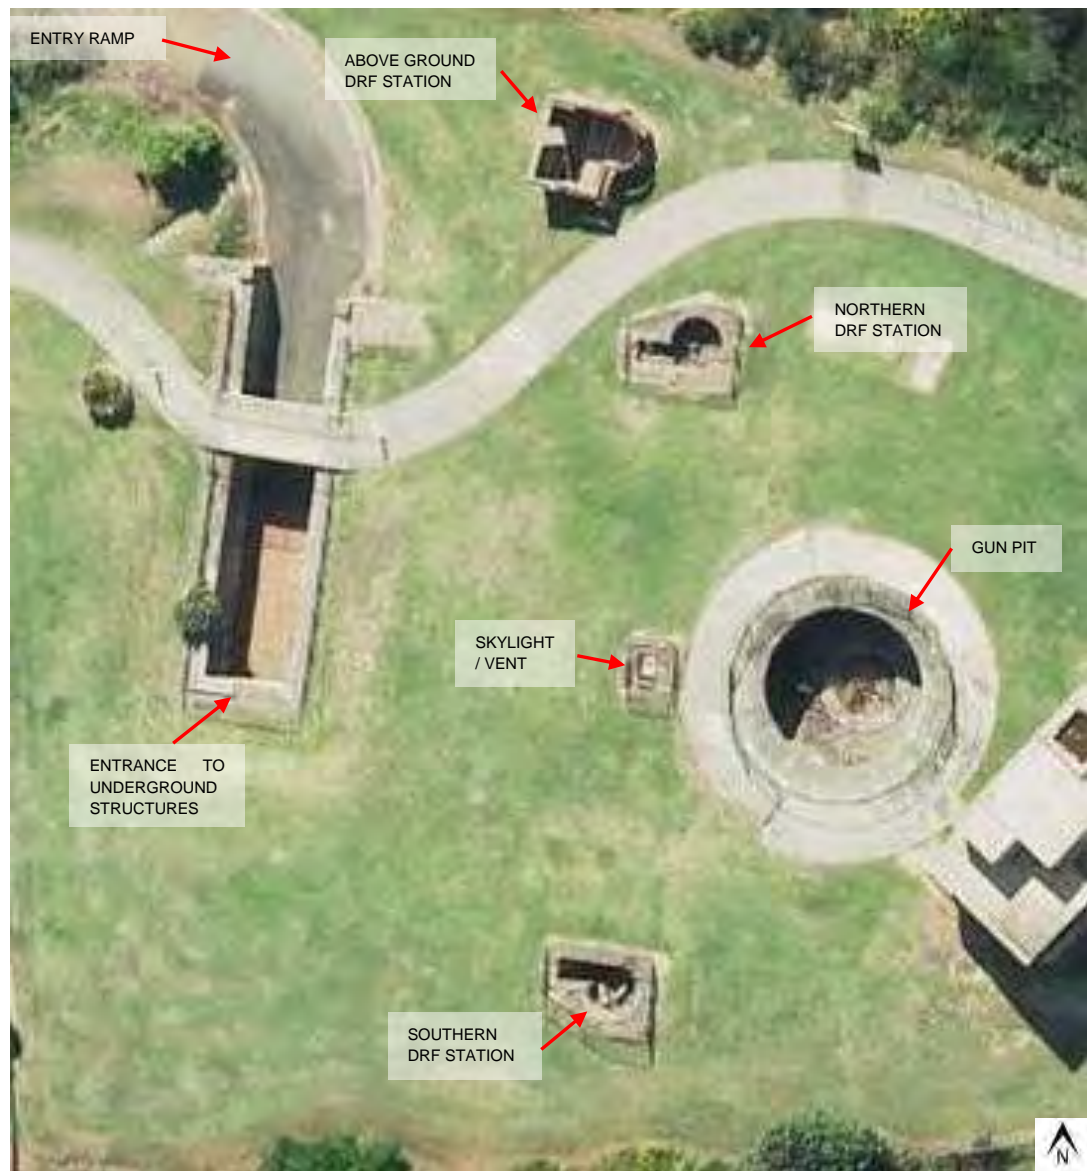
Figure 28: Detailed aerial view of the site showing the above ground gun emplacement structures. (Source: SIX Maps accessed 29 August 2017 via <https://maps.six.nsw.gov.au/>)

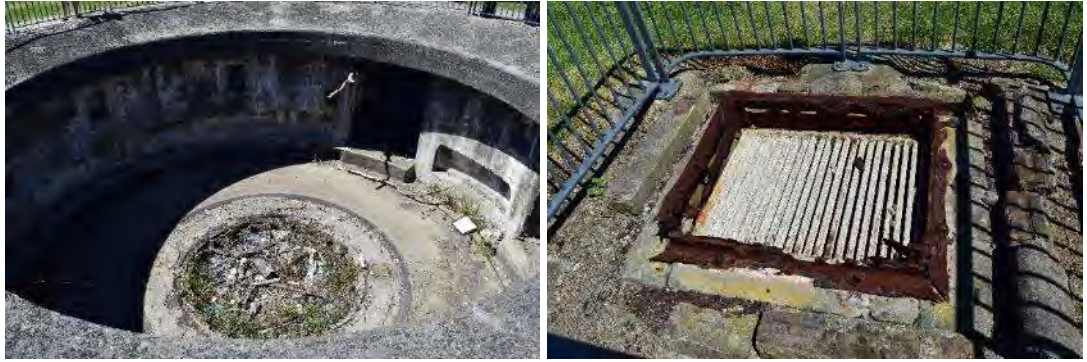
Figure 29: Views of the gun pit and skylight/vent from above ground. Note the corrosion to the skylight and rubbish present within the gun pit. The gun pit is also partially shaded by the concrete edge.

The skylight/vent is located west of the of the gun pit, directly above the main passage before entering the pit as indicated in Figure 29. As viewed from above ground, the vent/skylight consists of a central square metal vent encased within a very badly corroded metal frame, surrounded by concrete and then a series of bricks and some areas of concrete. The skylight/vent is also surrounded by a railing which prevents pedestrians and visitors from physically accessing the vent.

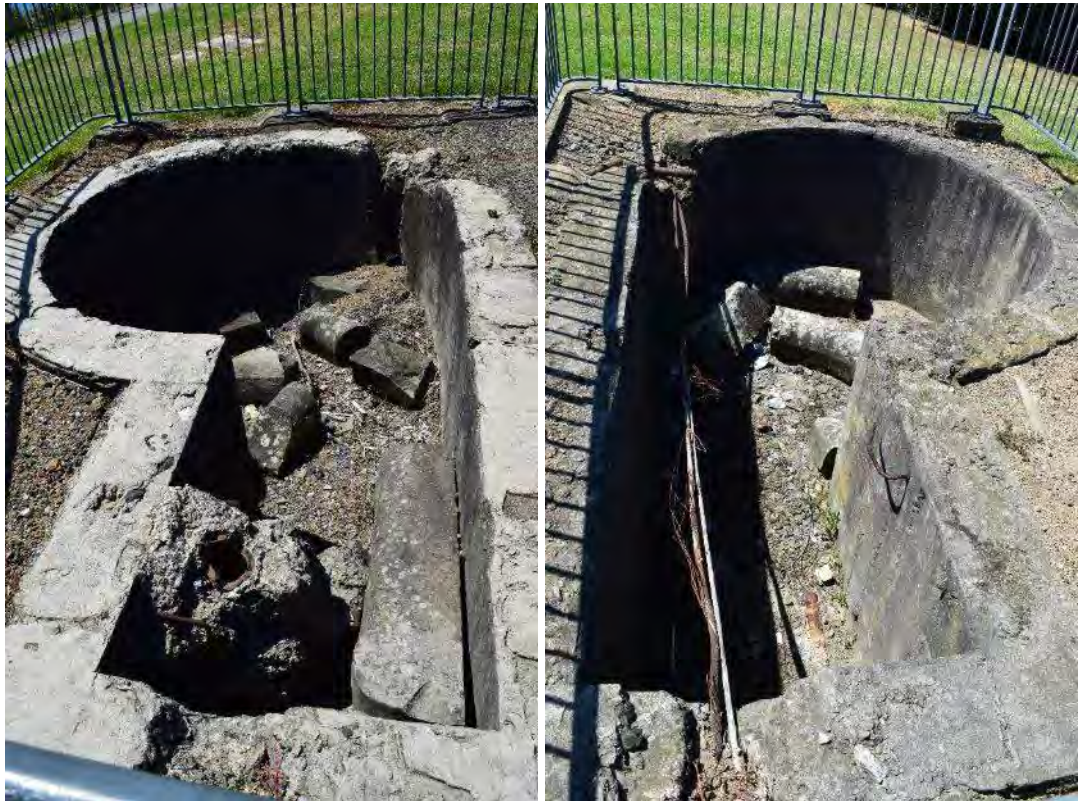
Both DRF stations are of relatively the same layout and design with each station consisting of a main rectangular pit with a circular end. Each pit includes concrete rendered walls that have significantly worn in areas. Internally, the pits have been partially filled in with sand and rubble which is present in both, reducing the depth of the pits significantly. The DRF stations are surrounded by gravel and fences which prevent access to the pits. However, this has not prevented people from disposing of their rubbish in the pits.

Figure 30: View of the DRF stations from above ground with the northern station pictured on the left and the southern station pictured on the right. These structures have been infilled with rubble present internally.

*The pits are of robust concrete construction. The pit walls have significant defects (large cracks, missing capping) but due to their construction and form are reasonably stable. The bases of the pits contain rubble that appears to be the remains of capping stones.*

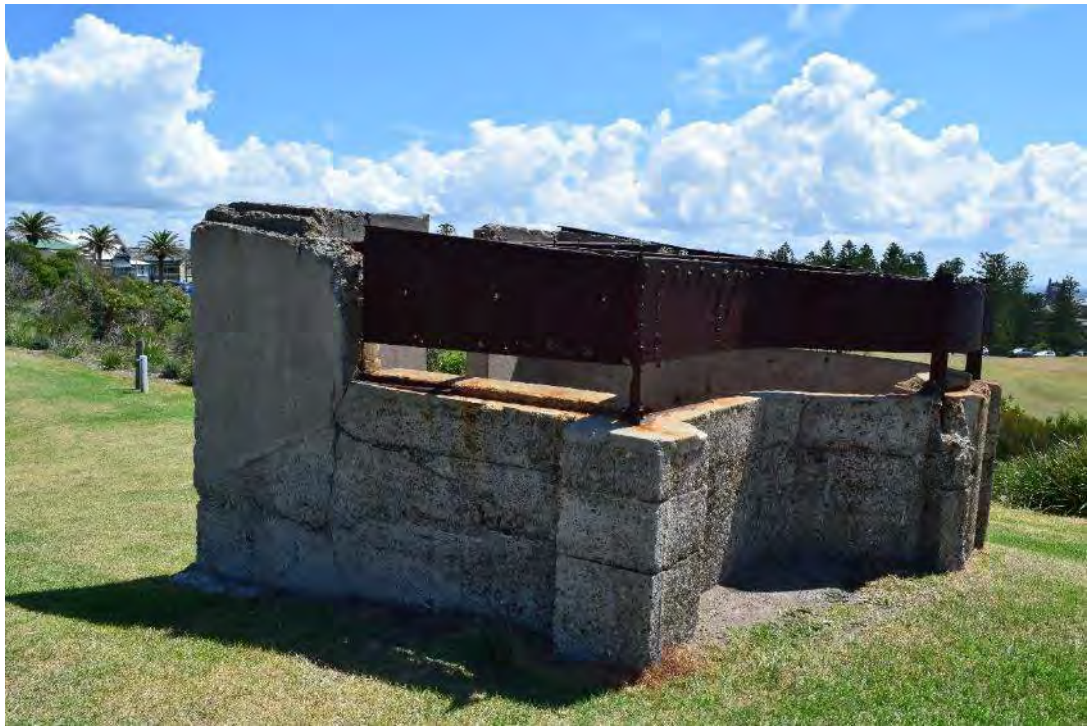
Figure 31: Above ground DRF station located towards the northern boundary of the site, within proximity to the inground northern DRF station. Note the metal guard to the eastern elevation and corrosion to the external concrete walls.

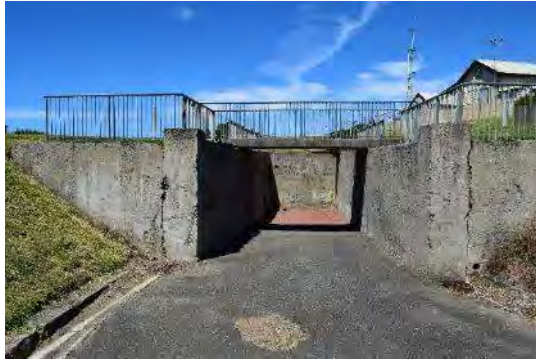
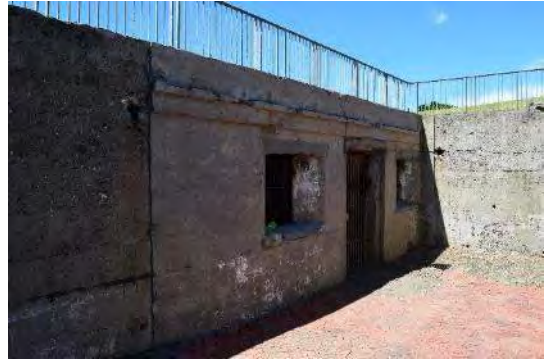
Figure 32: View of the ramp entrance to the underground structures from the access road looking south and view of the entrance to the underground structures.

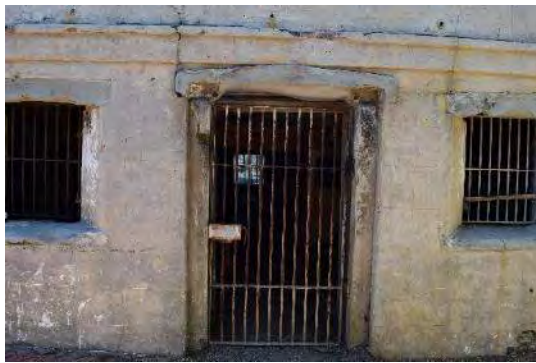
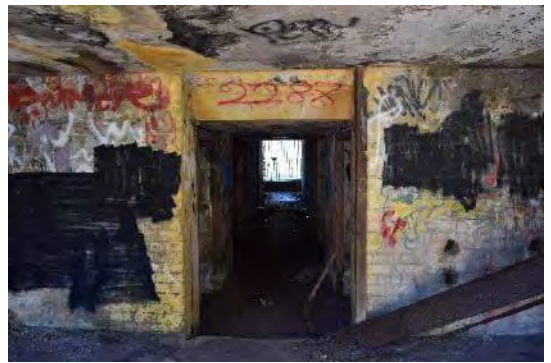
Figure 33: Detailed view of doorway entrance and internal view of the casement room.

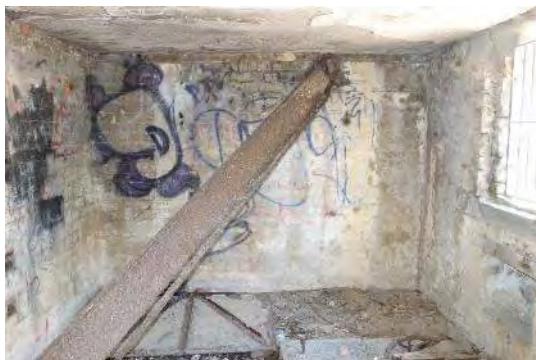
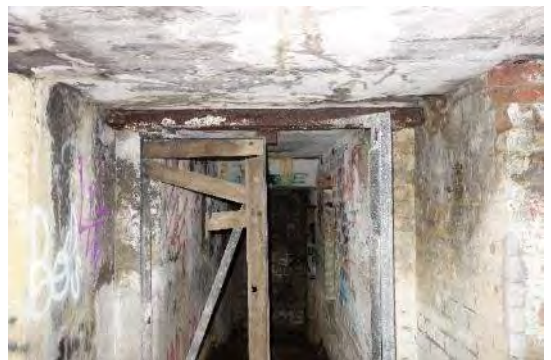
Figure 34: Internal views of the underground tunnels showing the casement area and main passage. (Source: Alex Been, Mott MacDonald)

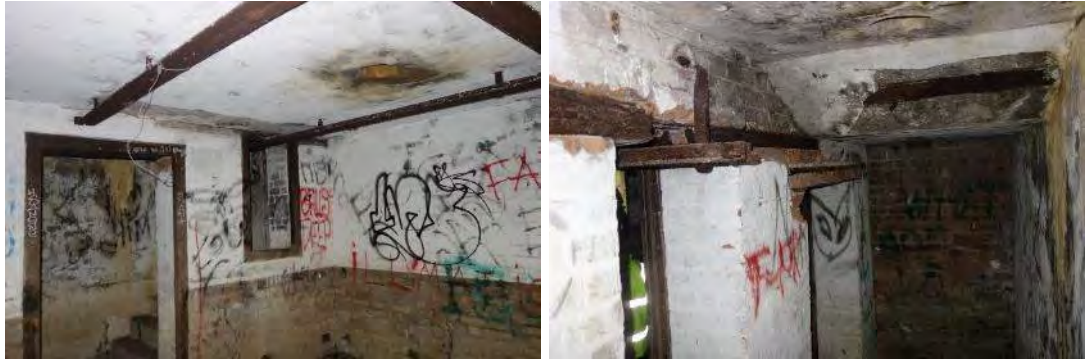
Figure 35: Internal views of the underground cartridge store and shell store. Graffiti is present to all interiors. (Source: Alex Been, Mott MacDonald)

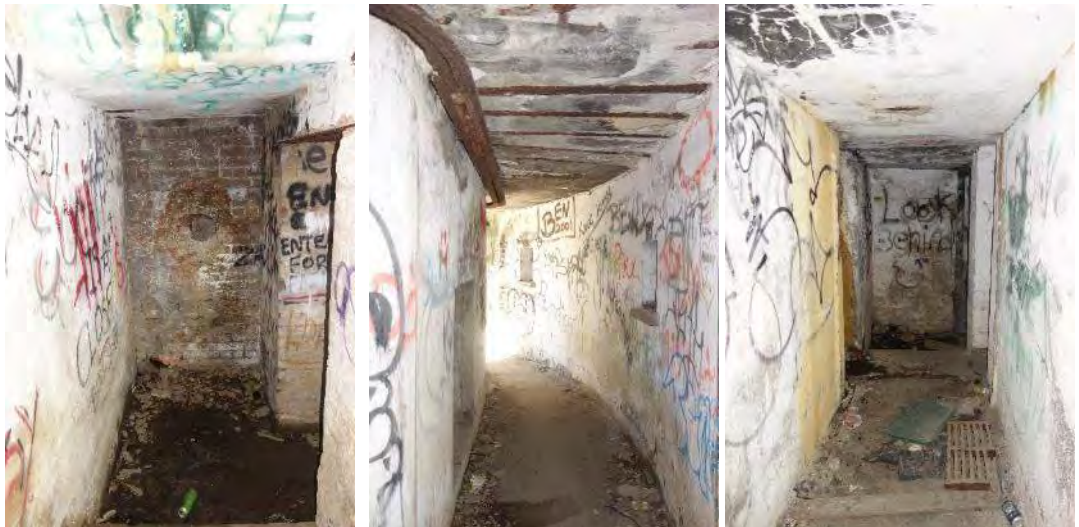
Figure 36: Interior views of the underground tunnels including the main passage, passage to cartridge storey and shell store. (Source: Alex Been, Mott MacDonald)

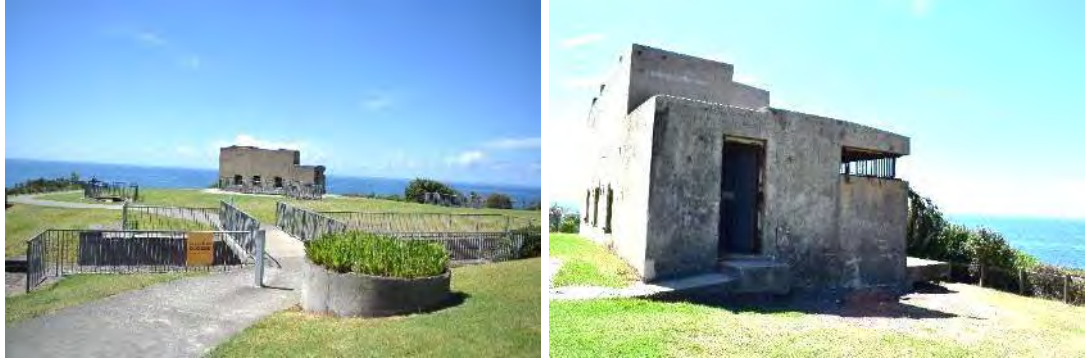
The Battery Observation Post is a geometric shaped building constructed from reinforced concrete with galvanised iron windows and doors. The building is approximately 8m tall and consists of five levels that step down towards the cliff face. Erosion has occurred to the land surrounding the building, particularly towards the eastern side and as a result, the foundations of the building are visible in some areas (Figure 38).

Figure 38: External view of the Battery Observation Post looking east towards the western elevation (left) and looking north towards the southern elevation (right). The building is highly geometric in form and no elevation is the same in appearance. The western elevation is the simplest in design and is relatively flat while the other elevations have various levels and projecting sections.

*The observation post is a robust reinforced concrete structure, but is in generally poor condition. Erosion of earth on the southern side of the building is undermining the structure. The lowest level of the building is subjected to frequent flooding during rainfall. It appears that the internal and external drainage systems are inadequate*

*or blocked. The majority of structural elements throughout the building are subject to active deterioration through corrosion of steel reinforcement and spalling concrete. Several elements are nearing structural failure and are at risk of collapse. Refer to the condition and repair schedule for further details. Major intervention is required to prevent ongoing, rapid deterioration of the building.*

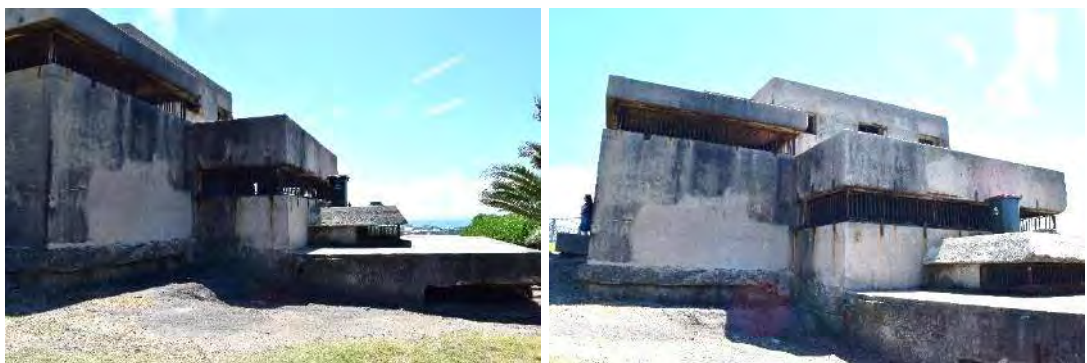
Figure 39: View of the front section of the Battery Observation Post looking north (left) and view of the eastern side looking west (right). Note the Park Battery section at the lowest level, a later addition to the structure.

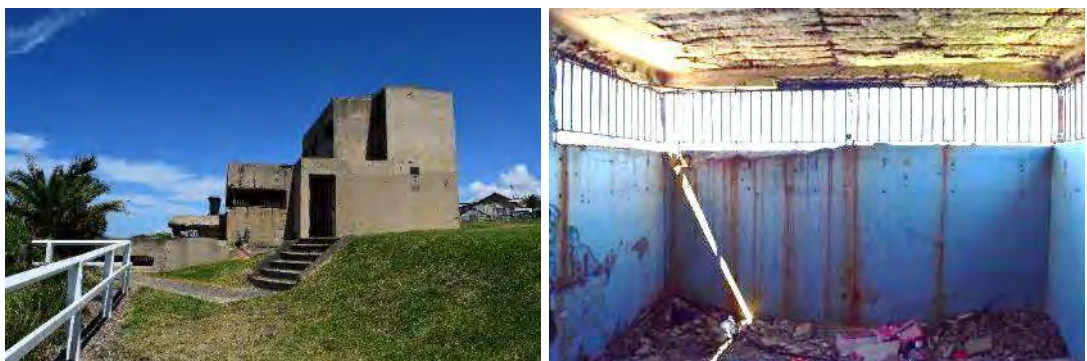
Figure 40: View of the northern side of the Observation Post looking south (left) and internal view of Room 3, Level 3 (former Port War Signal Station operated by the Royal Australian Navy) (right).

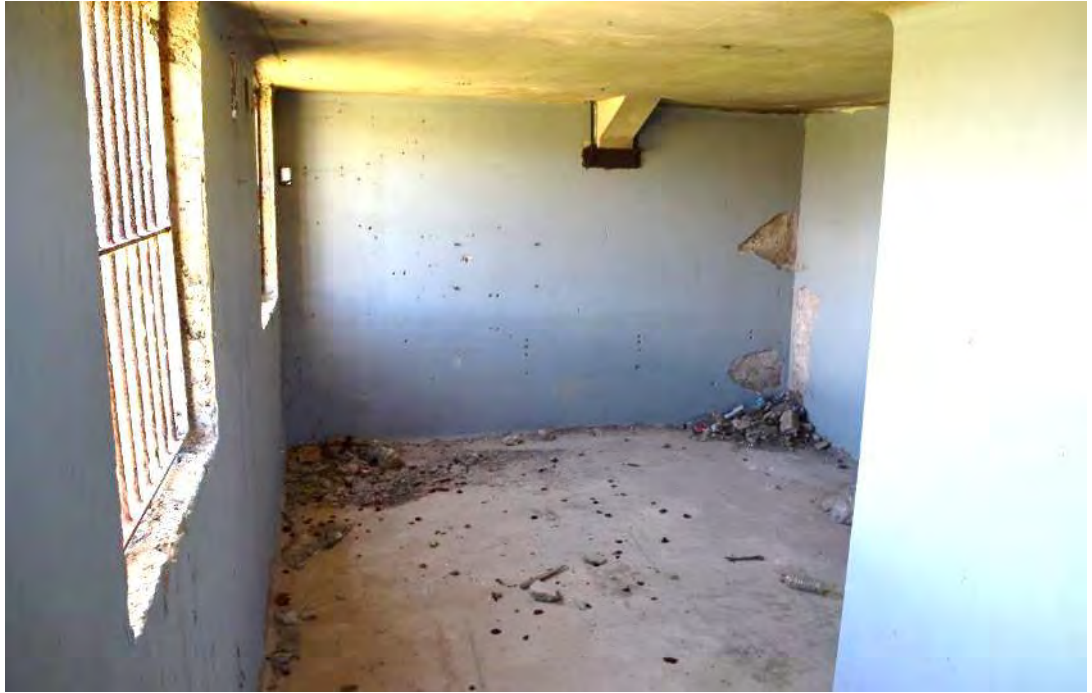
Internally, there are ten observation rooms which develop over five levels and include concrete floors and walls (Figure 41). The interior condition of the Observation Post is poor with rubbish and remnant fabric present. The walls in particular are significantly worn with cracked and broken concrete present along with a number of holes, possibly created when mounting equipment and other objects. The walls underneath the window grills, particularly along the eastern side of the building, show evidence of rust stains. The ceilings are also in a poor condition with the eastern section of the building being particularly worn (Figure 40).

Figure 41: Internal view of Room 2, located on level 3. Evidence of paint finishes can be seen and damage to interiors. This room is in a better condition to some of the other rooms within the Battery Observation post.

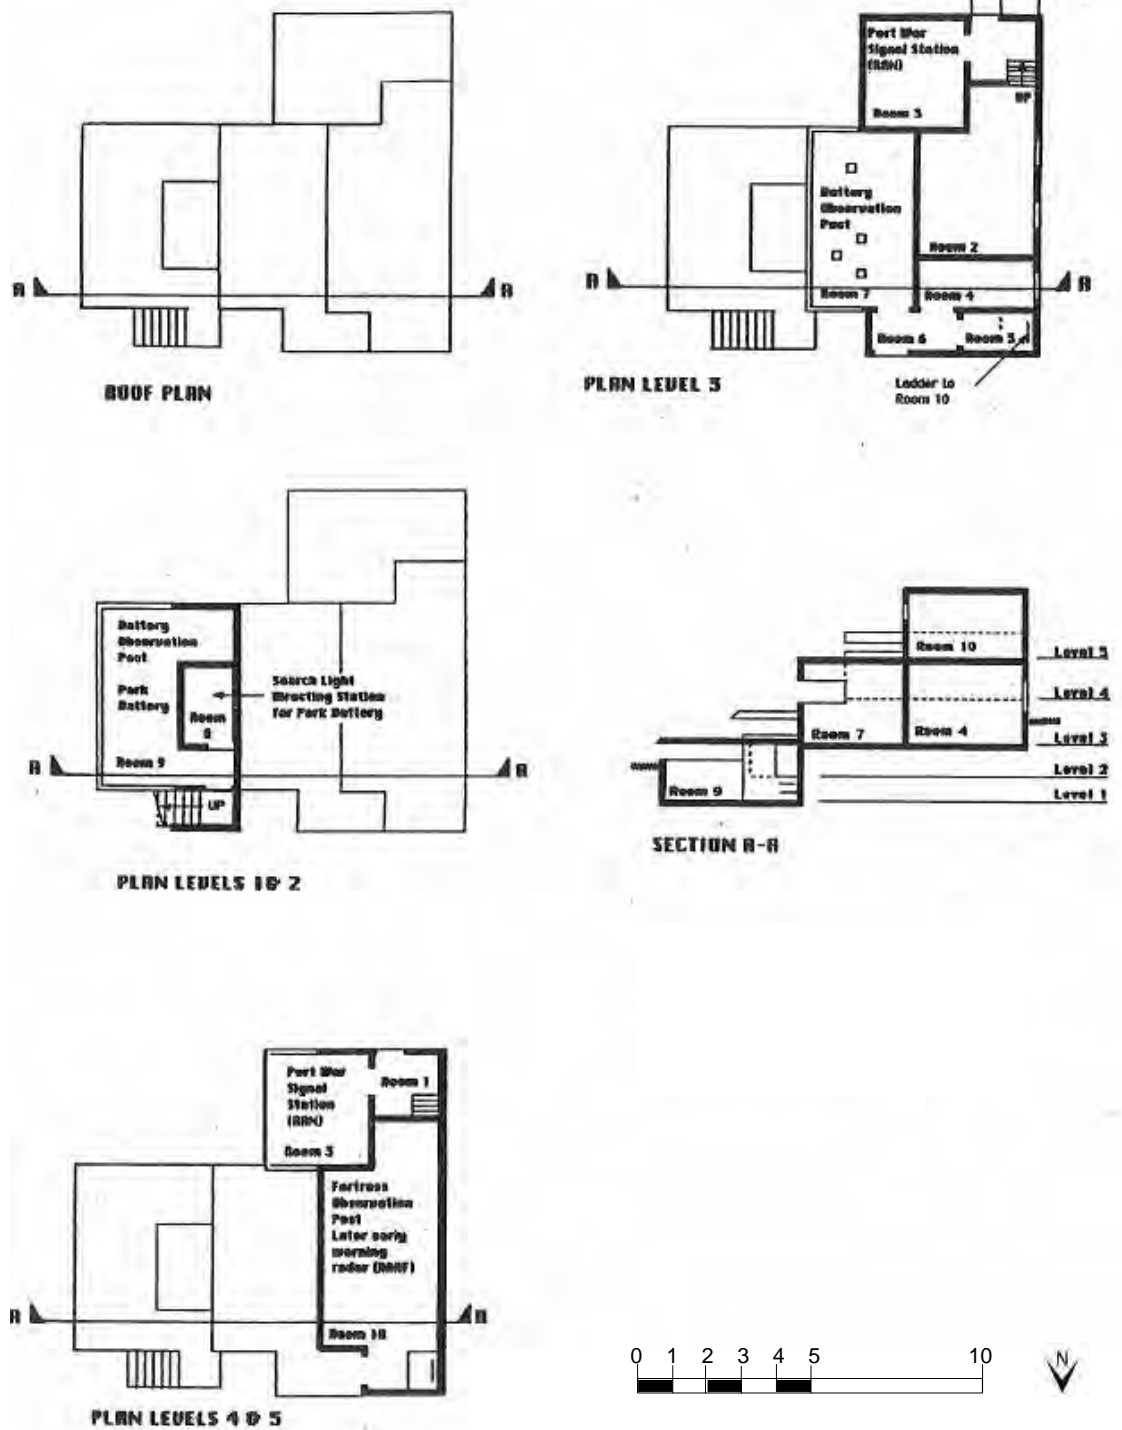
Figure 42: Plan for the Battery Observation Post dating from 1984. (Source: Shepherds Hill Cottage and Surrounds, Conservation Study, Gardner Browne, 1984)
