## Conservation Management Plan

Shepherds Hill Defence Group Military Installations  
SHR # 01806

41 The Terrace, Newcastle and 65 Nesca Parade, The Hill

Submitted to the Council of the City of Newcastle

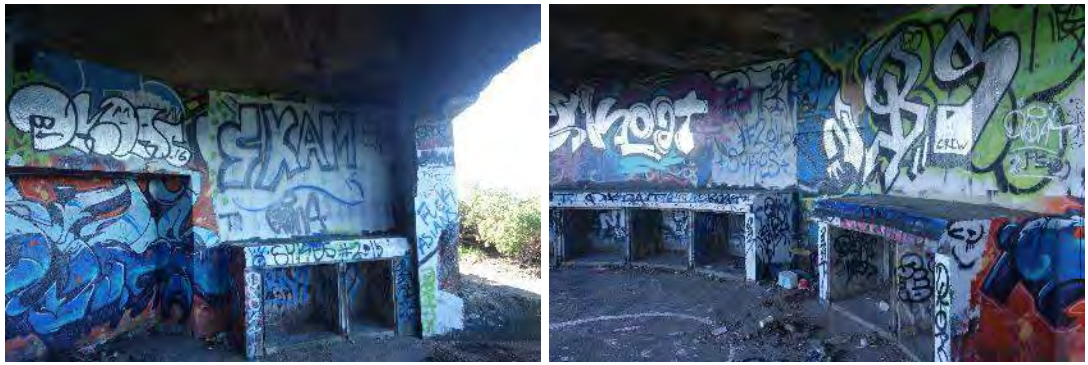
Figure 45: Internal views of the Park Battery, no.1 gun and bunker showing the simple internal detailing consisting of concrete bench-like structure. The interiors have also been predominately covered in graffiti.

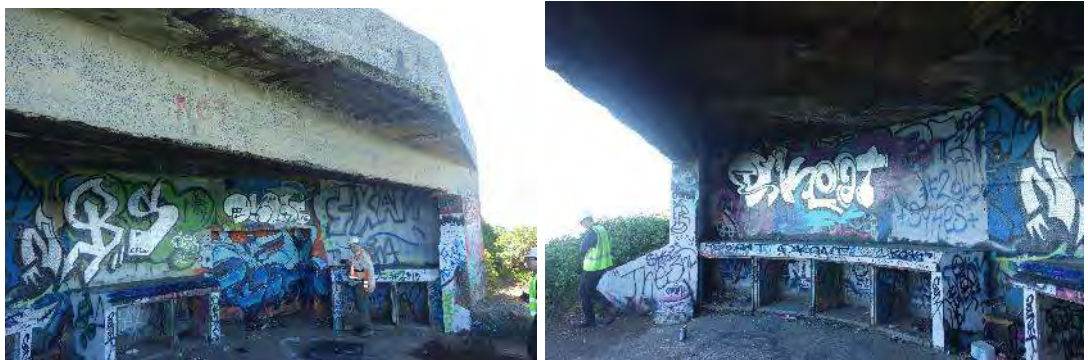
Figure 46: Internal views looking north east with sections of the exterior also present (left) and looking south west (right).

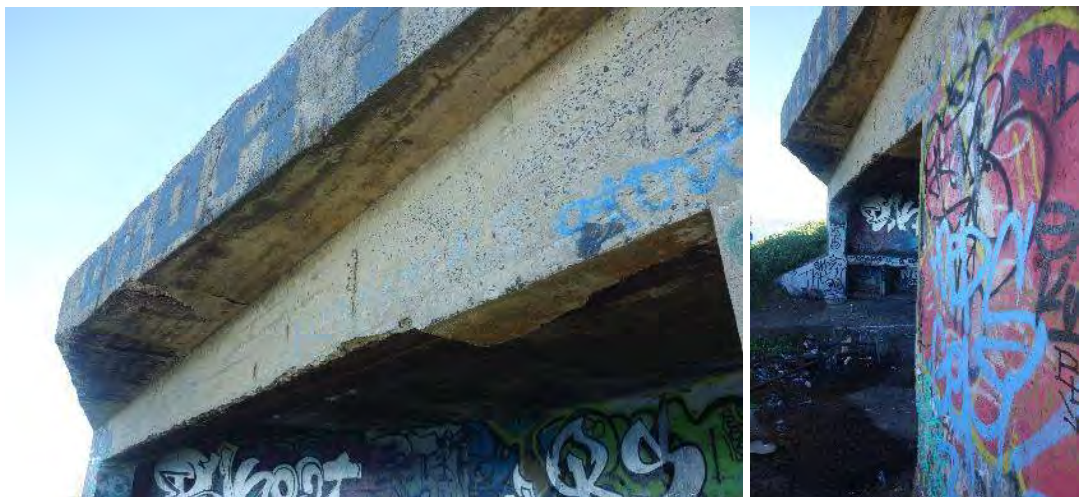
Figure 47: Detailed views of the opening of the Park Battery, no.1 gun and bunker opening. Note the simple design and form of the structure.

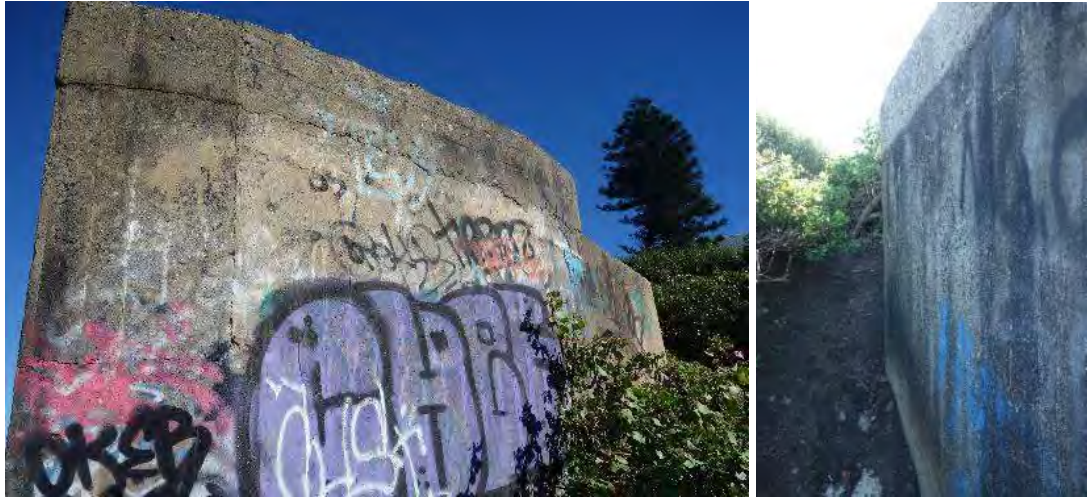
Figure 48: Views looking south west towards the north eastern external wall (left) and southern external wall (right). The eastern wall is visible when walking along the path that wraps around the building and continues south west.

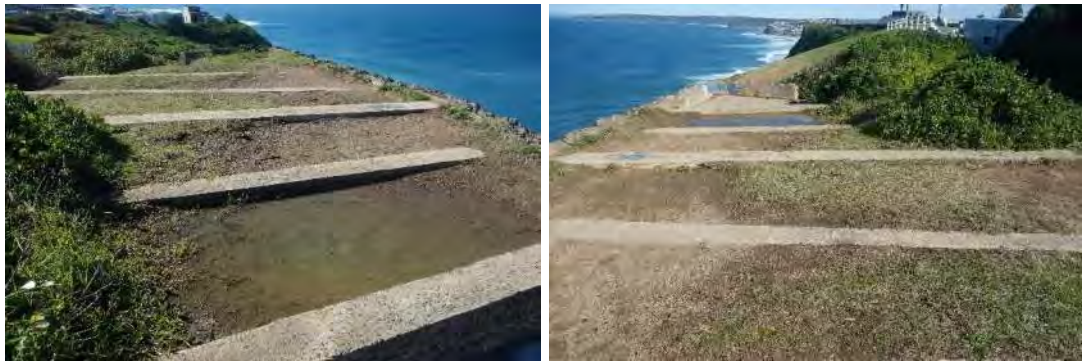
Figure 49: Views of the roof looking north east (left) and south west (right). Note the raised sections and vegetation present. This area also captures water as visible in the image on the right.

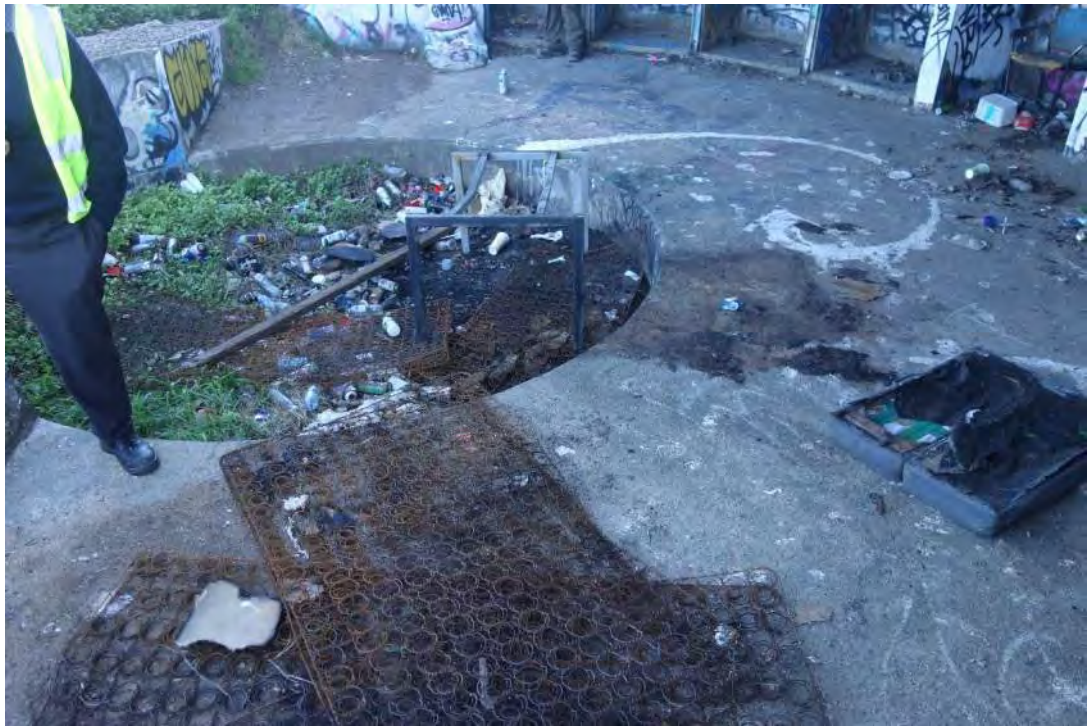
Figure 50: Internal view of the Strzelecki Observation Post showing the circular indentation in the concrete floor and rubbish present.

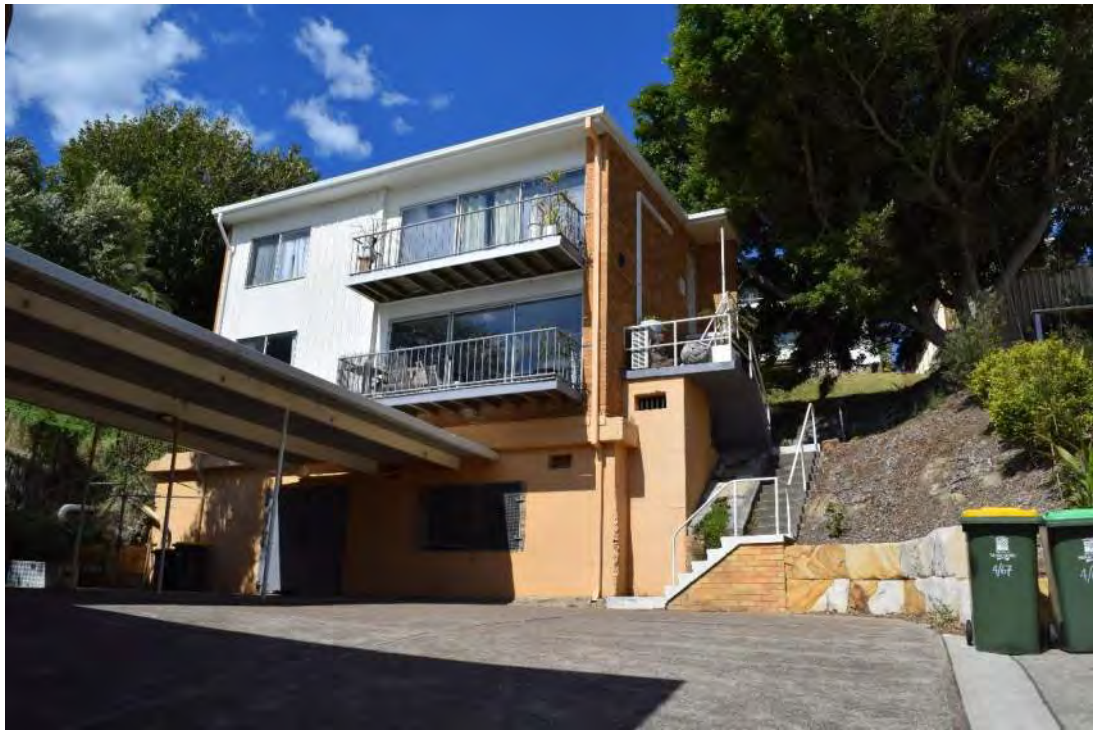
Figure 55: View of the Searchlight Engine Room looking south east towards the northern elevation. Note the structure has been painted to blend in with the residential flat building above. Part of the building is recessed into the hill.

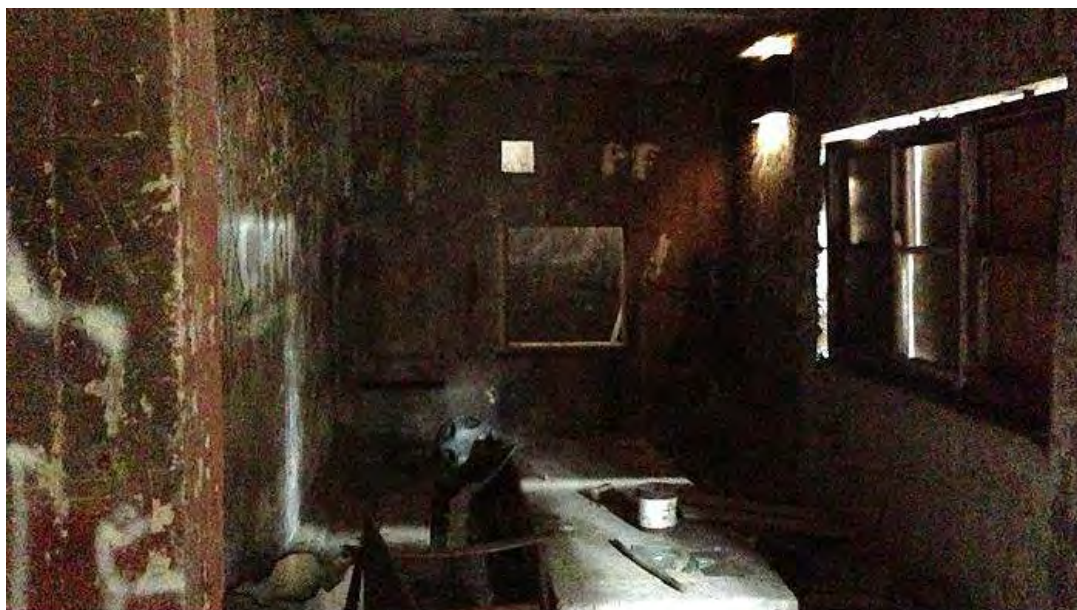
Figure 57: Internal view of the Searchlight Engine Room looking west. Note the boarded window and limited internal lighting present. (Source: Duncan, Carol, "The Memorial Drive Tunnel," ABC Newcastle website, 20 August 2013, accessed 24 August 2017 via <http://www.abc.net.au/local/photos/2013/08/20/3829654.htm>)

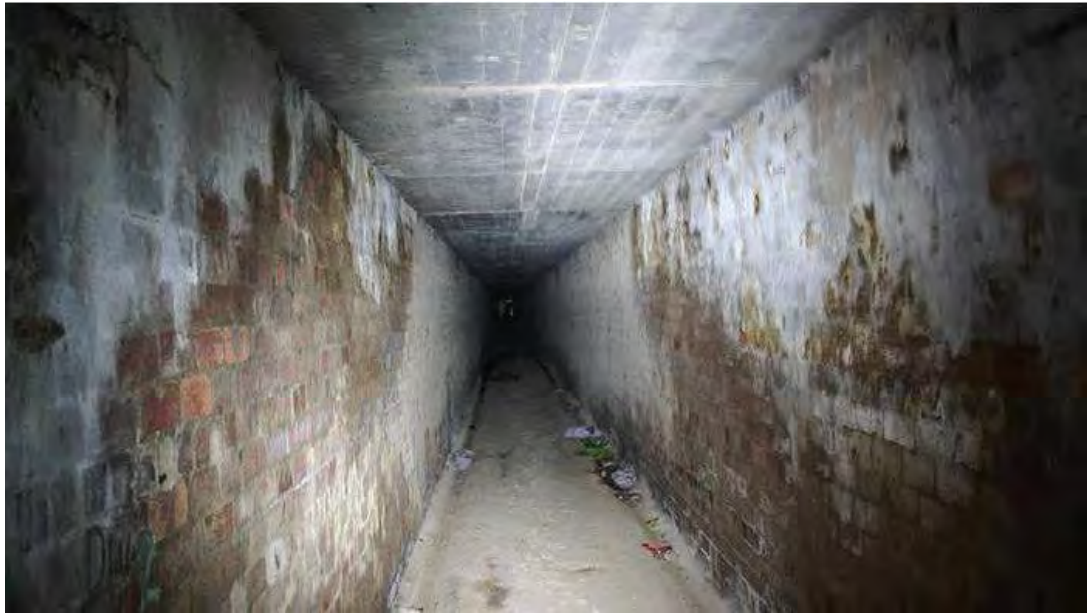
Figure 58: Internal view of the tunnel leading from the Searchlight Engine Room towards the Searchlight Bunker. Note the damp present to internal brick walls and the concrete roof. (Source: Duncan, Carol, "The Memorial Drive Tunnel," ABC Newcastle website, 20 August 2013, accessed 24 August 2017 via <http://www.abc.net.au/local/photos/2013/08/20/3829654.htm>)

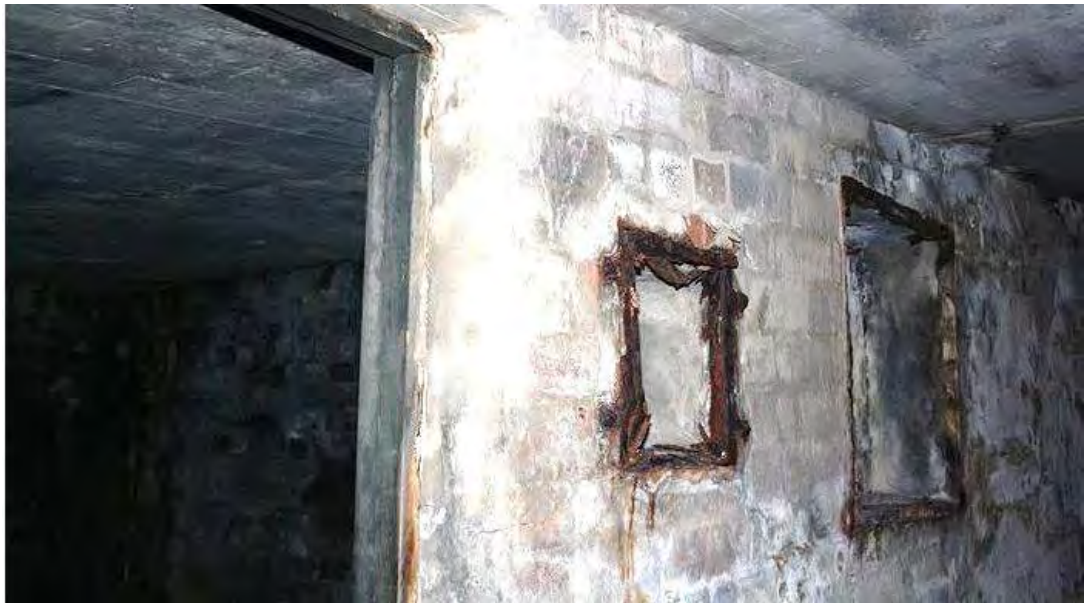
Figure 59: Another view within the tunnel leading to the Searchlight Bunker. Corroded metal framing is visible around openings. (Source: Duncan, Carol, "The Memorial Drive Tunnel," ABC Newcastle website, 20 August 2013, accessed 24 August 2017 via <http://www.abc.net.au/local/photos/2013/08/20/3829654.htm>)

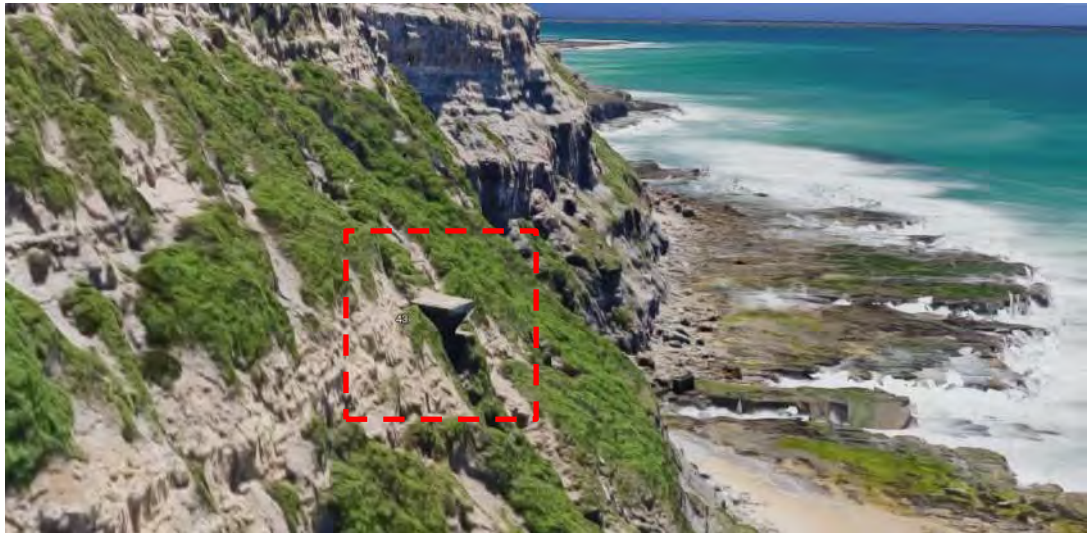
Figure 60: Oblique view looking north towards the southern elevation of the No.1 Searchlight. Note the structure recesses into the cliff face due to its size and the use of concrete. The design is similar to the Park Battery, no.1 gun and bunker. (Source: Google Maps 3D, accessed 30 August 2017 via <https://www.google.com.au/maps/place/Strzelecki+Lookout/@-32.9388057,151.7759448,54a,35y,340.12h,79.25t/data=!3m1!1e3!4m5!3m4!1s0x6b73146c7dcb8503:0x771e4820b5c1be76!8m2!3d-32.9368196!4d151.7770135>)

As with the Park Battery, no.1 gun and bunker, the No.1 Searchlight is a single storey concrete structure with a flat roof and open section facing east. The eastern opening extends around the northern and southern elevations creating a deep recess within the structure. Due to the use of concrete, small scale of structure and simple design. The No.1 Searchlight is not easily viewed and visually recesses into the cliff face (Figures 59-61).

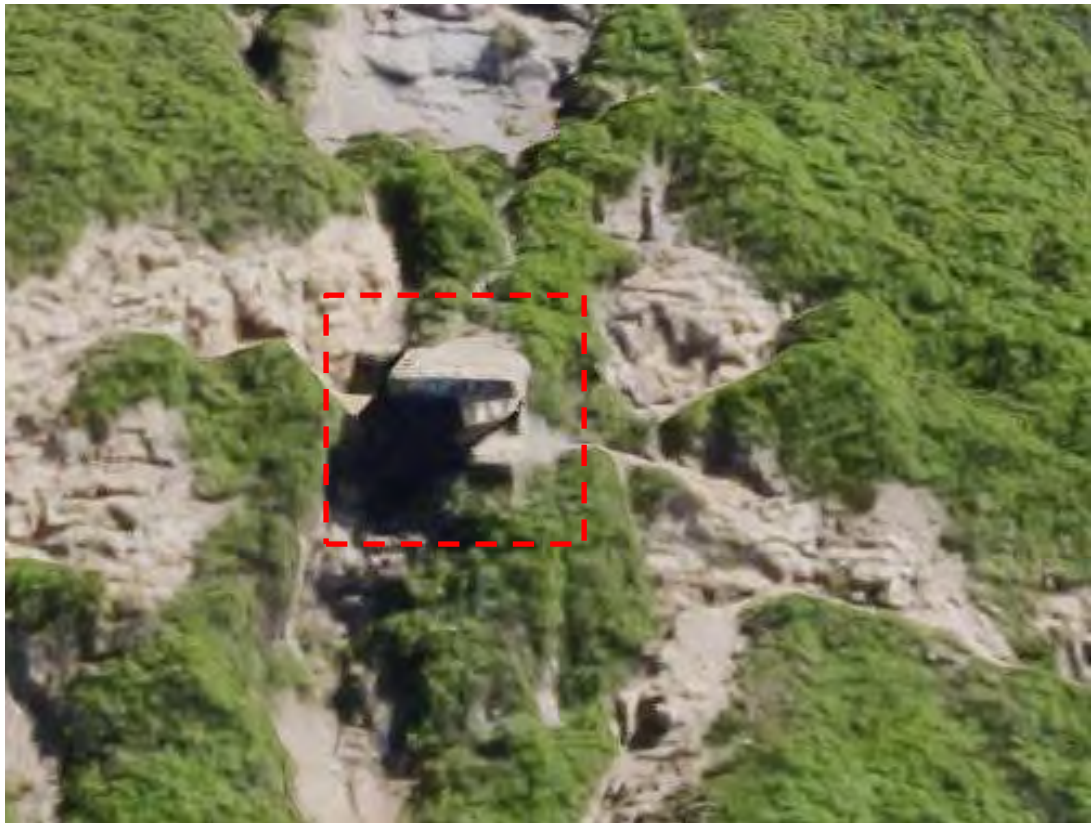
Figure 62: Front on view showing the eastern elevation of the No.1 Searchlight. Note the flat roof and simple form of the structure. (Source: Google Maps 3D, accessed 30 August 2017 via <https://www.google.com.au/maps/place/Strzelecki+Lookout/@-32.9388057,151.7759448,54a,35y,340.12h,79.25t/data=!3m1!1e3!4m5!3m4!1s0x6b73146c7dcb8503:0x771e4820b5c1be76!8m2!3d-32.9368196!4d151.7770135>)

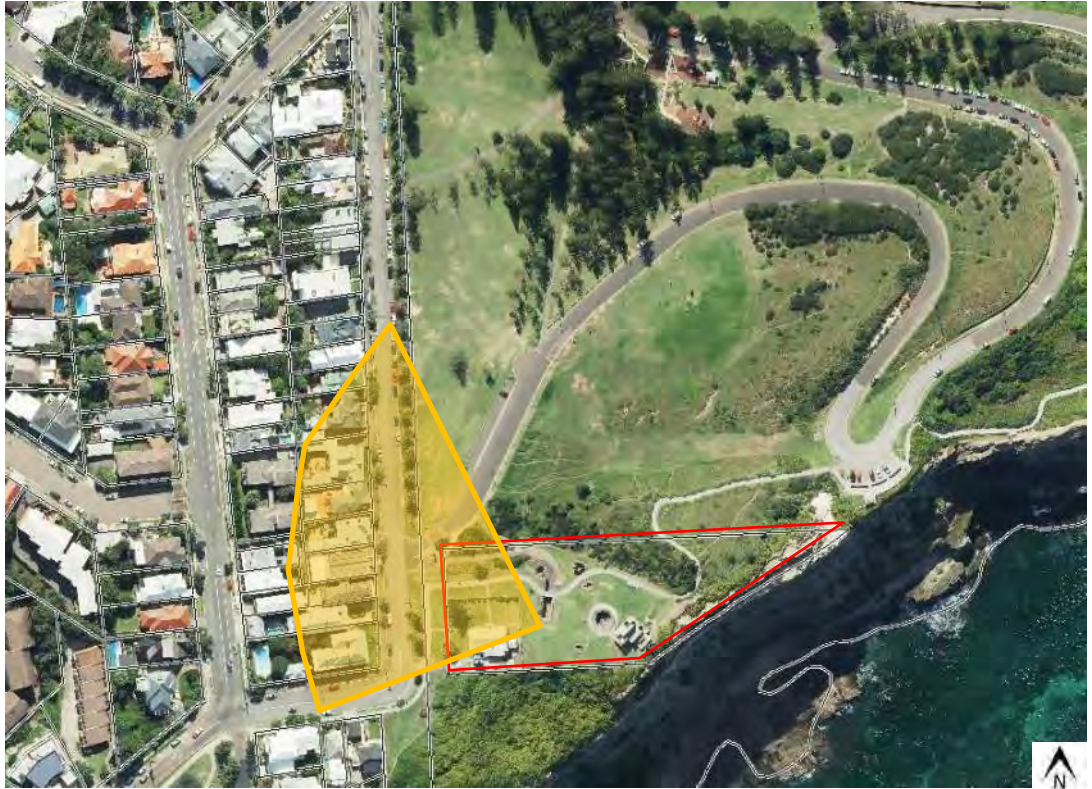
Figure 103: View 4 - views along The Terrace looking north and possible from the western end of 41 The Terrace and some views are possible from within the site; however, these are restricted due to the palm trees located along the eastern side of the road, within King Edward Park. (Source: SIX Maps accessed 28 August 2017 via <https://maps.six.nsw.gov.au/>)

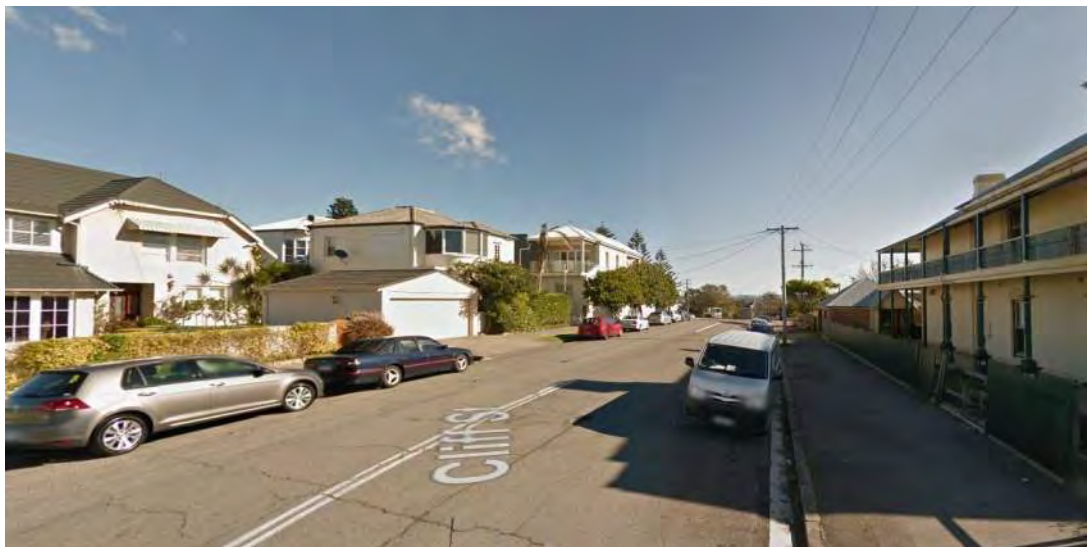
Figure 104: View 5, Cliff Street looking west from 41 The Terrace. Views to the street are mainly gained from the western boundary of the site and from within the grounds of the cottage. (Source: Google Street view, June 2015)

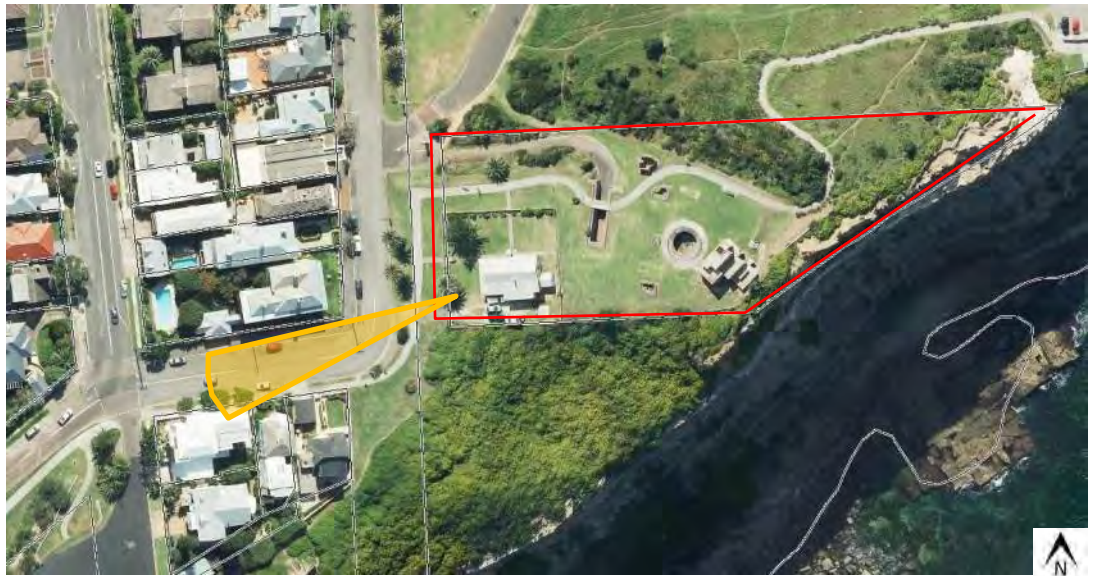
Figure 105: View 5 - visual access to Cliff Street can be gained from within the western section of the site. Views to this street are obscured from eastern sections of the site due to the presence of the cottage. (Source: SIX Maps accessed 28 August 2017 via <https://maps.six.nsw.gov.au/>)

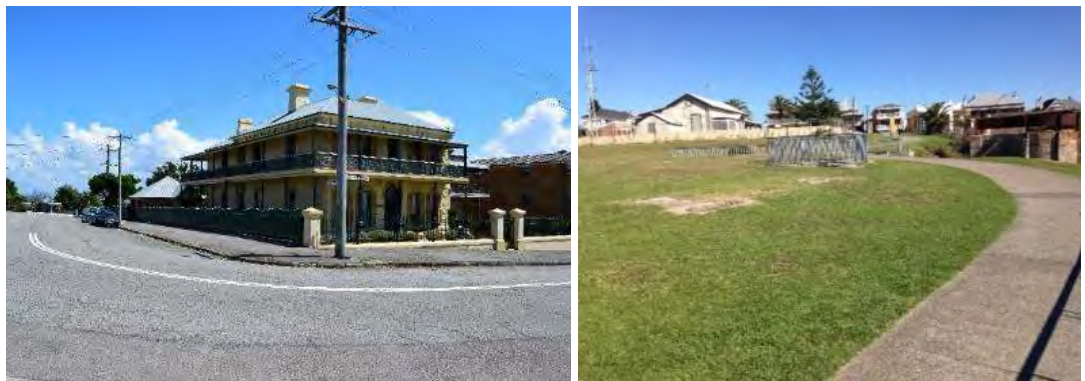
Figure 106: View 6, looking west and north-west towards the residences located in The Terrace.

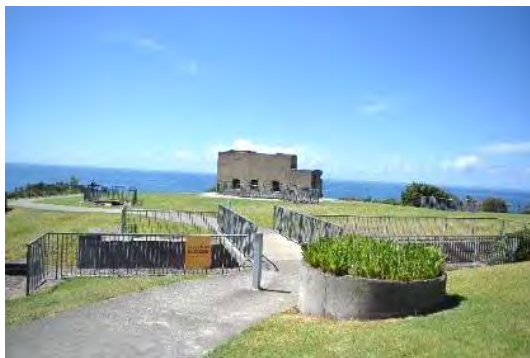
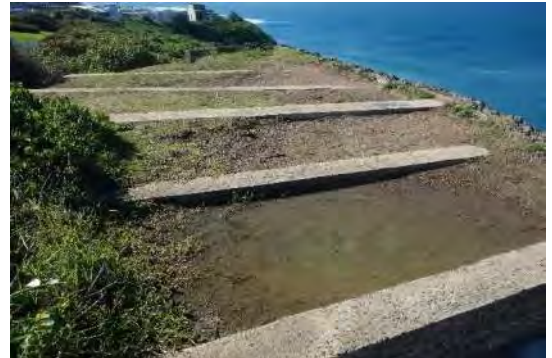
Figure 108: Views 8 and 9, looking east towards the Tasman Sea from 41 The Terrace (left) and looking north east from the Park Battery, no.1 gun and bunker (right).

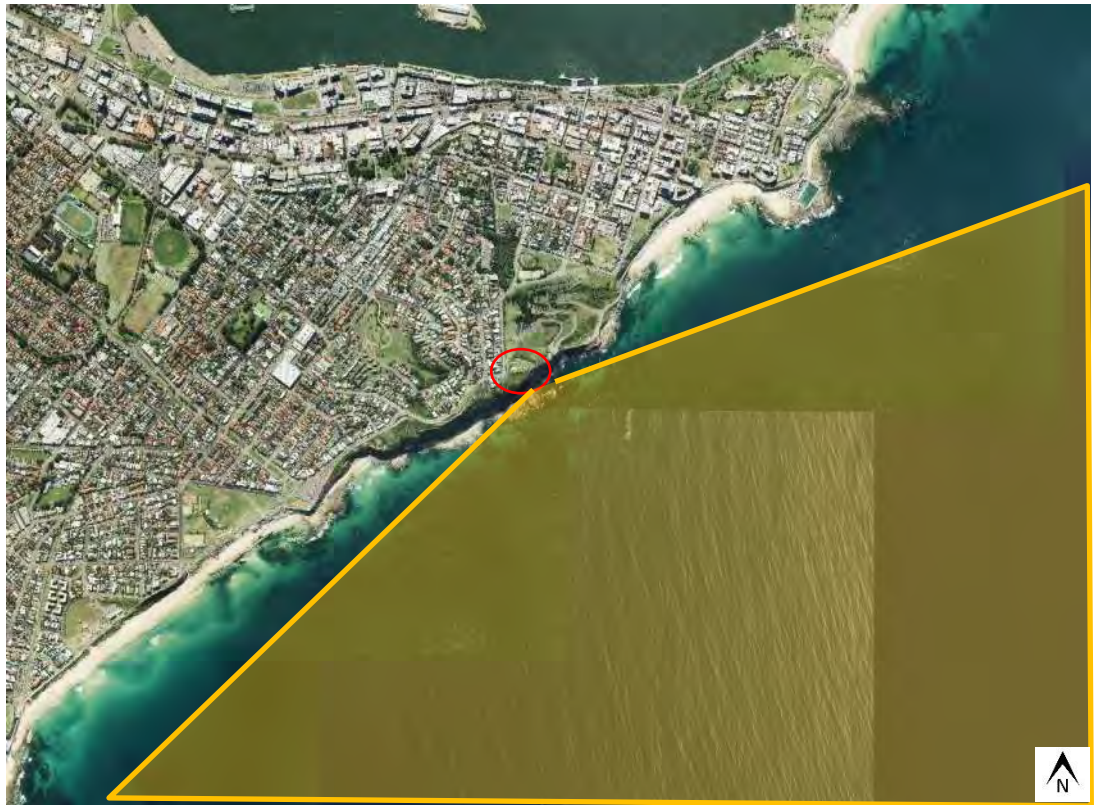
Figure 109: Views 8 and 9 - Views to the Tasman Sea from 41 The Terrace and the Park Battery, no.1 gun and bunker are expansive, as indicated in the image above. The view cone indicates views are available to the north, south and east. (Source: SIX Maps accessed 28 August 2017 via <https://maps.six.nsw.gov.au/>)

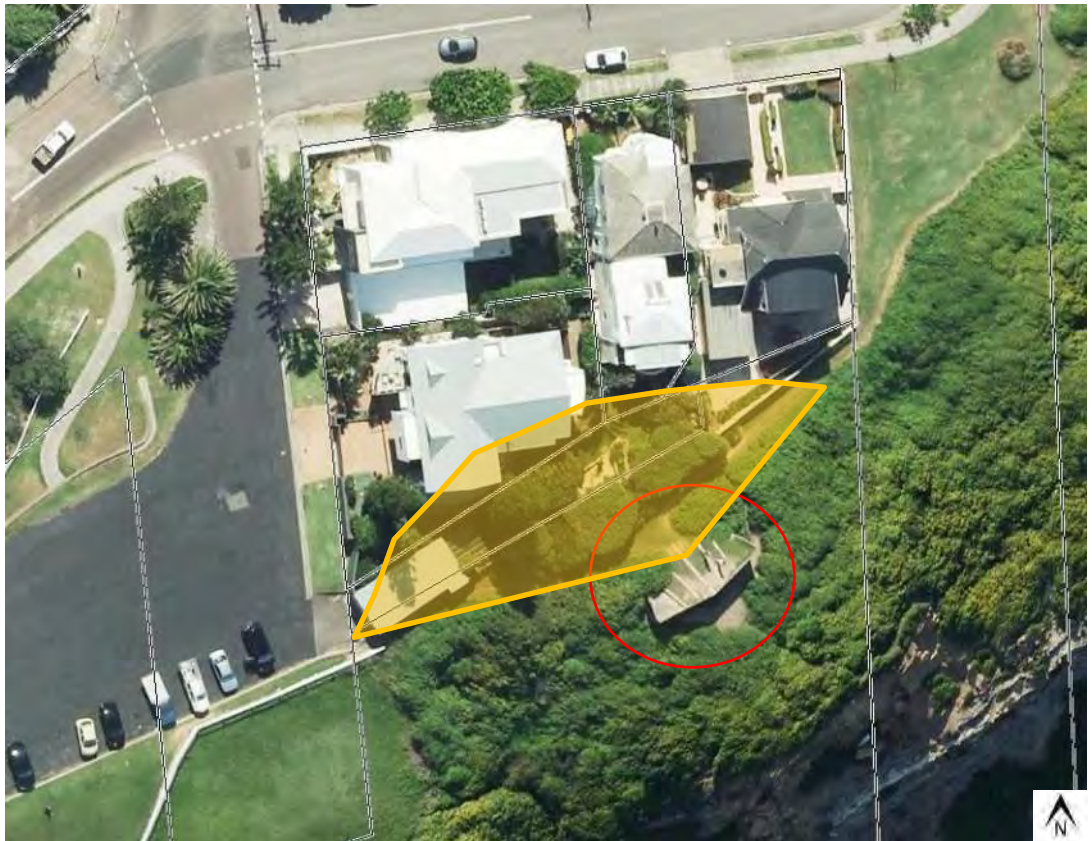
Figure 110: View 10 - Views looking north west towards the residential development to the rear is limited due to the proximity of the Park Battery, no.1 gun and bunker to the residences. The view cone therefore, while expansive, is limited to the residences directly abutting the boundary fence. These residences obscure others from view. (Source: SIX Maps accessed 28 August 2017 via <https://maps.six.nsw.gov.au/>)

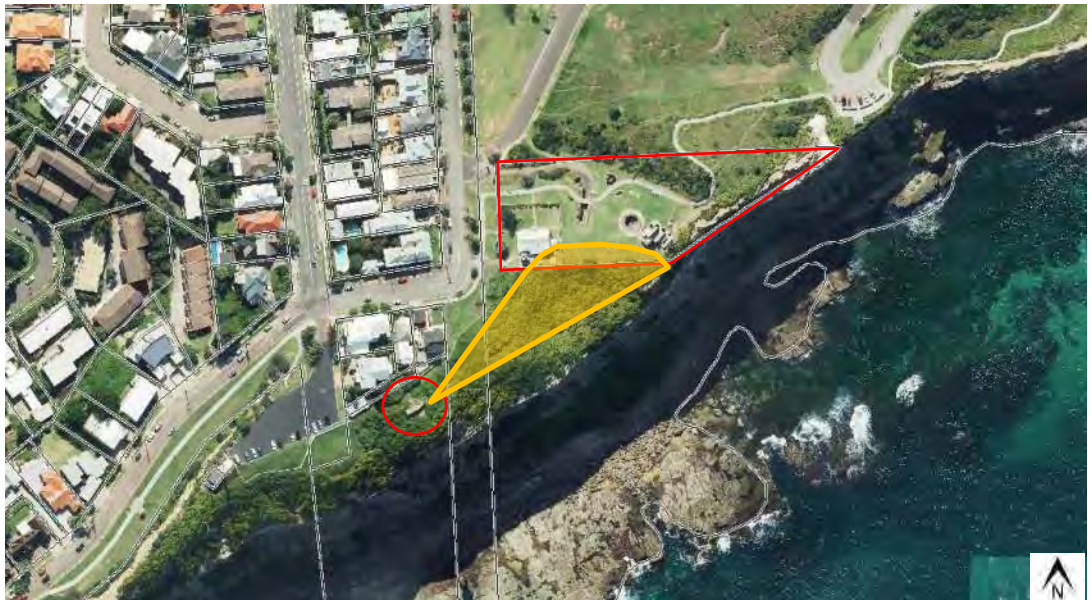
Figure 111: View 11 - While views can be gained to the site at 41 The Terrace from the Park Battery, no.1 gun and bunker, the view is partially obscured from view due to the topography of the site and vegetation present. As such, a full view of 41 The Terrace is not possible and predominately the structures present to the south are visible. (Source: SIX Maps accessed 28 August 2017 via <https://maps.six.nsw.gov.au/>)

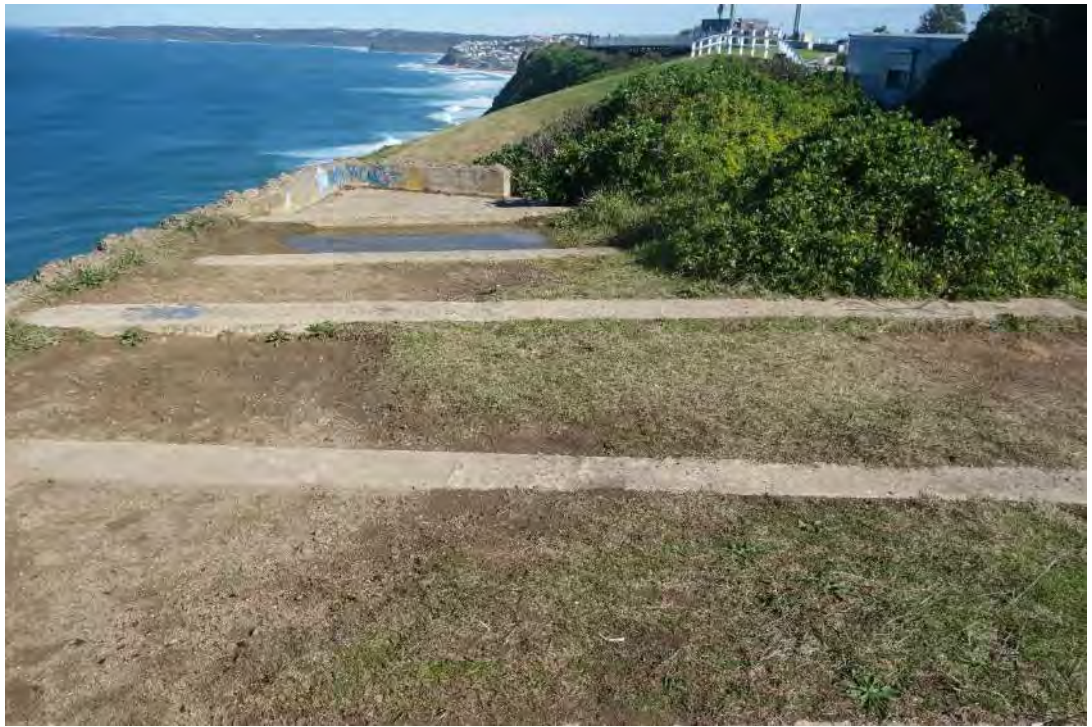
Figure 112: View 12, looking south west from the Park Battery, no.1 gun and bunker towards the Strzelecki Lookout and Memorial Walk. Distant views to neighbouring coastal areas including Bar Beach and Susan Gilmore Beach, can be seen in the background.

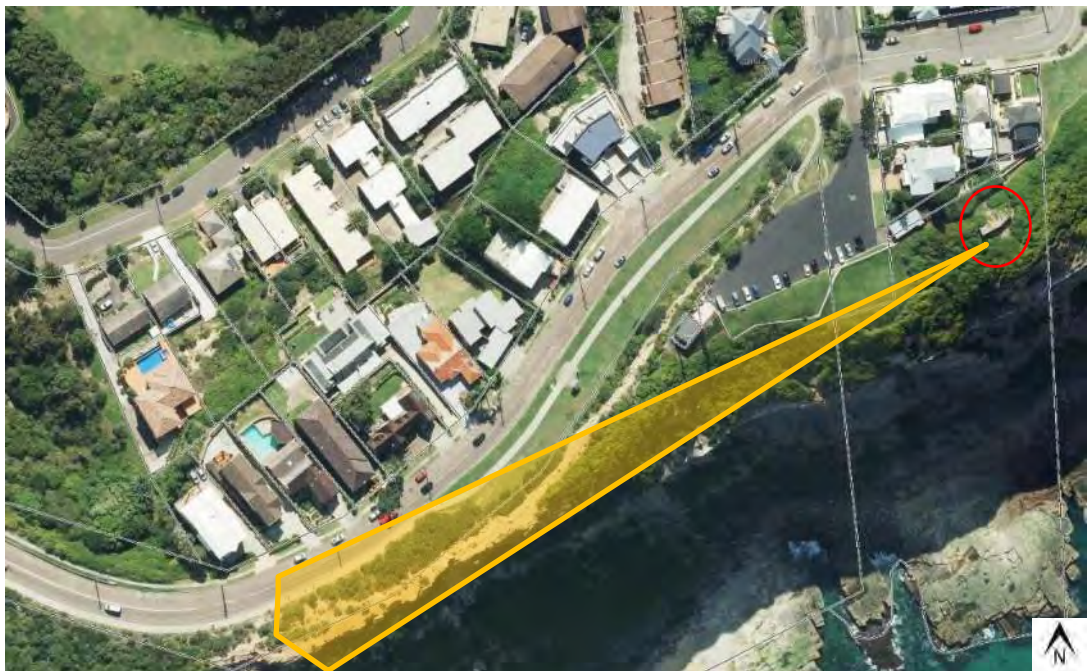
Figure 113: View 12 - The views afforded from the Park Battery, no.1 gun and bunker towards the Strzelecki Lookout and Memorial Walk are obtained from the south-western side of the structure and partially from the southern side, as indicated in the view cone above.

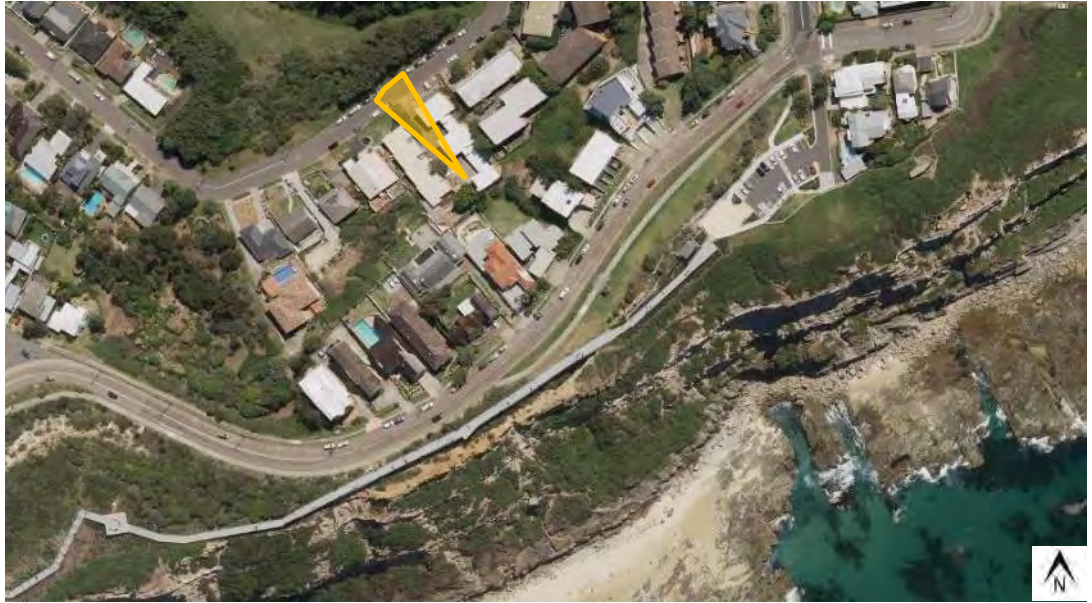
Figure 114: View 13 - The views that can be gained from the engine room are limited as the structure is located towards the rear of the residential complex. As such, only glimpses of Nesca Parade can be gained.

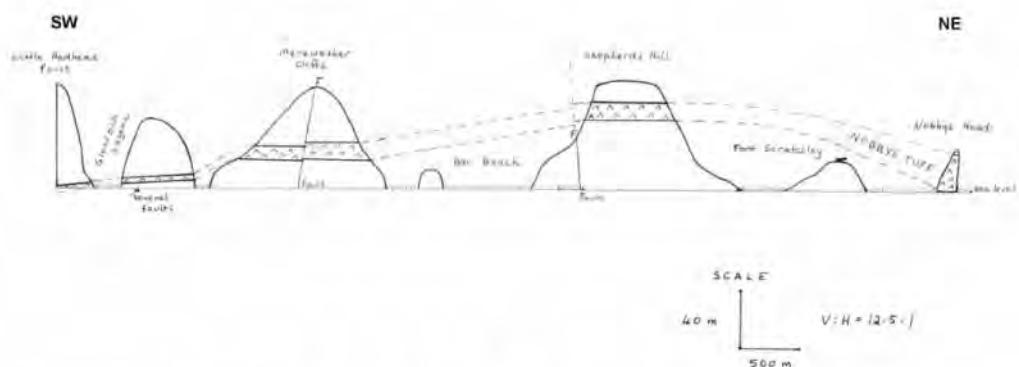
Figure 116: Cross Section of the Shepherds Hill Anticline from Little Redhead Point to Nobbys Head defined by Nobbys Tuff, also showing the location of the fault on Shepherds Hill. (Source: Figure 5, Kerr 2000 Bathers Way Geology report)

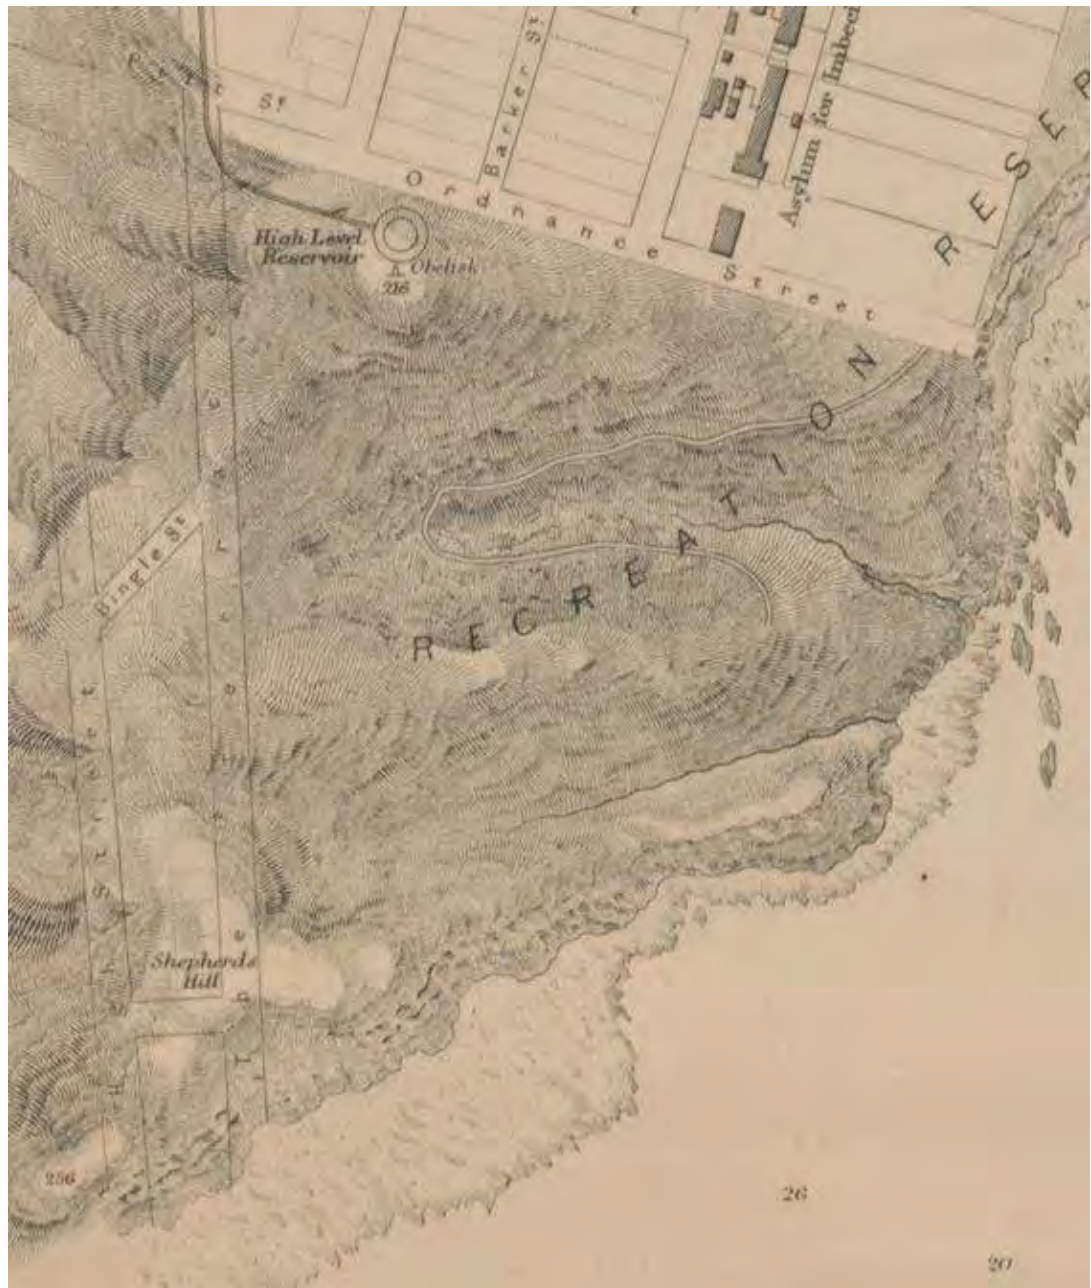
Figure 125: The 1881 maritime chart provided a clear image of the topography of the future Battery site at 41 The Terrace. (Source: Great Britain, Hydrographic Dept, Australia, East Coast, Newcastle Harbour, from surveys by F W Sidney and Officers of the Harbours and Rivers Department, 1881, NLA, MAP RM 2989)

The 1881 Harbour map also showed 'Shepherds Hill' (41 The Terrace) (Figure 125).<sup>50</sup>

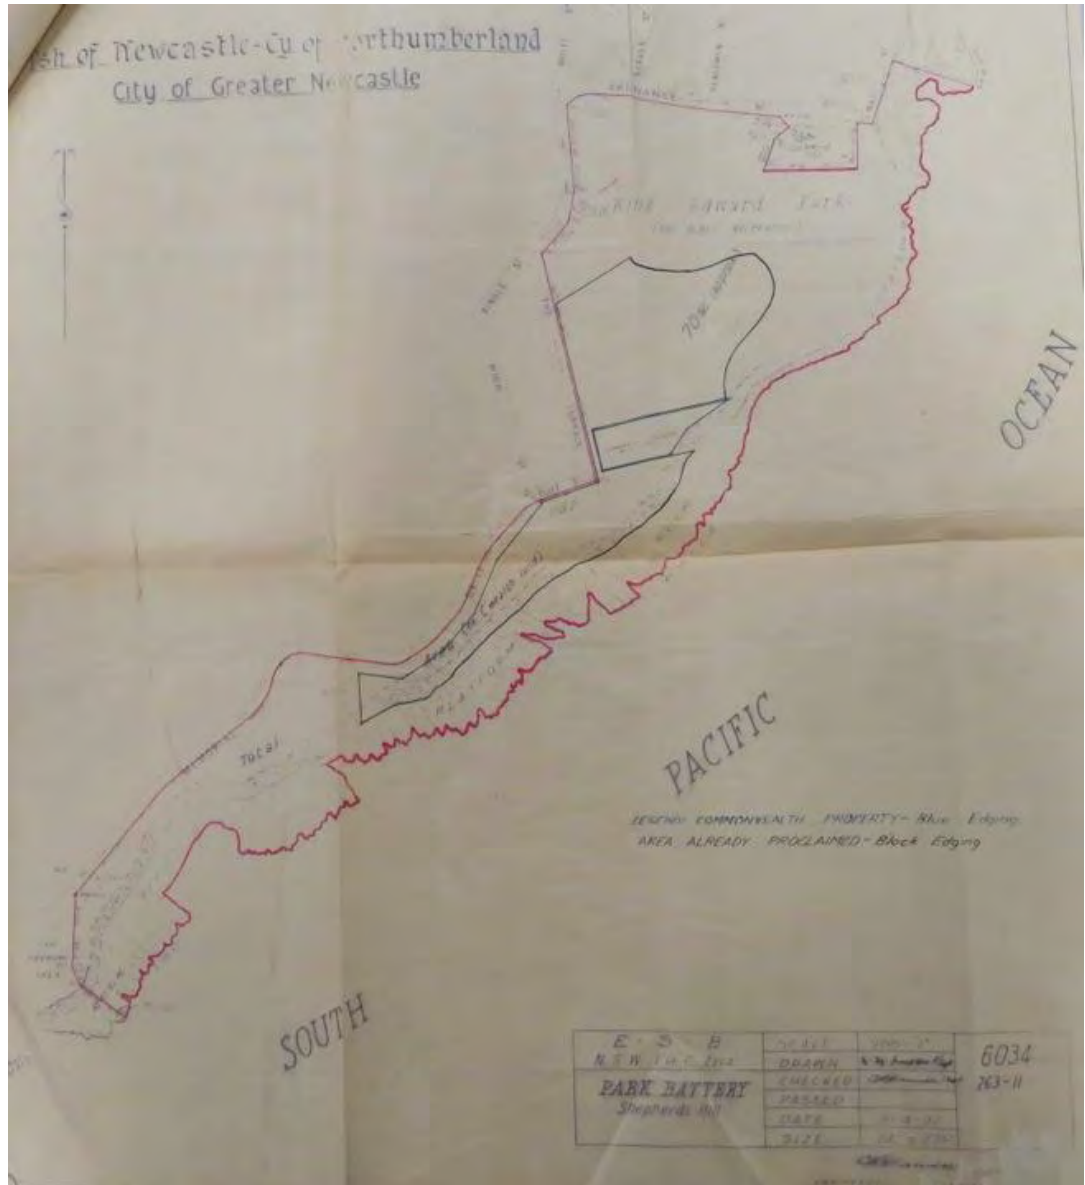
Figure 145: Plan of April 1942 showing the additional area to be acquired for defence. The area around the original battery was outlined in blue and the area already proclaimed was outlined in black. The red area defined the whole 'Park Battery'. (Source: NAA, SP857/3, PC607, Plan 6034)

The 17 acres shown on the survey of 8 January 1942 including 1, 3, Cliff Street, 37 High Street and the adjoining Crown and Council lands were formally acquired for the Coast Battery on 20 May 1942, though physical occupation had already occurred.<sup>172</sup> A plan of an additional area to be acquired for the Park Battery was completed on 30 April 1942.<sup>173</sup> That additional area was officially acquired by requisition on 13 June 1942 (Figure 145).<sup>174</sup>

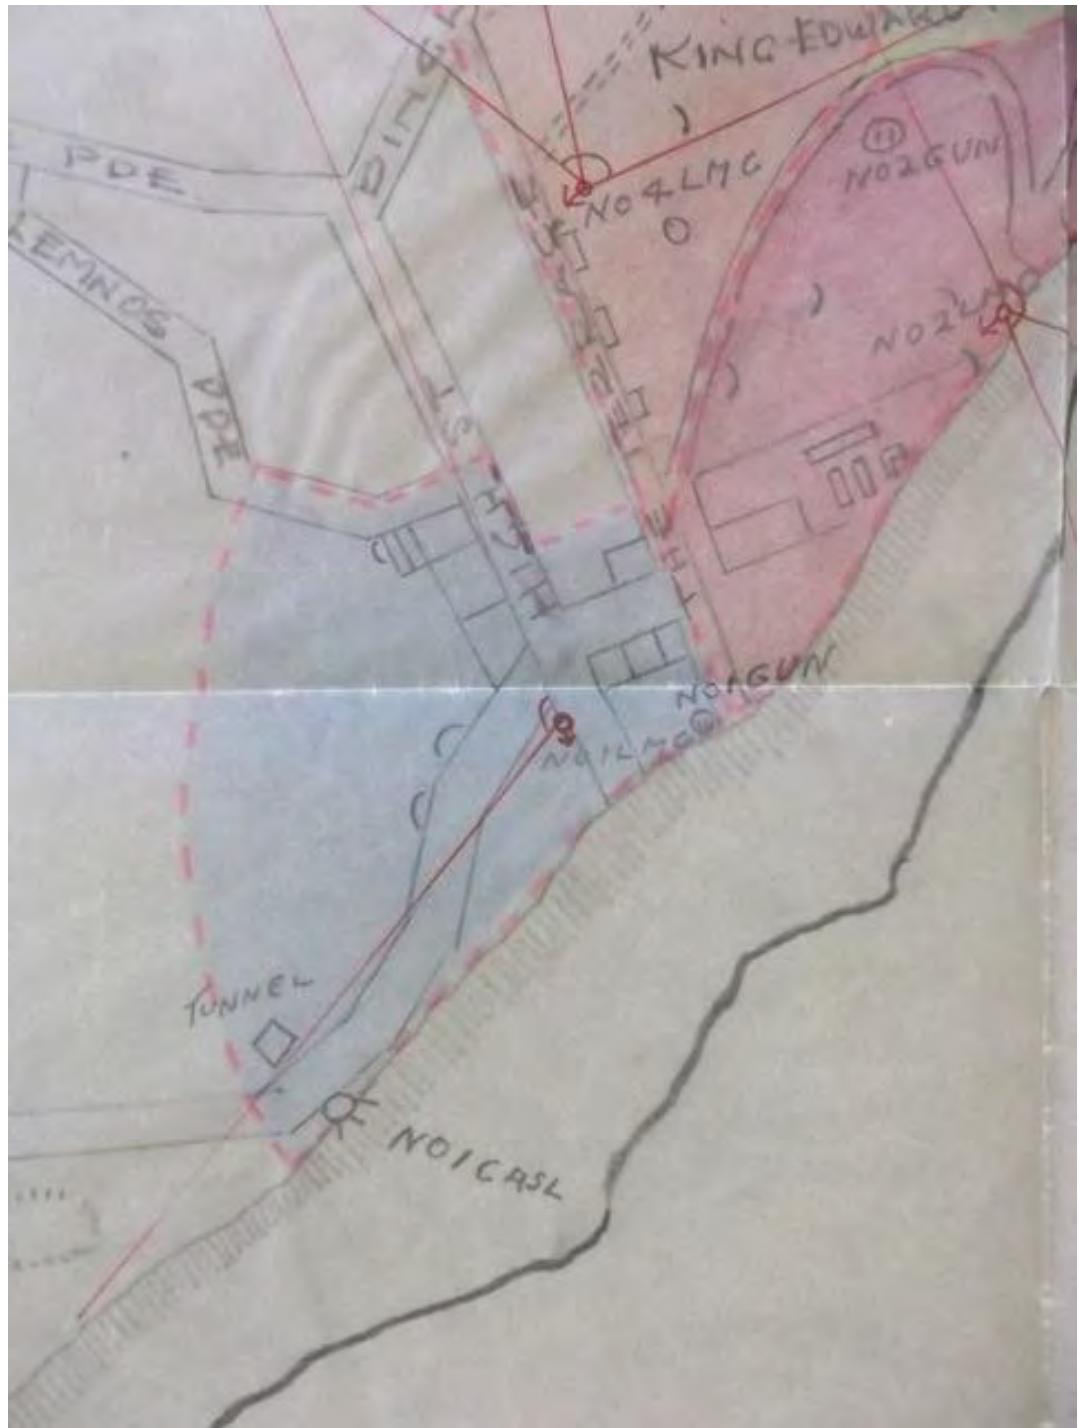
Figure 146: Detail of defences in 1942 near the Battery site. The map shows the position of Number 1 gun of the Park Battery No.1 searchlight and its tunnel as well as the position of No 1 LMG (light machine gun) near No.1 Gun. (Source: AWM 54, 243/6/67, Shepherds Hill map)

Instructions for the defence of 'Shepherds Hill Battery Area' were issued in 1942 with a plan. The defence plan showed the sites of No 1 and No 2 Guns plus two light machine guns (LMG) in defensive roles (Figure 146).<sup>175</sup>

The Close Protection Area map showed the areas allotted to each section (10 men each) of the Rifle Company guarding 41 The Terrace. Trenches and individual 'foxholes' appear to be indicated along with sightlines for defensive fire. A 3 inch mortar section has also been assigned for defence and they were shown located west of High Street and at the north-west corner of King Edward Park (M 3"). The ammunition store was sited south of the sunken garden.<sup>178</sup> A medium machine gun section had been assigned for defence, but no locations are indicated on the map. However, the plan in AWM 54 showed the positions of light machine guns and their arcs of fire (See Figure 146 and Figure 147).<sup>179</sup>
