## Conservation Management Plan

Shepherds Hill Defence Group Military Installations  
SHR # 01806

41 The Terrace, Newcastle and 65 Nesca Parade, The Hill

Submitted to the Council of the City of Newcastle

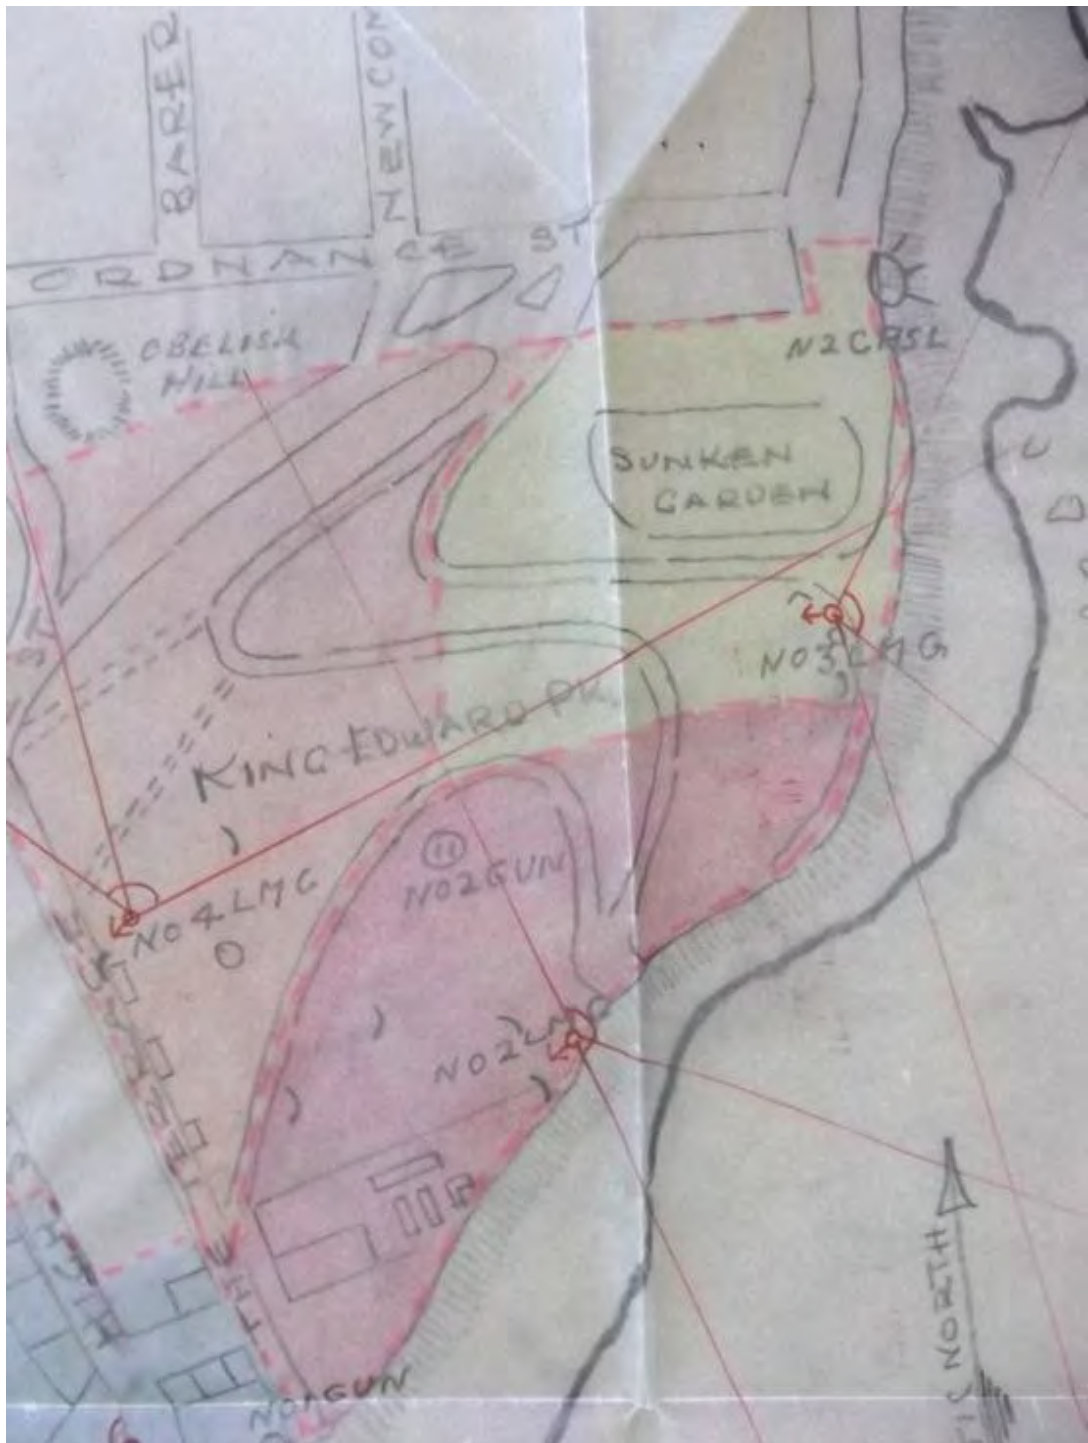
Figure 147: Detail of defences in 1942 near the Battery site. The map shows the position of Number 2 gun of the Park Battery, No 2 searchlight as well as the position of Numbers 2, 3 and 4 LMG (light machine guns). (Source: AWM 54, 243/6/67, Shepherds Hill map)

The Close Protection Area map showed the areas allotted to each section (10 men each) of the Rifle Company guarding 41 The Terrace. Trenches and individual 'foxholes' appear to be indicated along with sightlines for defensive fire. A 3 inch mortar section has also been assigned for defence and they were shown located west of High Street and at the north-west corner of King Edward Park (M 3"). The ammunition store was sited south of the sunken garden.<sup>178</sup> A medium machine gun section had been assigned for defence, but no locations are indicated on the map. However, the plan in AWM 54 showed the positions of light machine guns and their arcs of fire (See Figure 146 and Figure 147).<sup>179</sup>

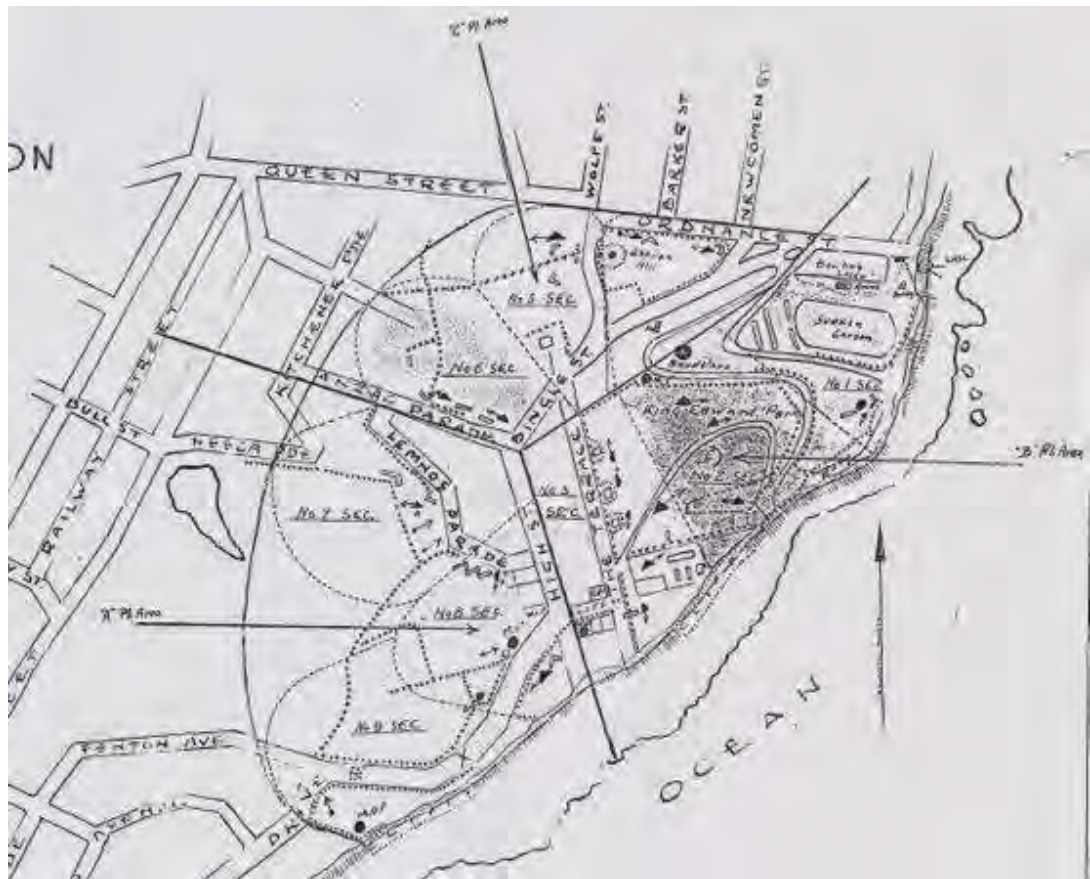
Figure 149: Enlargement of the plan showing the Close Protection Area at Shepherds Hill to defend the 6 inch guns and the BOP. (Source: NAA, SP553/1, 18)

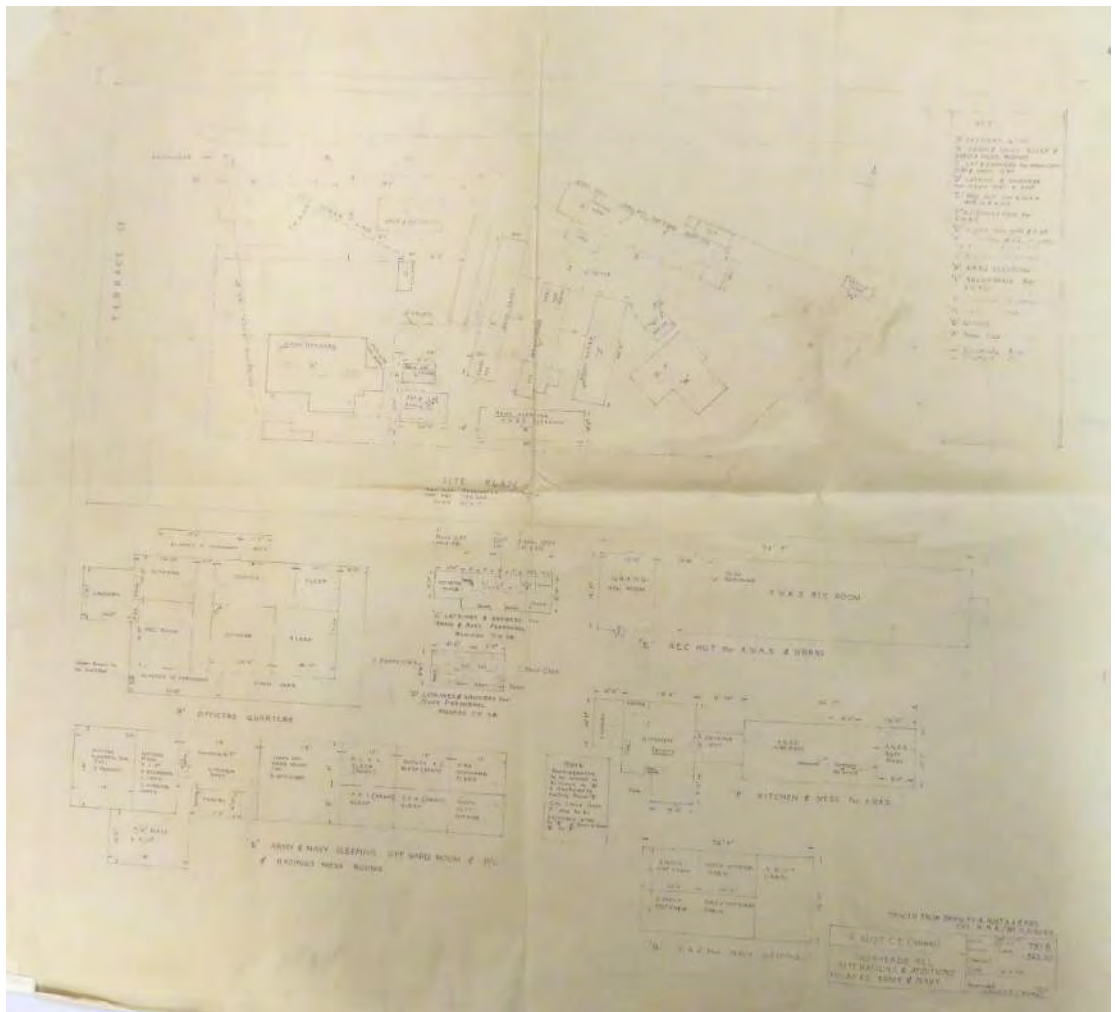
Figure 153: The complete plan showing the position of the buildings at Shepherds Hill plus new buildings to be erected. (Source: NAA, SP553/1, 125)

A significant plan by 2 Australian Chief Engineer (Works) of 41 The Terrace dated 14 March 1944 showing the 'Alterations & Additions For A W A S Army and Navy' [AWAS was the Australian Women's Army Service] provided considerable detail about the site. The plan showed the buildings on site plus their current uses. A Table on the plan detailed building occupiers and building functions. These included facilities for the WRANS [Women's Royal Australian Naval Service].<sup>190</sup> This plan also confirms that during World War II 41 The Terrace was occupied by Navy personnel, manning the Port War Signal Station, Army personnel in the Battery Observation Post, and Royal Australian Air Force personnel who operated the radio communication with aircraft. The addition of Australian Women's Army Service and Women's Royal Australian Naval Service personnel adds another layer to the intensity of military use and occupation of this site during World War II (Figure 152 and Figure 153).

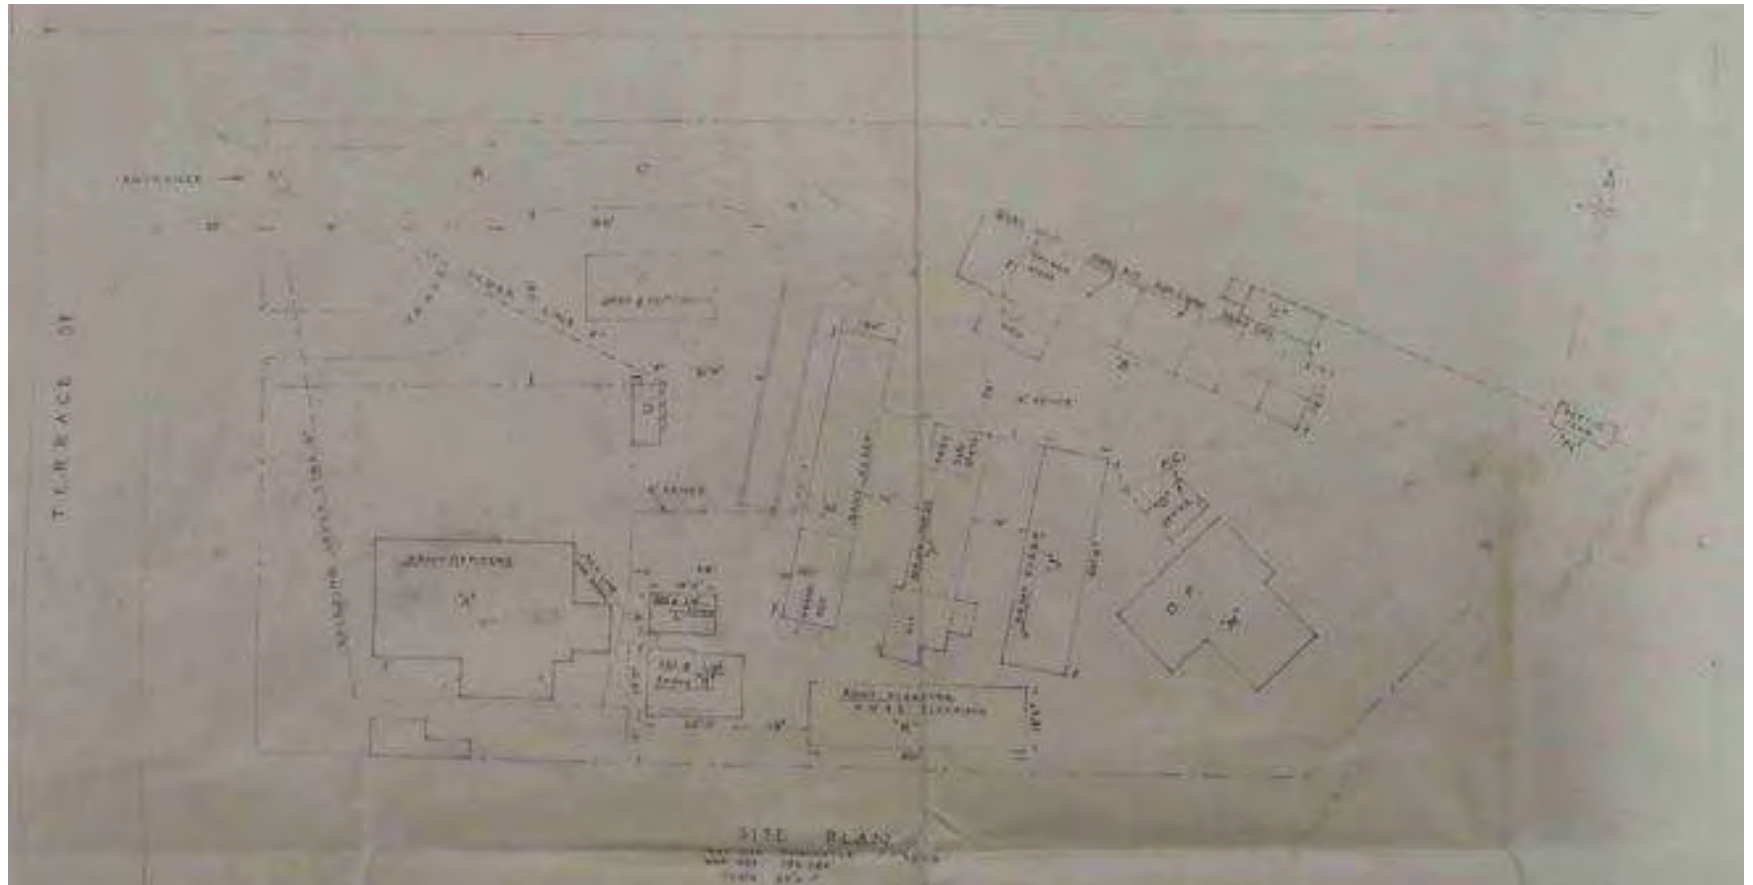
Figure 154: This enlargement of the plan showing the position of the buildings at Shepherd's Hill plus new buildings to be erected provides clearer detail of the buildings. (Source: NAA, SP553/1, 125)

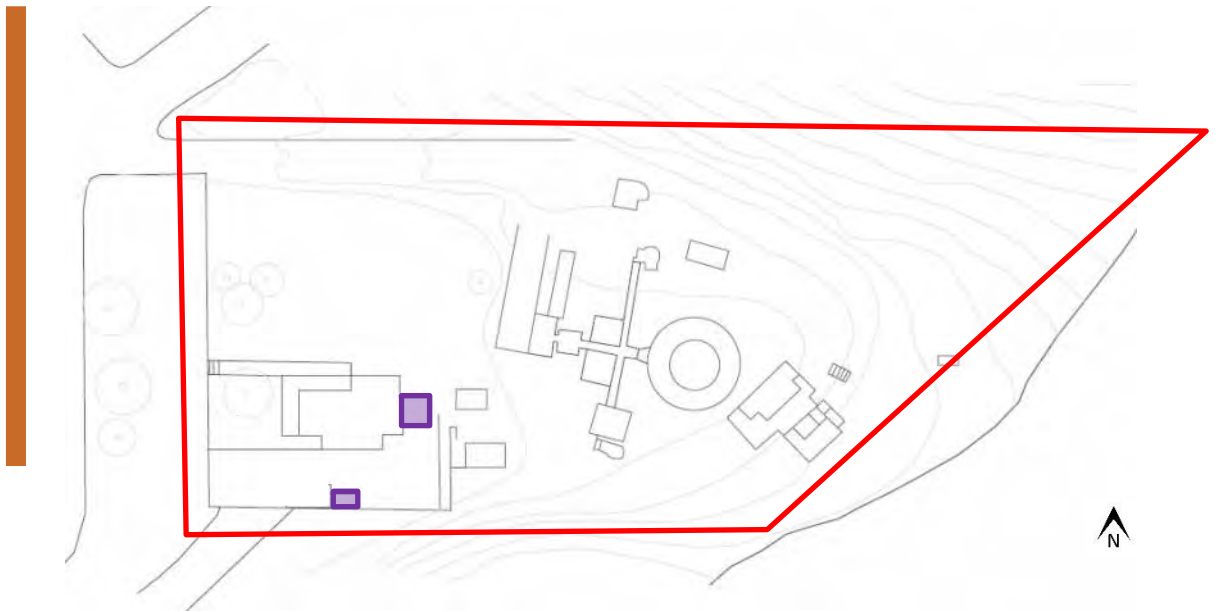
Figure 167: Plan for Shepherds Hill showing the sixth key phase of development, being the 1950s and 1960s. Little development appears to have occurred on the site, with the exception of the addition of a laundry to the east of the cottage and the toilet block to the south. These were both present by 1958 and may predate this. (Source: based on the plan for Shepherds Hill in Browne, Conservation Study 1984)

Views to the eastern elevation of the cottage were obstructed by the addition of the laundry, effectively obscuring the double chimney. No other view changes have been identified.

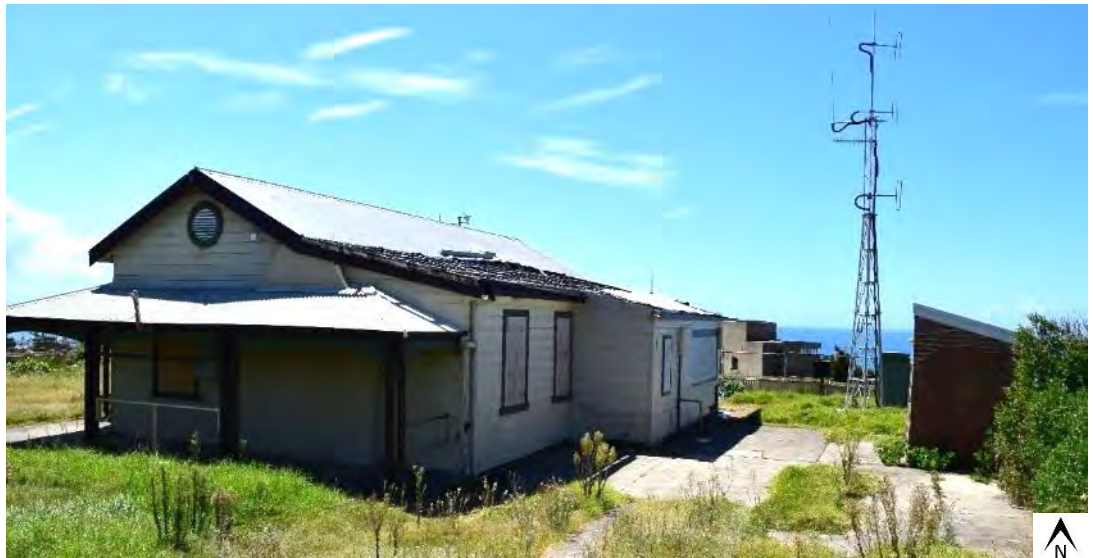
Figure 169: Image from 2016, showing the damage caused to the cottage following the storm of April 2015. The chimney was lost and damage was caused to the interiors.

The cottage was extensively damaged during severe storms experienced in April 2015 and has subsequently undergone asbestos removal which has left the internal fabric in a poor condition. It is currently undergoing conservation works under the supervision of Heritage Architect John Carr, whereby original features, layout and some 1920s detailing is being reinstated.

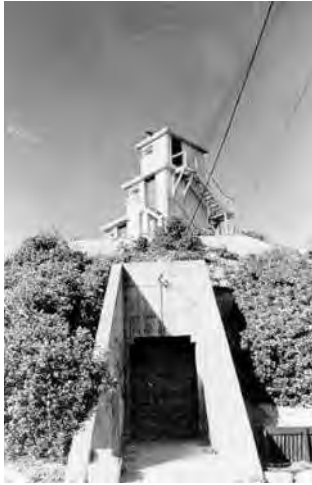
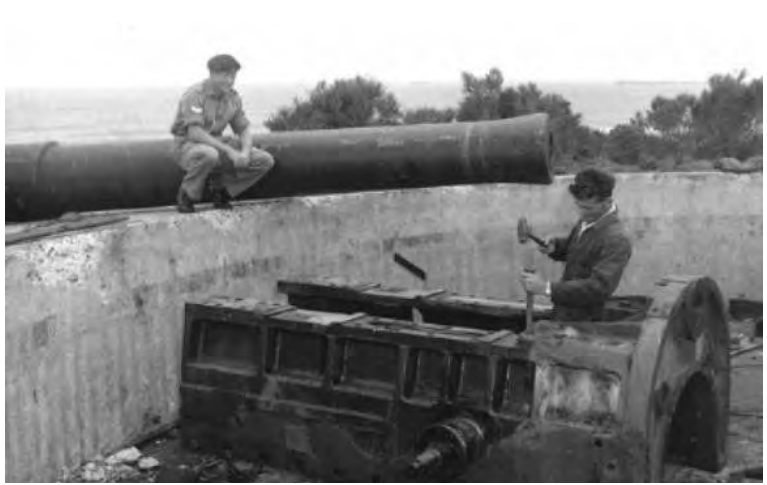
Figure 174: Photographs of Fort Wallace dating from 1969 and 1960. (Source: Newcastle Morning Herald, Newcastle Region Library, item no.'s 163 000624 and 104 012875)

The site encompasses various structures including gun emplacement and associated magazines, powerhouse and tunnels, observation tower, wireless room, casualty station, plotting room and underground plotting room (Figure 174 and Figure 175).

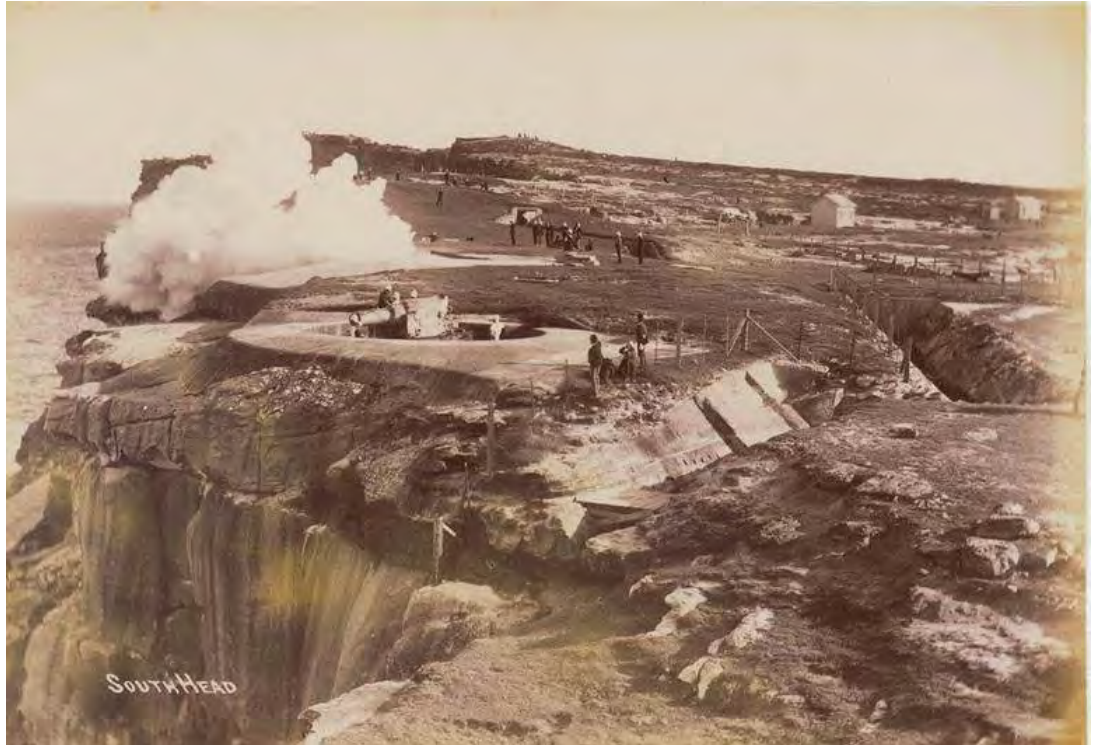
Figure 179: Photograph from c.1900 -1910 showing the South Head fortifications as viewed from the Hornby Light Tower. The two-gun emplacements construction in 1876 are visible. (Source: State Library of NSW, item no. PXE711/23)

While the signal station was dismantled after World War II, many defence structures still remain. The site is currently occupied by HMAS Watson and includes a number of structures such as officers' quarters, officer's mess, former sergeants mess, former stable/carriage shed, gun carriage coach house and annex, former guard house, former artillery barracks, sandstone drainage moat and rifle post wall, 80 pounder battery and five connected gun emplacements, World War I and World War II artillery fortifications on seaward cliffs, War Memorial Chapel of St George the Martyr, Aboriginal rock carving seaward side of Chapel (Figure 179 and Figure 180).

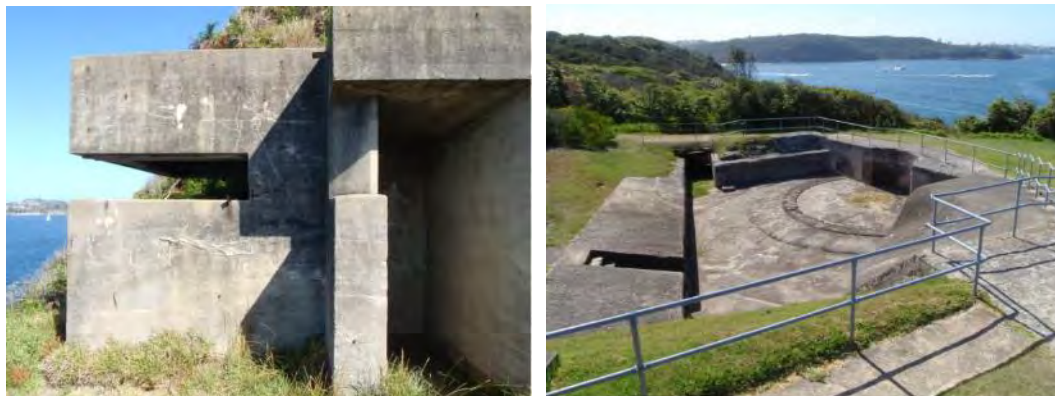
Figure 181: Middle Head fortifications including an Observation Post and gun pit. Photograph by Stirling Smith. (Source: State Heritage Inventory Form for Middle Head, <http://www.environment.nsw.gov.au/heritageapp/ViewHeritageItemDetails.aspx?ID=5045689>)

The Middle Head Military Fortifications (Figure 181) include a series of structures and buildings dating from 1801 to the mid-20th century. The fortifications are divided into five complexes which include the Outer Middle Head Battery, Inner Middle Head Battery, Inner Middle Head Barracks, Middle Head Fortifications and Obelisk Bay Fortifications. The earliest battery located on the site was built in 1801 and is included within the Middle Head fortifications complex.

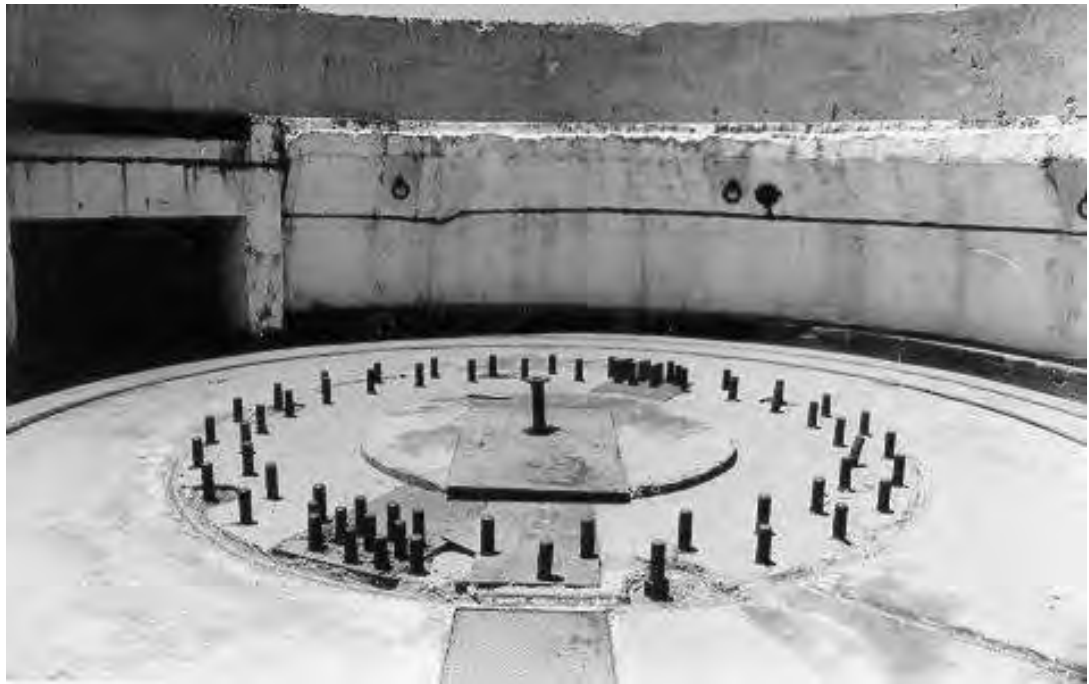
Figure 182: Photograph of one of the two gun pits located at North Head as pictured in 1986. (Source: SHI form for North Head Fortifications, <http://www.environment.nsw.gov.au/heritageapp/HeritageItemImage.aspx?ID=2020399#ad-image-0>)

The fortifications located at North Head included two 9.2 inch BL Mark 10 guns with associated magazines, shell store and pump chamber, all located underground with a concrete road above and connected by a series of tunnels (Figure 182). Also within the underground complex was an engine room and plotting room. Above ground, towards the northern end of the site, was a concrete Observation Post.

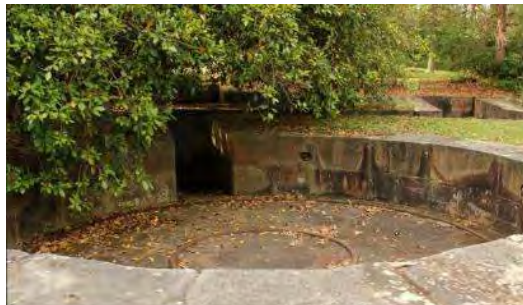
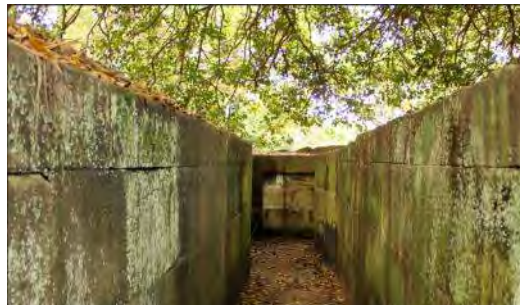
Figure 183: Views of Bradley's Head fortifications including a gun pit and trench. (Source: National Parks NSW, <http://www.nationalparks.nsw.gov.au/things-to-do/historic-buildings-places/military-relics-at-bradleys-head>)

The Bradley's Head Fortifications (Figure 183) are located within Ashton Park in Manly and consist of two fort complexes, dating from 1840 and 1871. Both are constructed from large blocks of sandstone and have been partially carved out of the site's original rock, making them somewhat unique in comparison to other coastal defence sites.

Comments	Unlike Shepherds Hill, the gun pits and associated structures have been constructed from sandstone blocks. There are also trenches rather than tunnels. The site has been consistently occupied during the various conflicts between 1839 and World War II and is associated with the early defence of Sydney/ NSW, prior to the withdrawal of British Troops.
----------	--

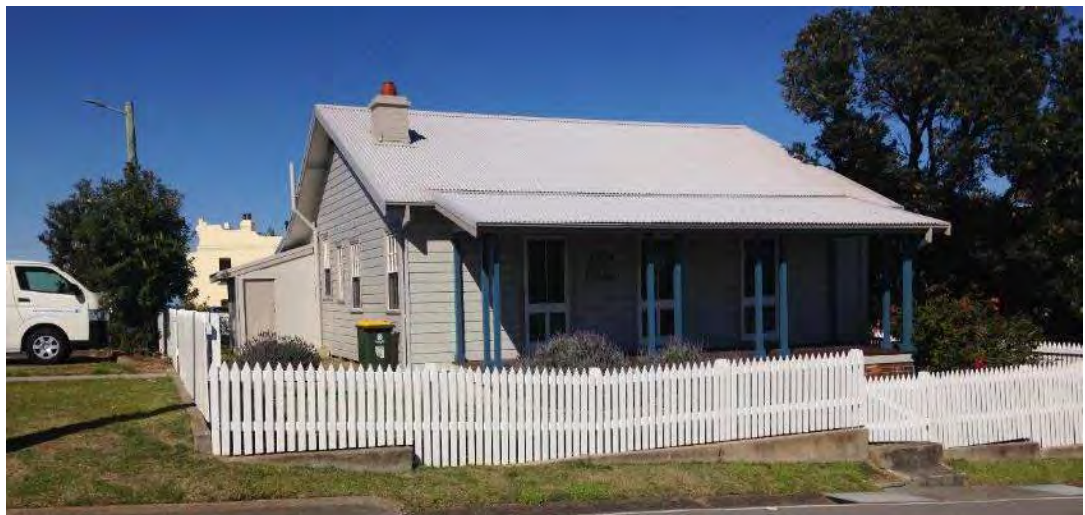
Figure 190: Master Gunner's Cottage at For Scratchley.

The Master Gunner's Cottage at Fort Scratchley (Figure 190) was constructed in c.1926 and internally includes four rooms with a small bathroom and kitchen. There is also a laundry and toilet located in a separate wing to the western side and a veranda to the north western elevation. The cottage façade is constructed from weatherboards and the iron gabled roof was replaced during the 1970s.

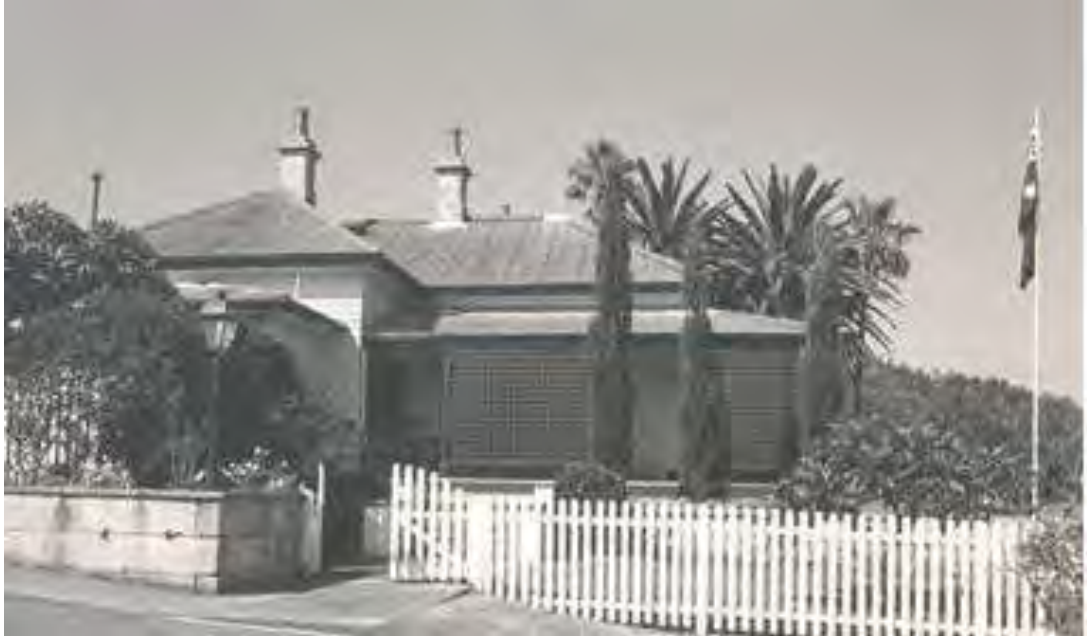
Figure 193: Cliff House as depicted in 1989. (Source: Woollahra Library, item no. pf002/pf002830)

Cliff House (Figure 193) was constructed at South Head in 1876 along with three other buildings and was originally designated as a mess and barracks for single officers. It is located westward on a slope and is single storied, clad in weatherboards with flagstone foundations. The roof is hipped and clad in corrugated galvanised iron. The veranda has a separate roof and there are three chimneys constructed from sandstone with terracotta pots.

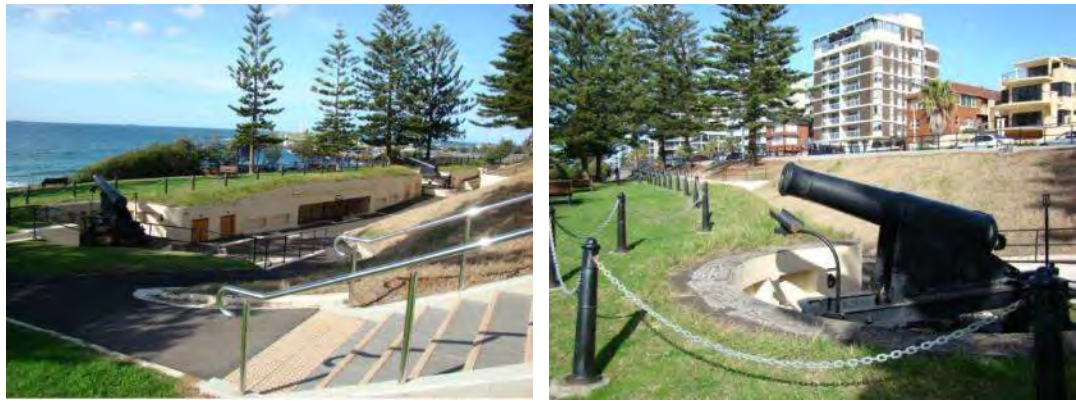
Figure 196: Images of the Smith's Hill fort including the gun pits and the two guns that are still present. (Source: SHI for Smith's Hill Fort, <http://www.environment.nsw.gov.au/heritageapp/ViewHeritageItemDetails.aspx?id=2700117>)

The Smith's Hill Fort (Figure 196), located in North Wollongong, was constructed between 1892 and 1893 and consisted of three gun emplacements and associated underground tunnels and storerooms. The two northern emplacements were larger and contained 80 pounder rifled muzzle-loader guns, manufactured by the Royal Gun Factory in Woolwich in the United Kingdom. The southern emplacement contained a 1 1/2 inch Nordenfelt quick-firing gun, however, only the two northern guns still remain.

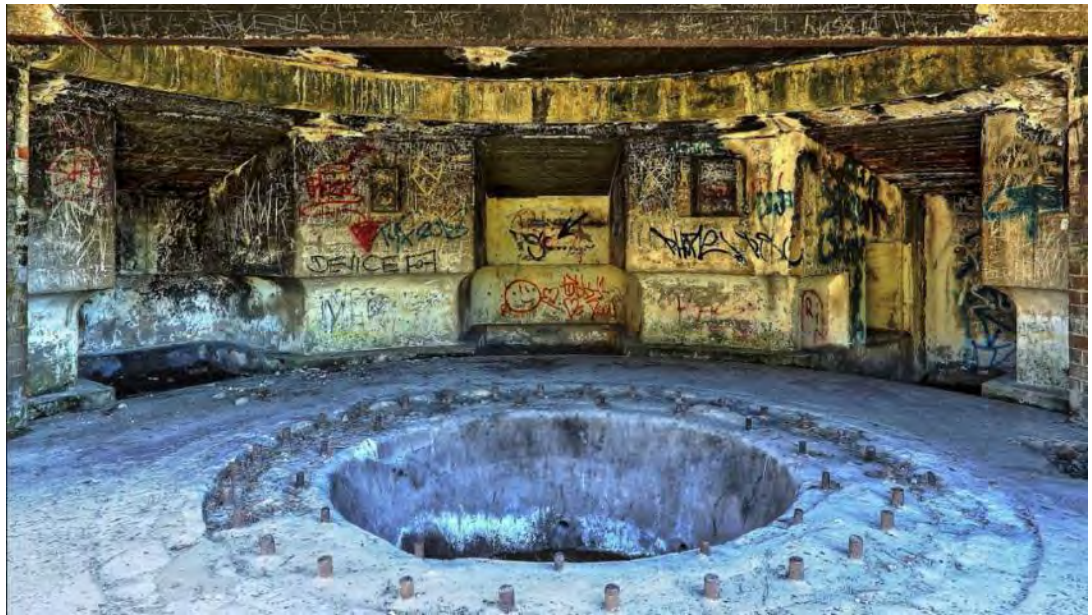
Figure 197: Photograph of one of the Henry Head gun emplacements. (Source: Flickr, photographed by Paul Huynh, [https://www.flickr.com/photos/aph\\_pixels/15266916612](https://www.flickr.com/photos/aph_pixels/15266916612))

The Henry Head Battery (Figure 197 and Figure 198) was constructed between 1892 and 1895 consisted of two gun emplacements that held BL 6-inch Mk V disappearing guns. There were also associated lookout posts used in conjunction with the gun emplacements and underground tunnels with double walls and ceilings which were installed to stop a collapse.

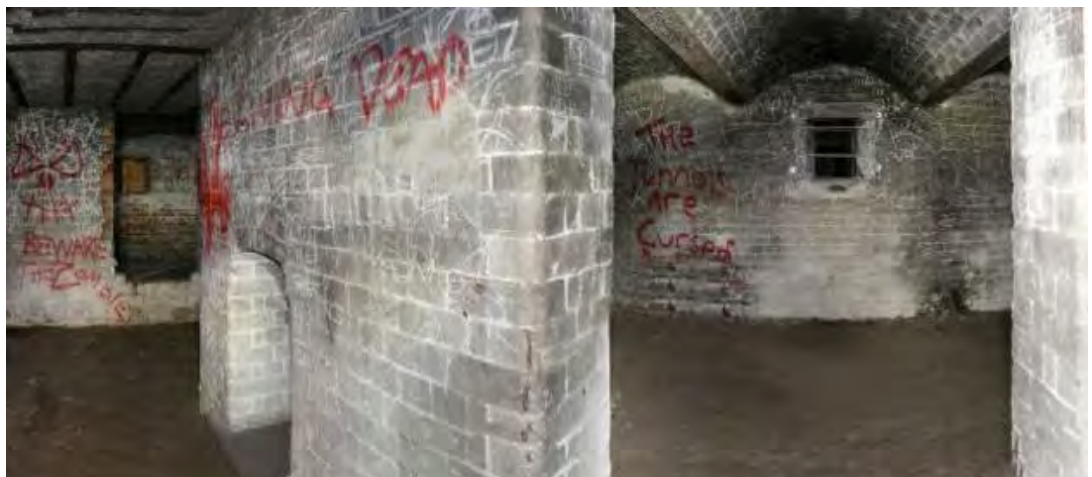
Figure 198: Interior view of the Henry Head tunnels. (Source: Photograph sourced from Urban Ghost Media, <http://www.urbanghostmedia.com/2014/07/henry-head-battery-botany-bay-military-bunker/>)

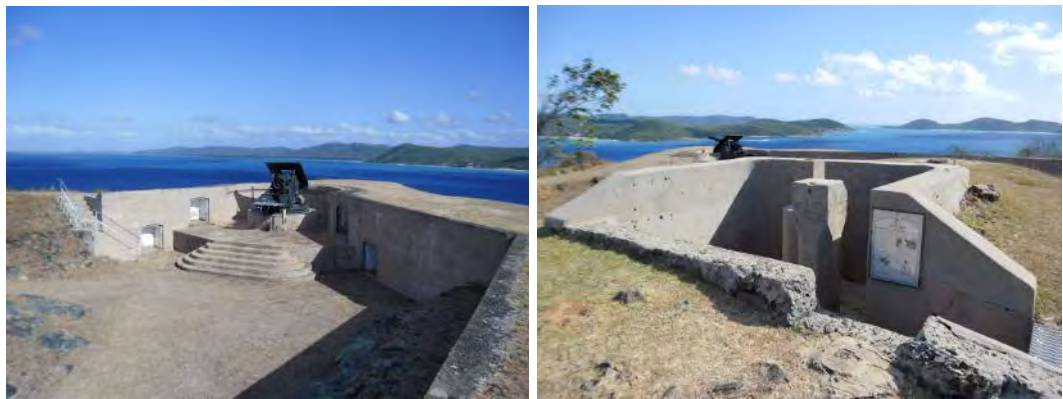
Figure 199: Gun emplacement and DRF station at Green Hill. (Source: Photographs by Trevor Costin, 2011, via <http://www.ozatwar.com/bunkers/greenhillfort.htm>)

The Green Hill Fort (Figure 199) is located on Thursday Island and was originally built between 1891-1893 for the purposes of defending against a possible Russian invasion and various other coastal threats that were apparent at the time. The fort was constructed as part of a network of coastal defence sites dotted along the NSW coast including Fort Scratchley, Kissing Point Fort in Townsville, Fort Lytton in Brisbane, Fort Nepean in Melbourne and Fort Glanville in South Australia.

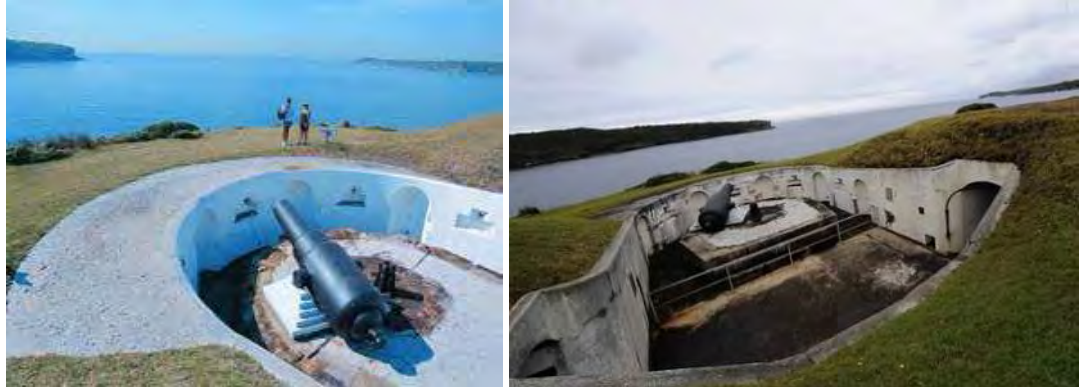
Figure 200: Detailed view of a gun pit at Bare Island. (Source: <http://www.sydney.com/destinations/sydney/sydney-east/attractions/bare-island>)

As detailed in Section 7.2.1 (Figure 200), the Bare Island Fort (is located near the entrance of Botany Bay and was developed as a coastal defence site to control the entrance of unwanted visitors into the Bay. The site includes an emplacement with five guns and bomb proof tunnels that were constructed from concrete and later found to be faulty, resulting in the closure of the fort.

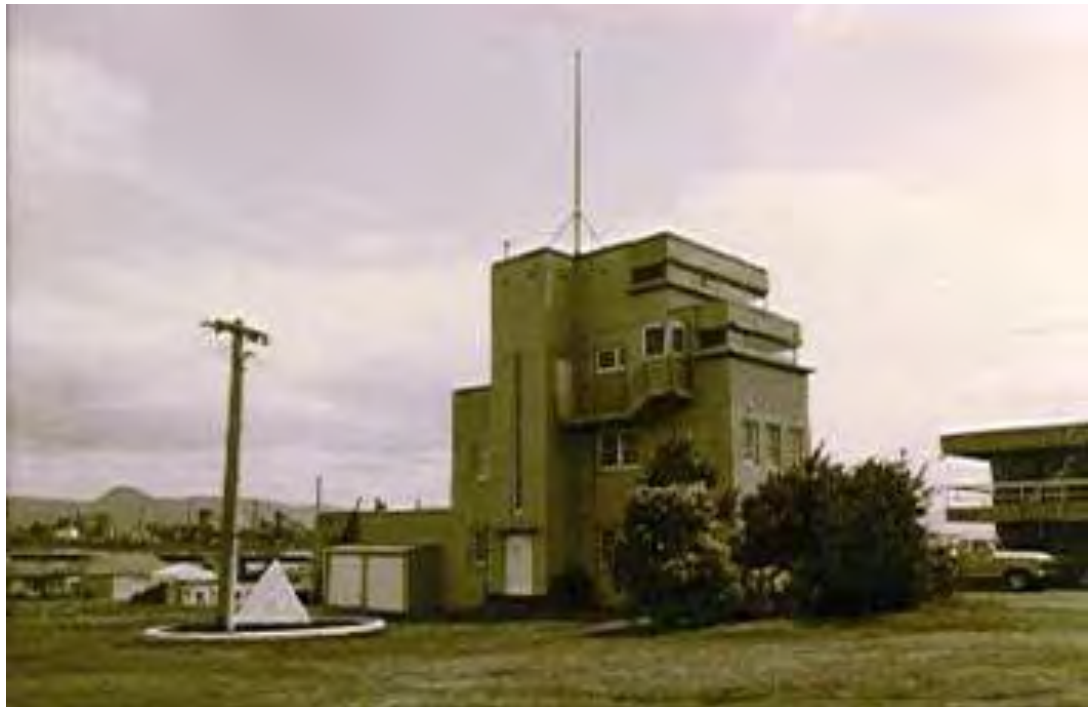
Figure 201: The Battery Observation Post designed to look like a block of units, located at Breakwater. (Source: SHI form for Historical Military Museum including Breakwater battery and concrete tank barriers,

Built in 1940, the Battery Observation Post at Breakwater was built on Hill 60, to the south, above red point (Figure 201). It was built as part of a network of coastal batteries dotted along the coastline with the purpose of providing protection for Newcastle and Port Kembla, two important port cities.

Characteristics	Comments
Address	Gloucester Boulevard, Port Kembla
Construction	1940
Use	Former military site, signal station and now Historical Military Museum
Level of Intactness	Good
Architect	unknown
Comments	This Observation Post is somewhat unique having been specially designed so as to appear like a residential block of units rather than a military building. As such, it differs in appearance to the Observation Post at Shepherd's Hill and does not have the same stepped down appearance. It is also more decorative.

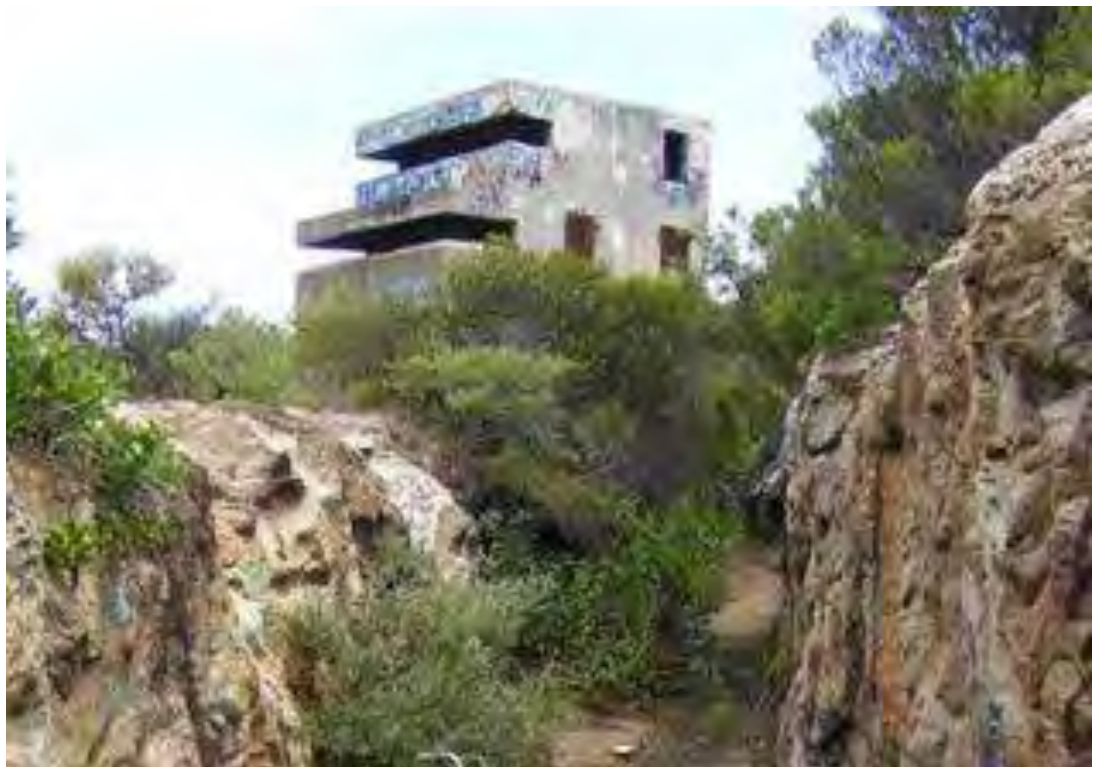
Figure 202: View of the Boora Point Observation Post. (Source: Visit Sydney website, <http://www.visitsydneyaustralia.com.au/little-bay.html>)

Located on the Malabar Headland at Boora Point is another Battery Observation Post built in 1943 (Figure 202 and Figure 203). The BOP was constructed along with fortifications at Cape Bailly and Cape Banks, as first line coastal defence against the Japanese. Prior to its construction, there had been Japanese submarine activity within proximity to the coast with three minisubs entering Sydney Harbour in 1942.

Characteristics	Comments
Address	Malabar Headland, Malabar, NSW
Construction	1943
Use	Former military site, now National Park
Level of Intactness	Fair
Architect	unknown
Comments	This BOP presents the same stepped down appearance as Shepherds Hill, however, does not have an addition towards the front section on the ground floor. The searchlight is not located within the building and is a separate structure. The window bars do not appear to be present and the overall form of the building is cube-like. Alike the Shepherds Hill BOP, the rear elevation of the building is relatively flat with limited detailing. Also constructed from concrete.

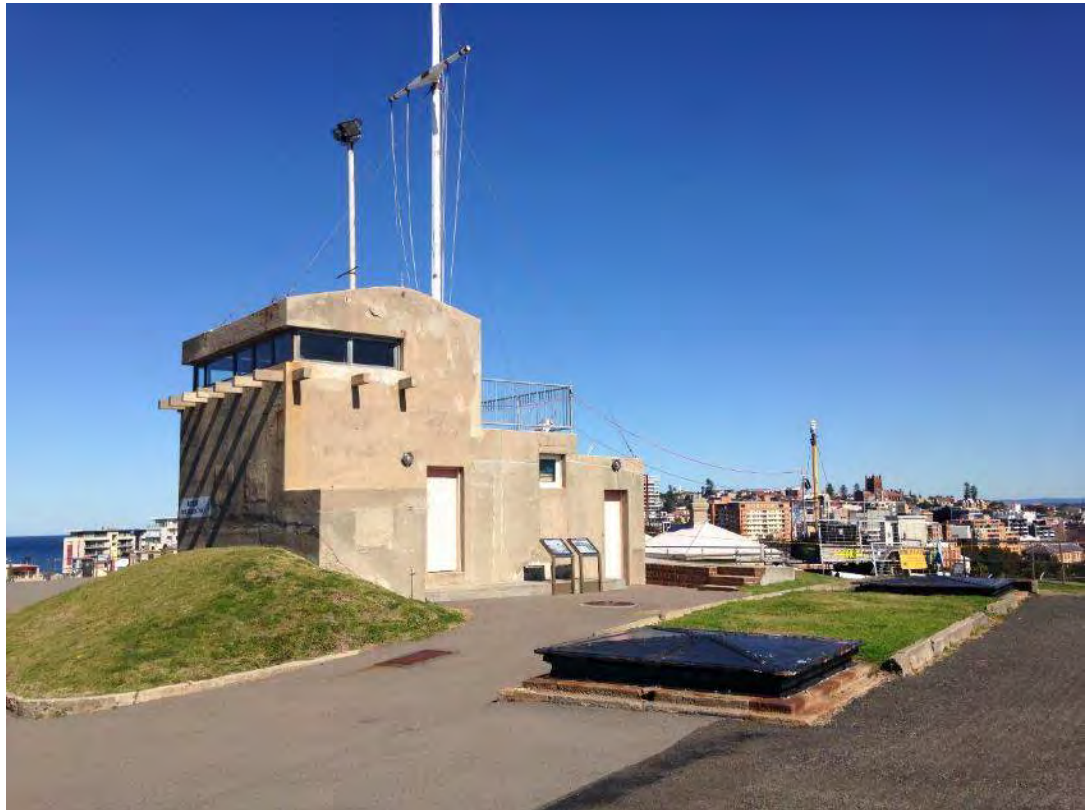
Figure 204: Fort Scratchley Battery Observation Post.

The Battery Observation Post located at Fort Scratchley (also known as the Battery Command Post) is located centrally within the fortifications and has expansive views east, north and south. The elevated position of the building also assists in the views to and from the building (Figure 204).

Characteristics	Comments
Address	Nobbys Road, Newcastle East, NSW, 2300
Construction	1914
Use	Museum
Level of Intactness	Good
Architect	unknown
Comments	This Observation Post was built during World War I and is therefore an earlier example. The structure is also bore cube--like with only one central window area to the top floor. The building does not have a stepped down appearance and is on a smaller scape to the Shepherds Hill BOP.

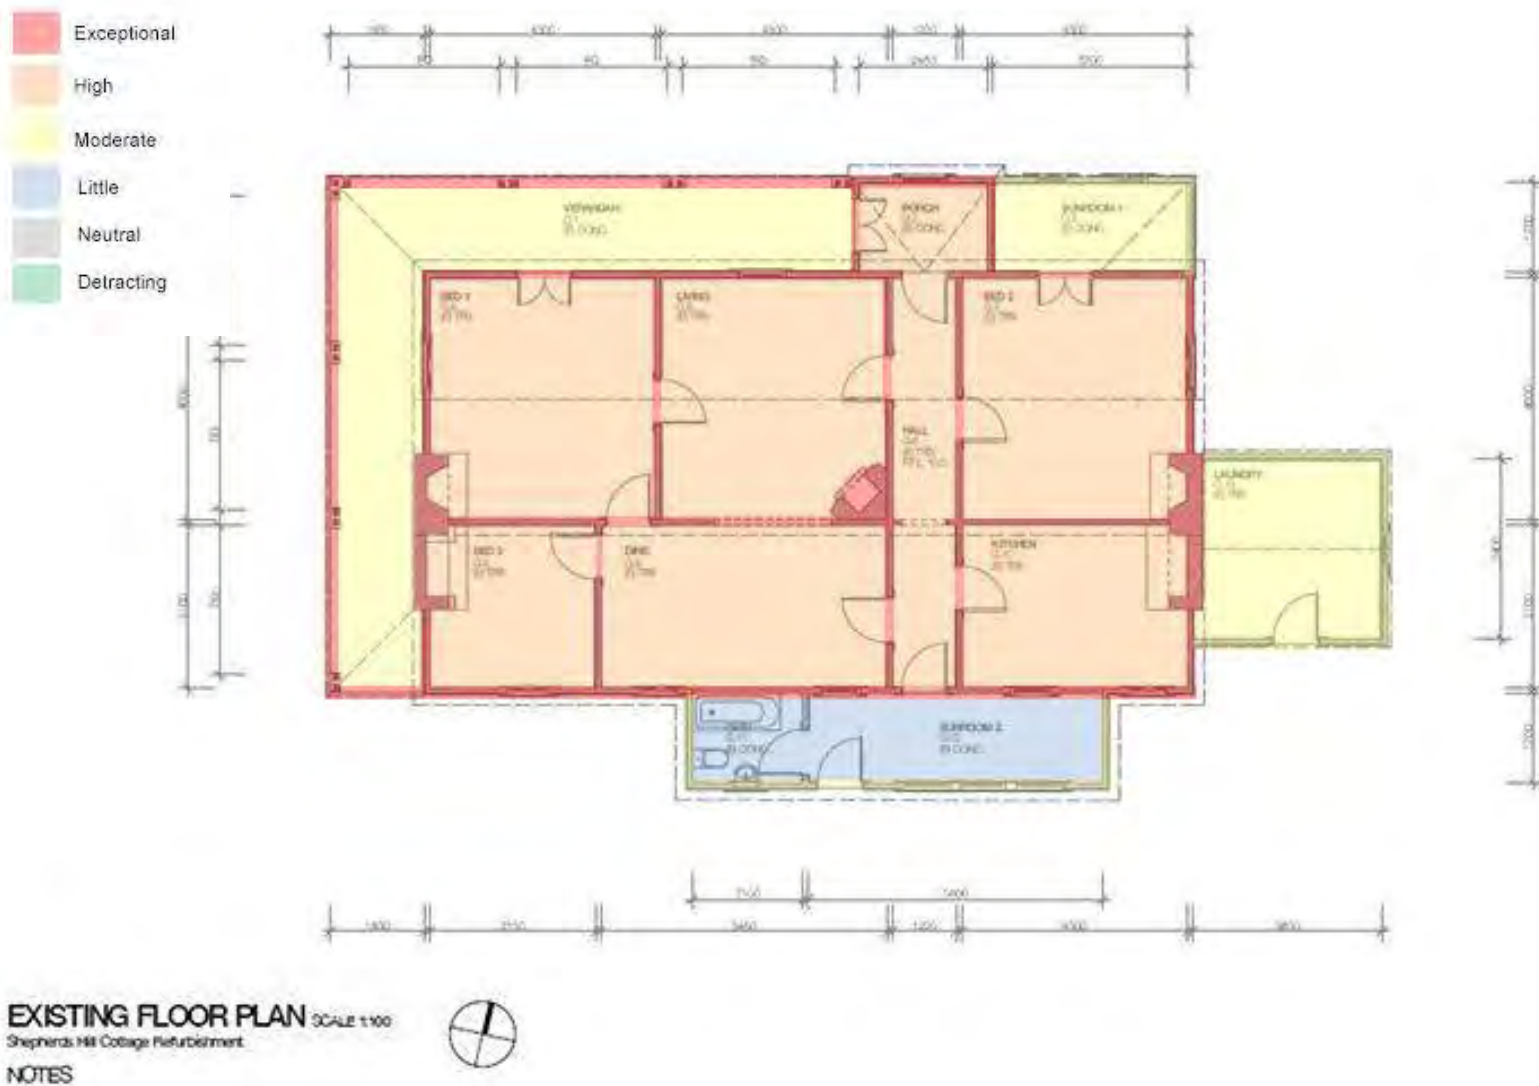
Figure 206: Floorplan for the cottage showing the significance ranking identified for each built element. (Source: Curran, existing floor plan, A100, revision A, 2 June 2017)
