## Conservation Management Plan

Shepherds Hill Defence Group Military Installations  
SHR # 01806

41 The Terrace, Newcastle and 65 Nesca Parade, The Hill

Submitted to the Council of the City of Newcastle

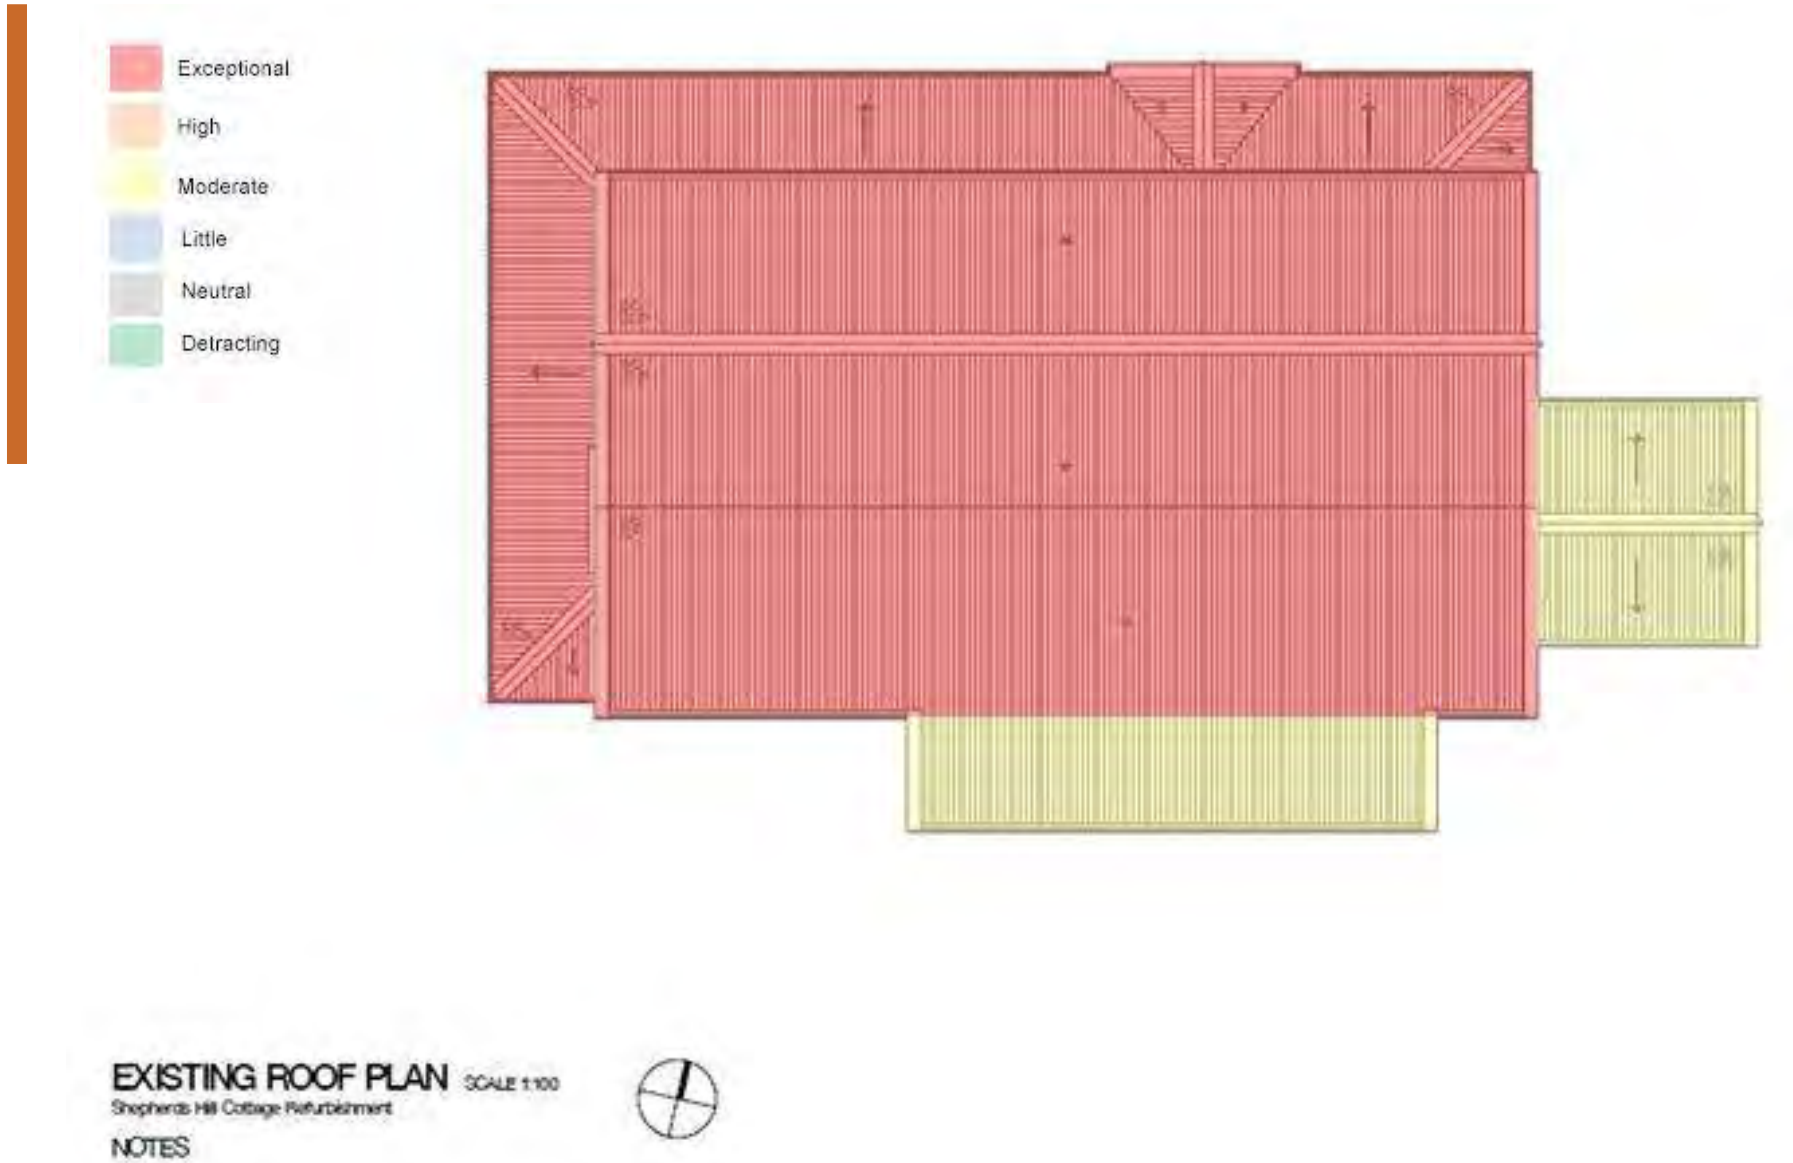
Figure 207: Significance ranking for the roof of the cottage. (Source: Curran, existing roof plan, A101, revision A, 2 June 2017)

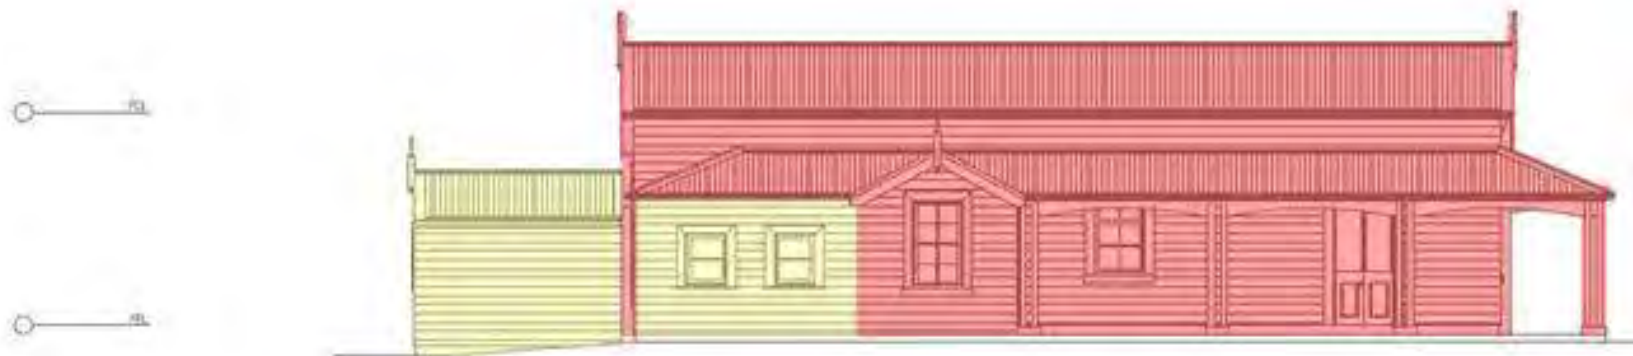
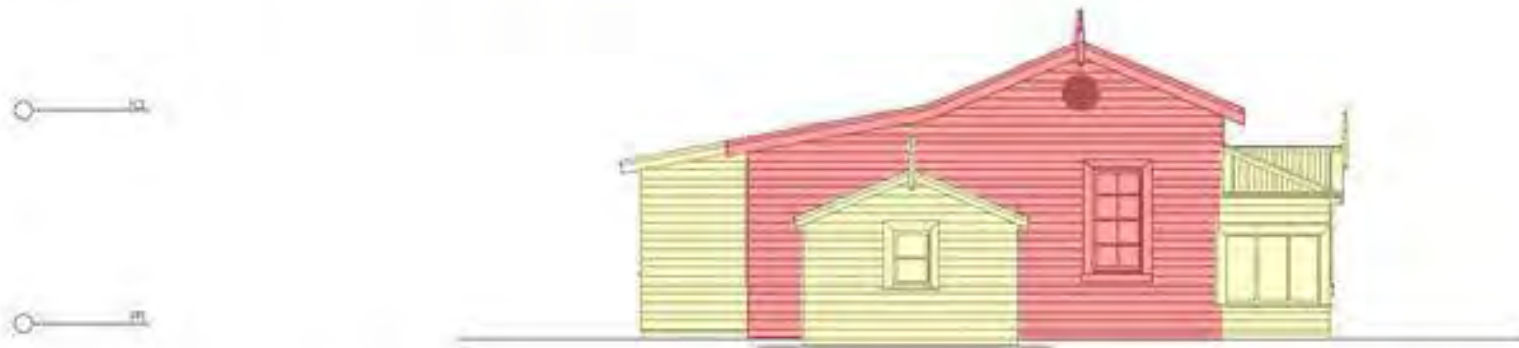
Figure 208: Significance ranking for the northern and eastern elevations of the cottage. (Source: Curran, existing north and east elevations, A400, revision A, 2 June 2017)

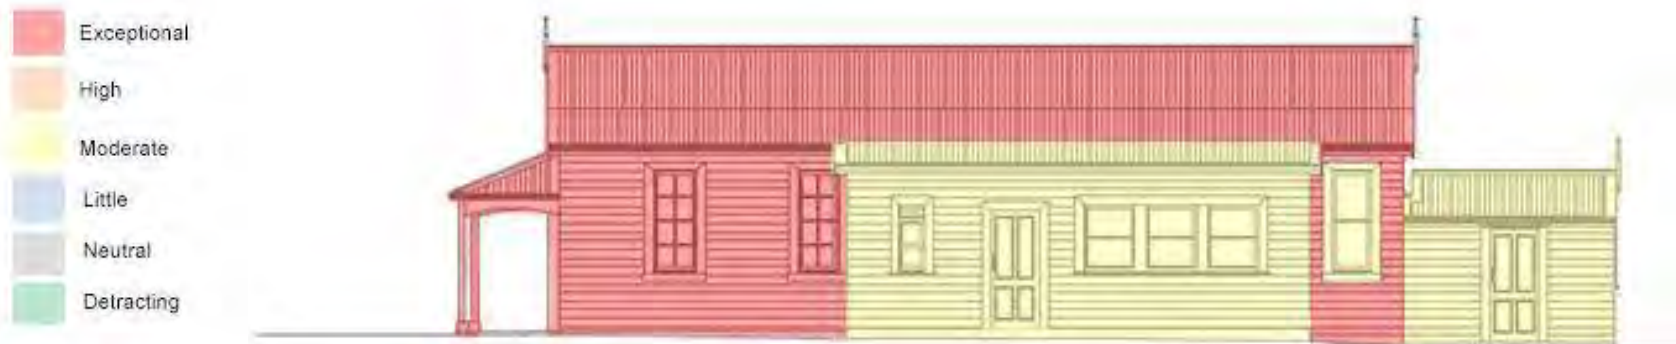
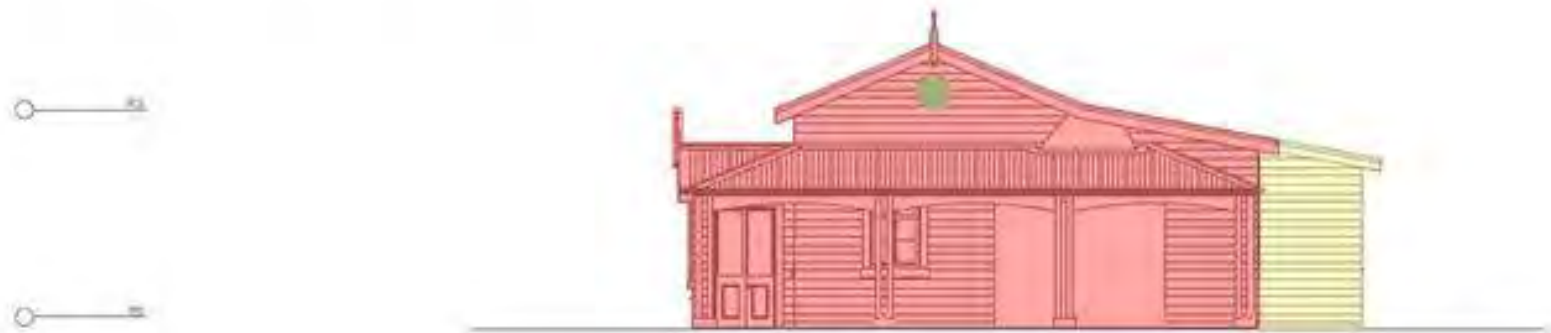
Figure 209: Significance ranking for the southern and western elevations of the cottage. (Source: Curran, existing south and west elevations, A401, revision A, 2 June 2017)

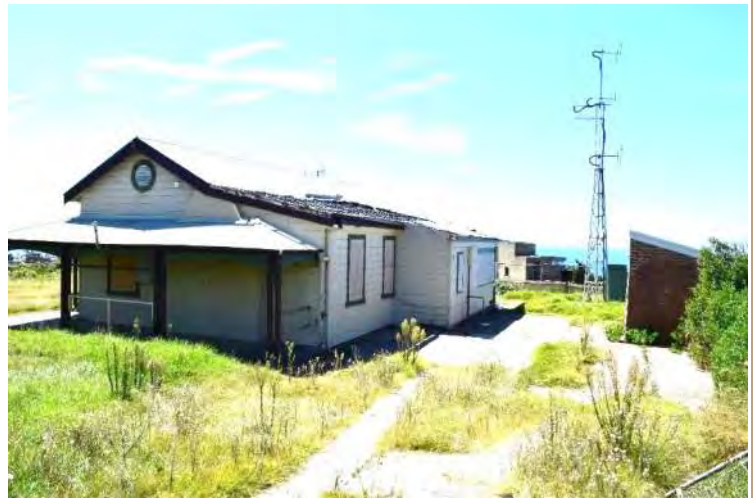
Eastern  
Elevation

Exceptional

The original eastern elevation is considered exceptional, however, is partially obscured by the later laundry addition. The circular vent also appears to be a later addition with early photographs seen in Figure 247 showing the northern façade with not vent present.

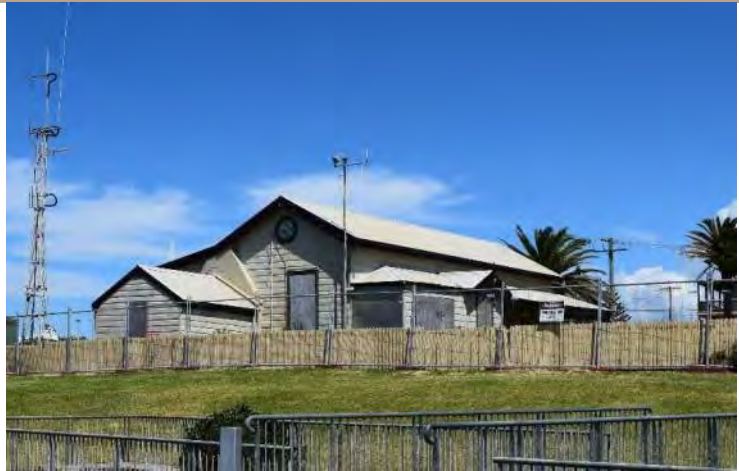
High

The southern elevation has also been modified and includes two later extensions towards the eastern end including the laundry, additional window to the kitchen and Sunroom/ bathroom extension. This extension covers the original southern façade which is only visible internally. Windows boarded up and a later addition except for a few windows to the south west.

The extended roof section to facilitate the Sunroom/ bathroom addition involved modification of the original gabled roof form and is also considered of moderate significance.

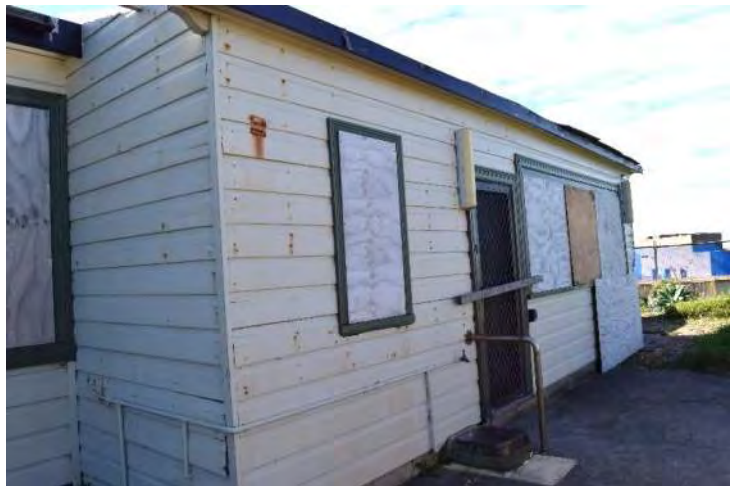
Moderate

The eastern elevation predominately consists of extensions made to the original section of the cottage including the laundry and north-eastern sunroom addition. The roof to the south, which can be seen from this elevation, is also a later addition and the chimney has been removed, although the breast remains.

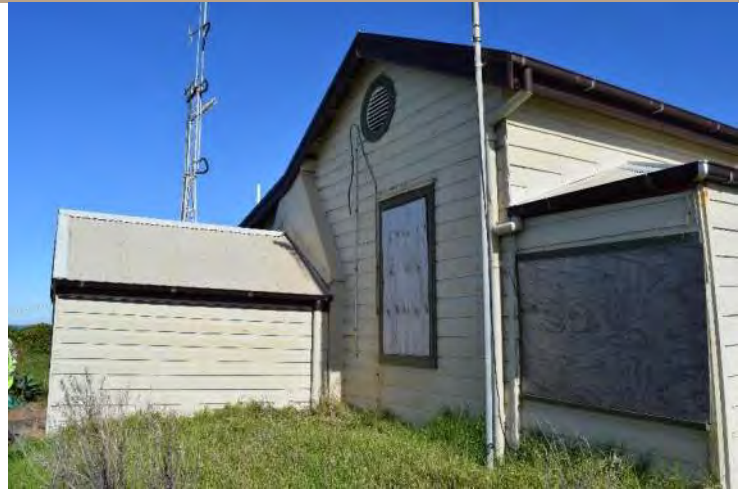
Western  
Elevation

Exceptional

The overall external form, configuration and materials of the western elevation are relatively intact and original (c.1890) despite the alterations and additions conducted which are partially visible from this elevation. This includes the enclosure of the entrance gablet and the north-eastern sunroom/ veranda enclosure (c.1958) and the sunroom extension to the south (c.1930). Of particular note are gabled roof, turned timber posts, veranda and weatherboards. It is a primary elevation, facing The Terrace.

The three chimneys which were once visible from this elevation, are no longer extant, which has reduced the profile of the cottage from this elevation. The windows have been boarded up.

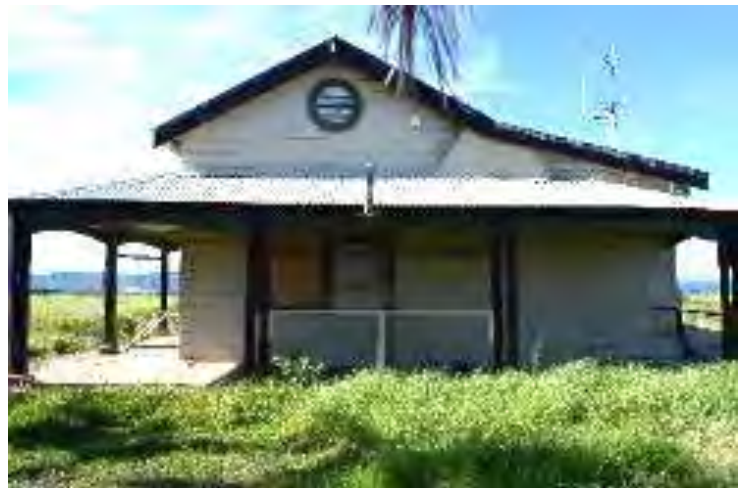
Moderate

The later additions that are visible from this elevation are considered of moderate significance and can only marginally be seen. The circular vent in the gable end is also a later addition, having been installed post 1976 (Figure 247).

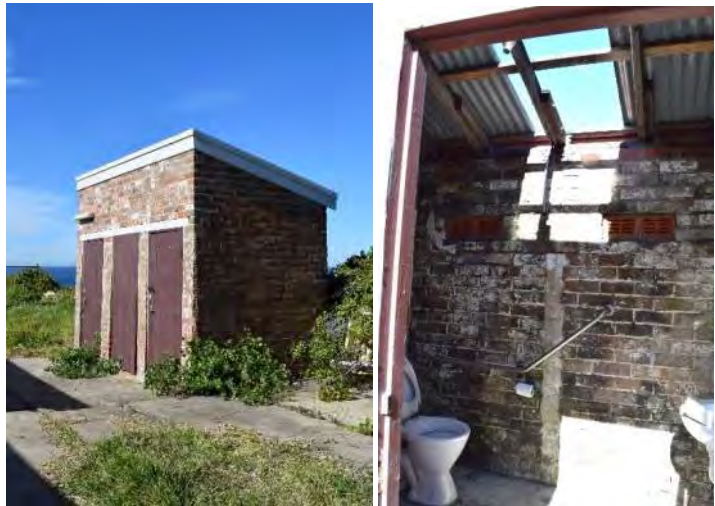
Out  
Building

Little

The ancillary out building/ toilet is a later addition dating from c.1890, the original construction. However, modifications have been made to the structure and have impacted on original fabric. The structure now contains toilet facilities from the 1990s.

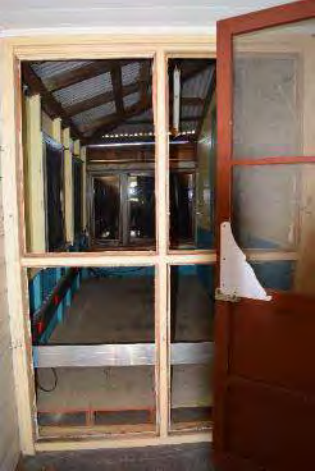
Little	The portico entrance has been modified significantly as a result of asbestos removal works conducted and damage caused by the April 2015 storm. As seen in the picture to the right, the wall dividing the enclosed veranda section has been removed and only the timber frames remain. The infill also dates

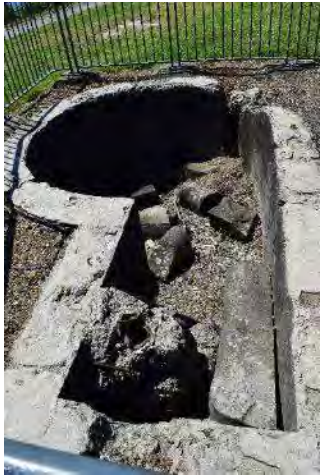
Left DRF Station	High	The left DRF station is partially infilled with rubble and other materials which has raised the depth of the pit. The concrete walls are original while the protective railing is a later addition.

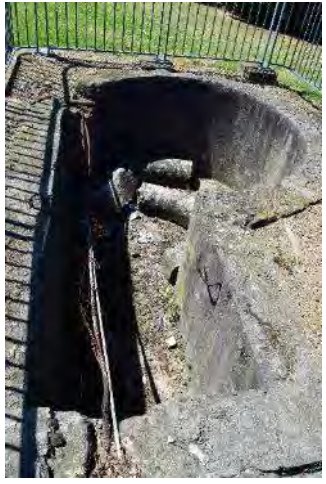
Tunnels - General	Exceptional	It is evident that they are relatively unchanged, however, have been significantly impacted by graffiti and the walls have somewhat deteriorated. The original layout appears to be relatively intact.

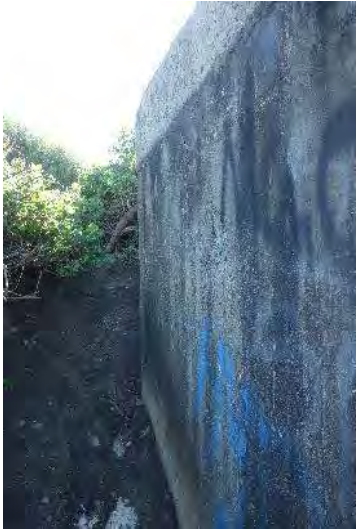
Building/ Site Element	Significance	Commentary	Photo
Southern Elevation	High	While somewhat obscured from view due to the vegetation surrounding the Park Battery, no.1 gun and bunker Structure, the southern elevation remains intact and relatively unchanged excluding the contemporary graffiti present. It reflects the simple design employed to reduce the prominence of the structure from the sea although is less descriptive than the other elevations. It is therefore considered to be of High significance.

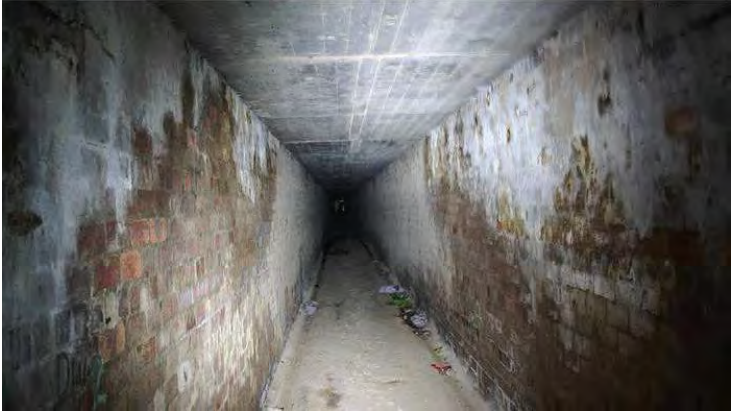
No.1 Searchlight	Exceptional	The No.1 Searchlight is considered of exceptional significance due to its prominent location, views possible along the coast and to the sea and its association with other defence structure constructed during World War II. In addition, the simple geometric design and concrete construction is considered of particular note, reflecting the requirements of defence structures at the time.

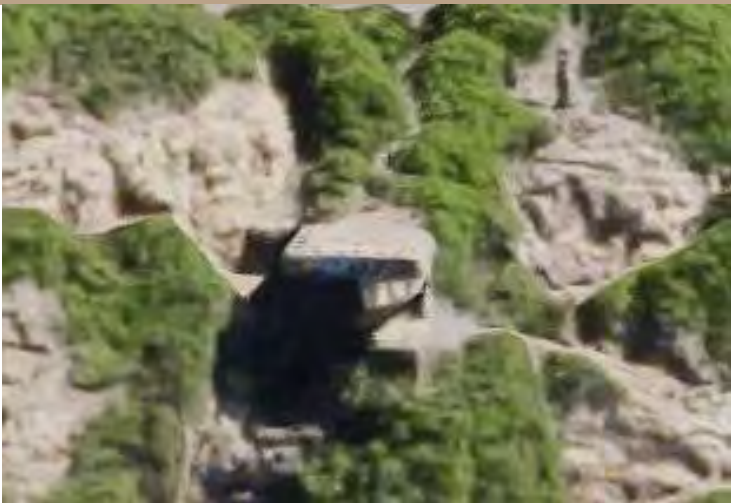
Exceptional	The grounds of the No.1 Searchlight are of exceptional significance due to its location along the coast of Newcastle, topographical benefits and views. It is for these reasons the site was chosen for defence purposes.	
	Little	The grounds of the Searchlight Engine Room have been significantly modified, having been developed for residential purposes. The context of the Searchlight Engine Room and the setting as therefore been lost.

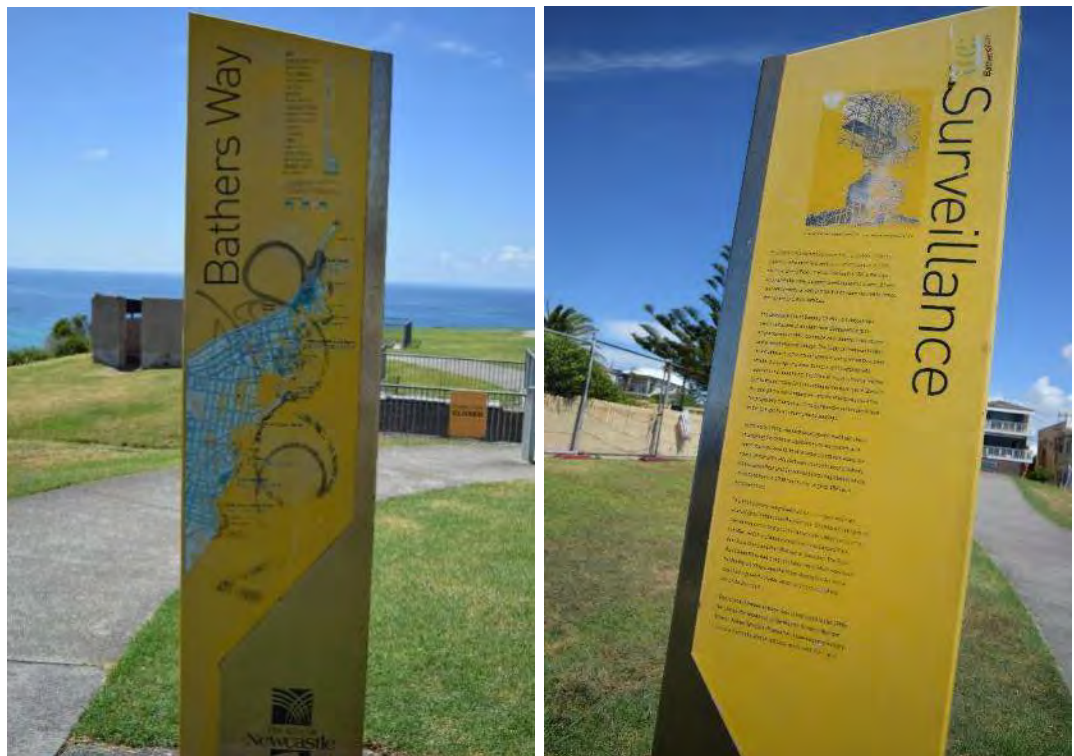
Figure 226: Existing interpretation sign present at 41 The Terrace between the cottage and the gun emplacement built elements. The sign is strategically placed along the pedestrian path that continues east towards the Battery Observation Post.

The following images provide an overview of the heritage interpretation currently in place at 41 The Terrace (Figure 226 and Figure 227).

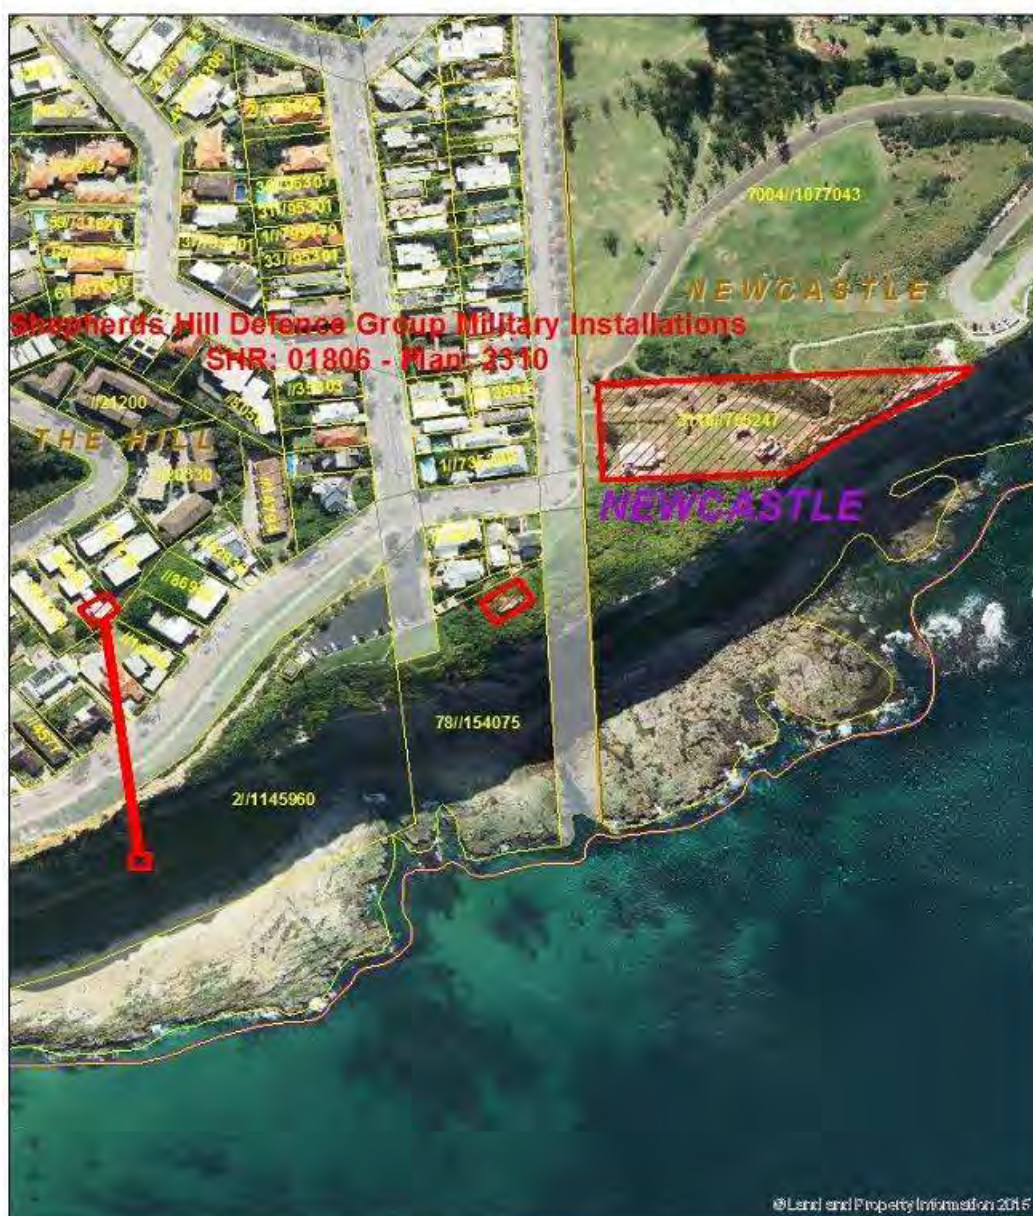
State Heritage Register - SHR 01806, Plan 2310  
Shepherds Hill Defence Group Military Installation  
41 The Terrace, Newcastle

Figure 228: State Heritage Register curtilage map for the Shepherds Hill Defence Group Military Installations. The sites incorporated in the listing are hatched in red. (Source: State Heritage Register form for the Shepherds Hill Defence Group Military Installations, accessed 11 September 2017 via <http://www.environment.nsw.gov.au/heritageapp/ViewHeritageItemDetails.aspx?ID=5061075>)

The physical curtilage of the overall Shepherds Hill Defence Group Military Installations site is defined by its SHR listing curtilage as detailed in the table below and Plan in Figure 228. The statutory curtilage for a heritage item is usually restricted to the lot or lots on which the item is located but the visual curtilage or setting can be much larger and is often critical to conservation of the setting of the item. There are strong visual links between Shepherds Hill, Fort Scratchley and Nobbys that are an important part of their significance for maritime communication and coastal defence.

- Policy 47 The physical curtilage of the overall Shepherds Hill Defence Group Military Installations is defined by its SHR curtilage (see Figure 228 ). Any new works should be designed in a way so it can be reversed if required. It must allow for the preservation and legibility of significant spaces and be readily identifiable as new work.

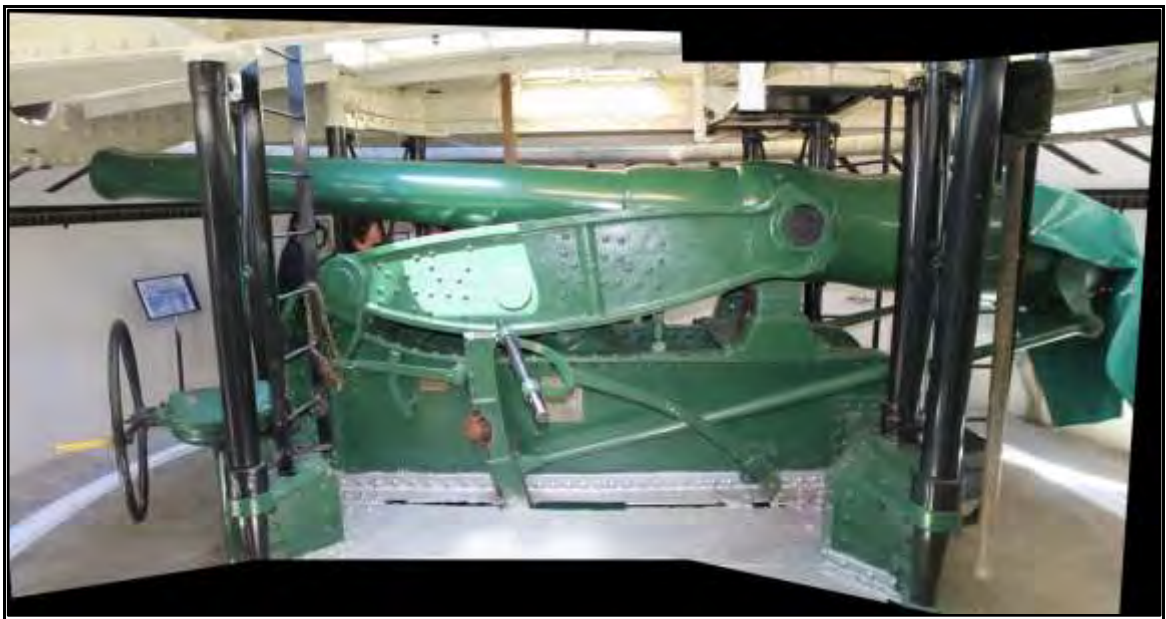
Figure 4: Preserved and restored BL 6-inch Mk V gun on hydro-pneumatic carriage, Tairaroa Head, Otago, New Zealand

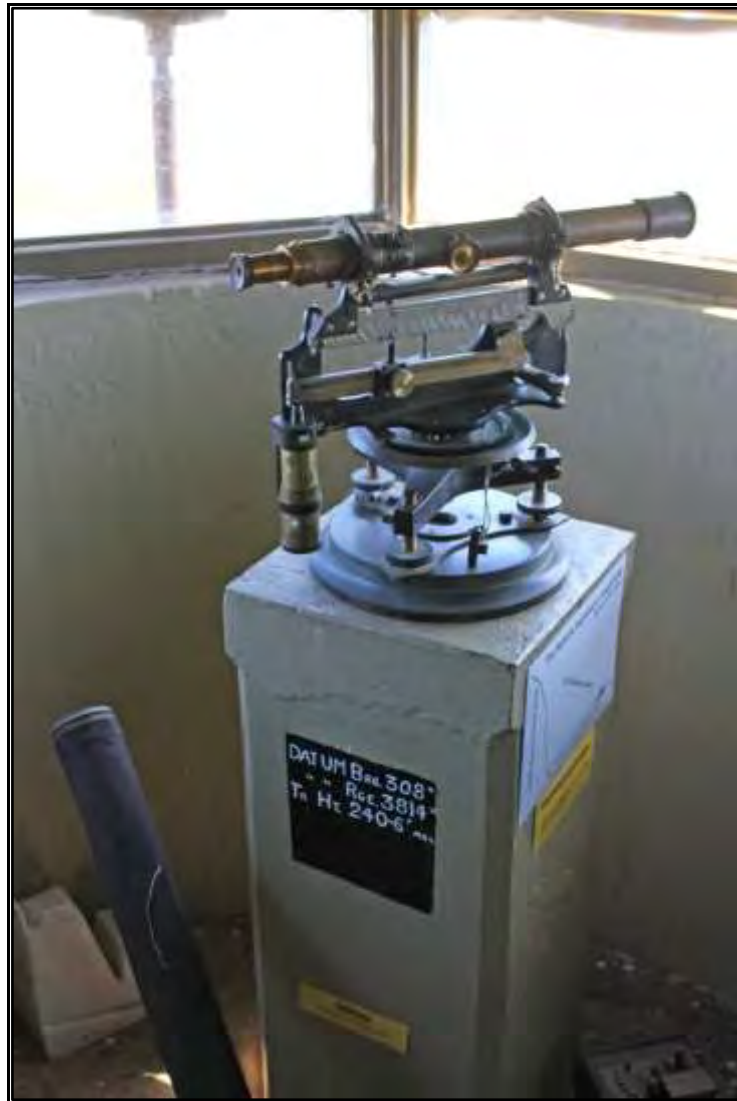
Figure 5: Depression Range Finder restored on concrete mounting Taiaroa Head, Otago, New Zealand (note the datum figures on the mounting for quick reference)

The Watkin depression range finder (DRF) was a device, not unlike the standard Surveyors' theodolite of the time that measured the range and azimuth of the target (Figure 5). It relied on the precise height of the DRF above the sea being known (including a measurement of the tide) and that the waterline of the target could be seen. Provided all went well, then the range and bearing to the target would be calculated and the gun pointed and elevated accordingly.

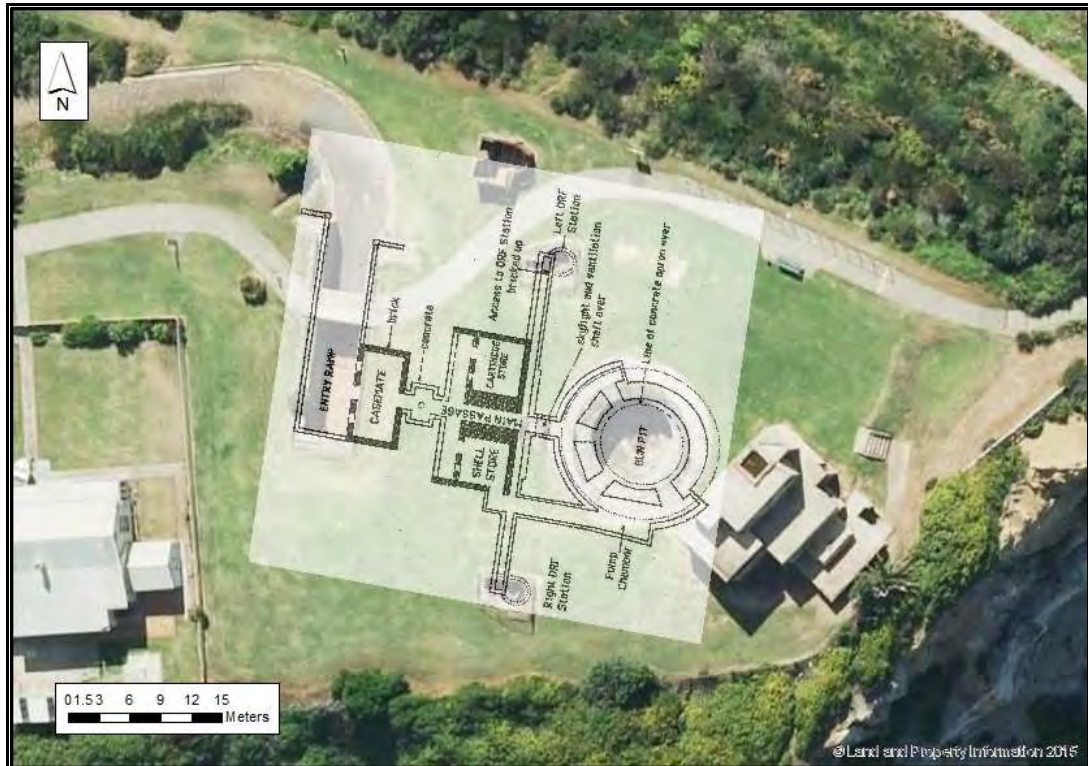
Figure 7: Gun emplacement features overlain on aerial image of the site

The names of the buildings, structures and features are from the Browne Conservation Management Plan (1984) for consistency; although the term “store” has been changed to “magazine” to reflect appropriate usage (see Figures 7, 8 and 9).

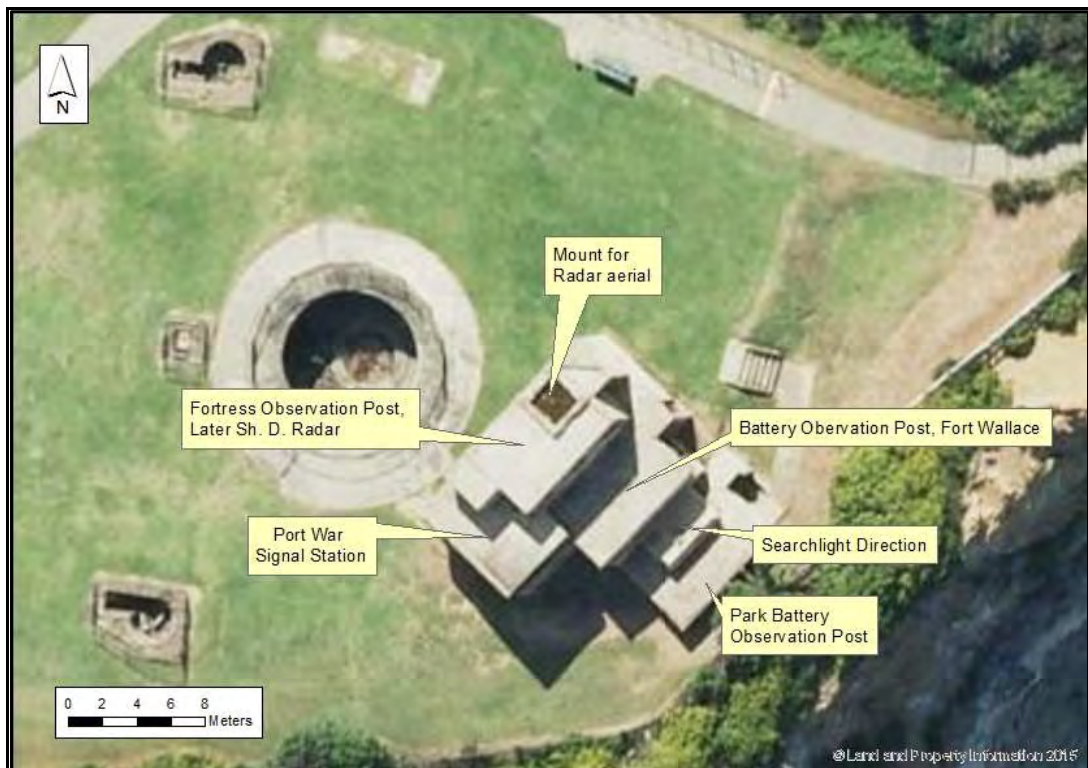
Figure 8: Features of the observation post

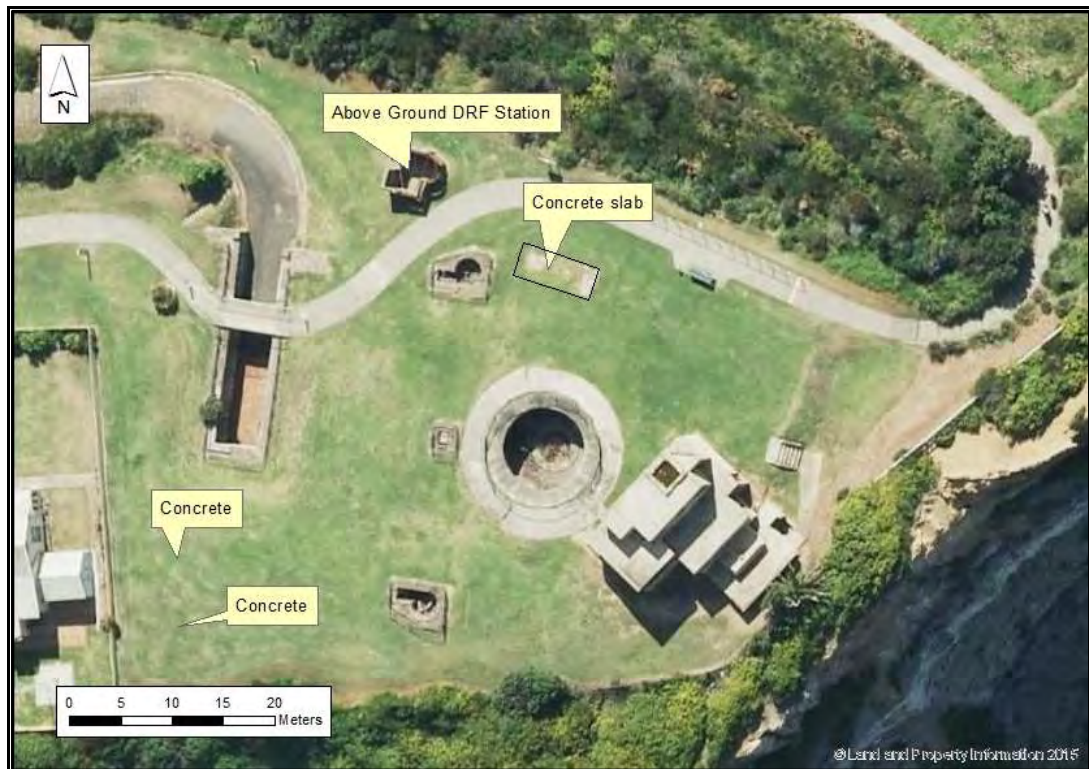
Figure 9: Other site features

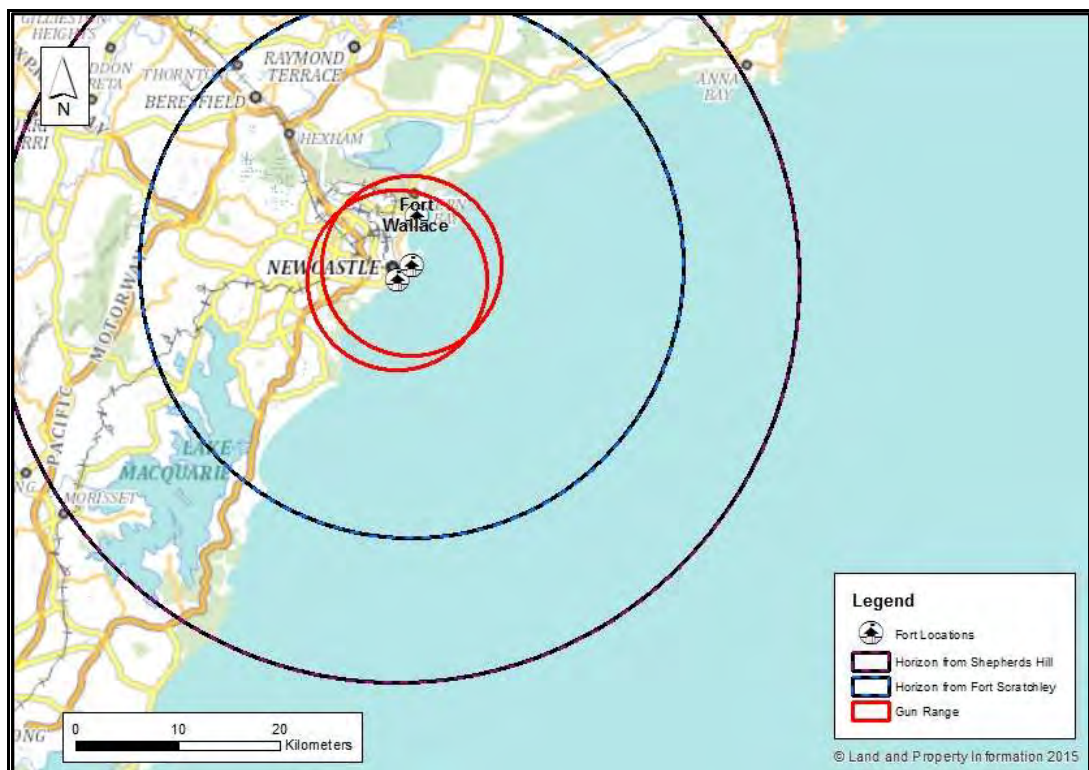
Figure 10: Horizon and gun ranges from Shepherd Hill and Fort Scratchley

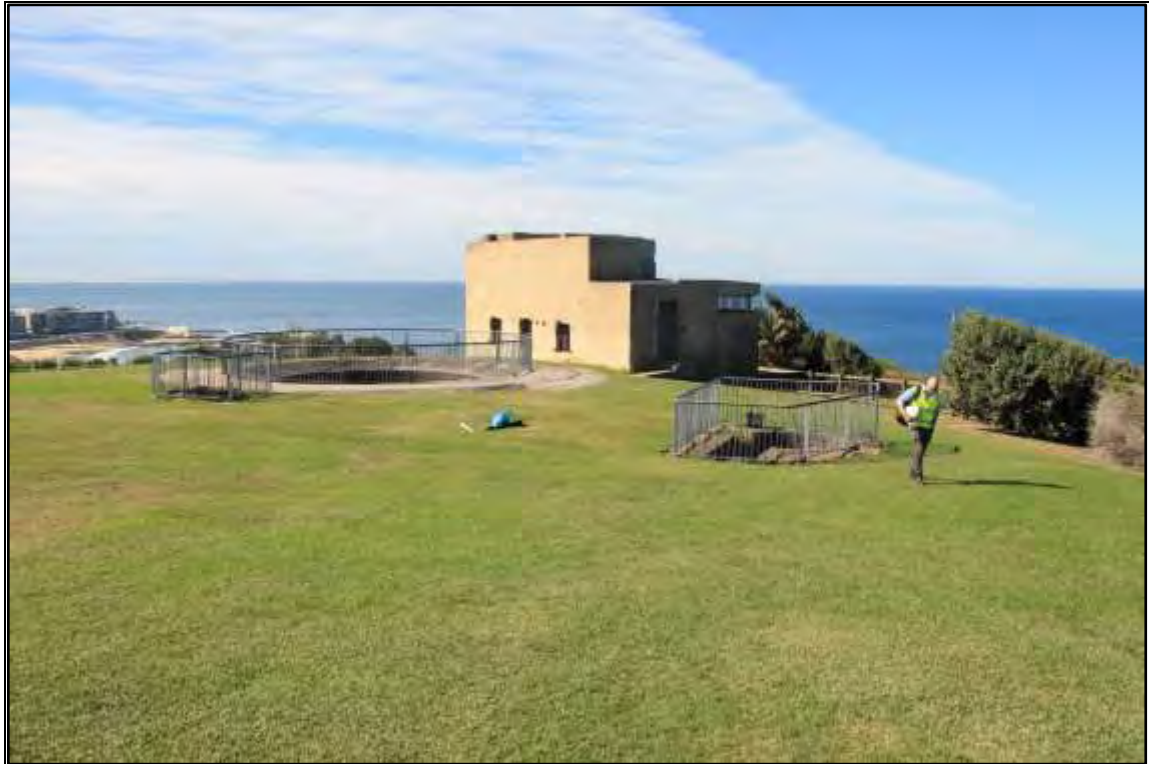
Figure 11: Looking NNE across the site showing the south DRF station, the gun emplacement and the observation post

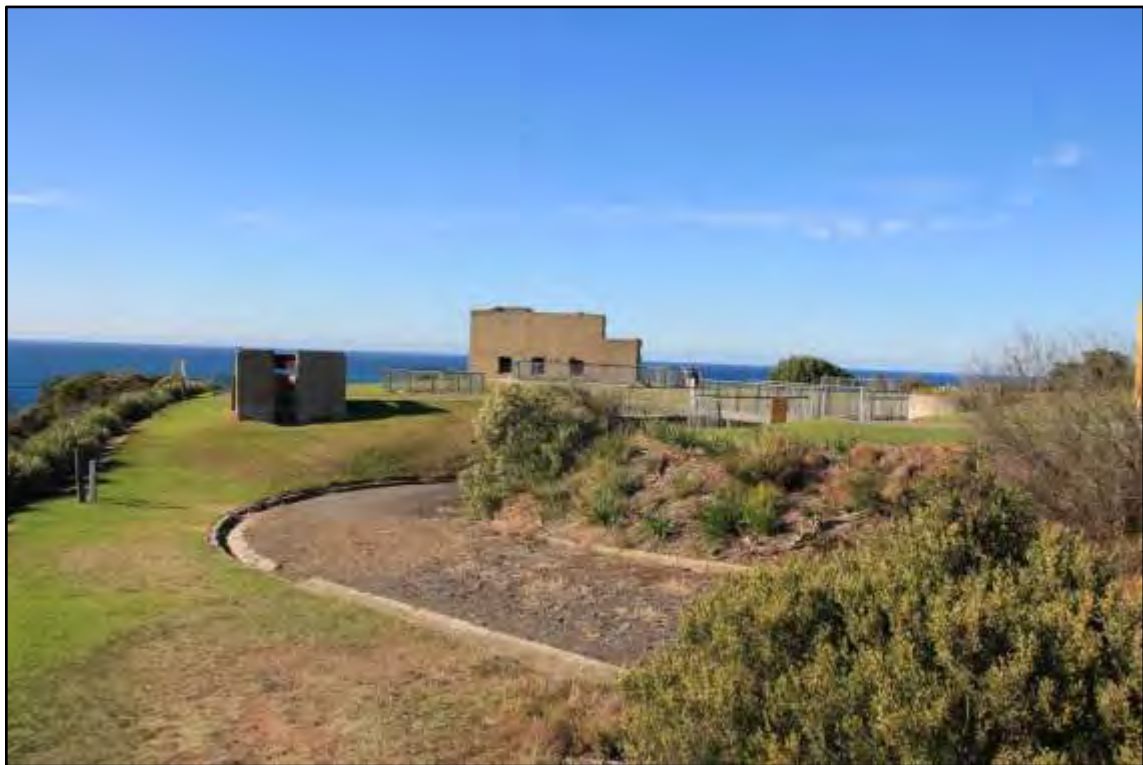
Figure 12: Looking east across the site showing the entrance to the magazines and the above ground DRF Station

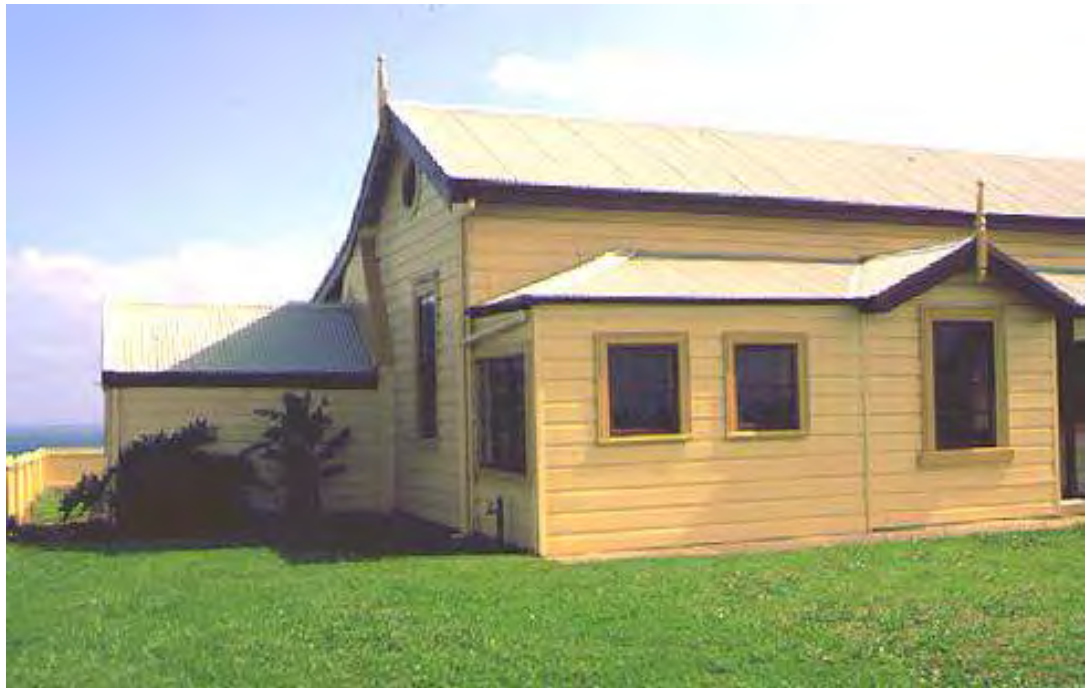
Figure 247: Photograph of the cottage at Shepherds Hill from 1976. The previously destroyed chimney can be seen, circled in red. (Source: Newcastle Region Library, no. 005 000472)

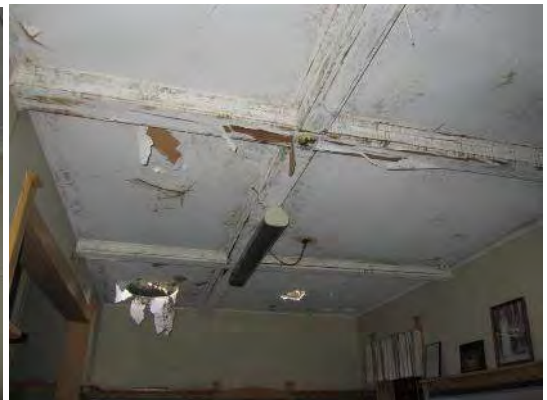
Figure 251: Photographs of the interior of the cottage taken shortly after the April 2015 storm. The first photograph is of Bedroom 2 while the second photograph is of the dining room. (Source: photographs taken by John Carr and provided by Newcastle City Council)

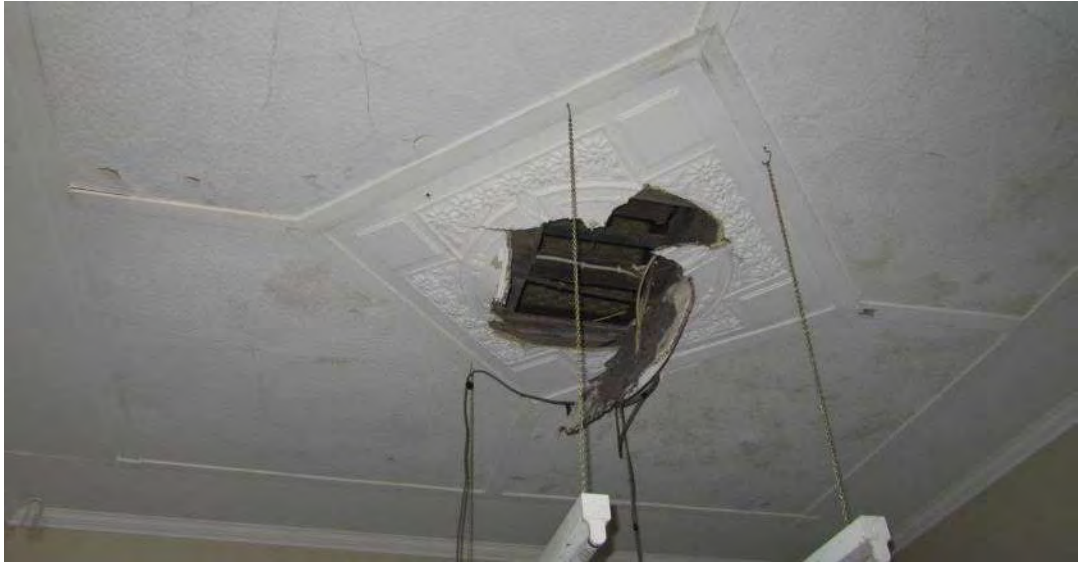
Figure 252: Photograph of the ceiling of the living room showing the damage caused by the storm. (Source: photographs taken by John Carr and provided by Newcastle City Council)

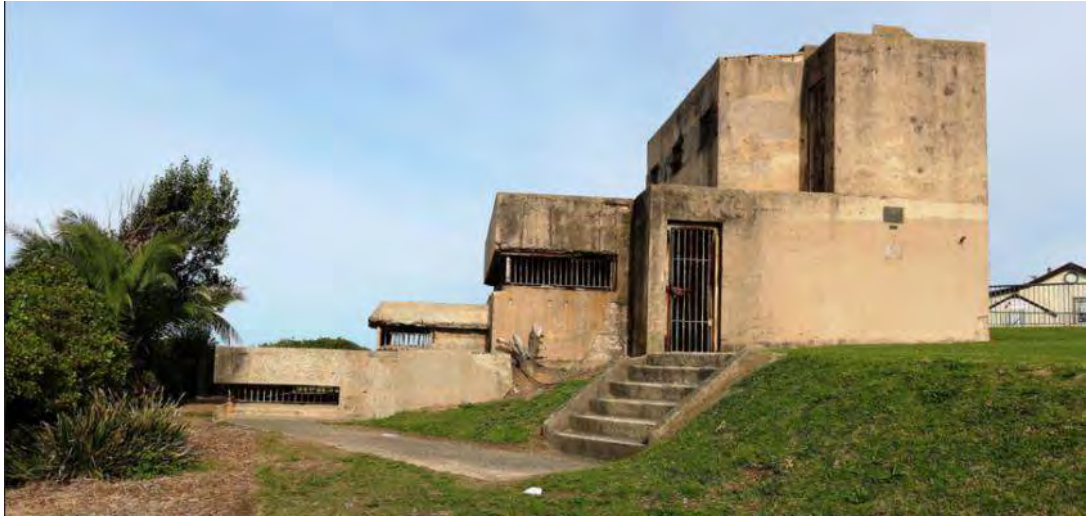
Figure 255: Photograph of the Observation Post and gun pit looking east. By Grant White in 1998. (Source: Newcastle Region Library, no ID number)

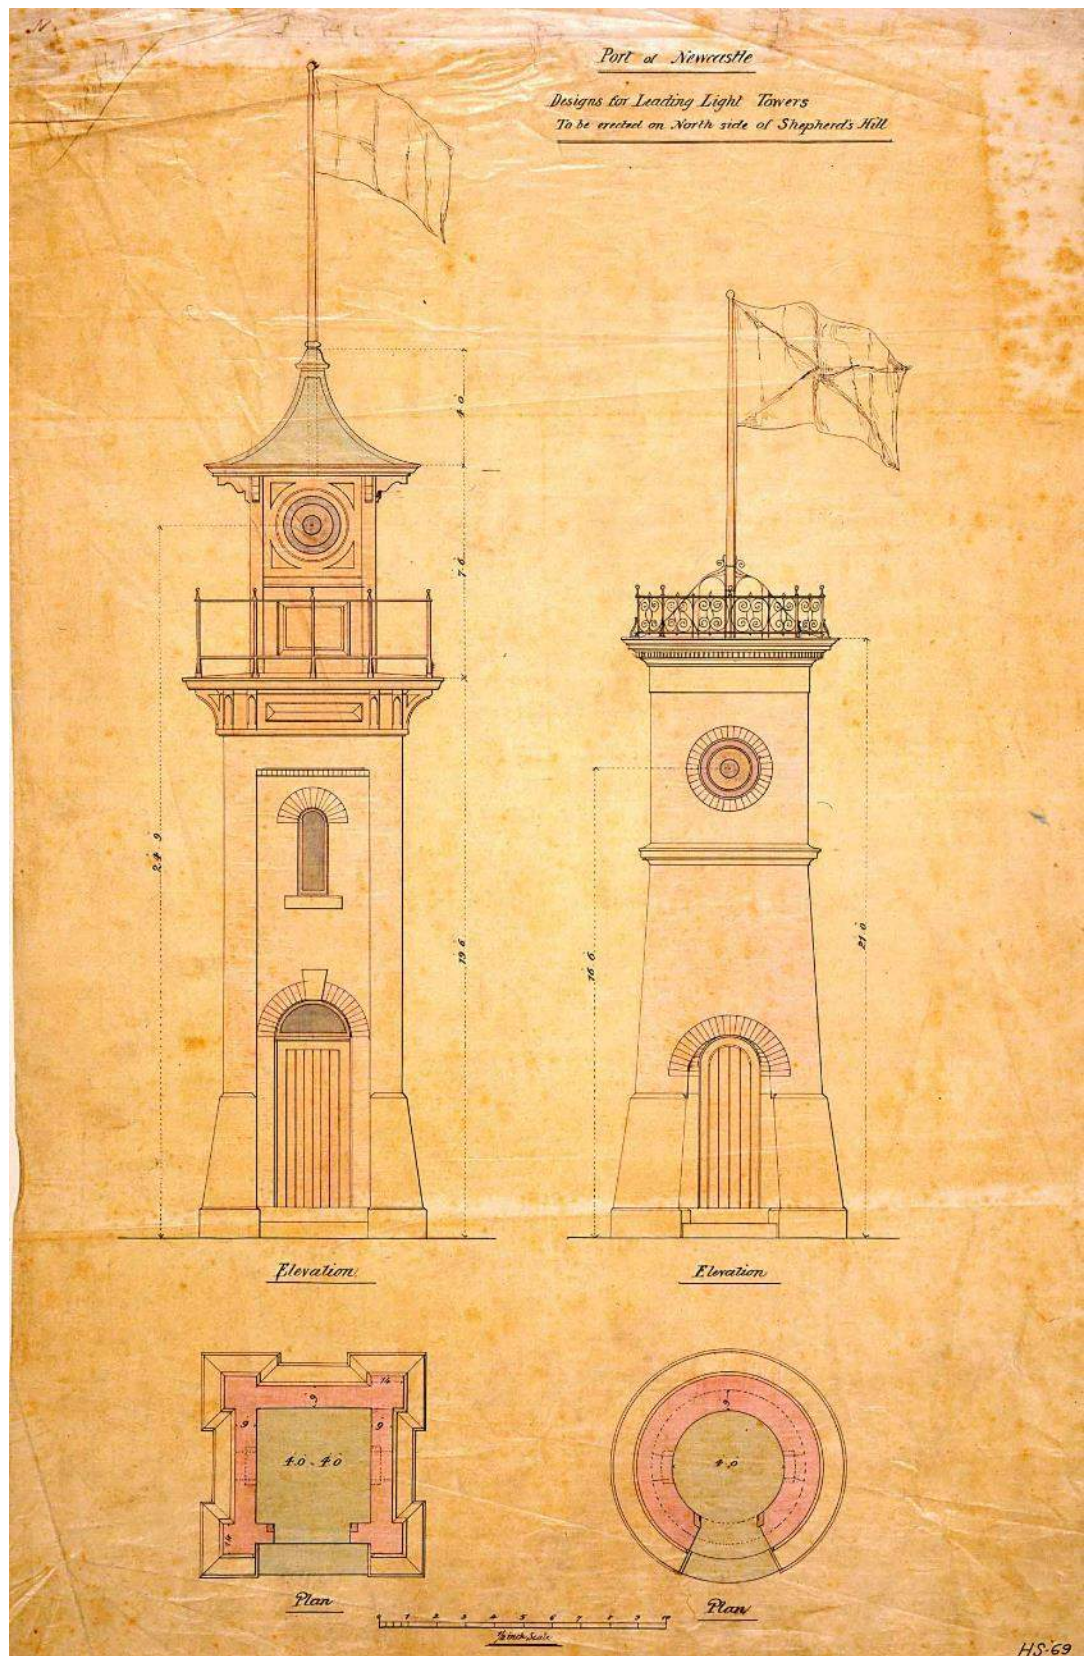
Figure 261: Drawings of two leading light towers proposed for erection on the northern side of Shepherds Hill site. The plans were not executed and are dated c.1875, prior to the construction of the gun emplacement and cottage. (Source: National Archives of Australia, series no. A9568)
