## Conservation Management Plan

Shepherds Hill Defence Group Military Installations  
SHR # 01806

41 The Terrace, Newcastle and 65 Nesca Parade, The Hill

Submitted to the Council of the City of Newcastle

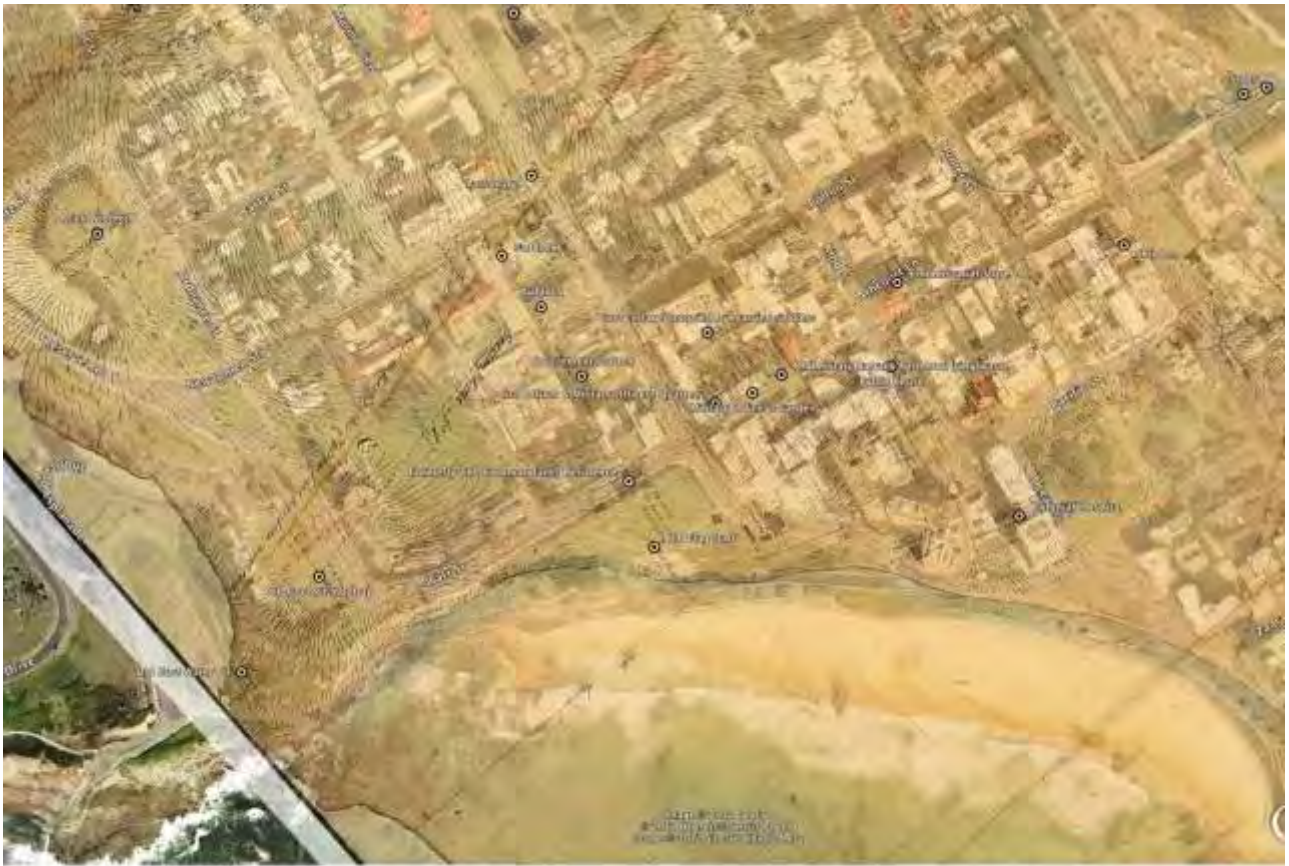
**Plan of the Town of Newcastle New South Wales shewing it's present actual state with part of the adjoining Country, and the coal works of The Australian Agricultural Company from a Careful Survey in 1830 by Jno. Armstrong.**  
(Courtesy Alexander Turnbull Library, National Library of New Zealand)

The image above is an overlay of a section of John Armstrong's 1830 map of Newcastle with Google Earth, providing an overhead view of the same scene depicted in the painting some years later. Again click the image for a greater detail. Various features identified in the 1830 map are pin pointed in the modern overlay.
