Hunter Coast and Estuary Management Committee

January 2003

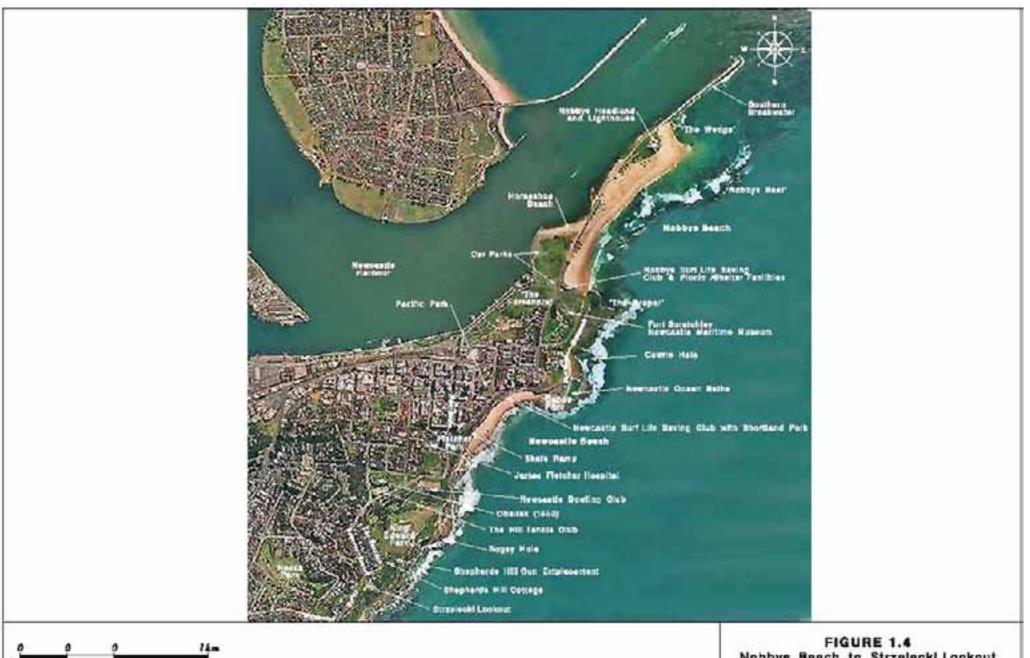
Umwelt (Australia) Fig Limited Source: Courtel Surveillance Aerial Photo 1999 Nobbys Beach to Strzelecki Lockout Coastal Features

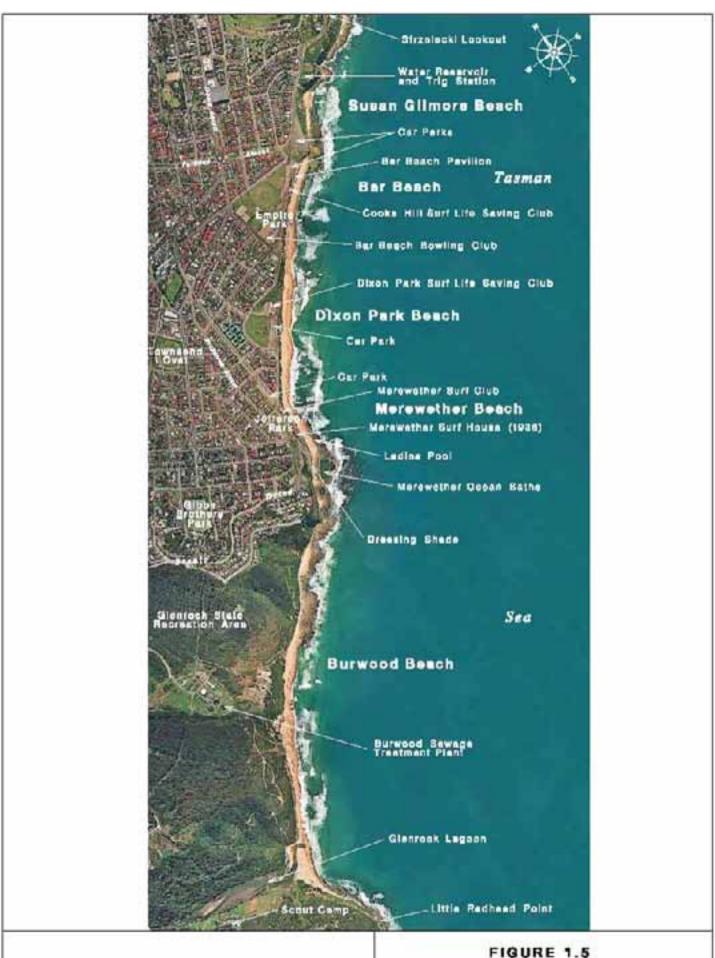
Umwels (Averralla) Pry Limited Jource: Cassial Surveillance Aerial Photo 1999 FIGURE 1.5 Strzelecki Lookout to Glenrock Lagoon Coastal Features

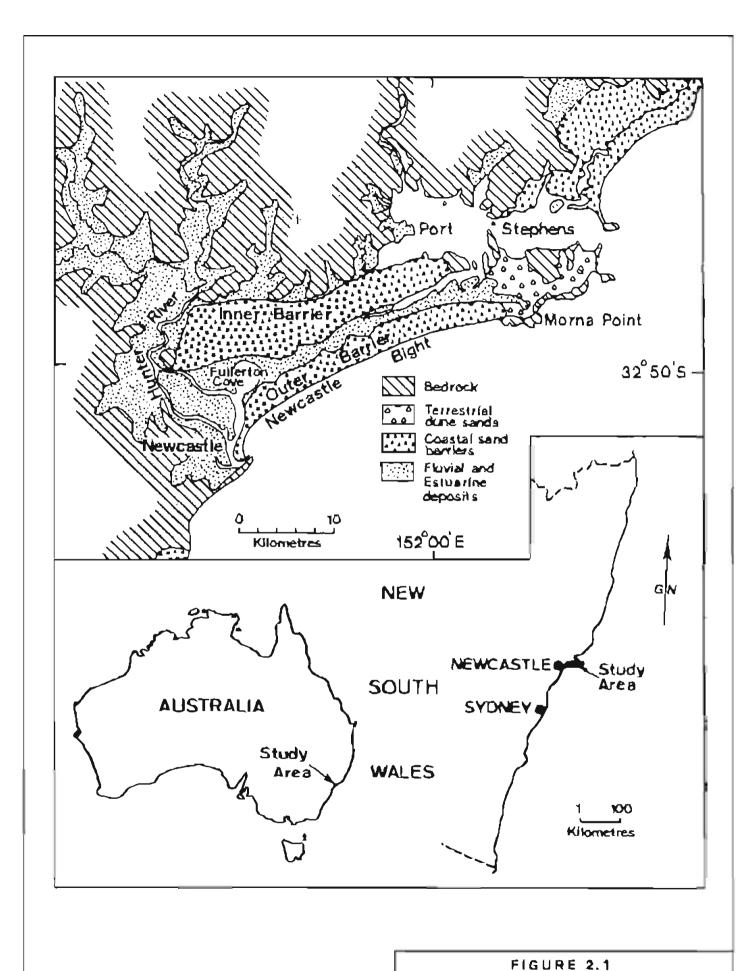
Locality Plan Depicting the Geological Sadimentary Features of the Newcastle Region

At maximum sea level rise (6,500 years ago) sand barriers linked Nobbys Head and Birubi Point, creating an extensive coastal lagoon between the Hunter River and Port Stephens (**Figure 2.1**). Continued deposition by the Hunter River gradually infilled the coastal lagoon leaving Tilligerry Creek and Fullerton Cove as the last remnants of the former lagoon. Wave action in Stockton Bight continued to bring sand onshore, and some sand was blown off the beach to form mobile dunes. The barrier beach and dune system is known as the Outer Barrier (**Figure 2.1**). Another, older sand mass known as the Inner Barrier (or Tomago Sandbeds), formed by a similar process about 120,000 years ago, when sea level was approximately 5 metres higher than it is today.

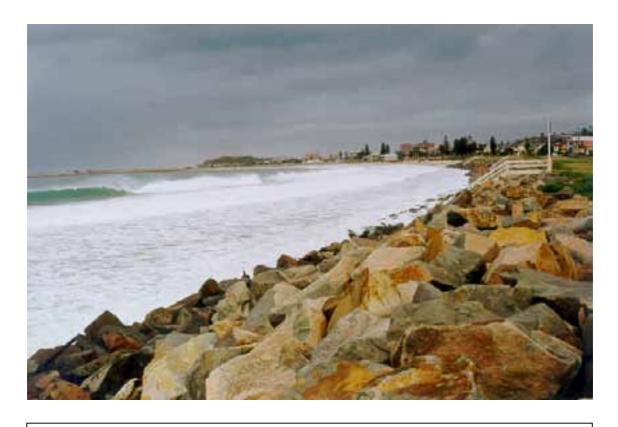
Plate 3
Mitchell Street seawall at Stockton Beach looking south.
Part of the Newcastle skyline is in the background. (Source: WBM Oceanics Australia)

The northern breakwater is a key aesthetic element and popular for its Shipwreck Walk and fishing. The ocean beach has been severely eroded north of the Caravan Park and protective seawalls have been provided in places. This beach erosion has had a significant impact on the aesthetic appeal of Stockton (see **Plates 3** and **4**).

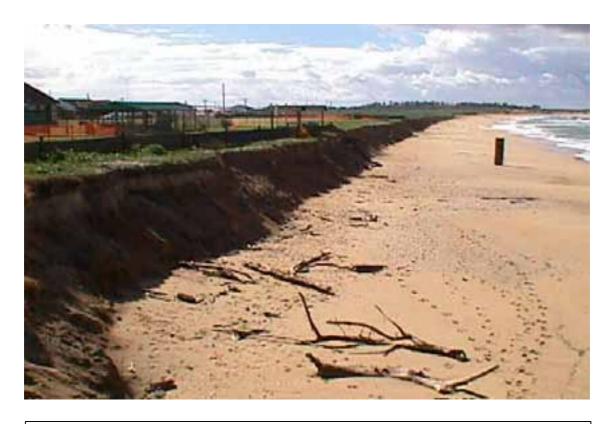
Plate 4
Stockton Beach (1998) looking north from the end of the Mitchell Street seawall past the North Stockton Day Care Centre. (Source: WBM Oceanics Australia)

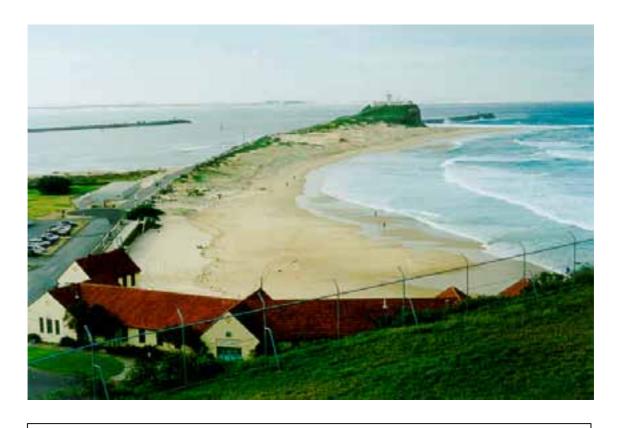
Plate 5

Nobbys Beach and Head (1998). The northern breakwall can be seen in the top left and behind that is Stockton Bight. (Source: WBM Oceanics Australia)

Nobbys Beach has been created by the construction of the southern breakwater (see **Plate 5**). Earlier, the current shoreline was shallow water with rock outcrops. The beach has formed against the breakwater. The Foreshore (the reserve system on the southern side of Newcastle Harbour, extending from Nobbys Beach to the Honeysuckle Development in the west) has been created by reclamation for the port. The area is outstanding for its visual qualities. Nobbys Headland is described in the Heritage Places Plan of Management (POM) as ... "one of the most distinctive physical icons of the Lower Hunter and a potent symbol of the history of the Port of Newcastle...".

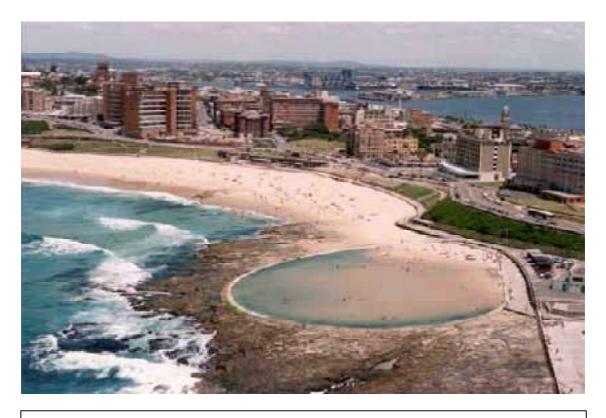
Plate 7

Newcastle Beach looking west over CBD and harbour in the background. Note one of Newcastle's many rock platforms in the foreground. (Source: Newcastle City Council)

Newcastle Beach, with its backdrop of tall buildings and predominantly paved surfaces, has a strong urban character unlike other Newcastle beaches (see **Plate 7**). Here the historic character has been largely replaced by a new urban character. This presents an area of intensive urban development and of strong visual character, at the edge of the City Centre, dominated by the tall buildings of the Royal Newcastle Hospital and residential units and motels on the beachfront. As recently as June 2001, another beachfront residential tower (the York) has been approved by Council in front of the Royal Newcastle Hospital's former north wing.

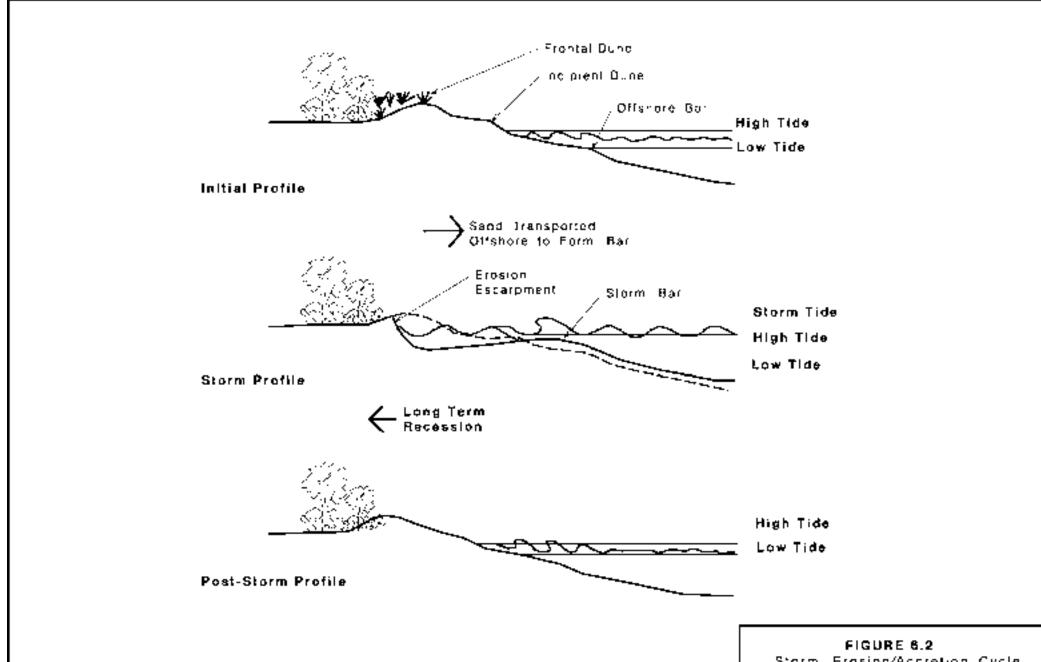
Storm Erosion/Accretion Cycle
(No Permanent Sand Loss)

However, in some instances, not all of the sand removed from the berm and dunes is replaced during the beach-building phase. Once the sand has been transported offshore into the surf zone, it may be moved alongshore under the action of waves and currents and out of the beach compartment. Some of the sand transported directly offshore during storms may become trapped in offshore reef systems thereby preventing its return to the beach. Other direct losses of material from the beach may include inland transport of sand under the action of onshore winds; this mechanism being called aeolian sand transport. Evidence of such action occurs at Stockton Beach and Stockton Bight. Over the longer term, should the

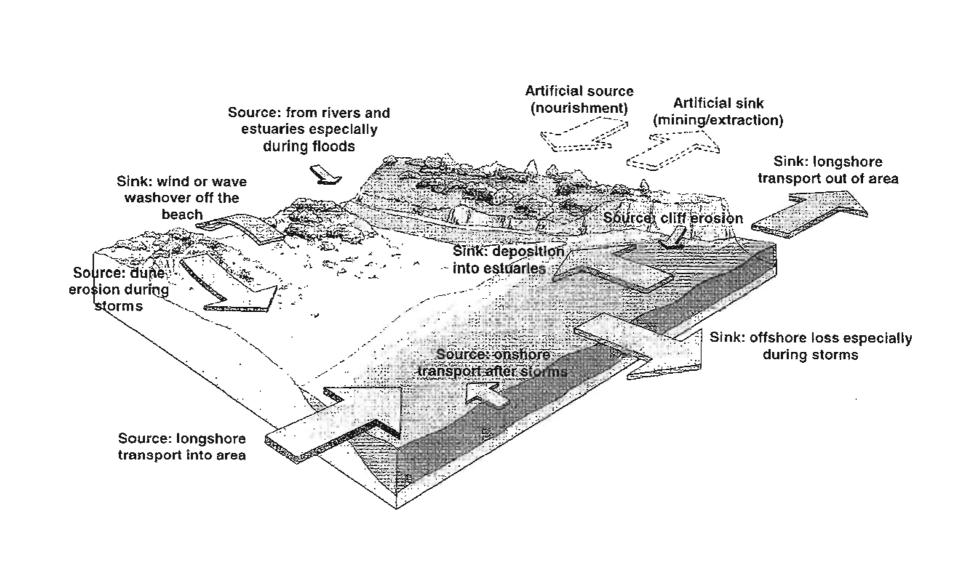
FIGURE 6.3

Typical Sediment Budget Diagram showing Possible Sources and Losses of Sand for a Beach

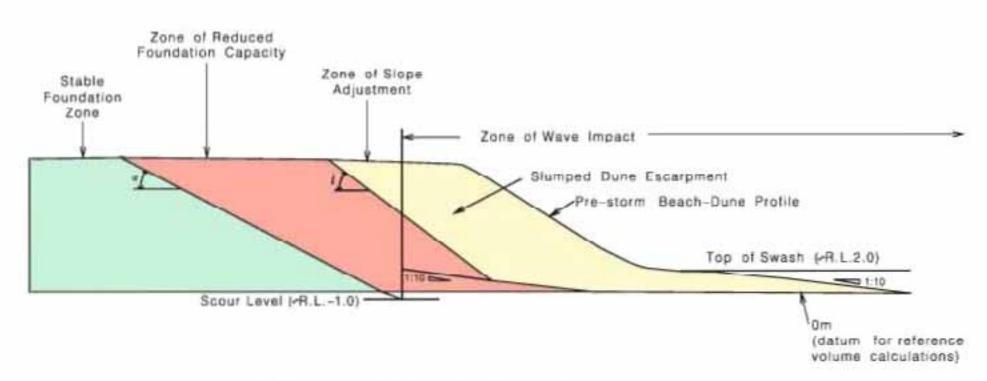
FIGURE 6.6

Angle of response of dune sand: $i \sim \phi \neq 34$ Safe angle of response of dune sand $\alpha = \tan^{-1}\{(\tan \phi)/1.5\} \neq 24$ All levels to AHD

For the same conditions, landward of the *Zone of Slope Adjustment* structures not adequately piled would be founded in a zone that could be considered to have an inadequate factor of safety (*Zone of Reduced Foundation Capacity*). Foundations for structures within this zone

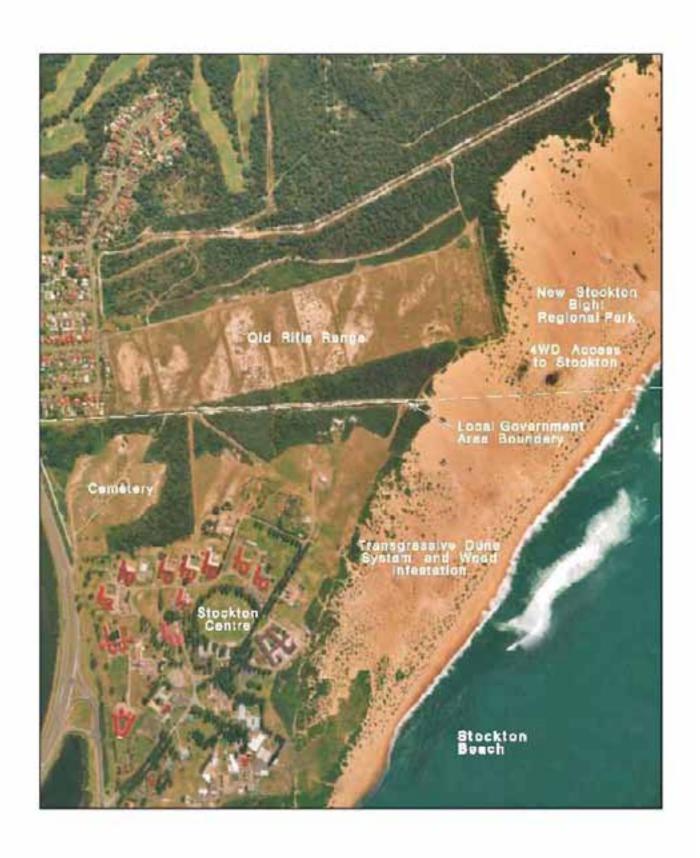
Umwelt (Australia) Pty Limited Photo Source: Courtel Surveillance Aerial Photo 1999 FIGURE 7.1
Newcaetie / Port Stephens Boundary
Management Issues

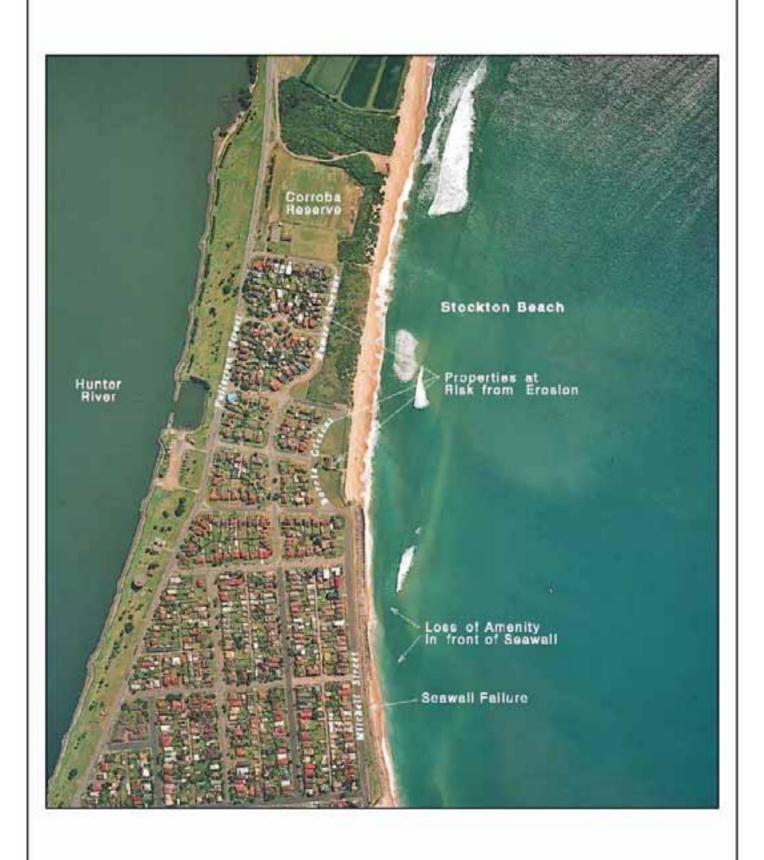
Umwelt (Australio) Pty Limited Photo Source: Coastal Surveillance Aerial Photo 1999 FIGURE 7.3 Stockton Beach (North of Seawall) Management Issues

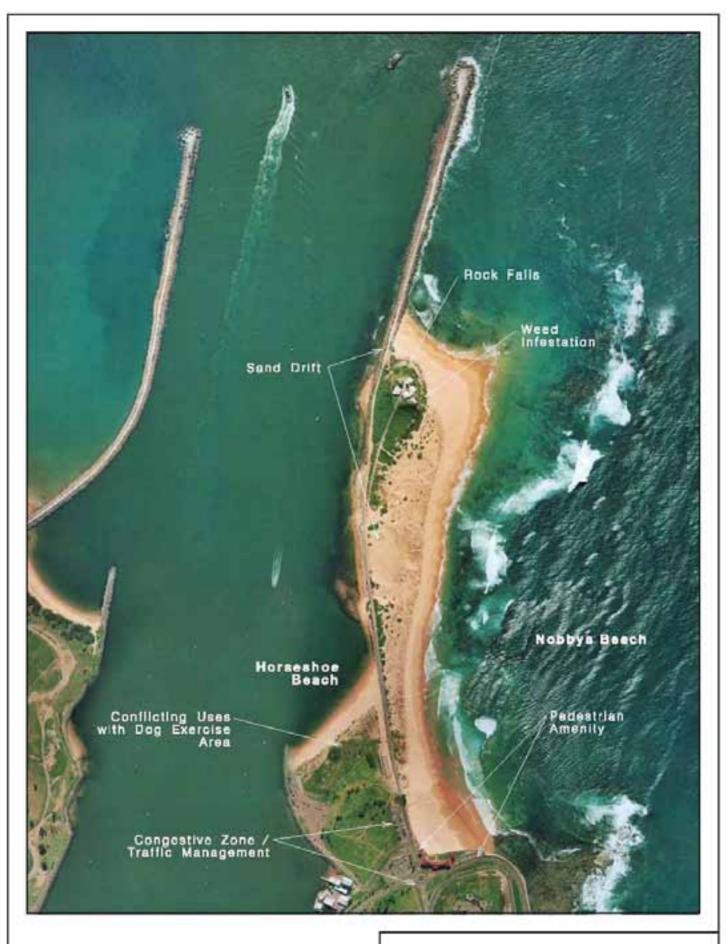
Umwelt (Australia) Pty Limited Photo Source: Contai Surveillance Aerial Photo 1999 FIGURE 7.5 Nobbys Beach Management Issues

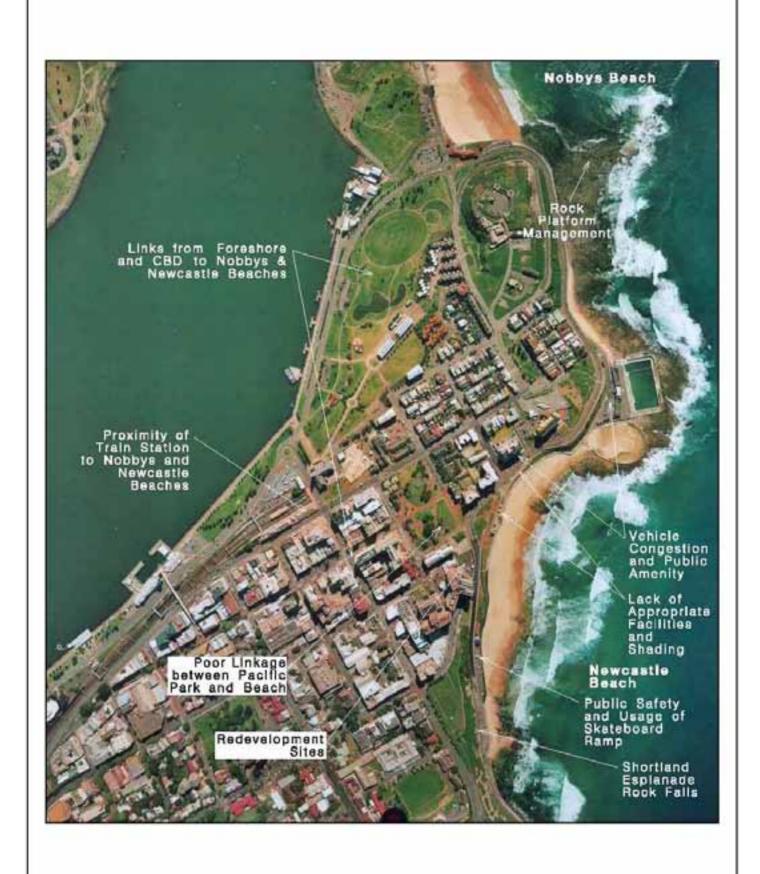
Umwels (Australia) Psy Limited Photo Source: Coastal Surveillance Aerial Photo 1999 FIGURE 7.6 Newcastle Beach Management Issues

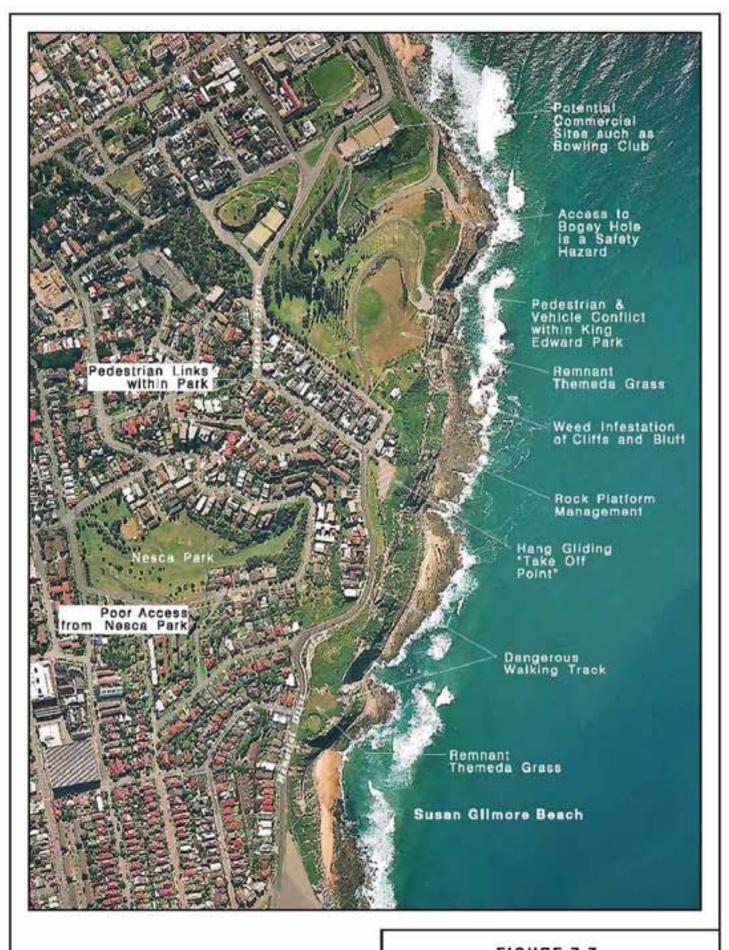
FIGURE 7.7 Shepherds Hill Management Issues

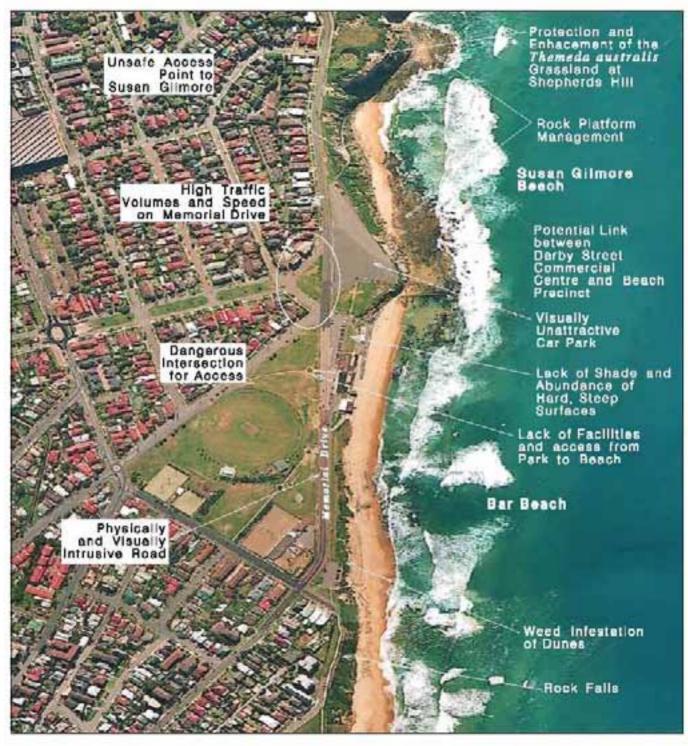
FIGURE 7.8

Bar Beach / Susan Gilmore Beach Management Unit - Coastal Features

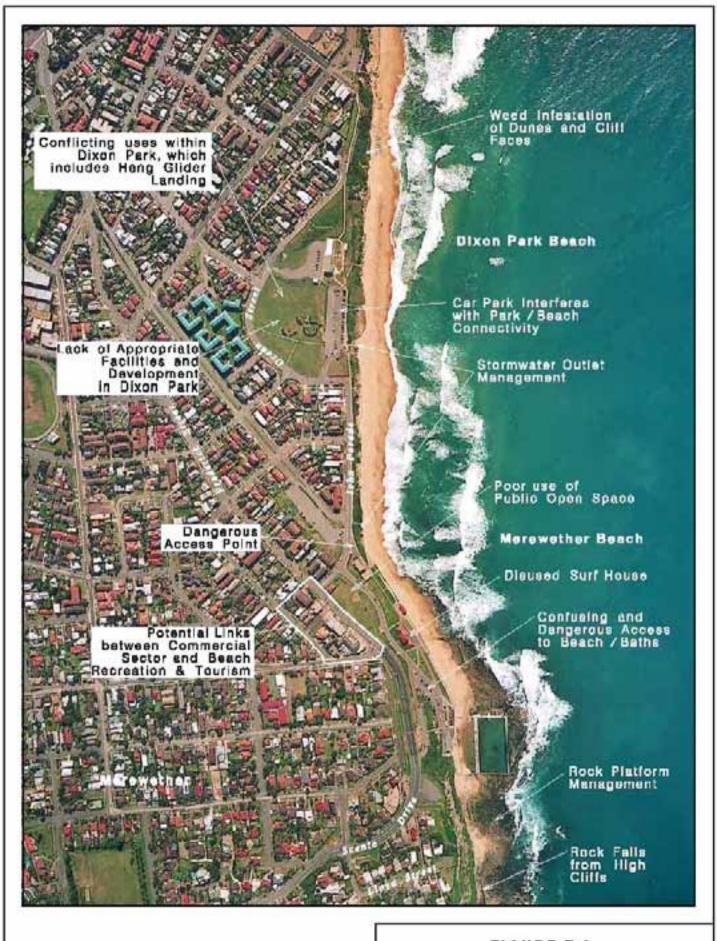
FIGURE 7.9

Merewether / Dixon Park Beaches Management Issues

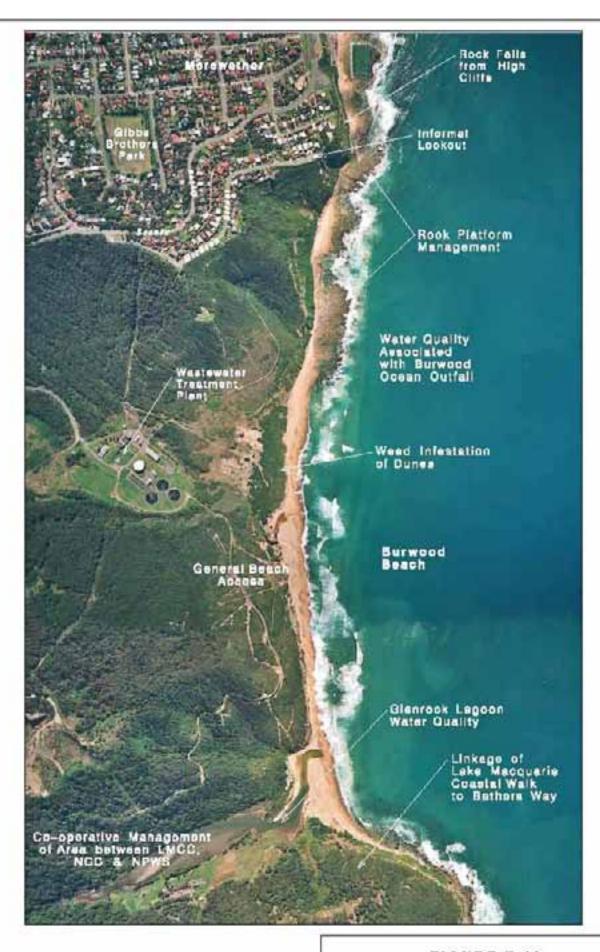
FIGURE 7.10 Burwood Beach Management Issues

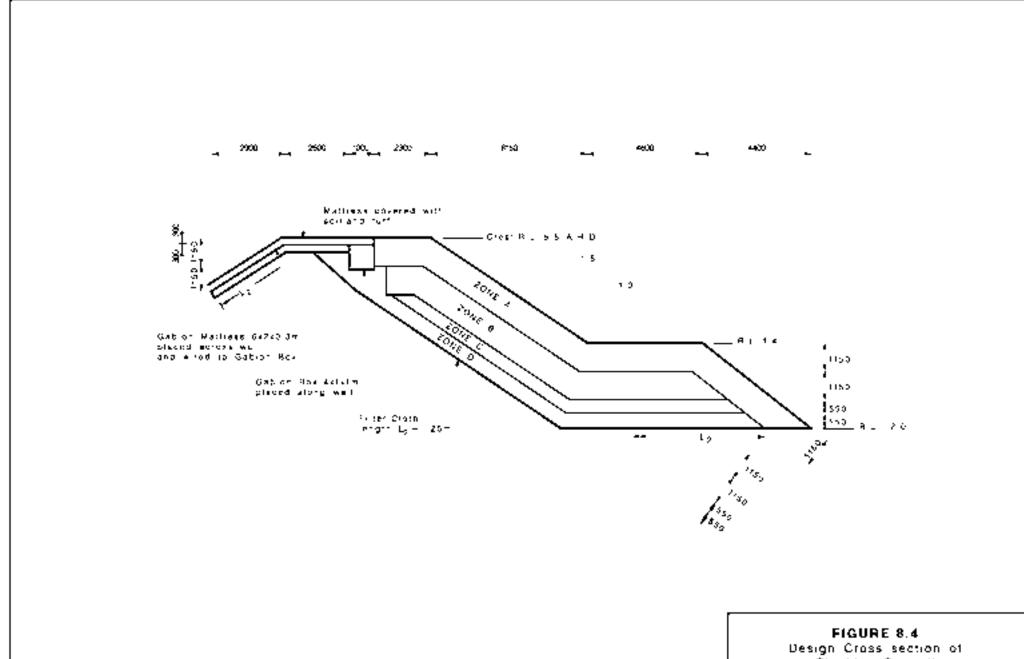
Design Crass section of Stocklon Seawall

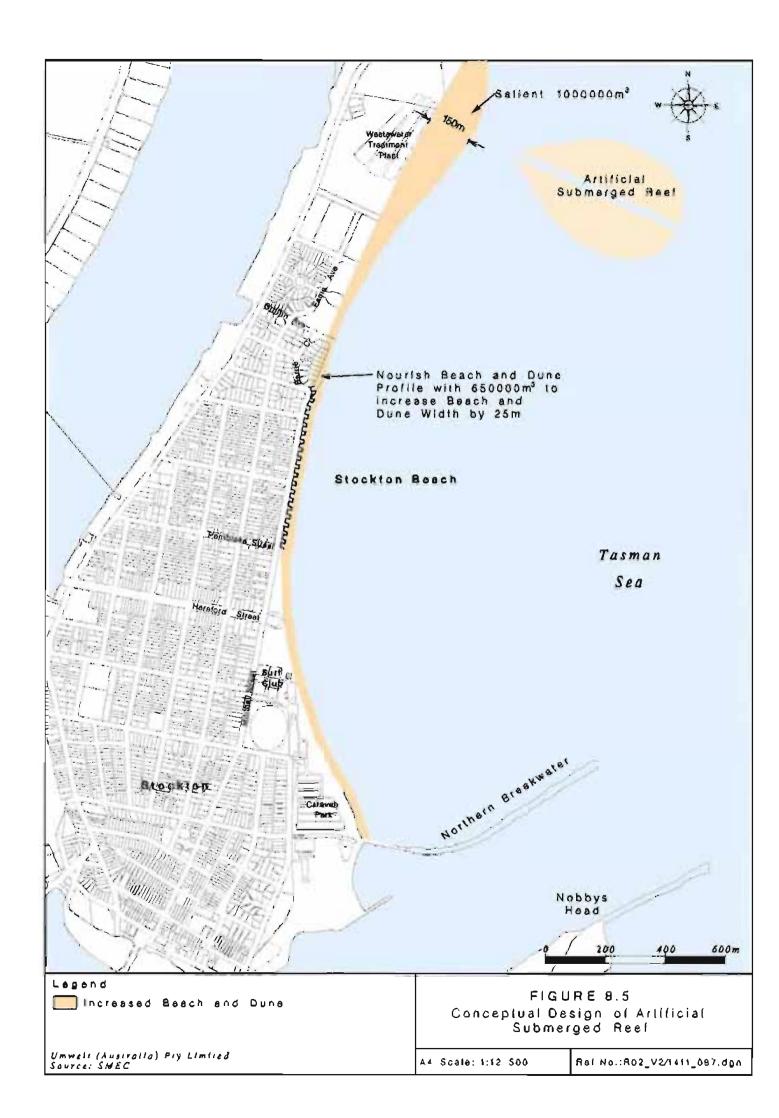
- Two smaller artificial submerged nearshore reefs (950,000 m³) at a capital cost of \$11.4 million with an ongoing maintenance cost of \$0.26 million (see **Figure 8.6**);
- Planned retreat which may result in the loss over the next 50 year period of approximately \$215 million in real estate and infrastructure along and adjacent to Stockton Beach as detailed in **Table 8.4** (see indicative **Figures 8.7** and **8.8**). Voluntary purchase may from part of the Planned Retreat option or couple with other options however, realistically only small numbers of properties may be able to be acquired over a number of years due to constraints on available funding;

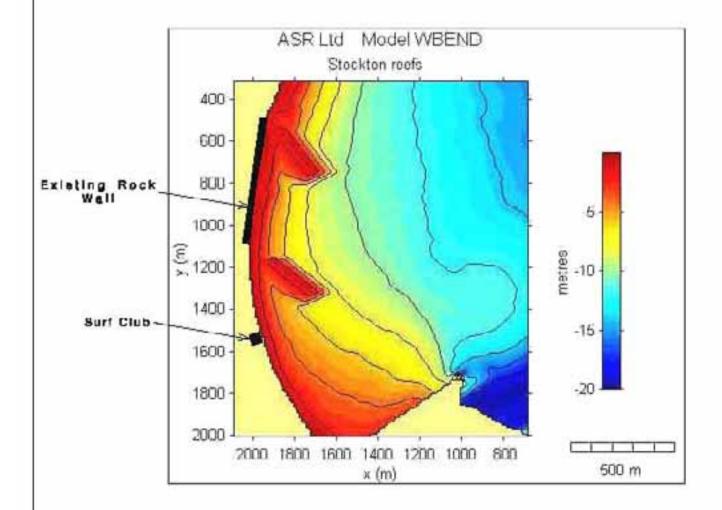
FIGURE 8.8
Conceptual Design of Two
Artificial Submerged Heets
