# Tree Failure Casebook History

Informing Tree Management in Newcastle

2000 - 2011

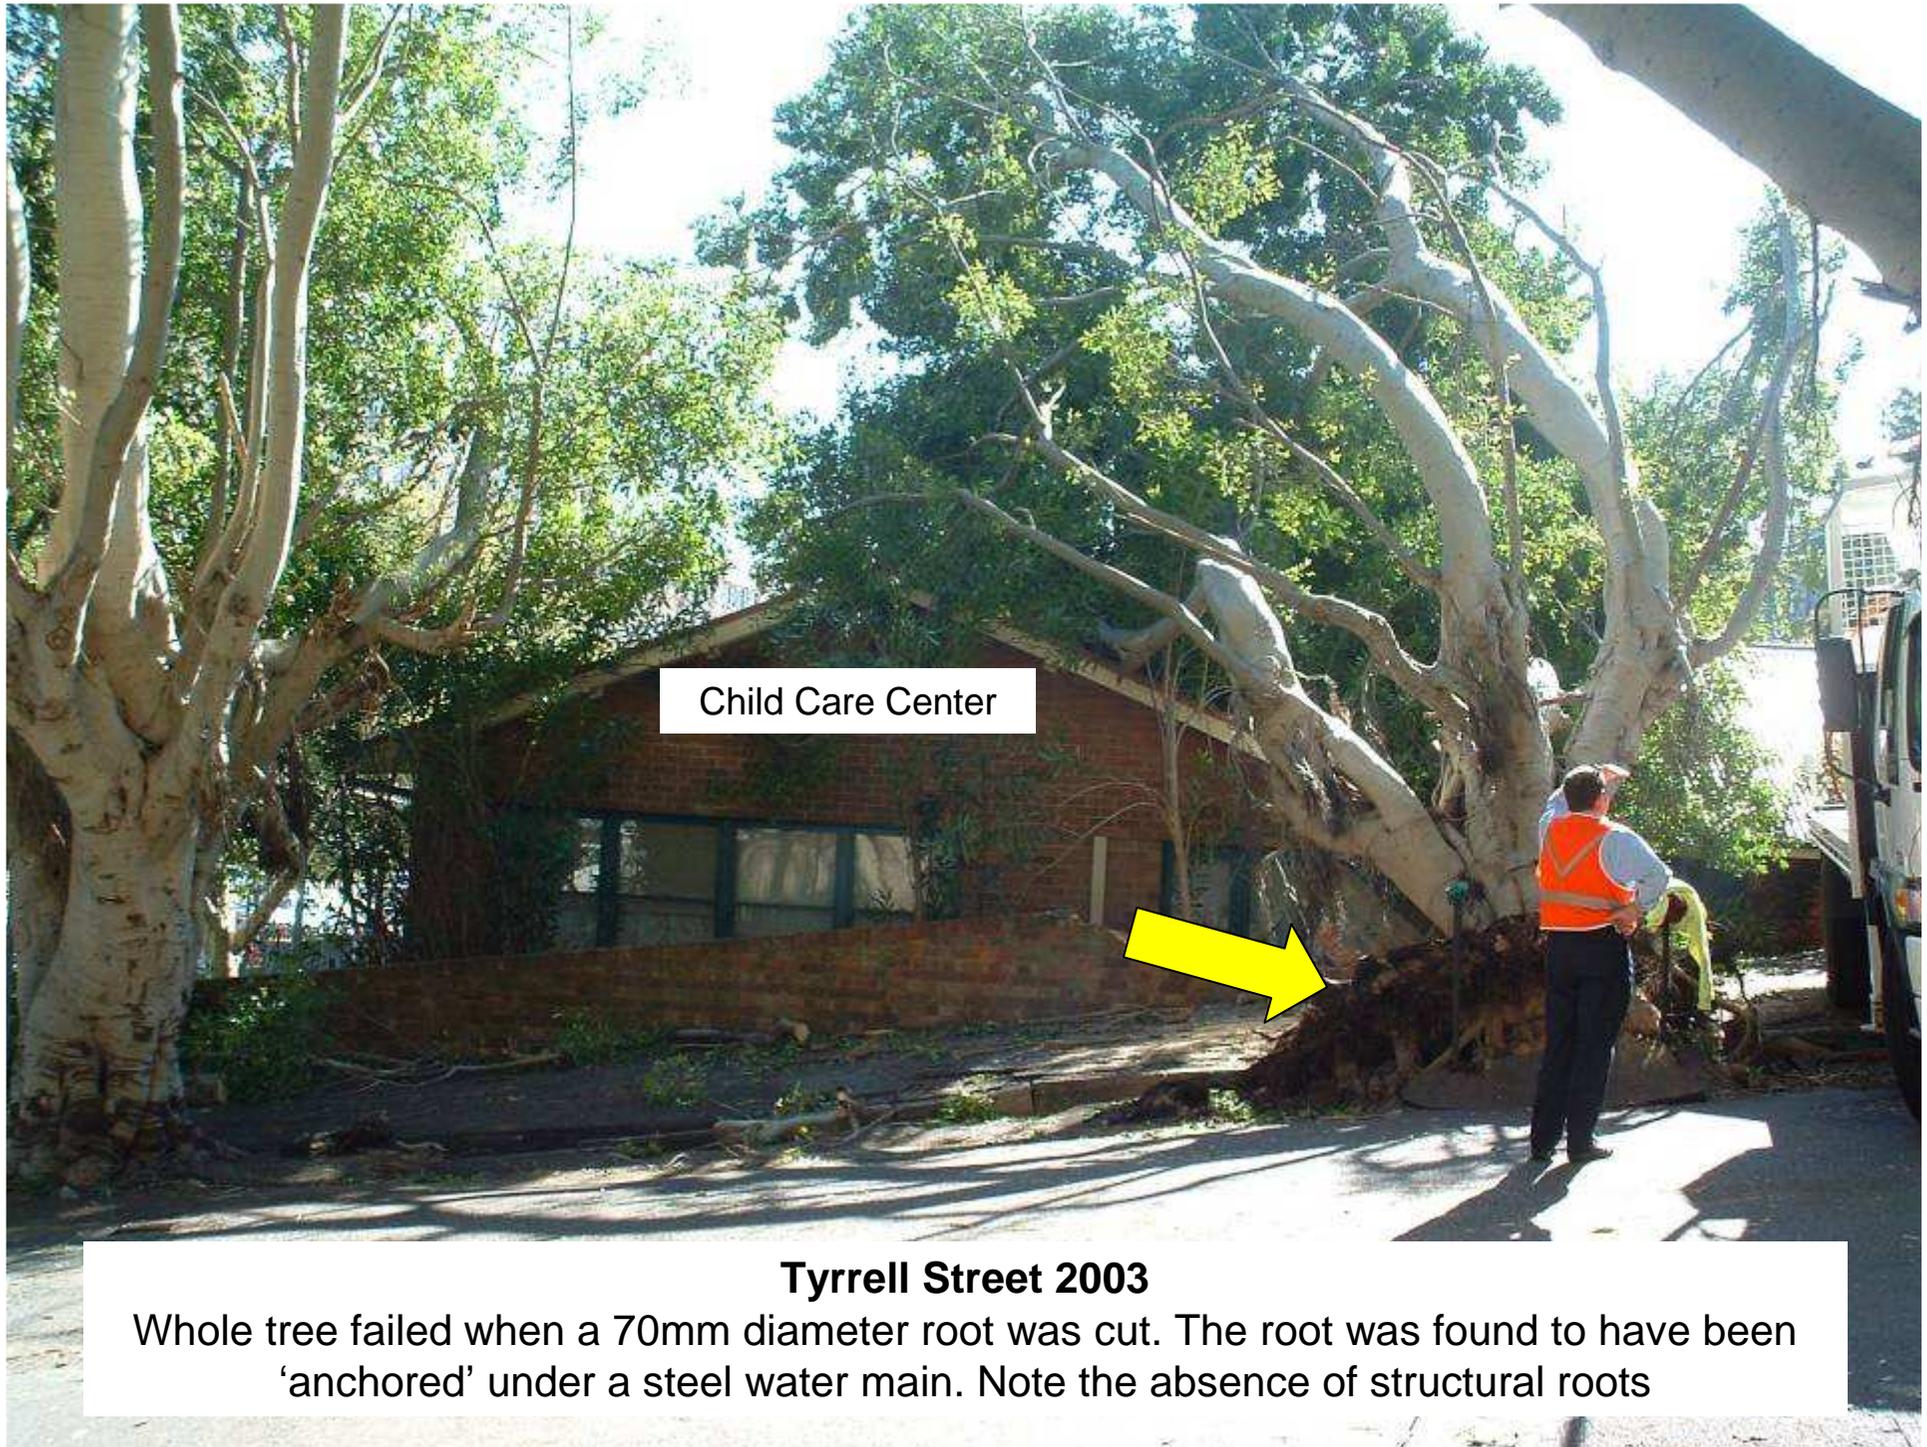
**Tyrrell Street 2003**

Tyrrell Street 2003 – extreme crown bias to the north contributing to extreme root instability

Whole tree failed when a 70mm diameter root was cut. The root was found to have been 'anchored' under a steel water main. Note the absence of structural roots

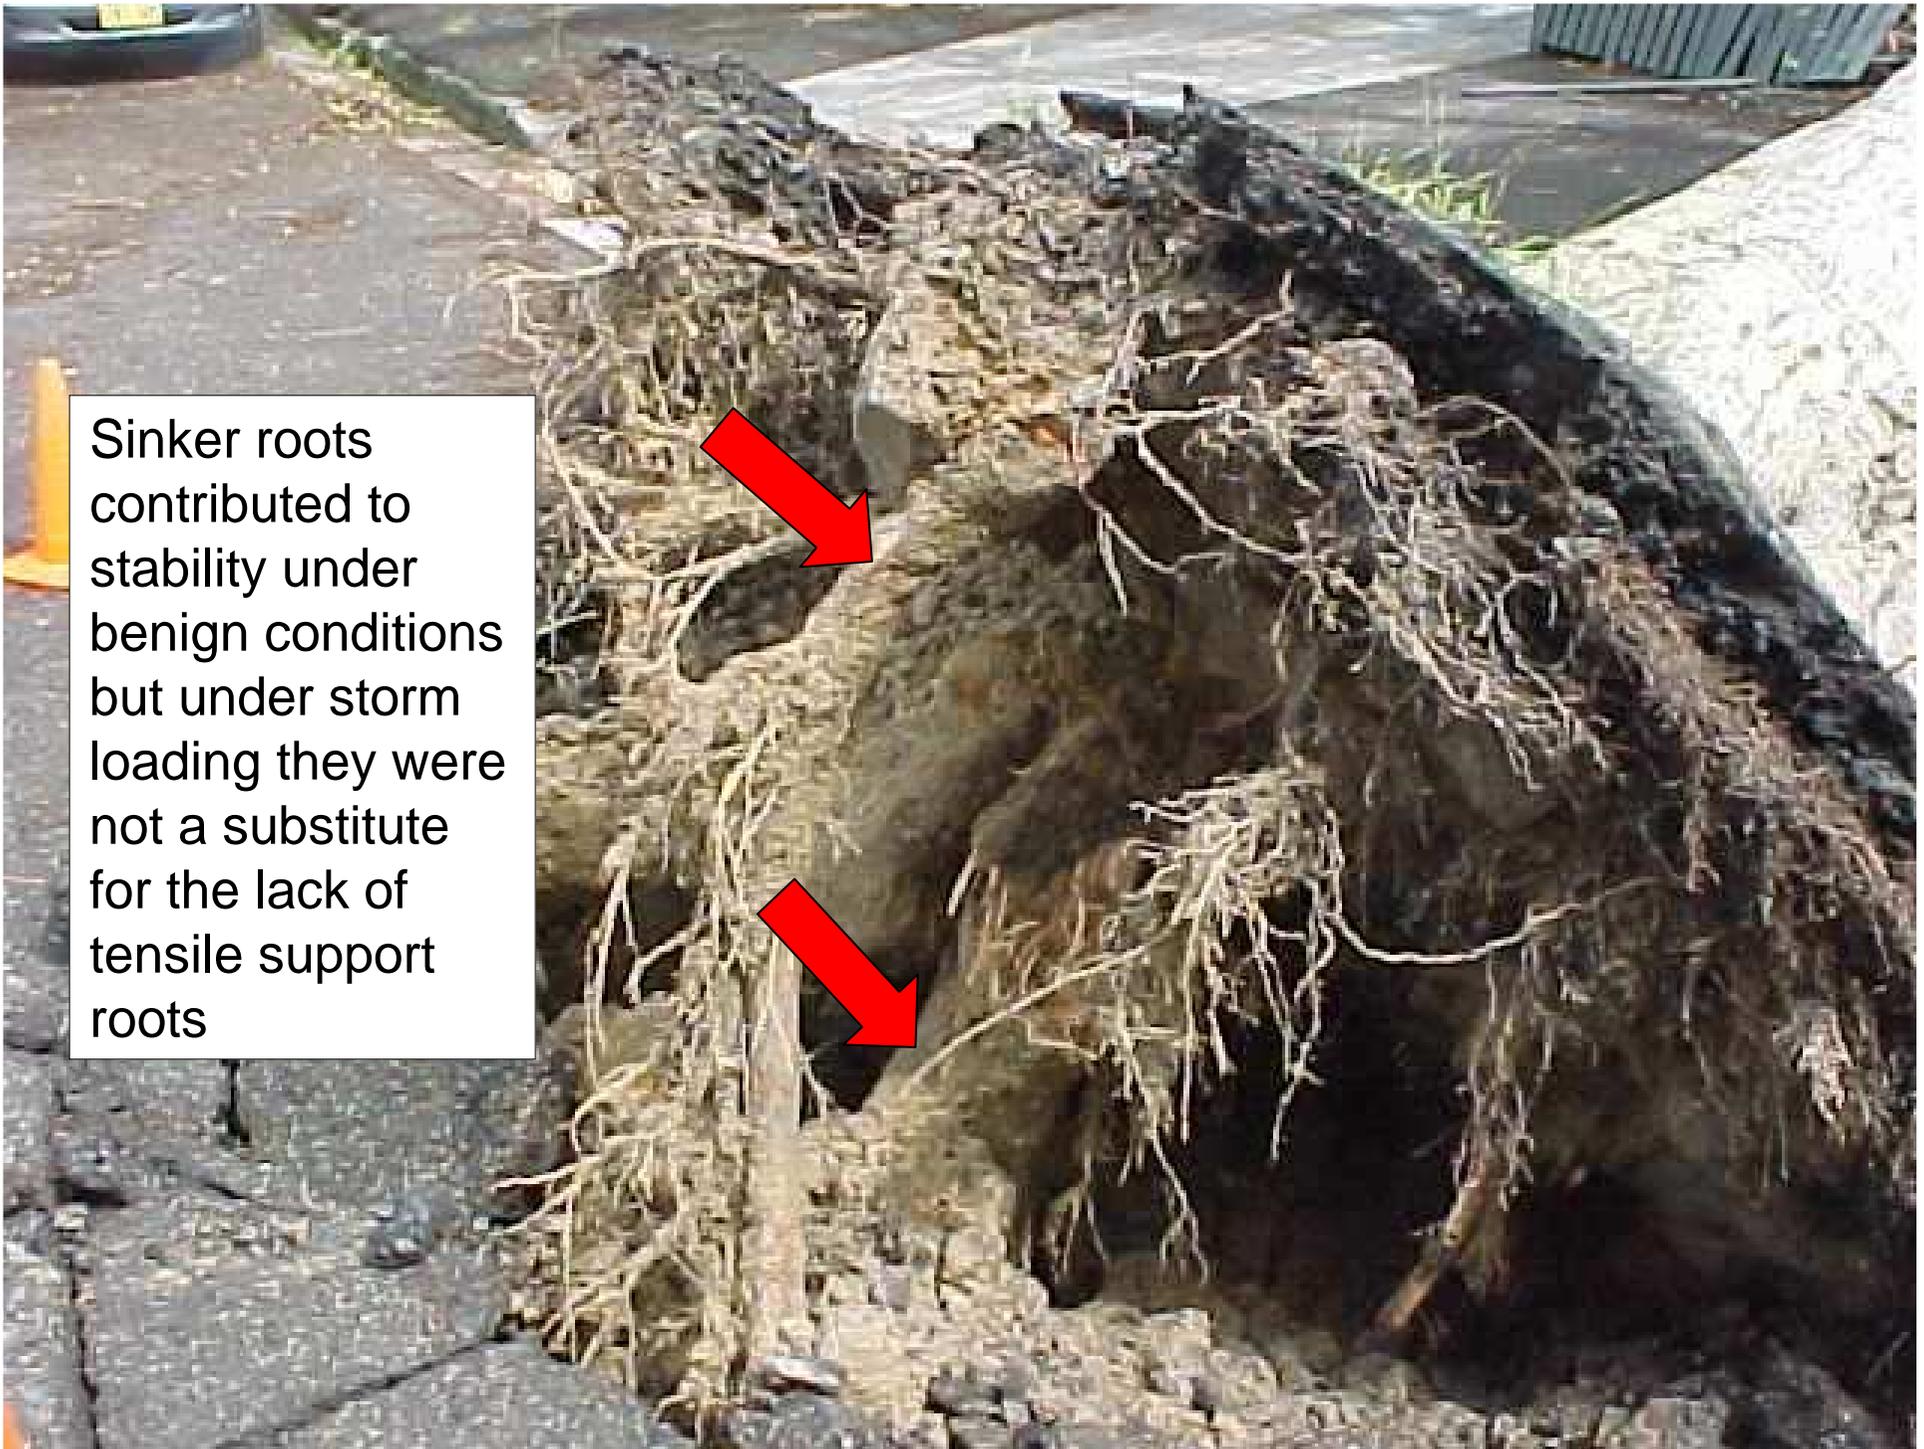
Whole-tree failure due to linear (eccentric) root plate and absence of mechanically effective structural roots

Sinker roots directly beneath trunk did not provide the necessary tensile support

Sinker roots contributed to stability under benign conditions but under storm loading they were not a substitute for the lack of tensile support roots

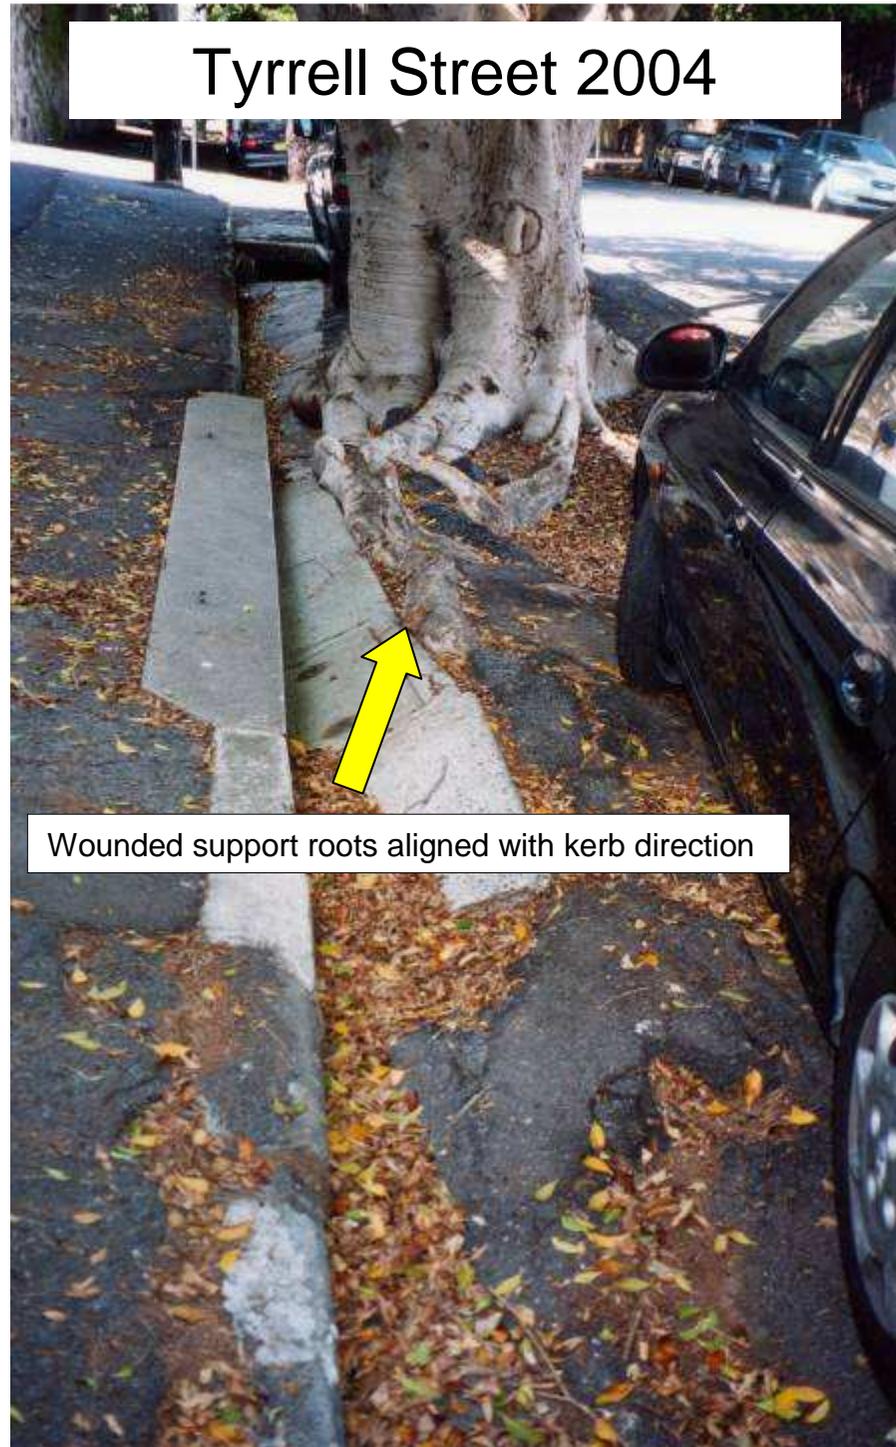
Tyrrell Street 2004

Wounded support roots aligned with kerb direction

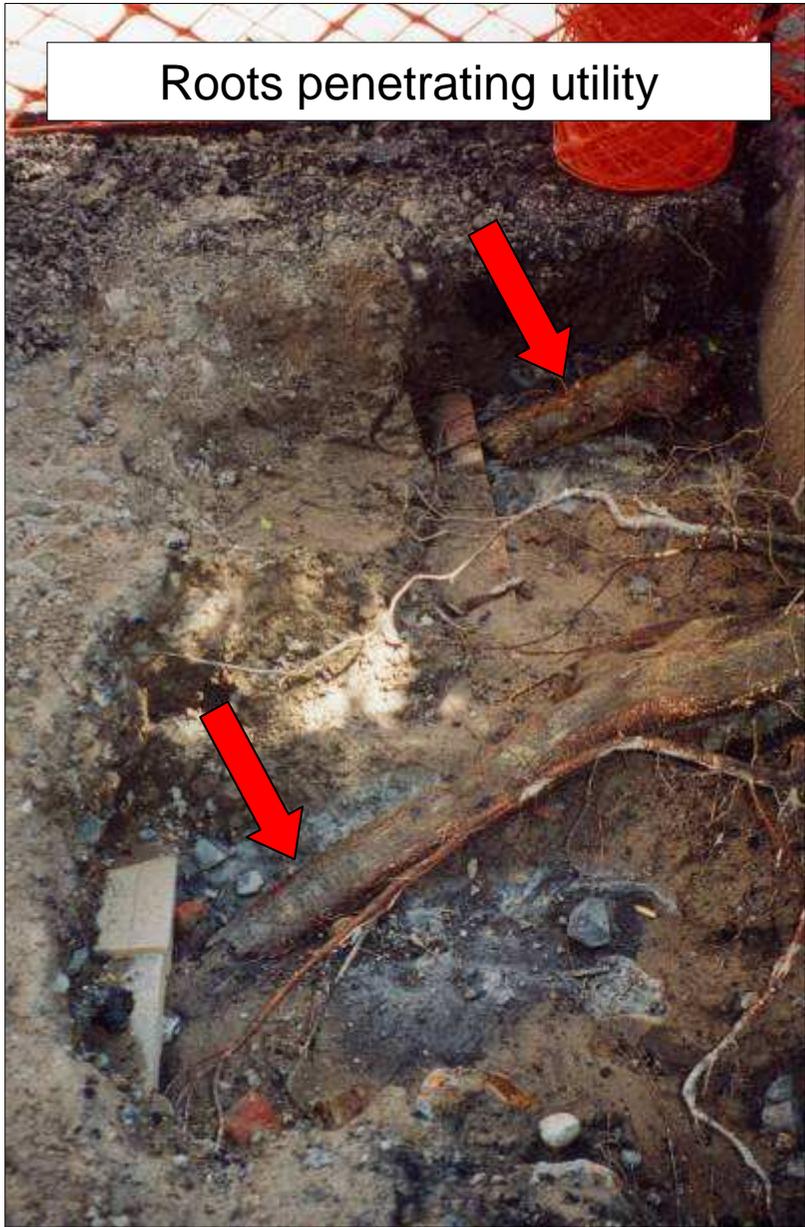
Tyrrell St 2003  
proposed cut-out  
for root  
investigations

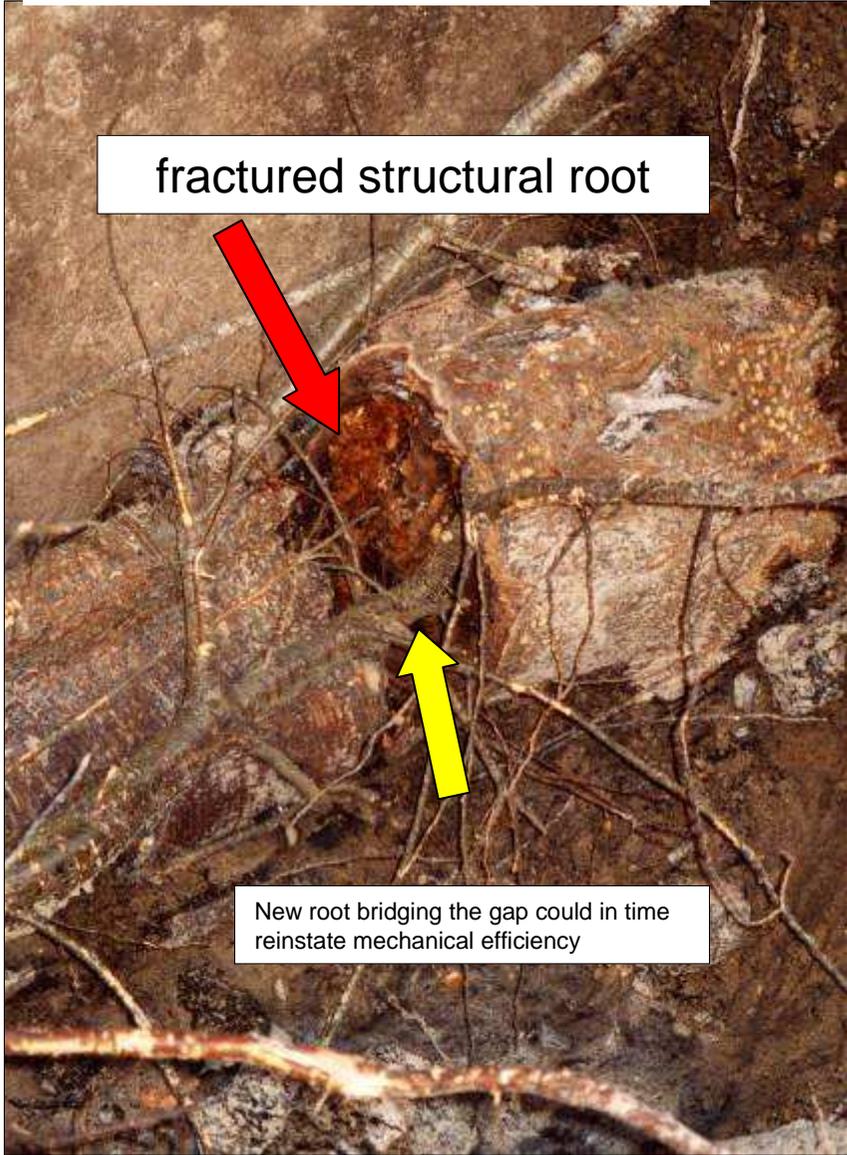
Tyrrell St cut-out root investigations 2003

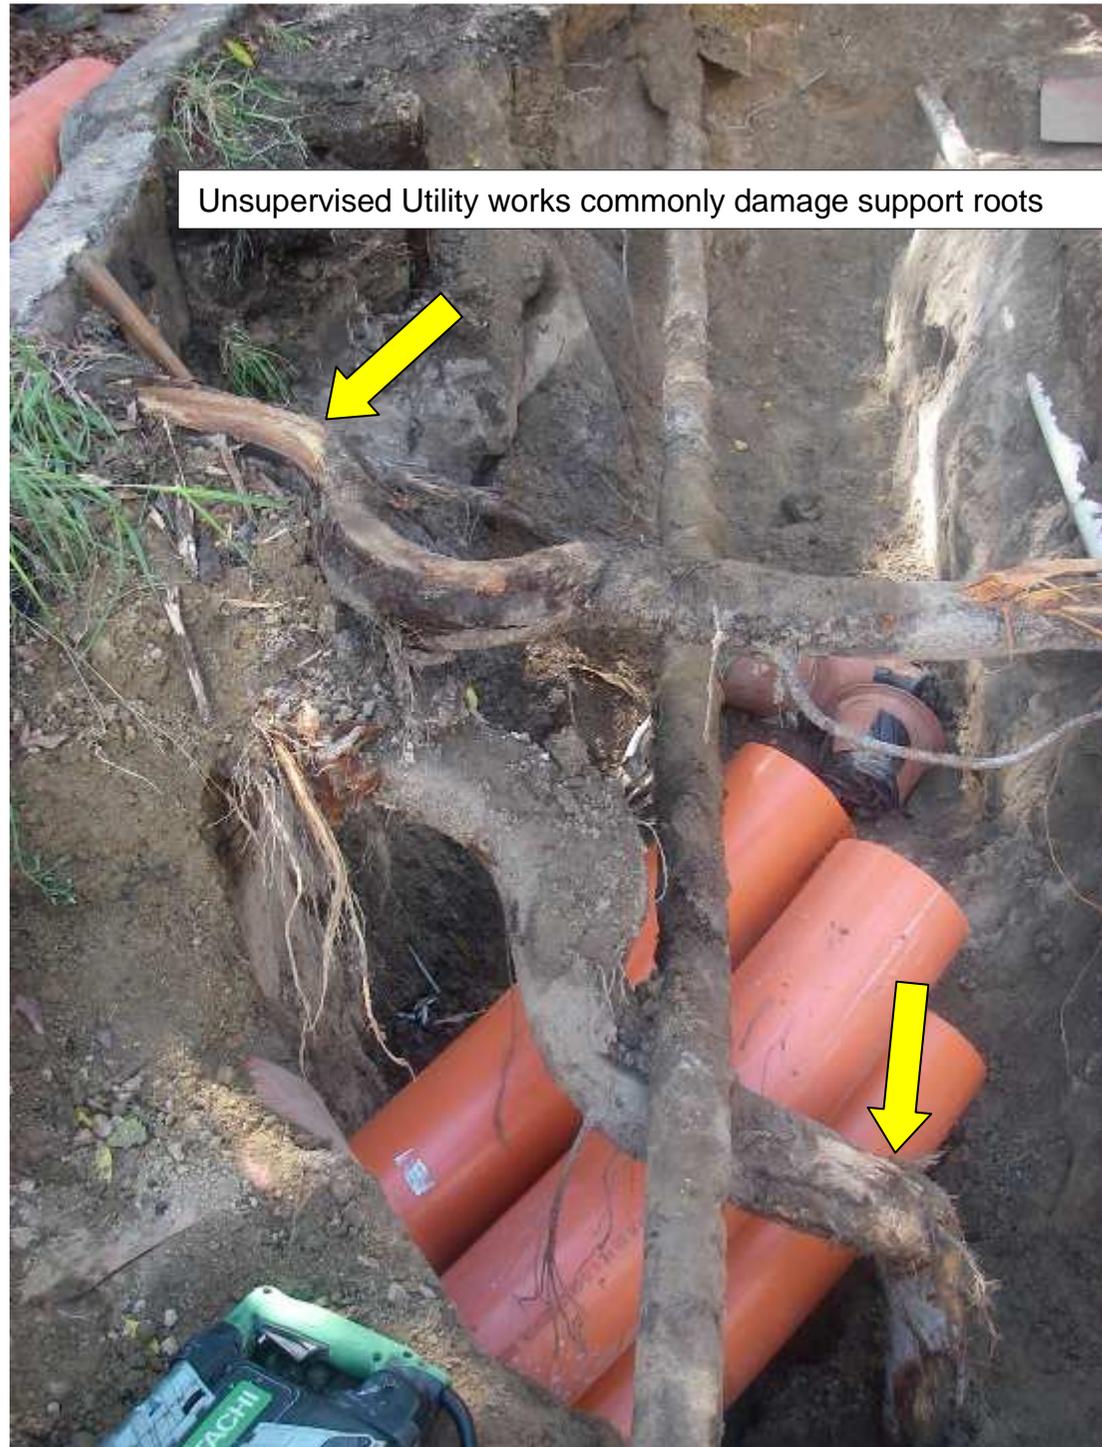
Tyrrell St (southern side)

Pipes & cables providing support to Fig tree.

The tree relies on the pipes for stability thus producing less mechanically functional roots than would occur in the absence of pipes

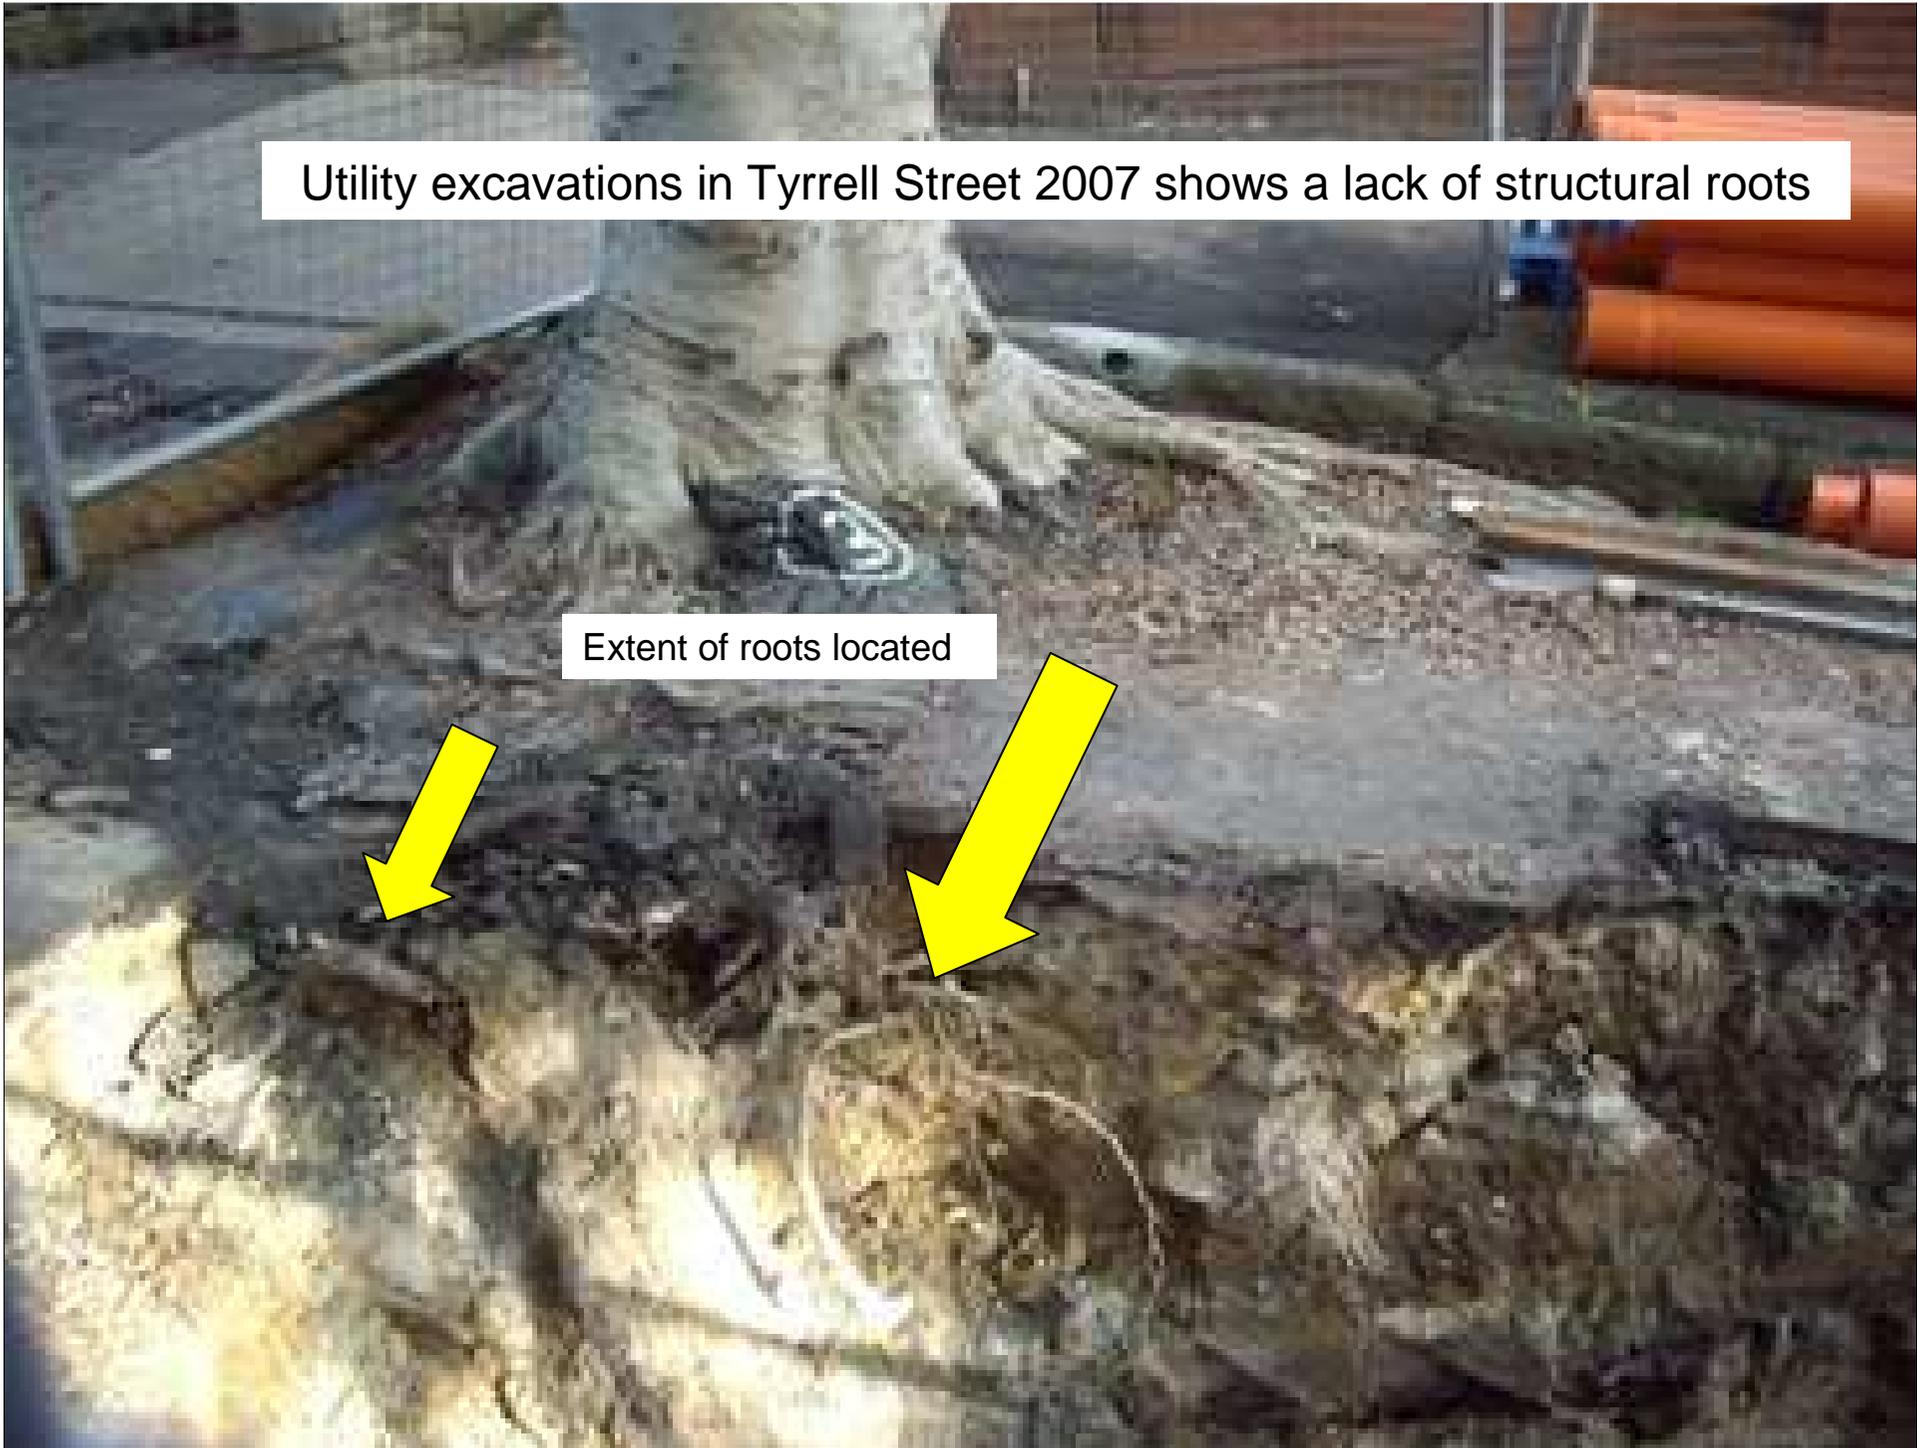
Utility excavations in Tyrrell Street 2007 shows a lack of structural roots

Extent of roots located

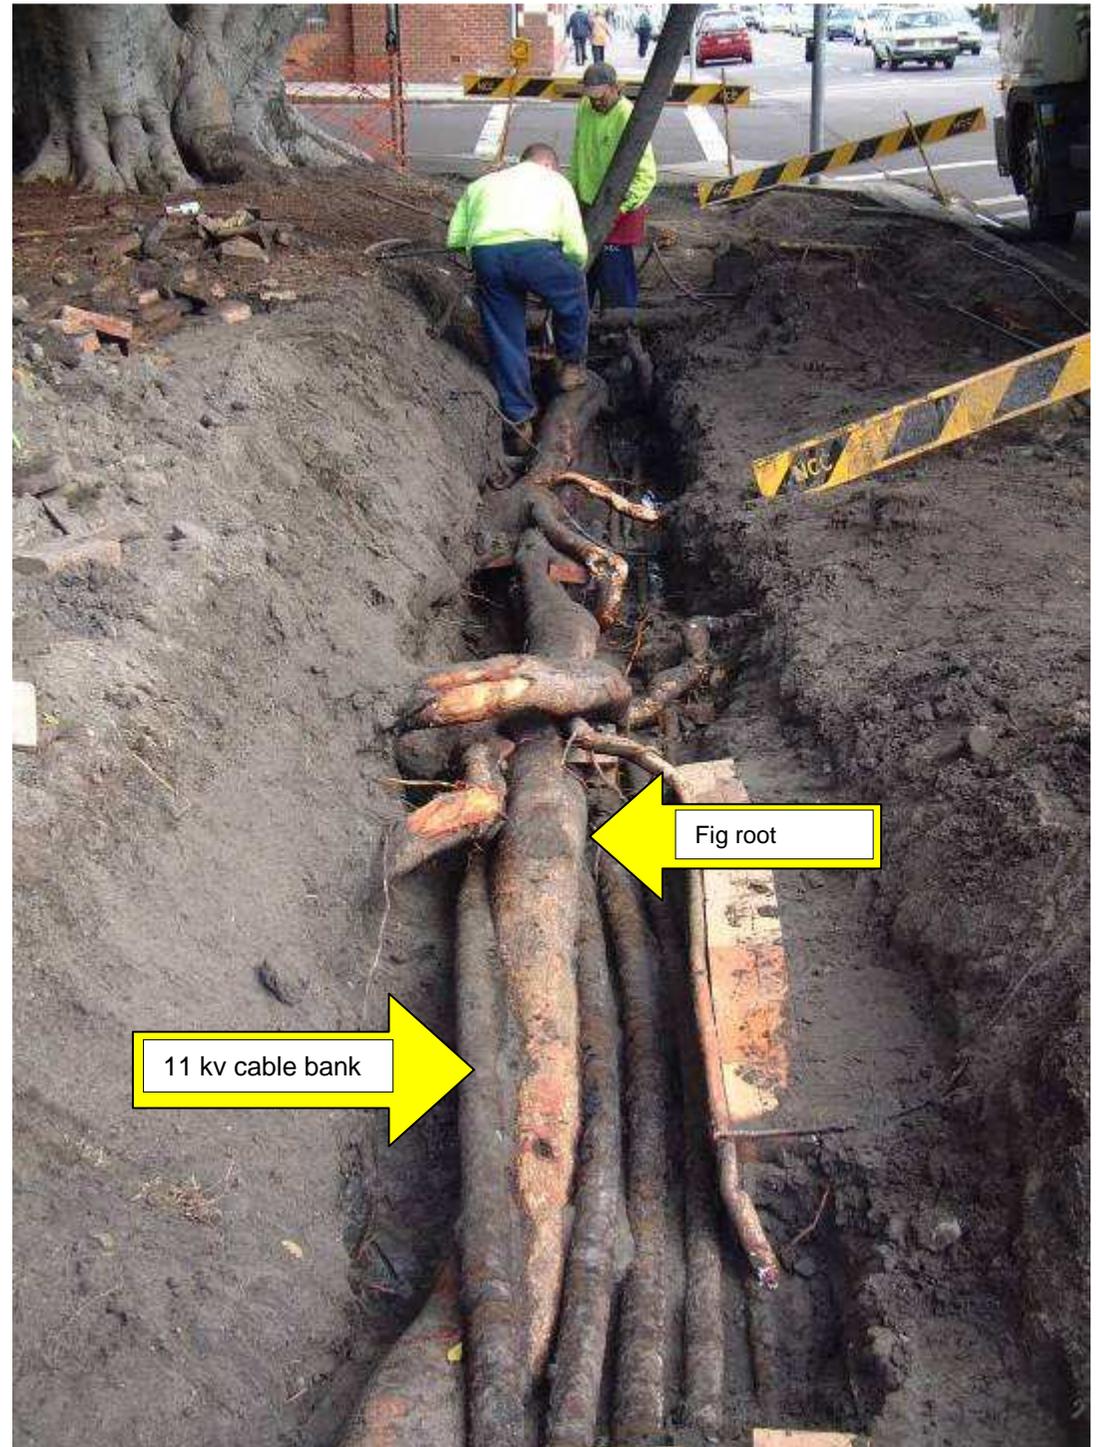
11 kv Cables stretched  
by fig roots

Utility trenches may  
provide conditions  
suited to  
opportunistic root  
development ie  
oxygen and water

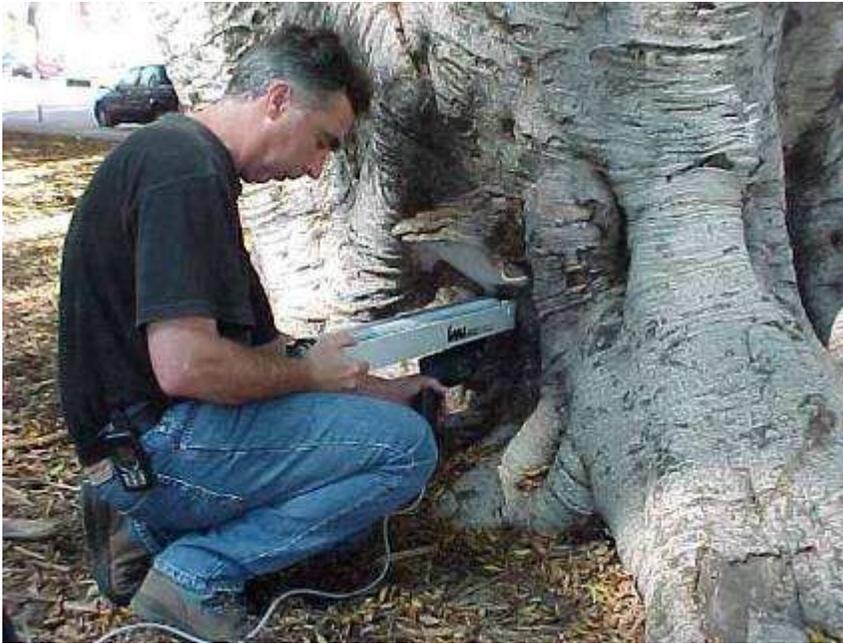
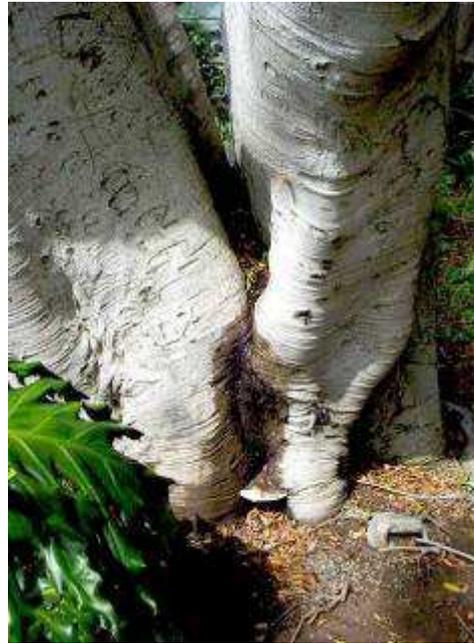
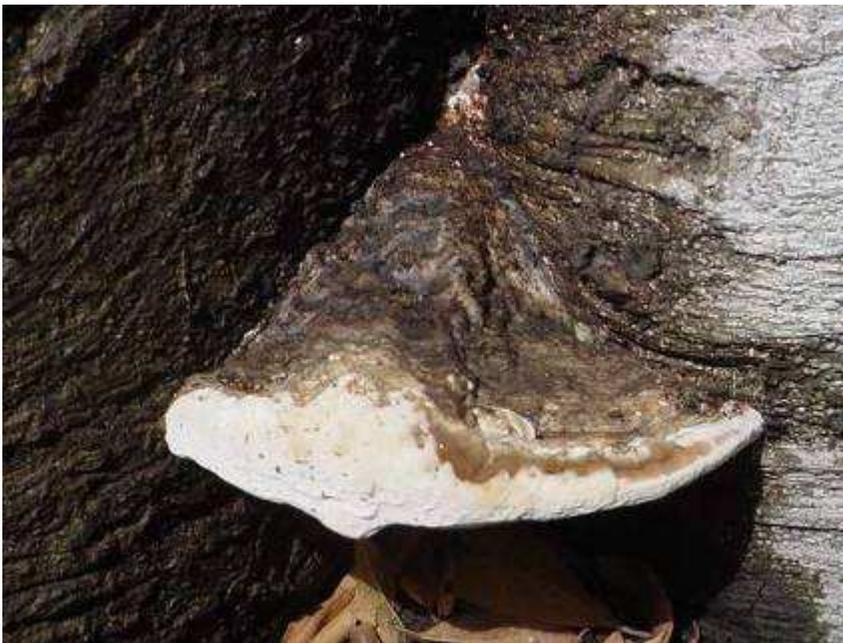
Stage 2 Visual Tree Assessment examination for extent of decay and strength loss due to Ganoderma fungus invasion in two Civic Park Hills Figs. Both trees subsequently removed in 2002

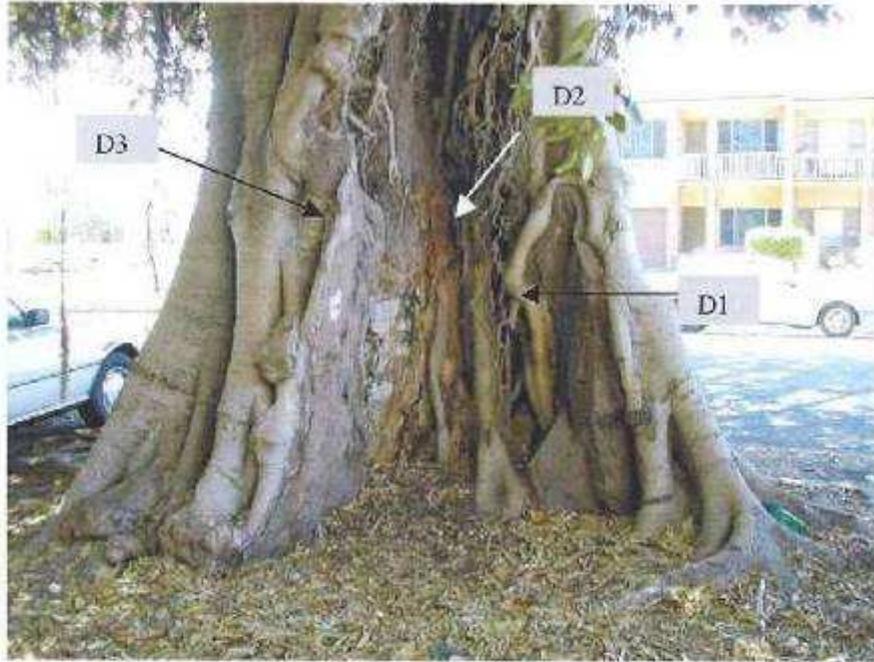
Fig Tree Place, Hamilton.

Severely wounded partially hollow and decaying Port Jackson Fig.

Exploratory use of a resistance drill (Resistograph) to determine and map residual trunk wall thickness.

The tree was subsequently removed as mapping showed the hollow exceeded the safety threshold

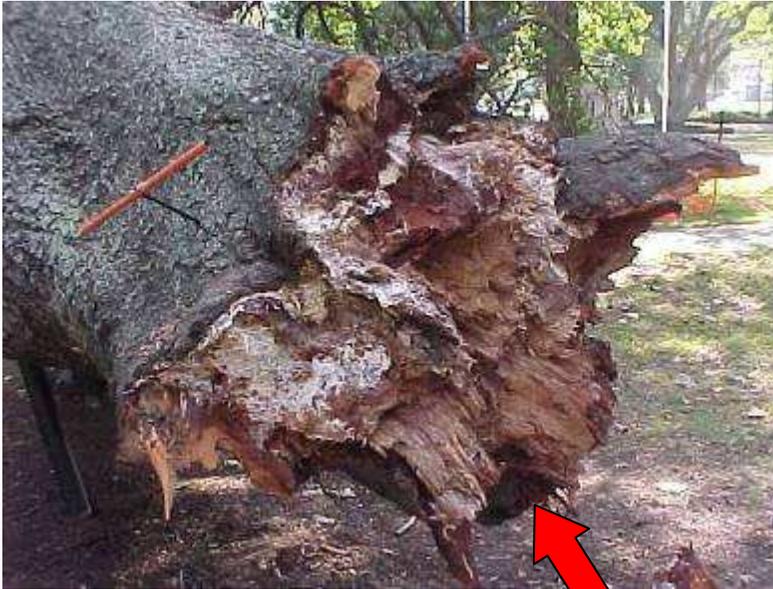
## Failure of Kaffir Plum Civic Park 2000

Brown Rot in the stem base and root crown. Failure occurred at night time under calm conditions

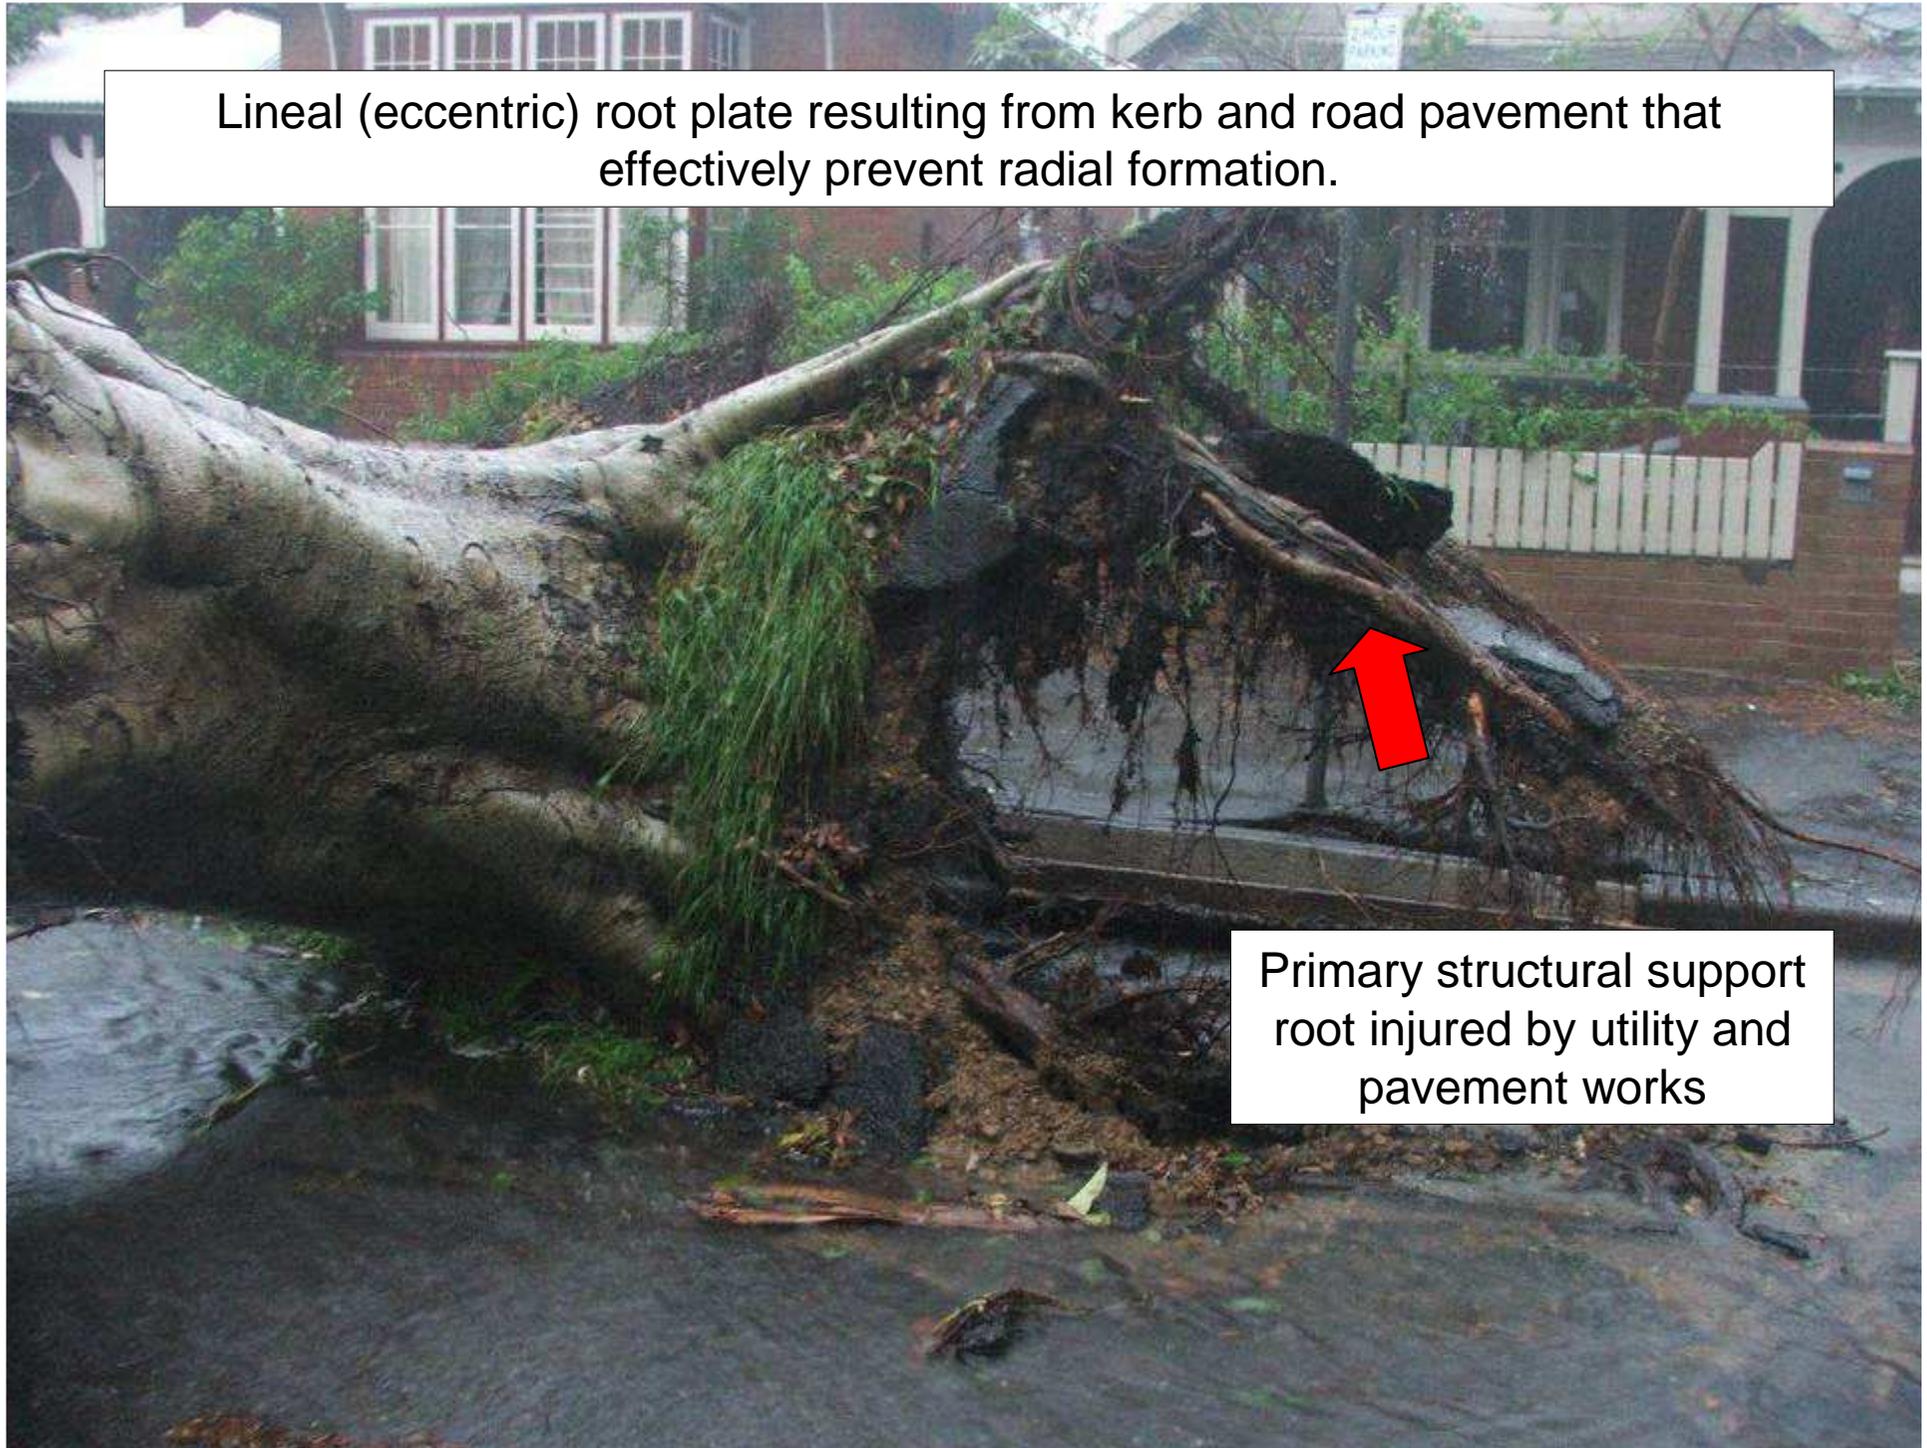
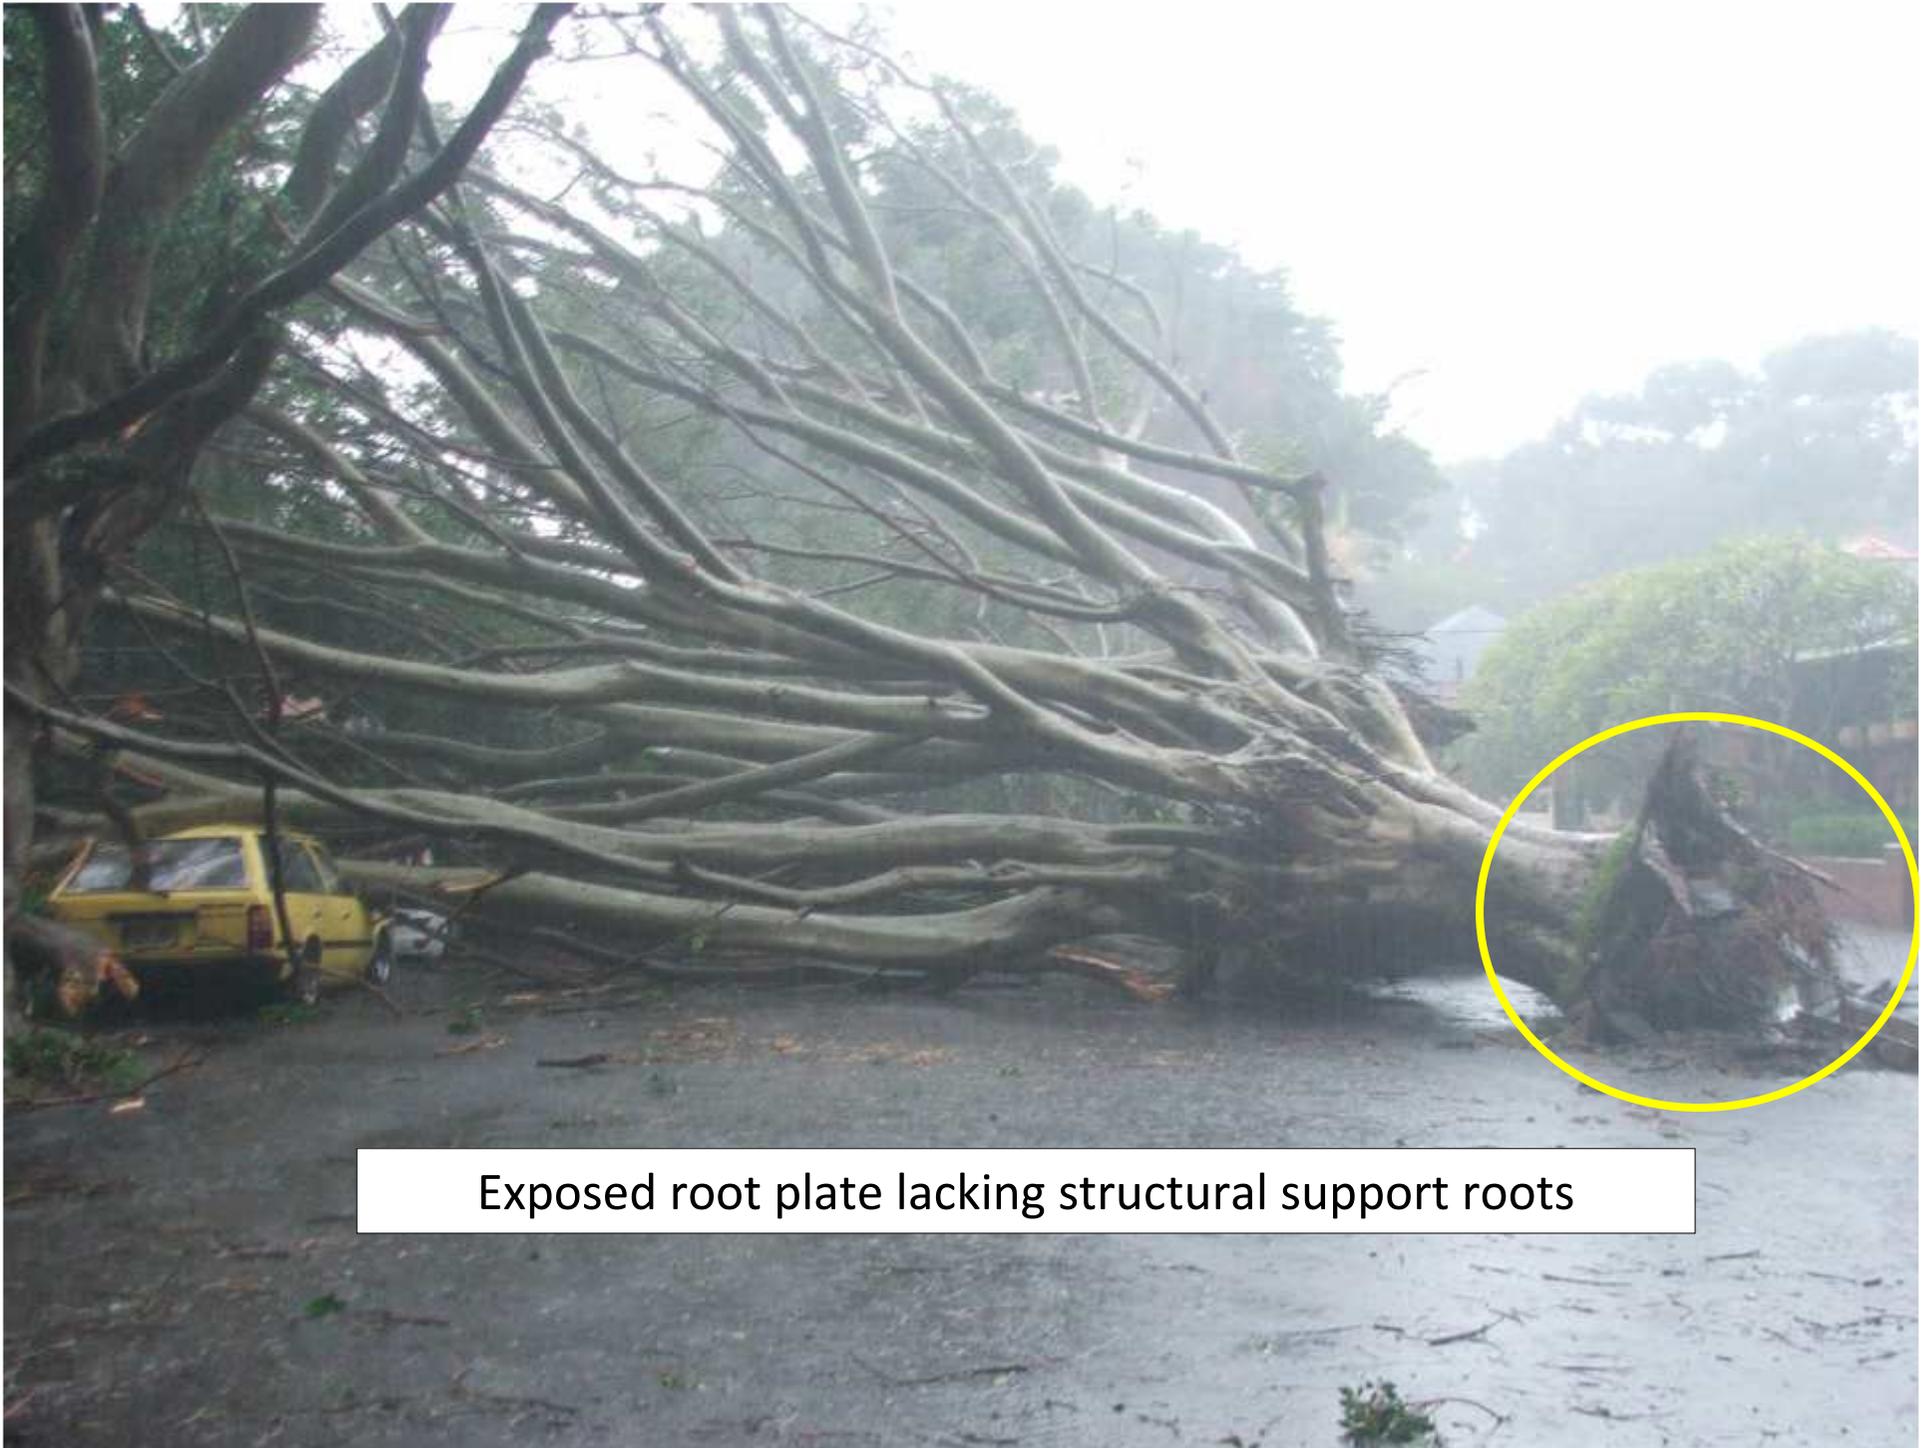
Primary structural support root injured by utility and pavement works
