# Tree Failure Casebook History

Informing Tree Management in Newcastle

2000 - 2011

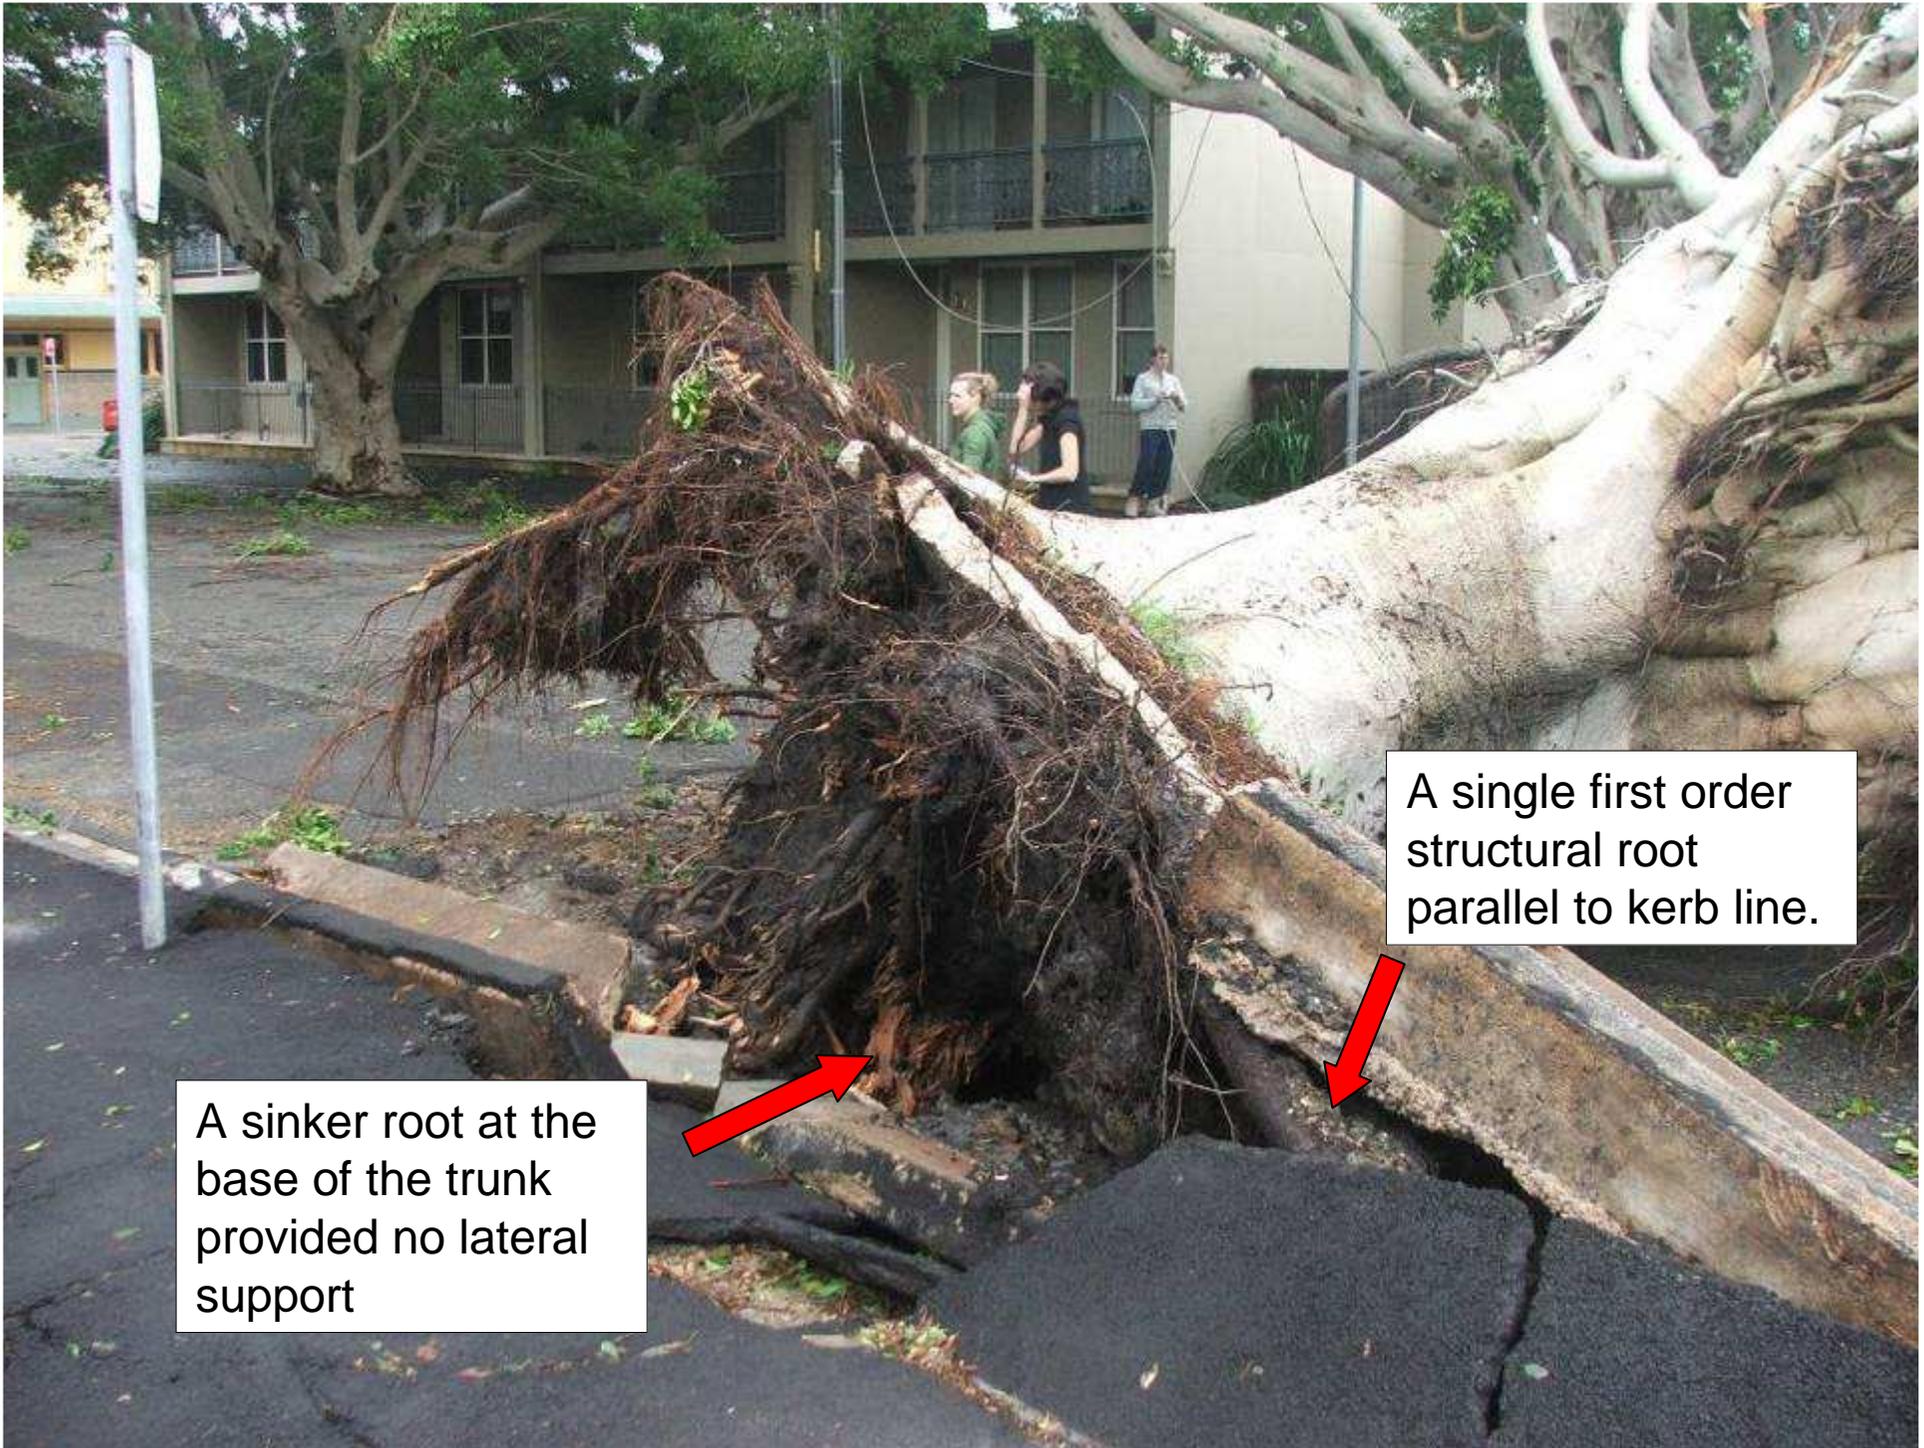
Exposed root plate lacking structural support roots

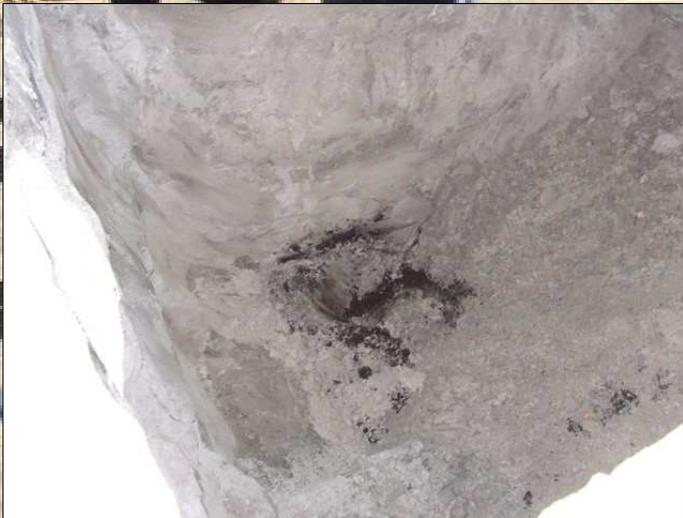
Bruce St 2010 – investigations for drainage works. Pot-holing at the centre of the street. Fine sand forms 100% of the substrate.

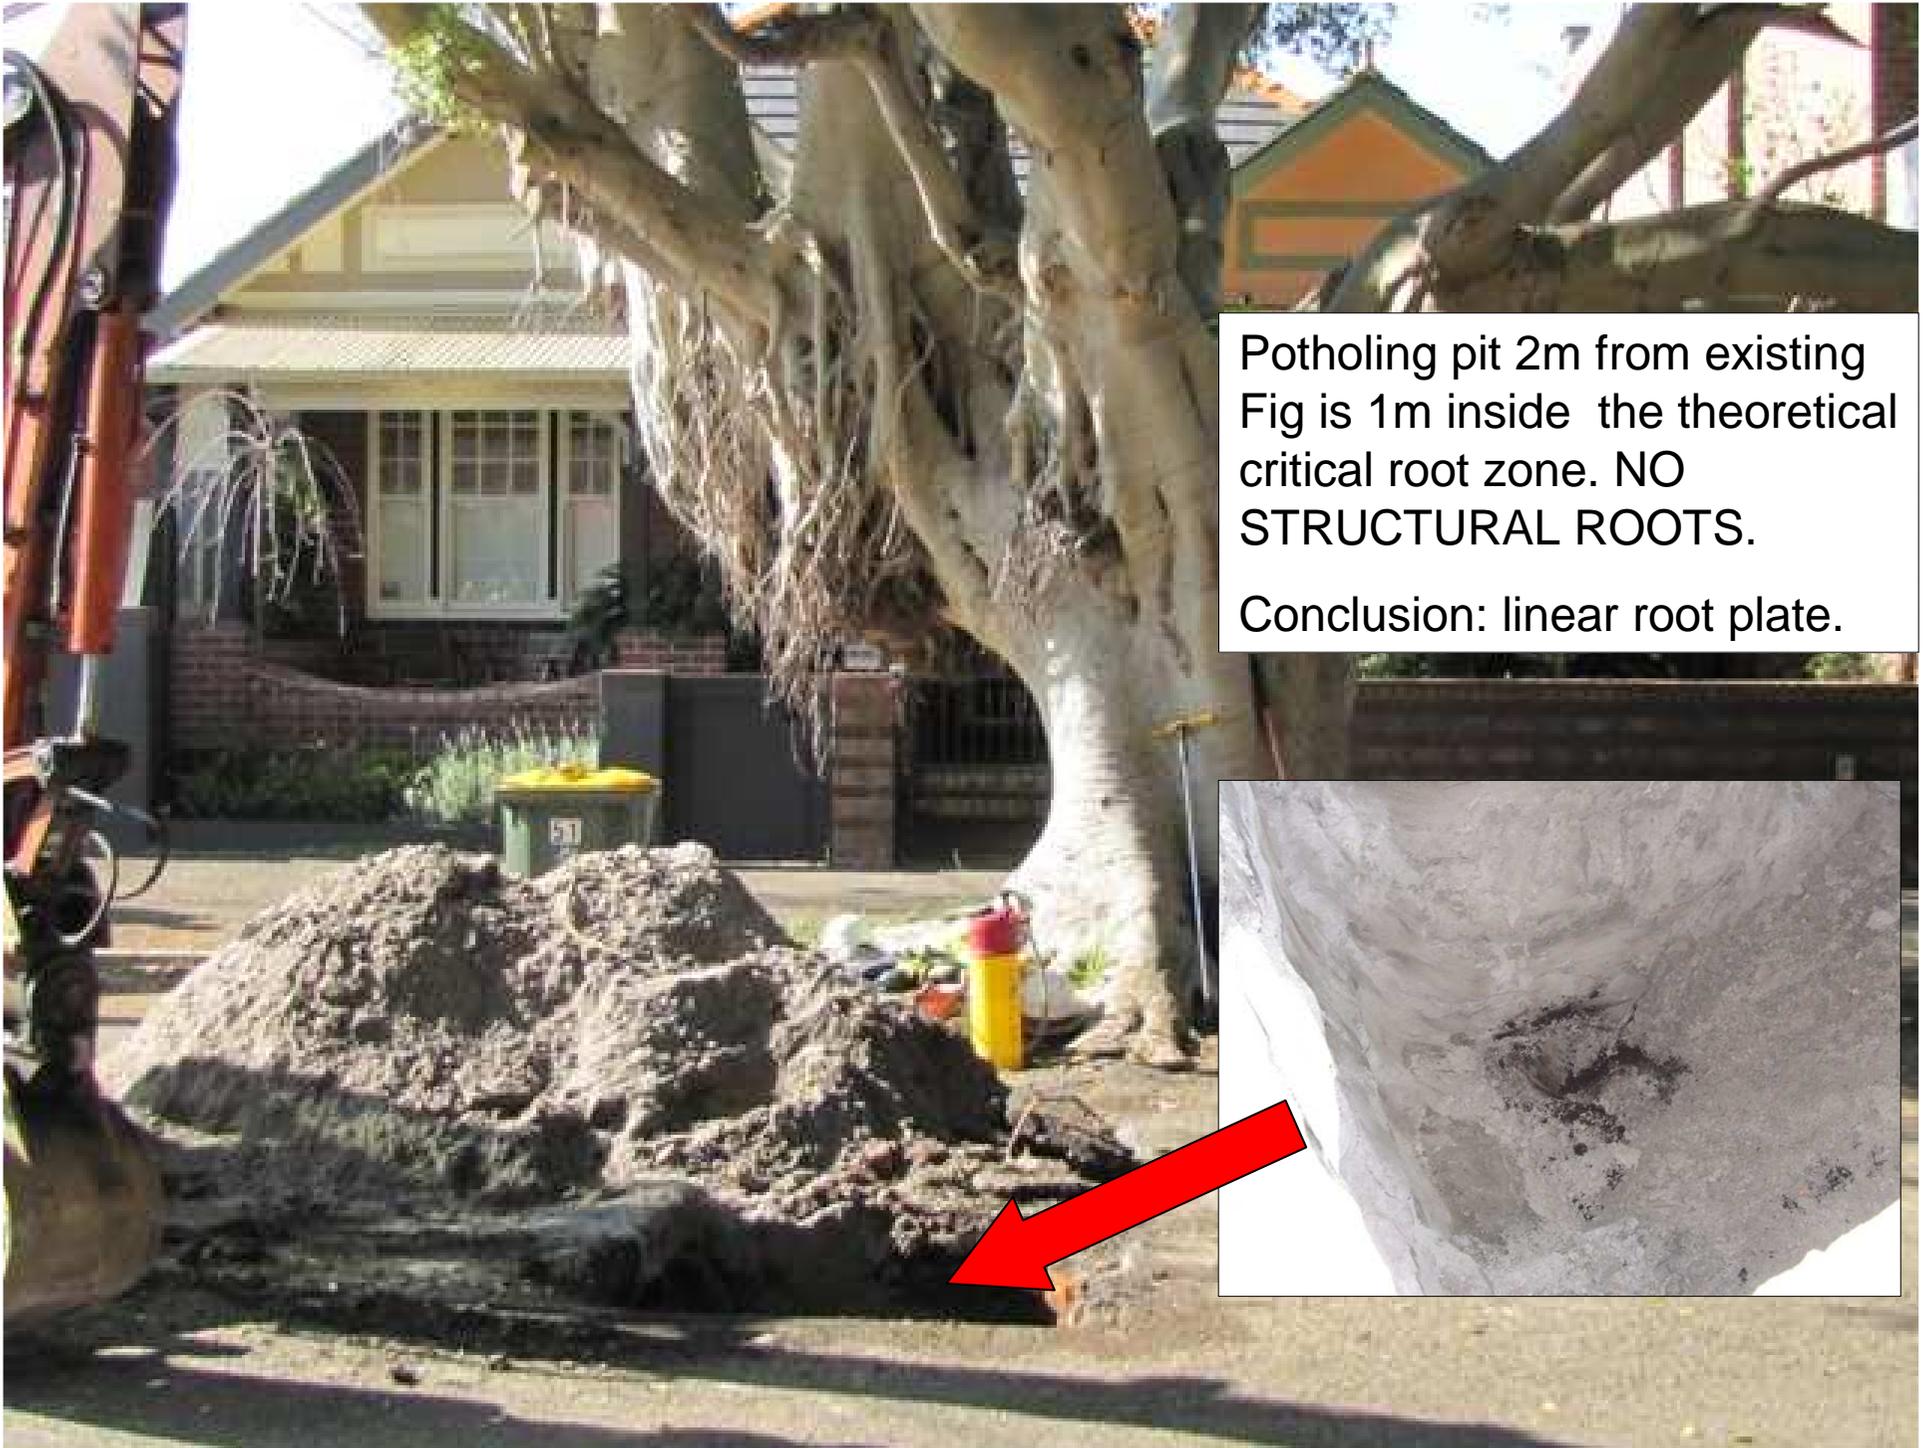
Potholing pit 2m from existing Fig is 1m inside the theoretical critical root zone. NO STRUCTURAL ROOTS.

Conclusion: linear root plate.

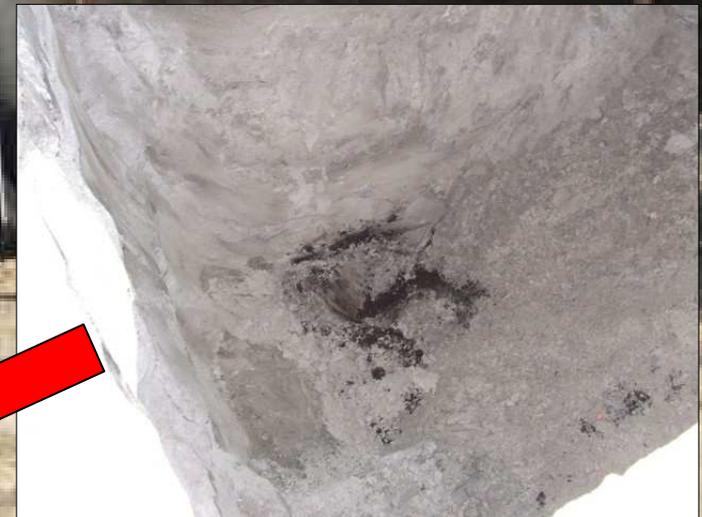
Pot hole excavation 7m from existing tree & 5m from the Fig that failed in the 2007 storm. One non-structural root – no other roots found

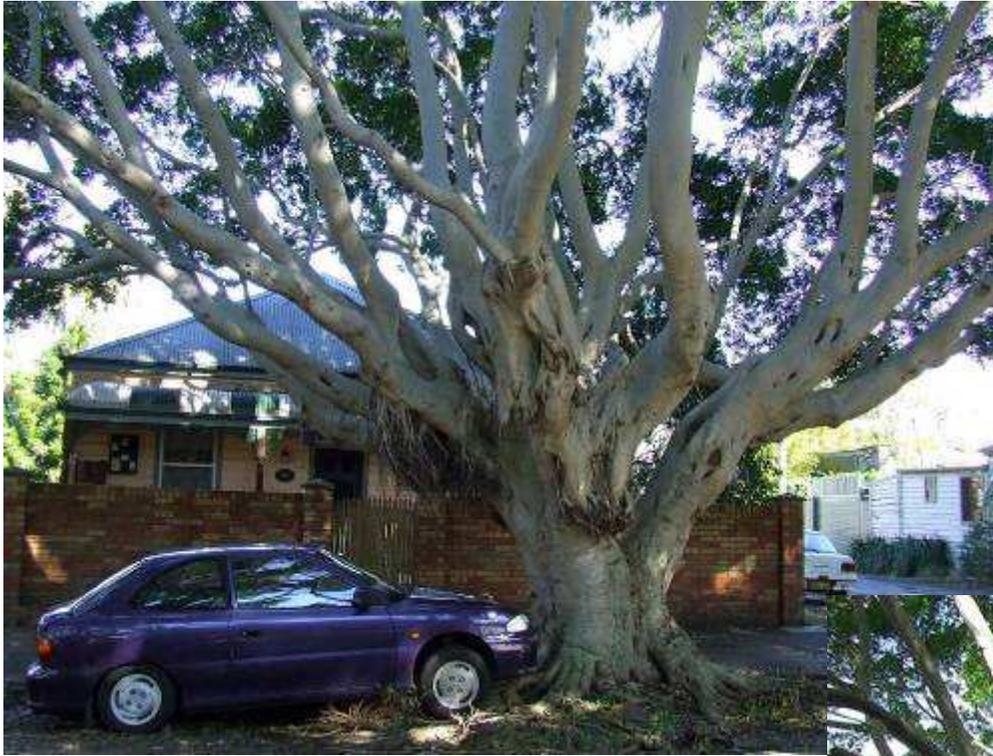
ID 12357.

Utility works have been backfilled and  
the extent of root loss and injury  
concealed

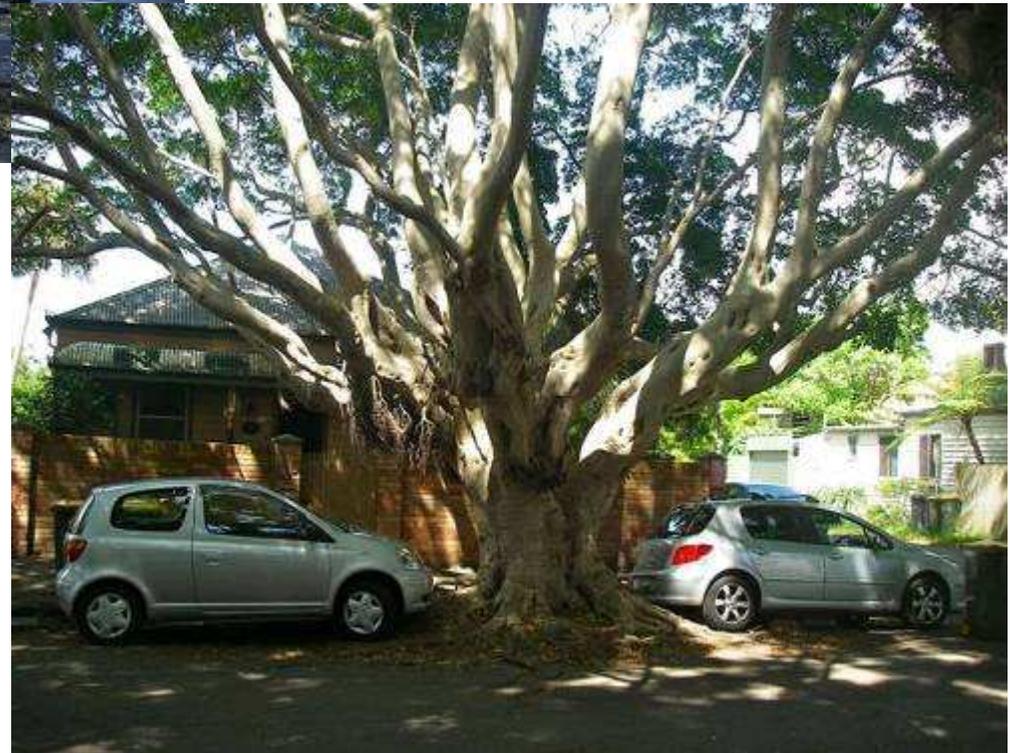
Council Street.

Root and trunk abrasion  
and root zone pollution  
from recurrent vehicle  
parking

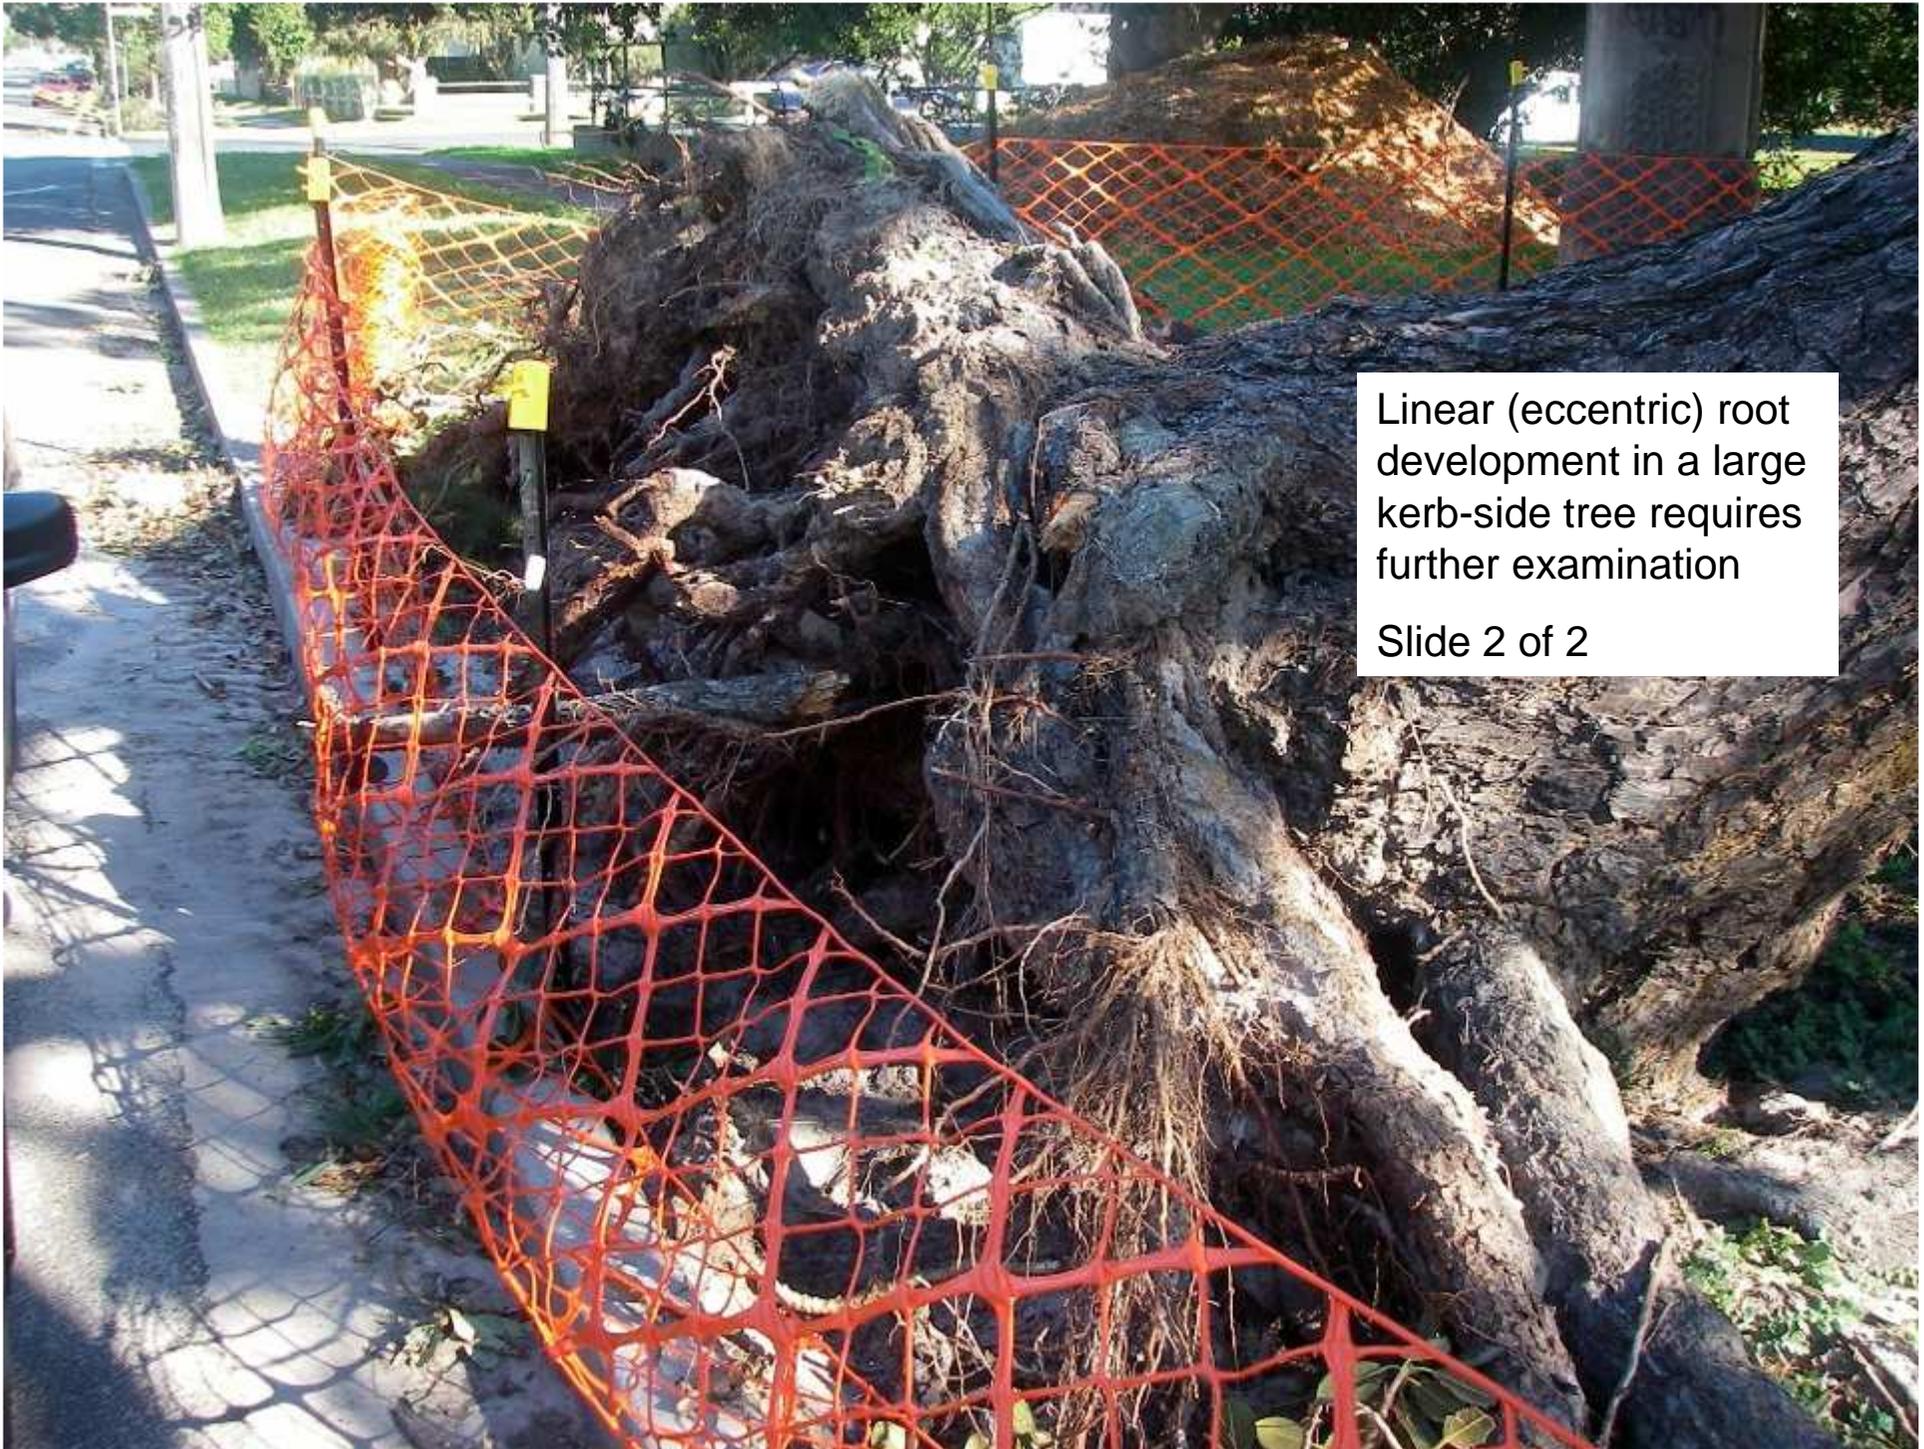
Linear (eccentric) root development in a large kerb-side tree requires further examination

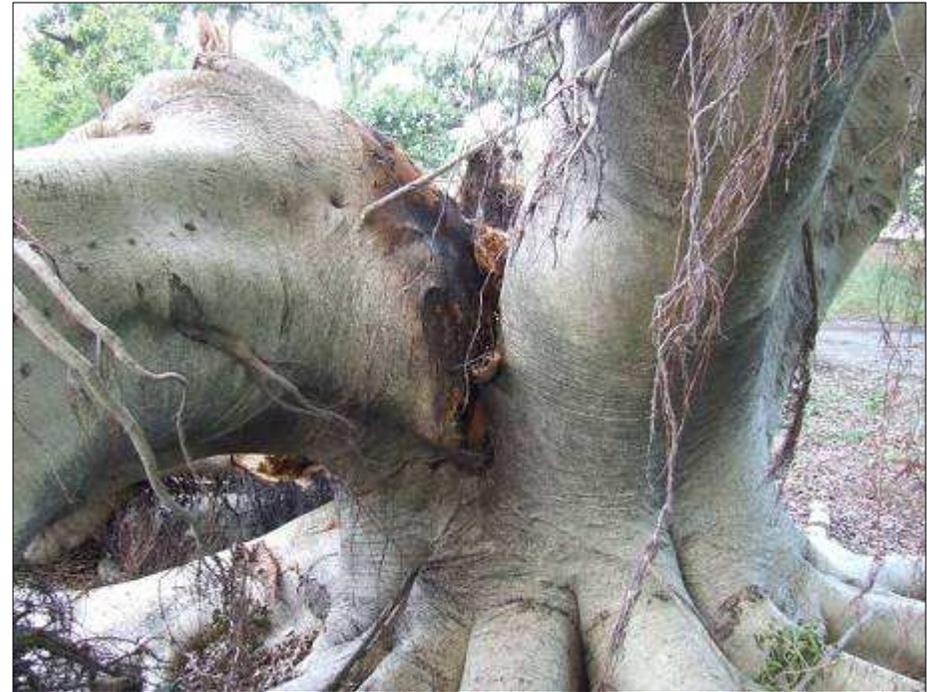
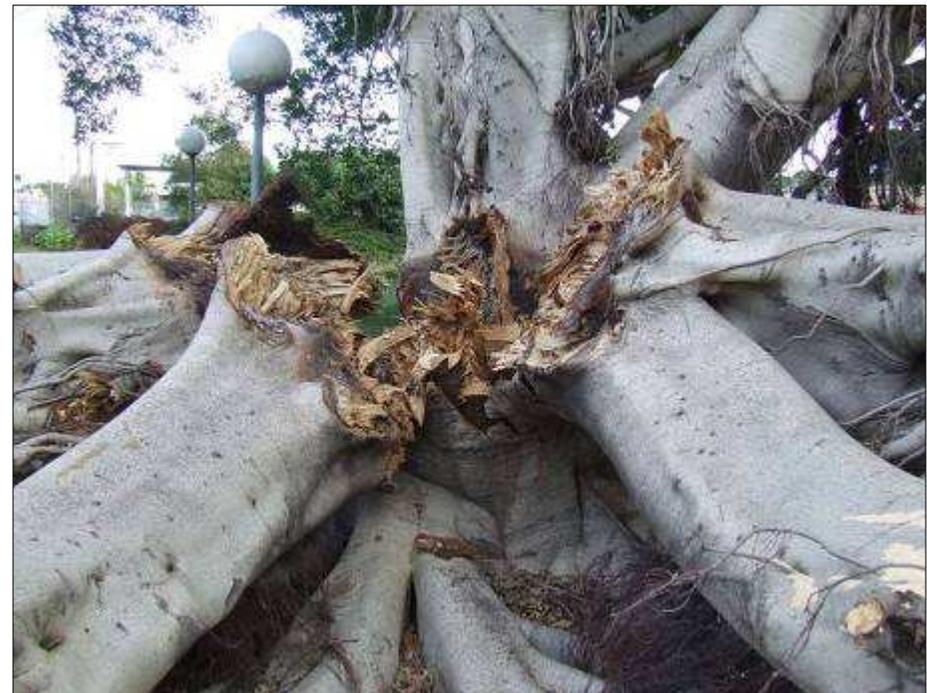
TAFE Campus - Tighes Hill

Mature Hills Fig multiple failures  
due to compression forks with bark  
inclusion

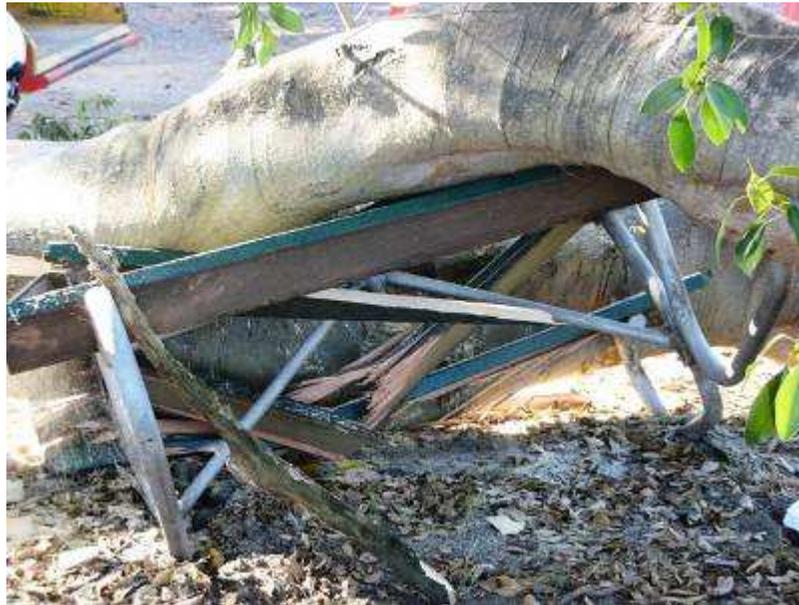
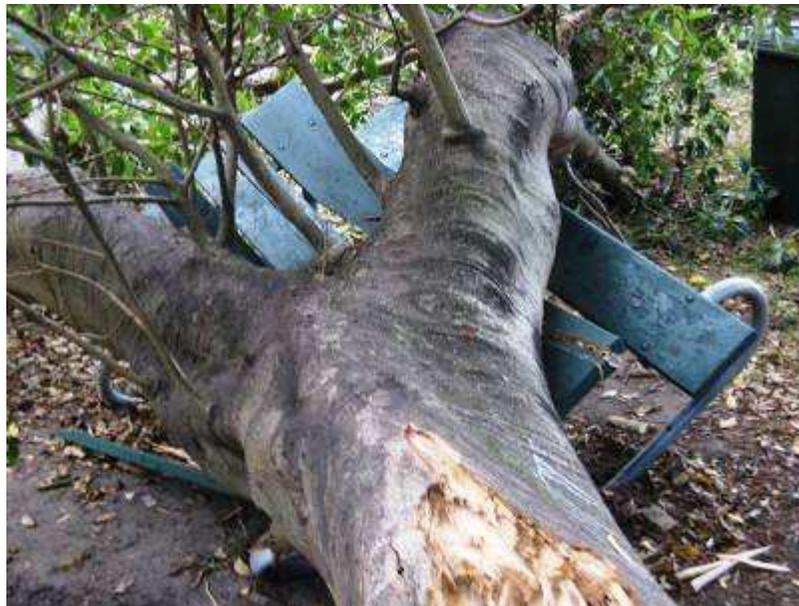
# Port Jackson Fig – Sudden Limb Failure at Wallsend Park January 2011

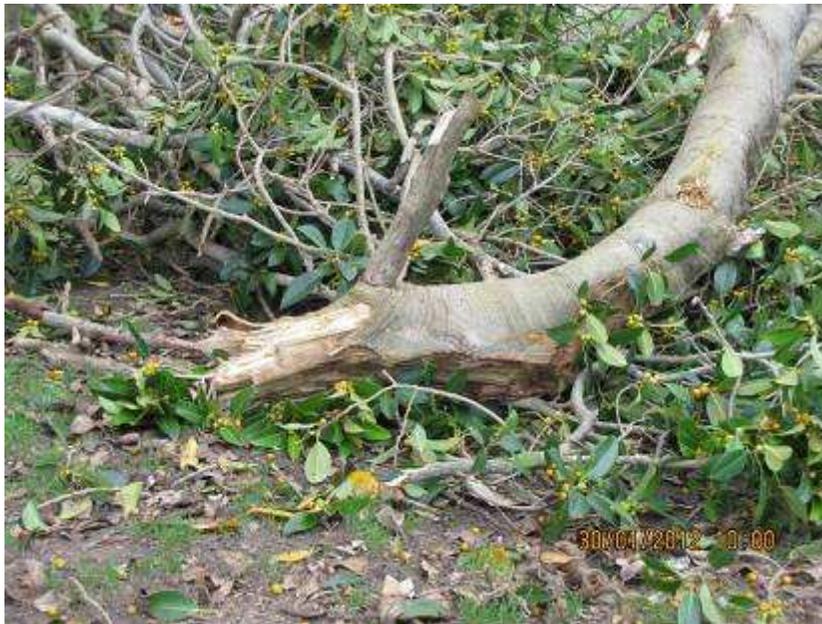
Port Jackson Fig at  
Wallsend Park.

Second branch failure  
incident

Temporary safety fencing restricting public access following a second branch failure incident. The location (in a Heritage Park); the trees very large size and age status means that the tree will be retained and permanent fencing installed

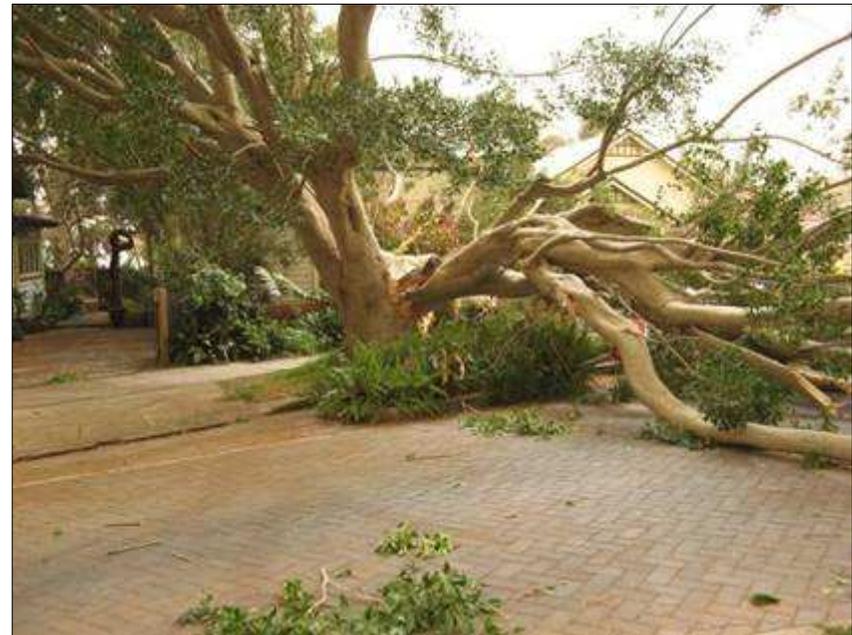
Single massive linear root aligned with kerb direction

Increased canopy exposure due to the loss of adjacent trees

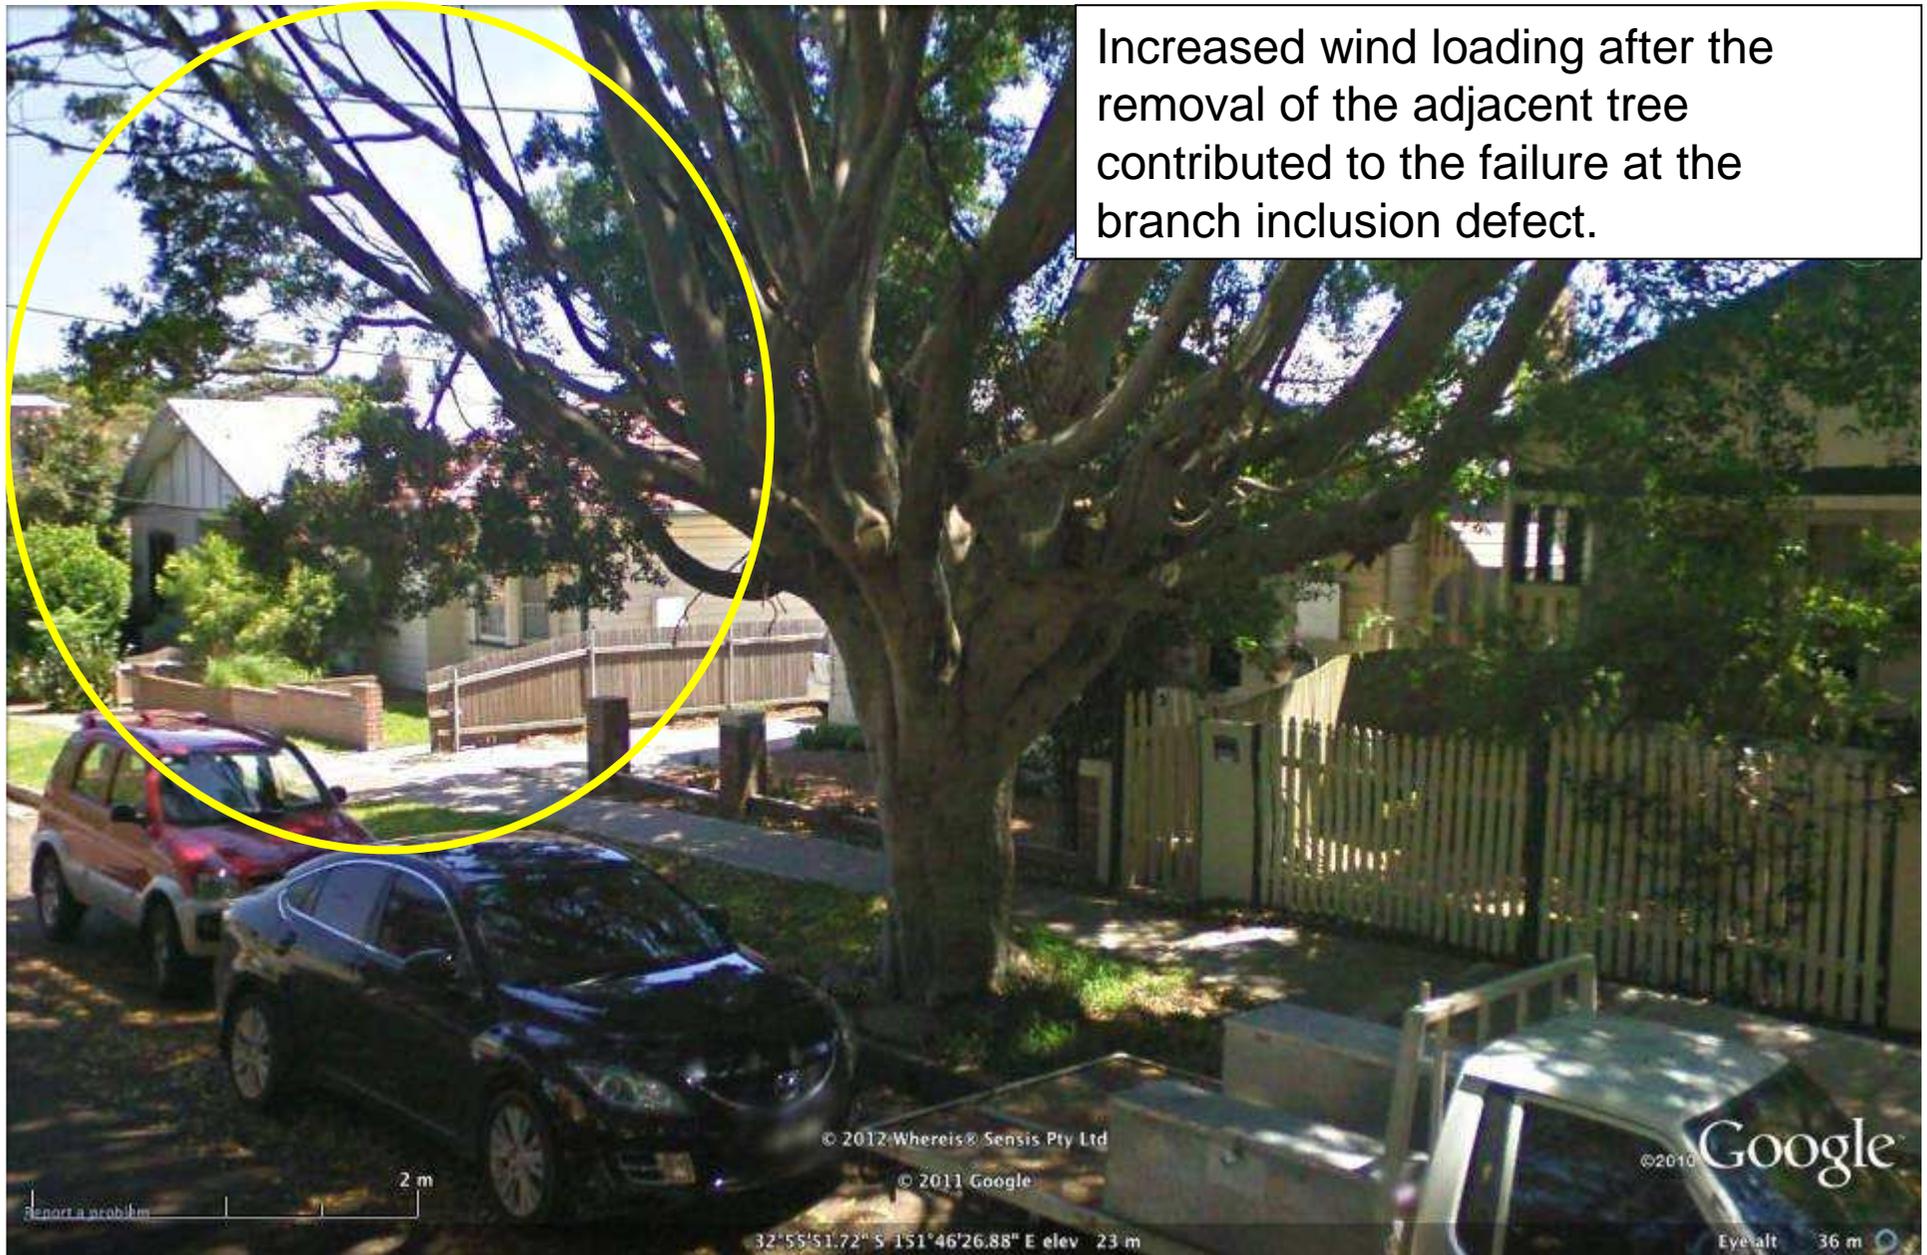
Tree ID 15469 (21 Swan St )

Increased wind loading after the removal of the adjacent tree contributed to the failure at the branch inclusion defect.

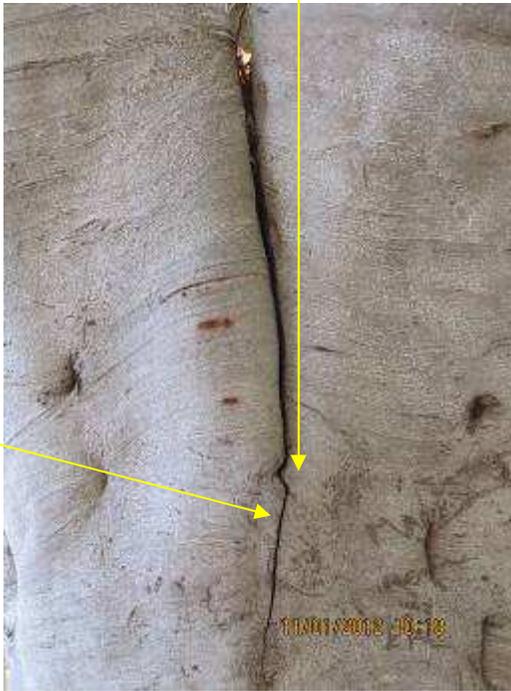
Tensile fracture at the base of the branch inclusion

Road side crack & stem closure after the tensile load was reduced during felling

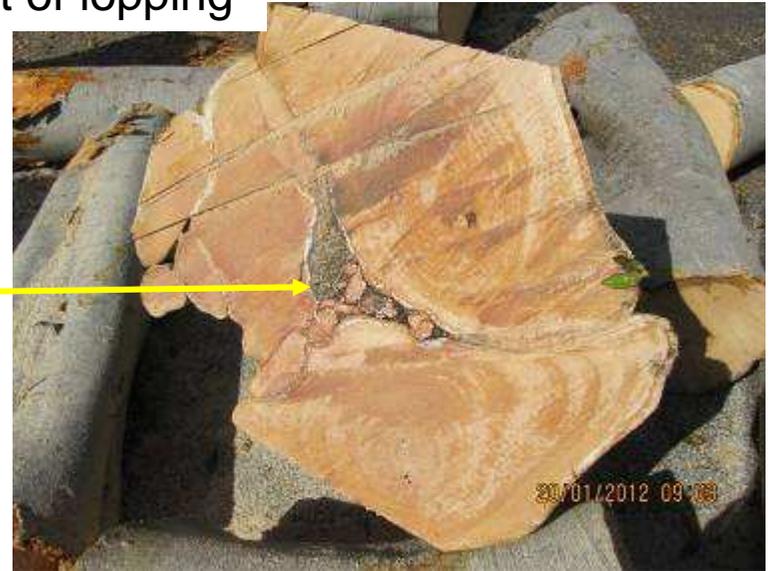
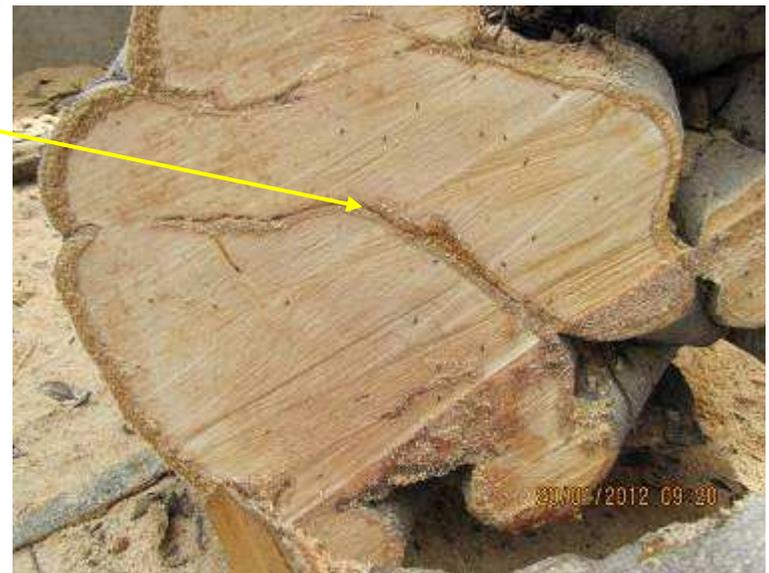
# Canopy Bark inclusion defects as a result of lopping

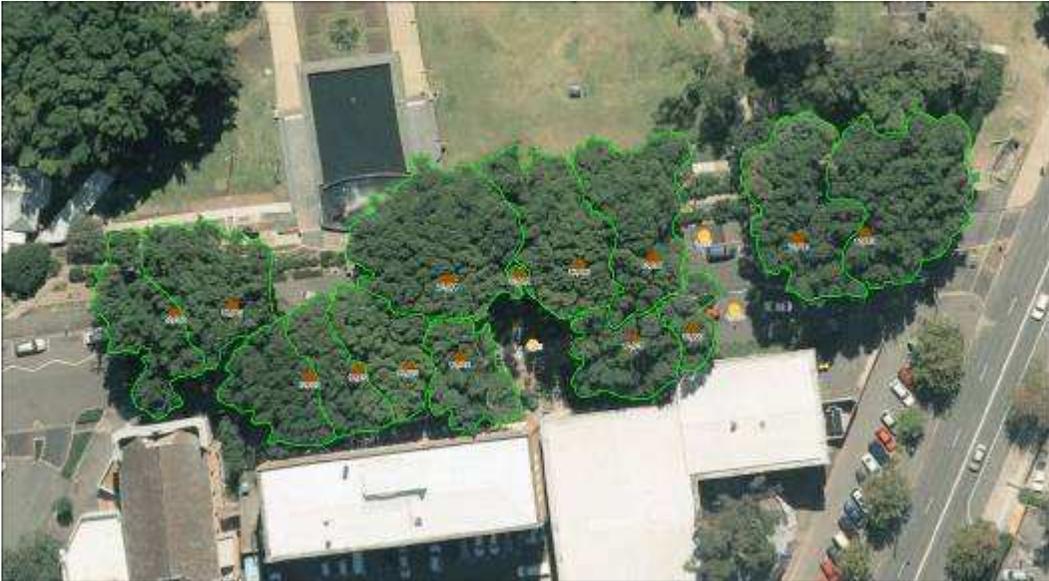
Laman Street Fig canopy after June 2007 - three trees removed due to root plate failure

Crown rotation

Tension roots failed under pavement

Compression roots failed along edge of parking lane

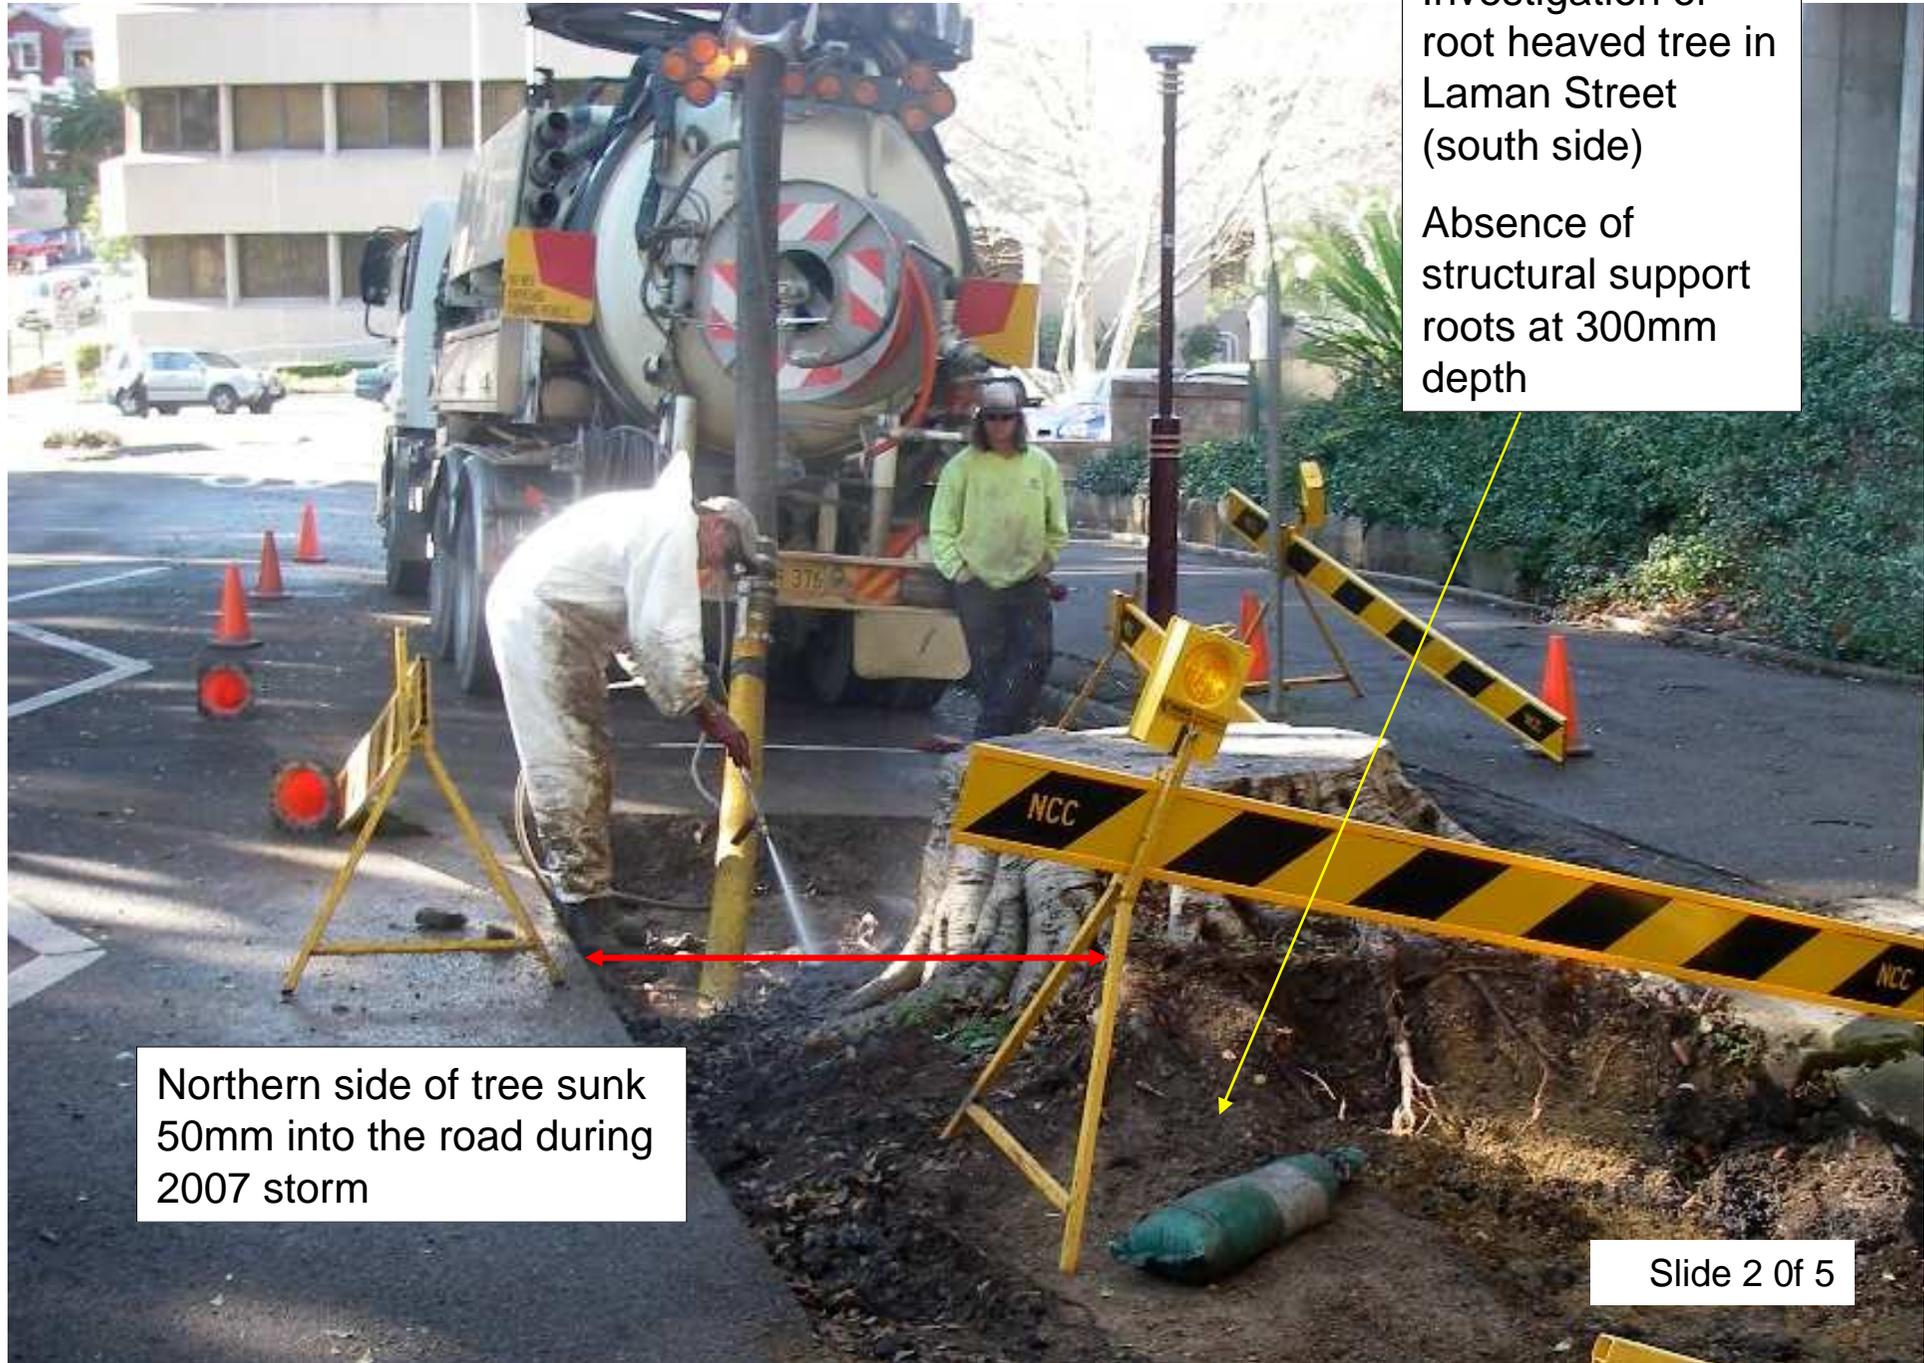
Investigation of  
root heaved tree in  
Laman Street  
(south side)

Absence of  
structural support  
roots at 300mm  
depth
