# Tree Failure Casebook History

Informing Tree Management in Newcastle

2000 - 2011

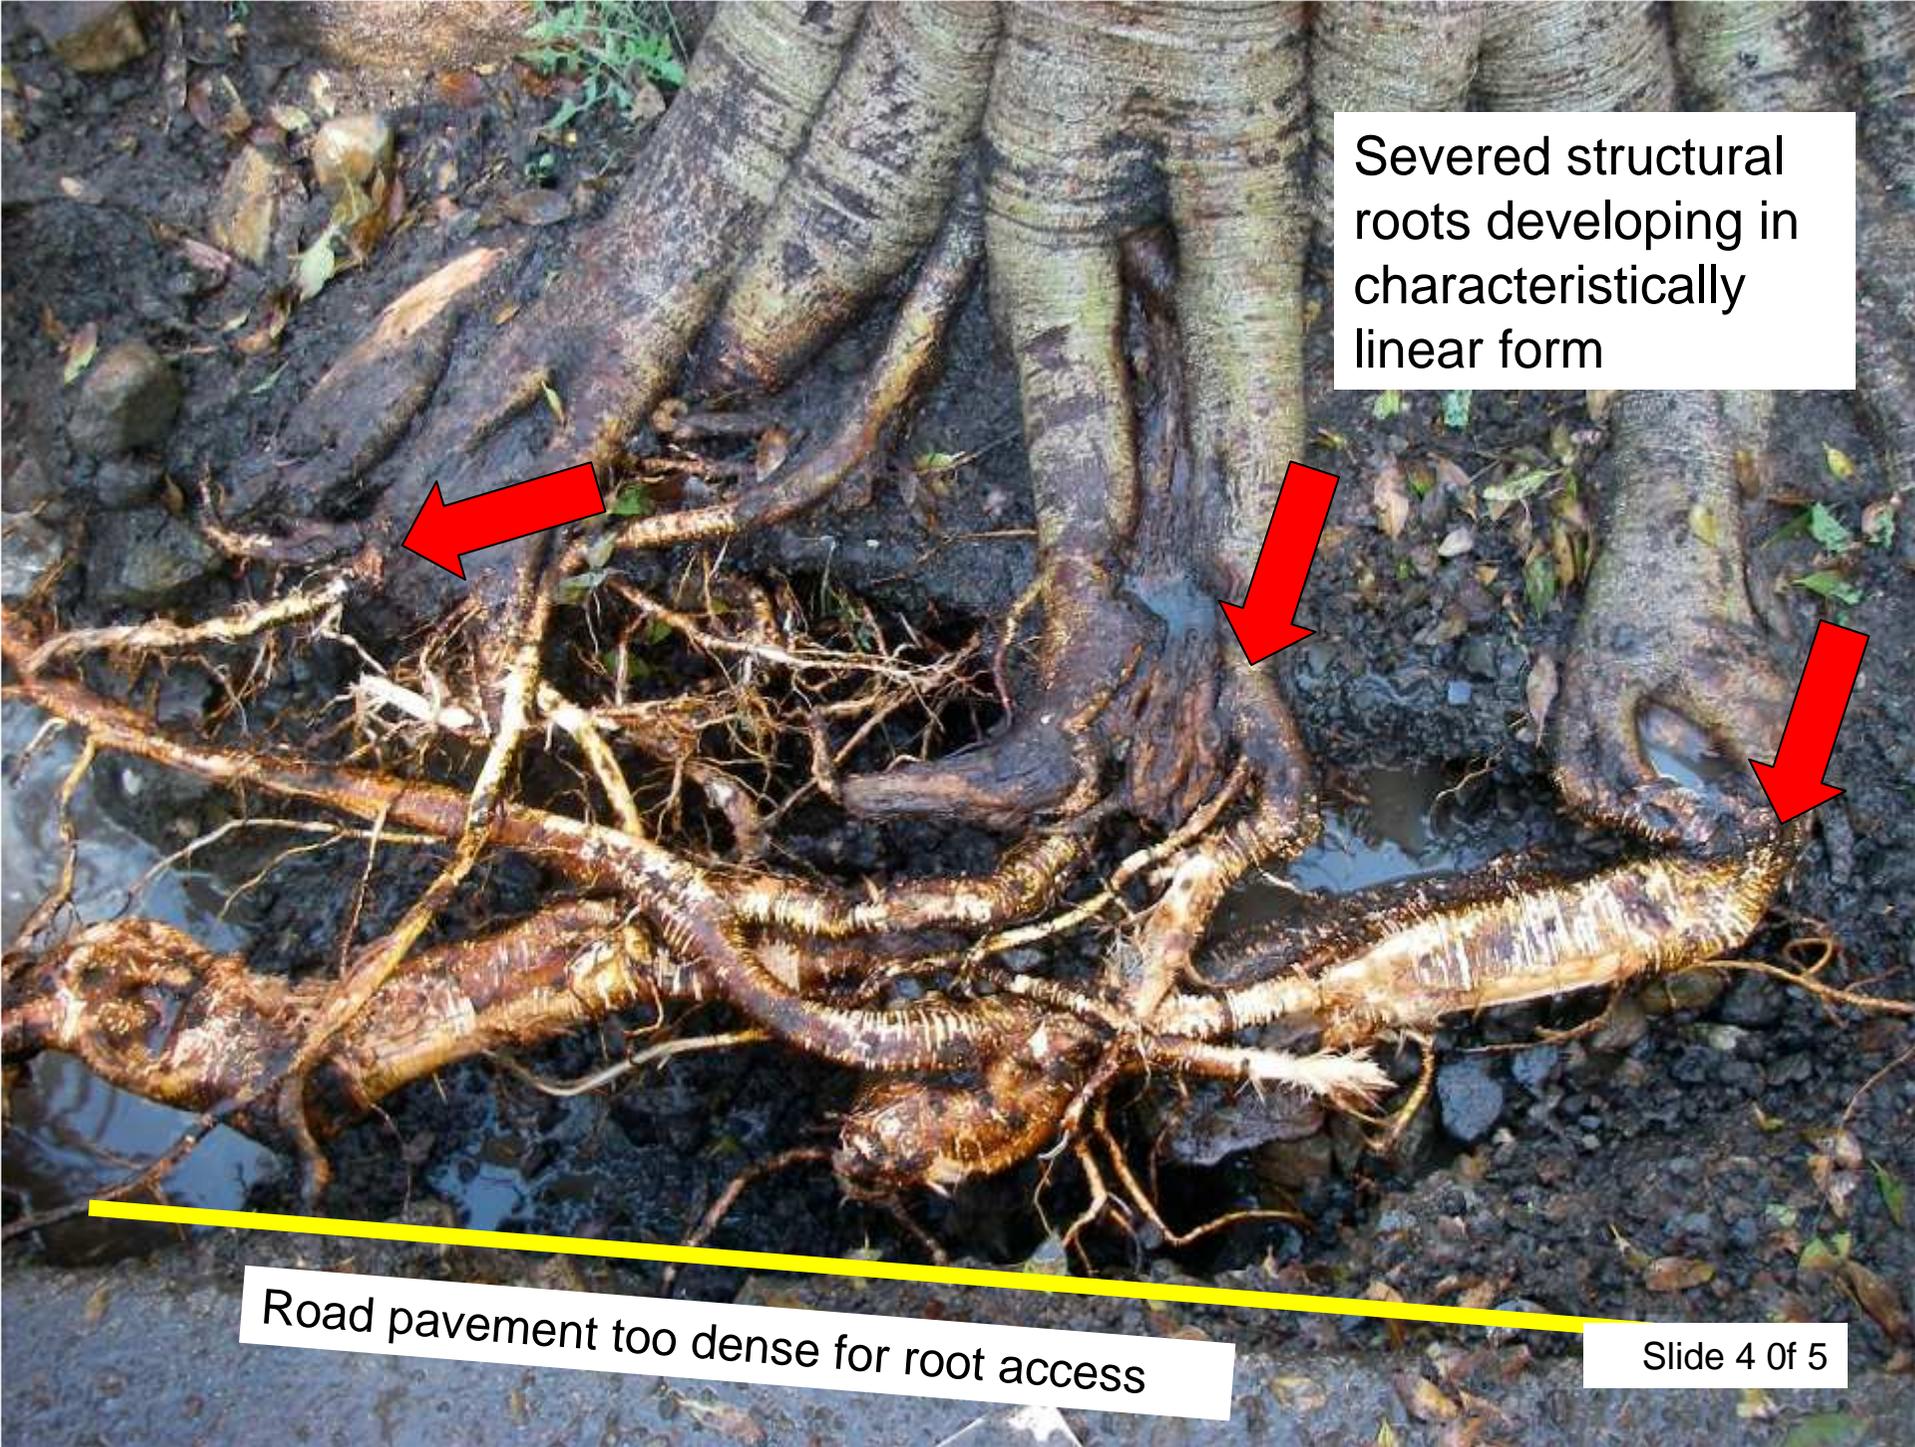
structural roots cut for road repairs have regenerated. Roots unable to penetrate the road due to density of pavement. Roots follow line of least resistance developing a typically linear form.

These new roots provide no mechanical support on the compression side of the root plate.

The tree's tension side root plate thus carries the full load under prevailing wind.

Severed structural roots developing in characteristically linear form

Road pavement too dense for root access

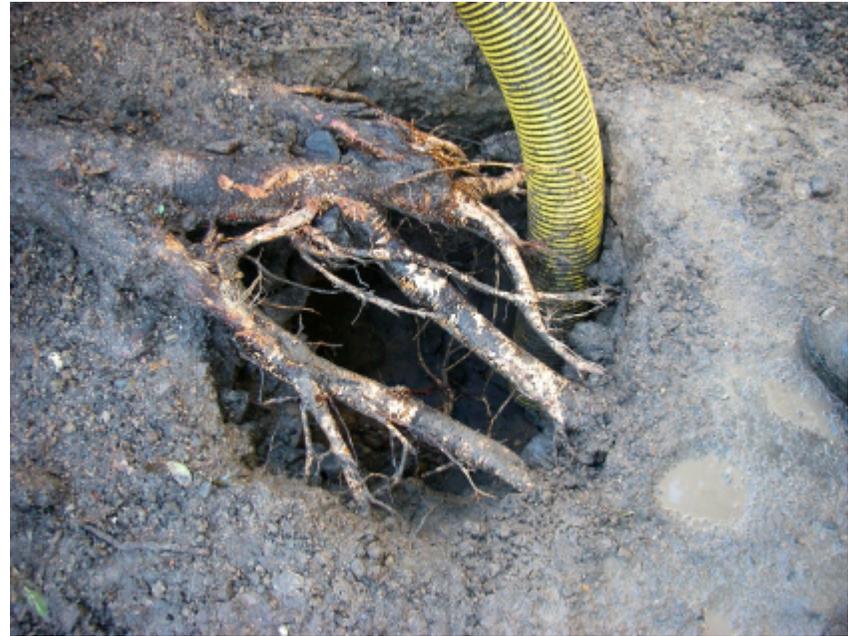
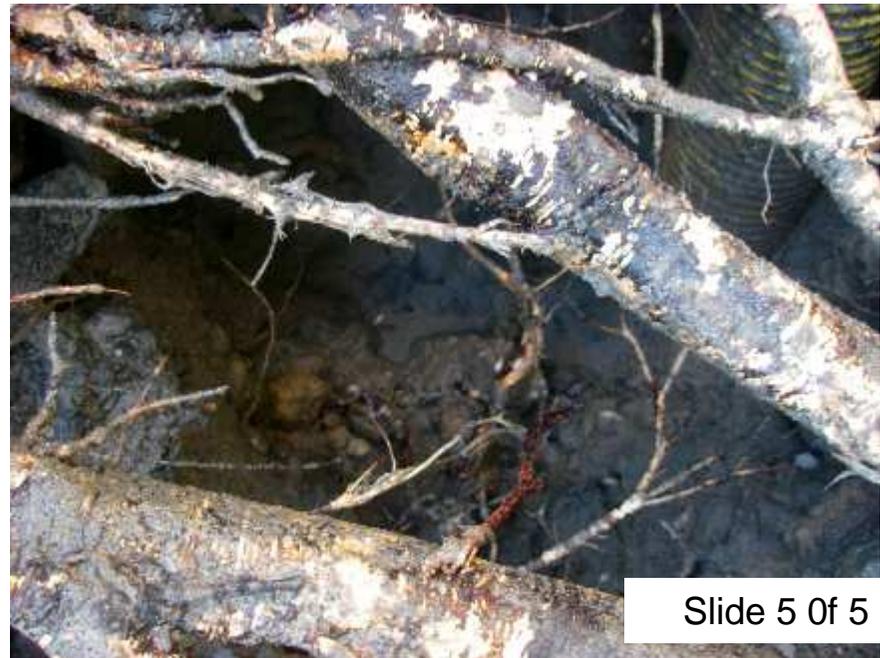
Laman Street root excavations investigation found no roots below the immediate surface layer, consistent with investigations in Bruce Street and Tyrrell Street

The extent of the root plate on the northern side of the Laman Street trees i.e. the trees on south side, is defined by the edge of the parking lane.

Critical damage. Typically wounded buttress roots that form the tree's primary mechanical support.

Fractured  
kerb and  
channel  
caused by  
flexing of  
tensile  
loaded roots

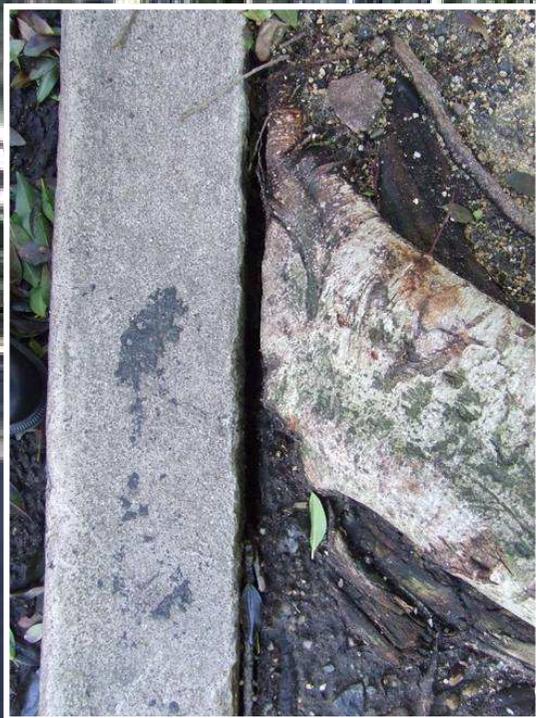
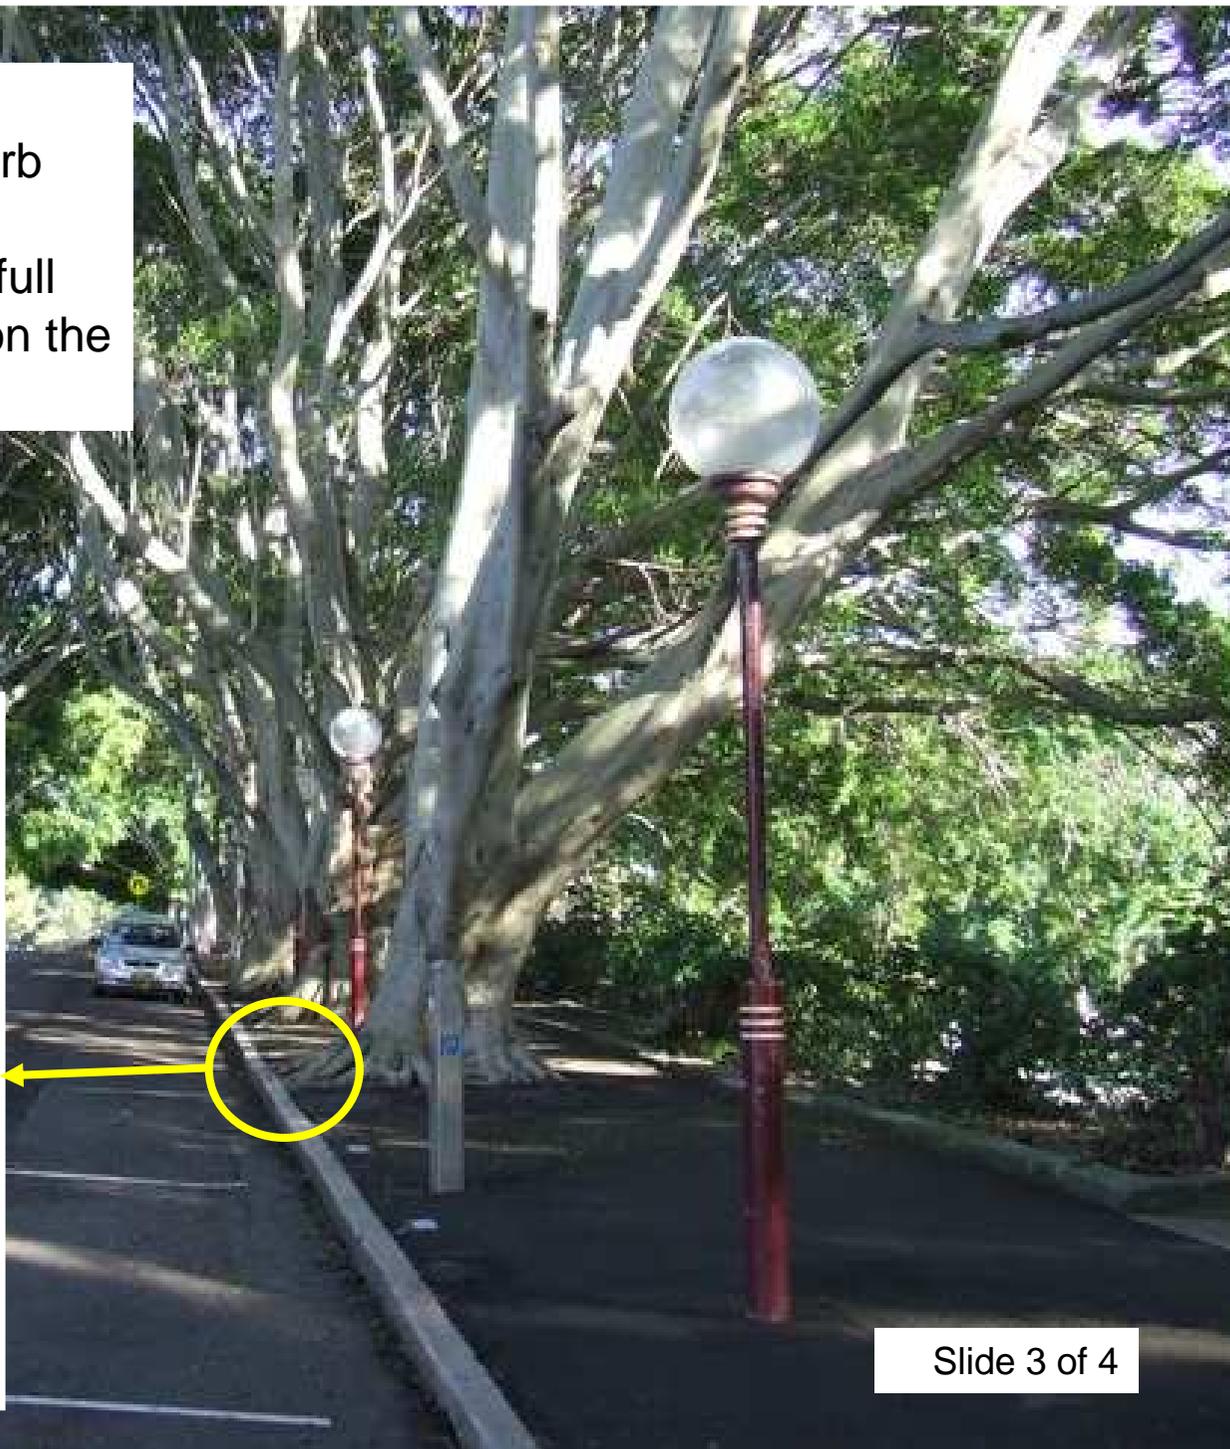
Tree 4797. Structural root movement away from the kerb during the 2007 storm. The illustration below shows the full extent of root development on the southern side of this tree.

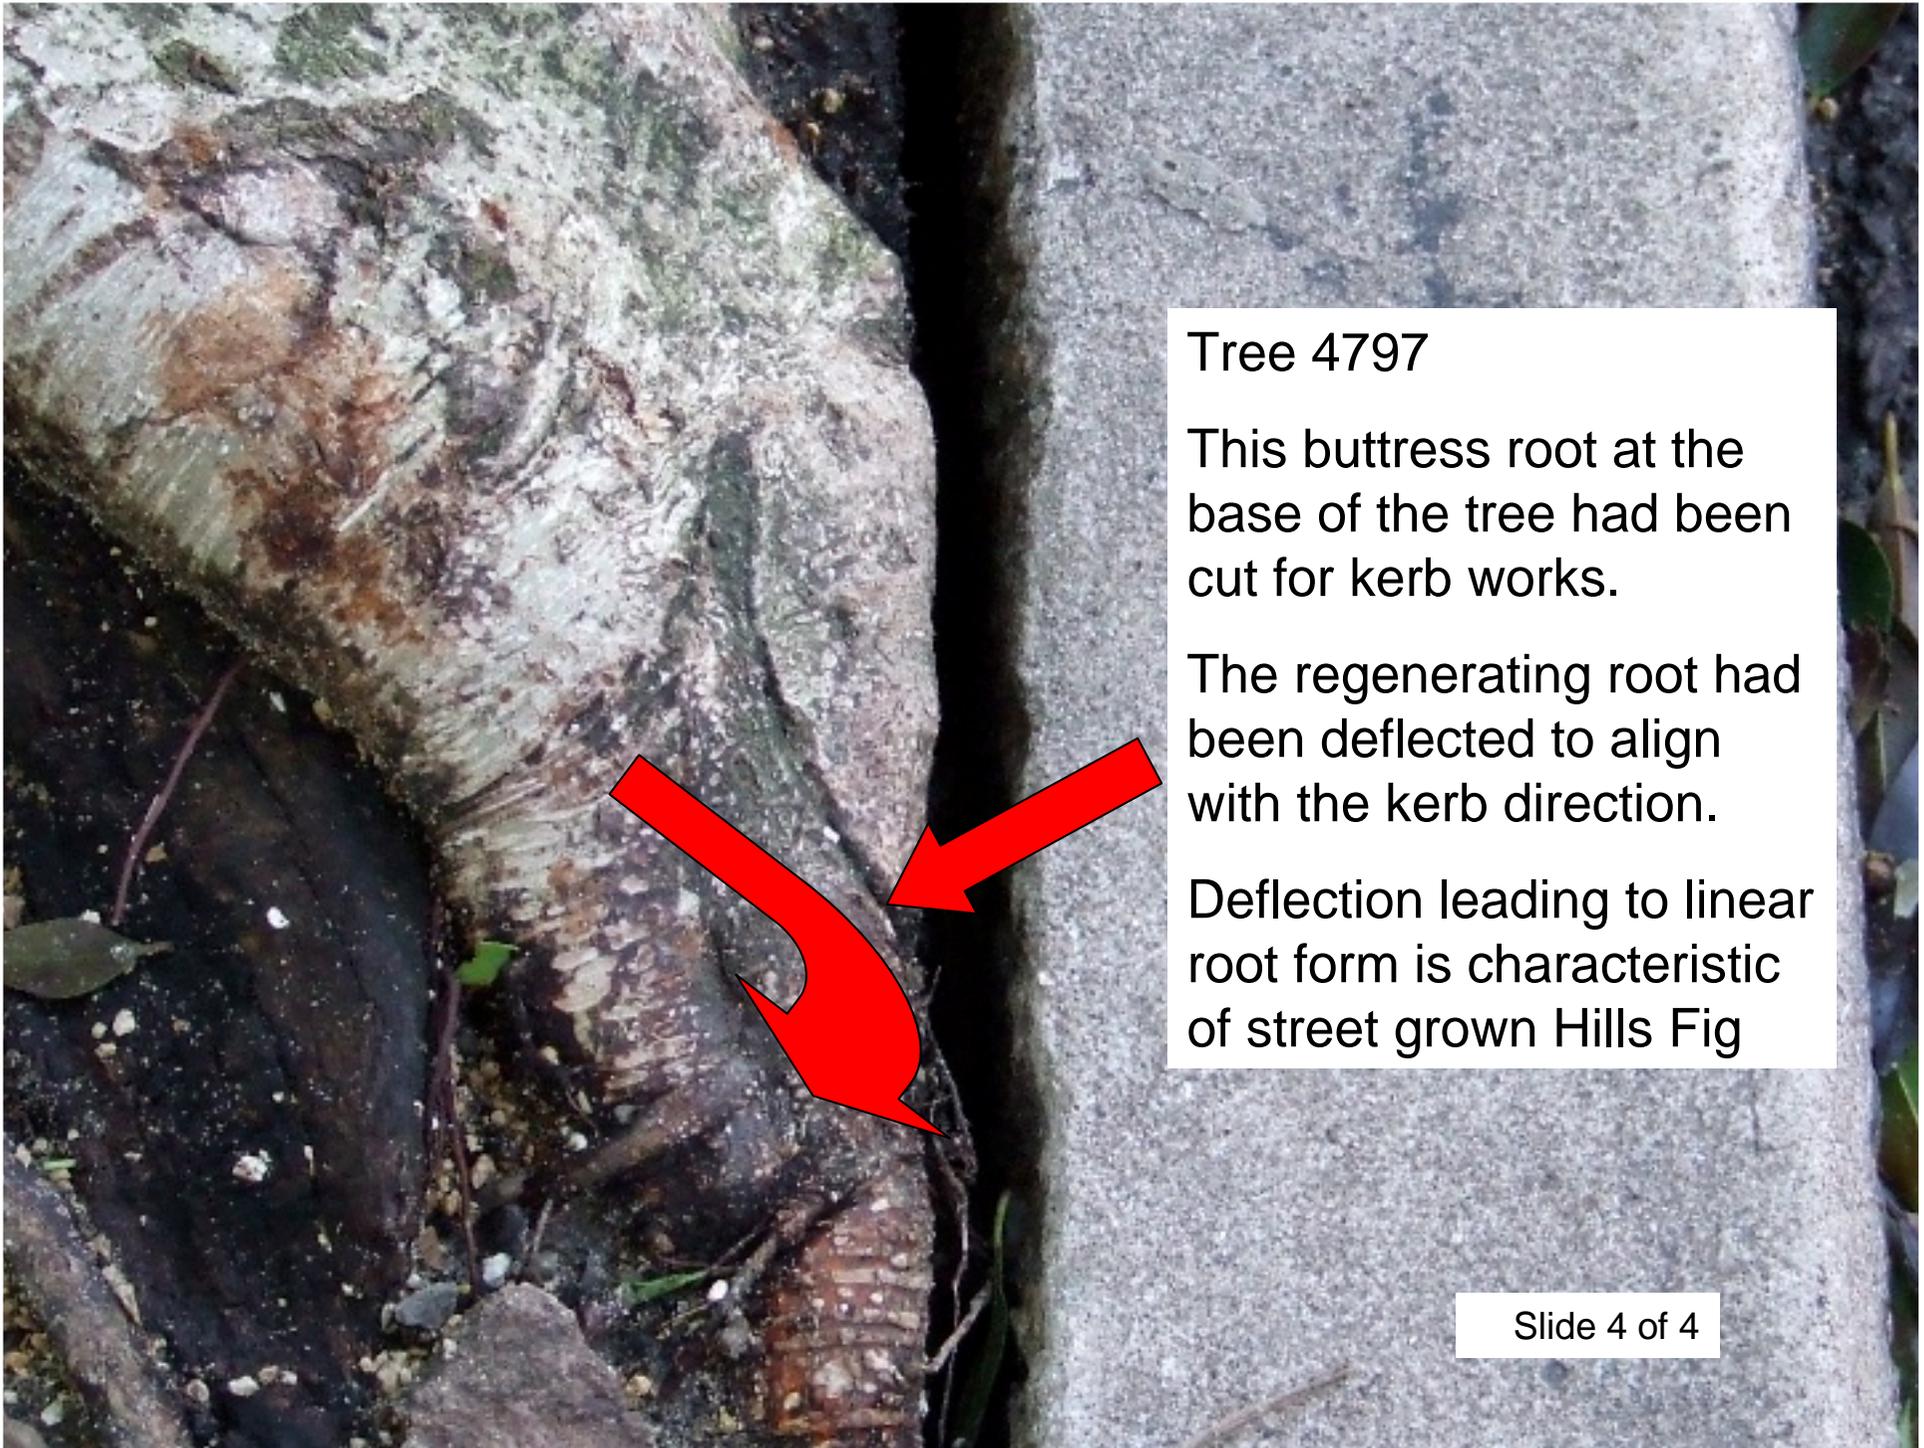
Tree 4797

This buttress root at the base of the tree had been cut for kerb works.

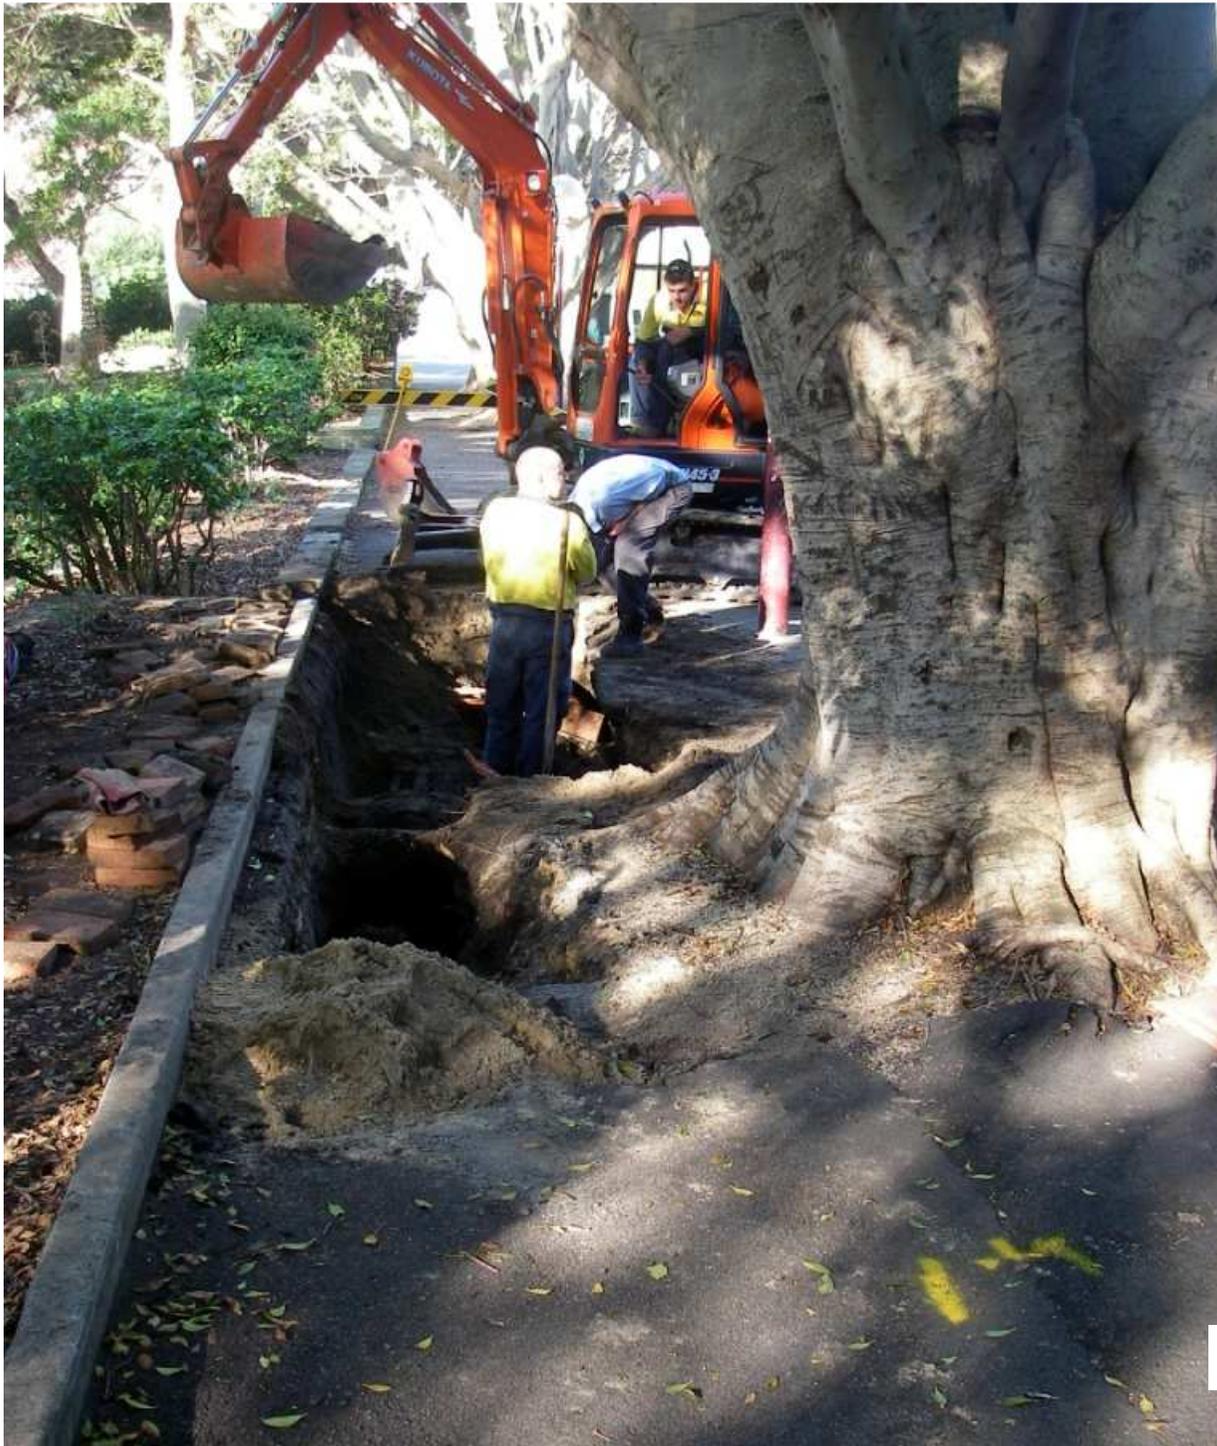
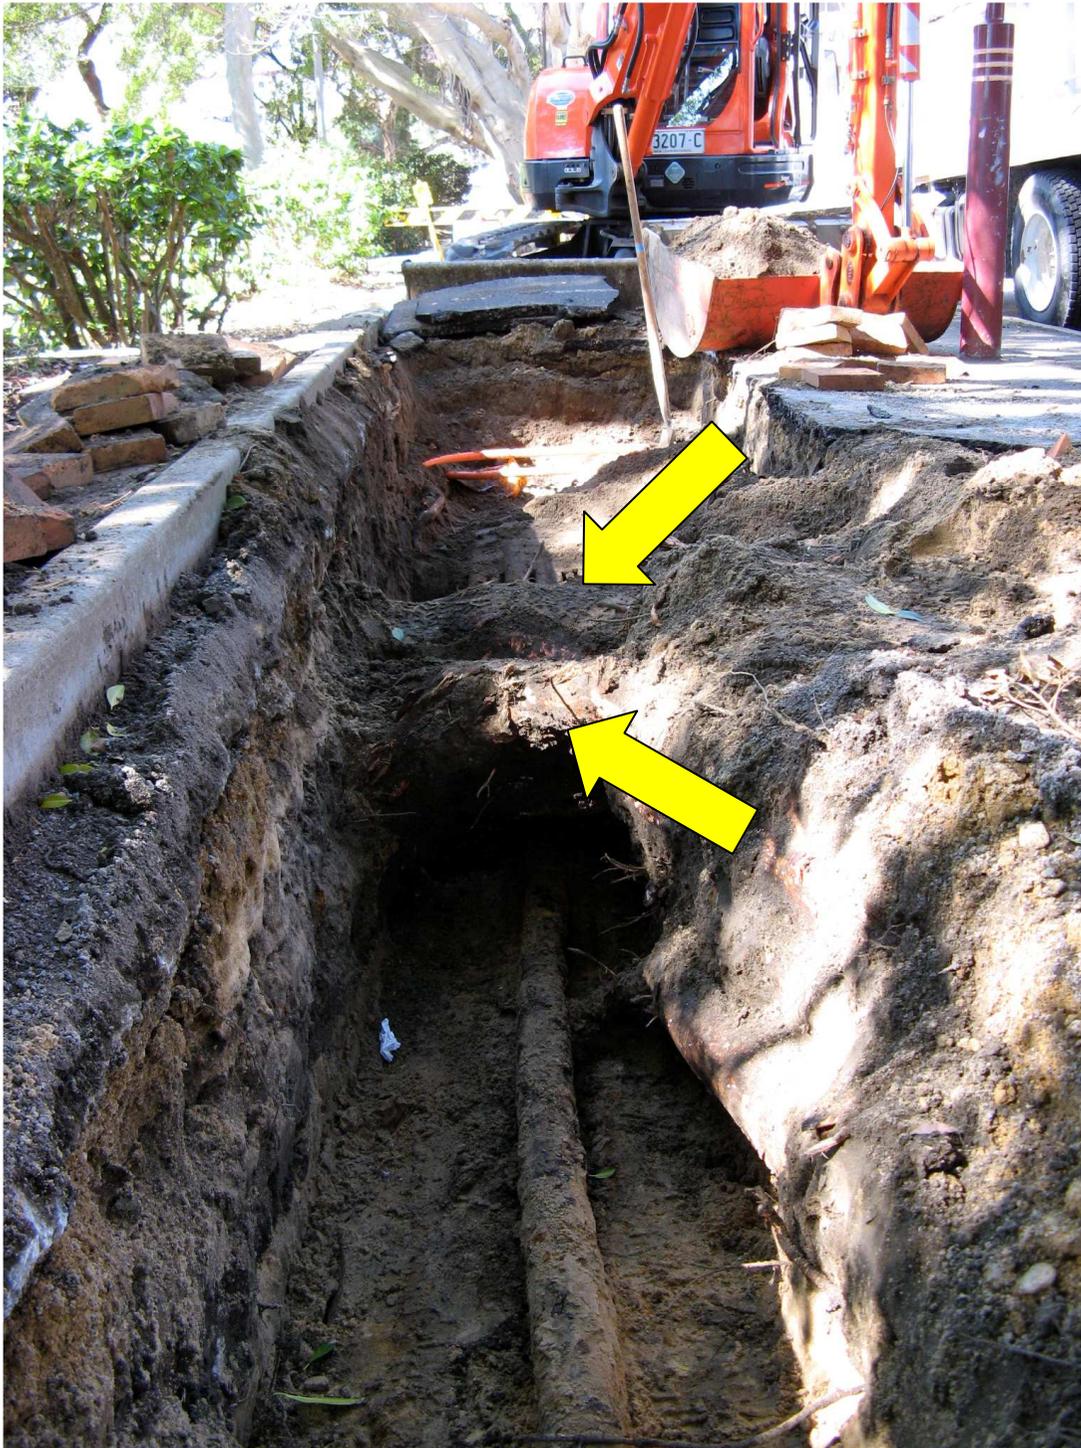
Laman Street  
northern side

Two structural  
roots growing  
toward Civic  
Park batter.

Considerably  
less roots than  
the Auckland  
St/Civic Park  
Hills Fig.

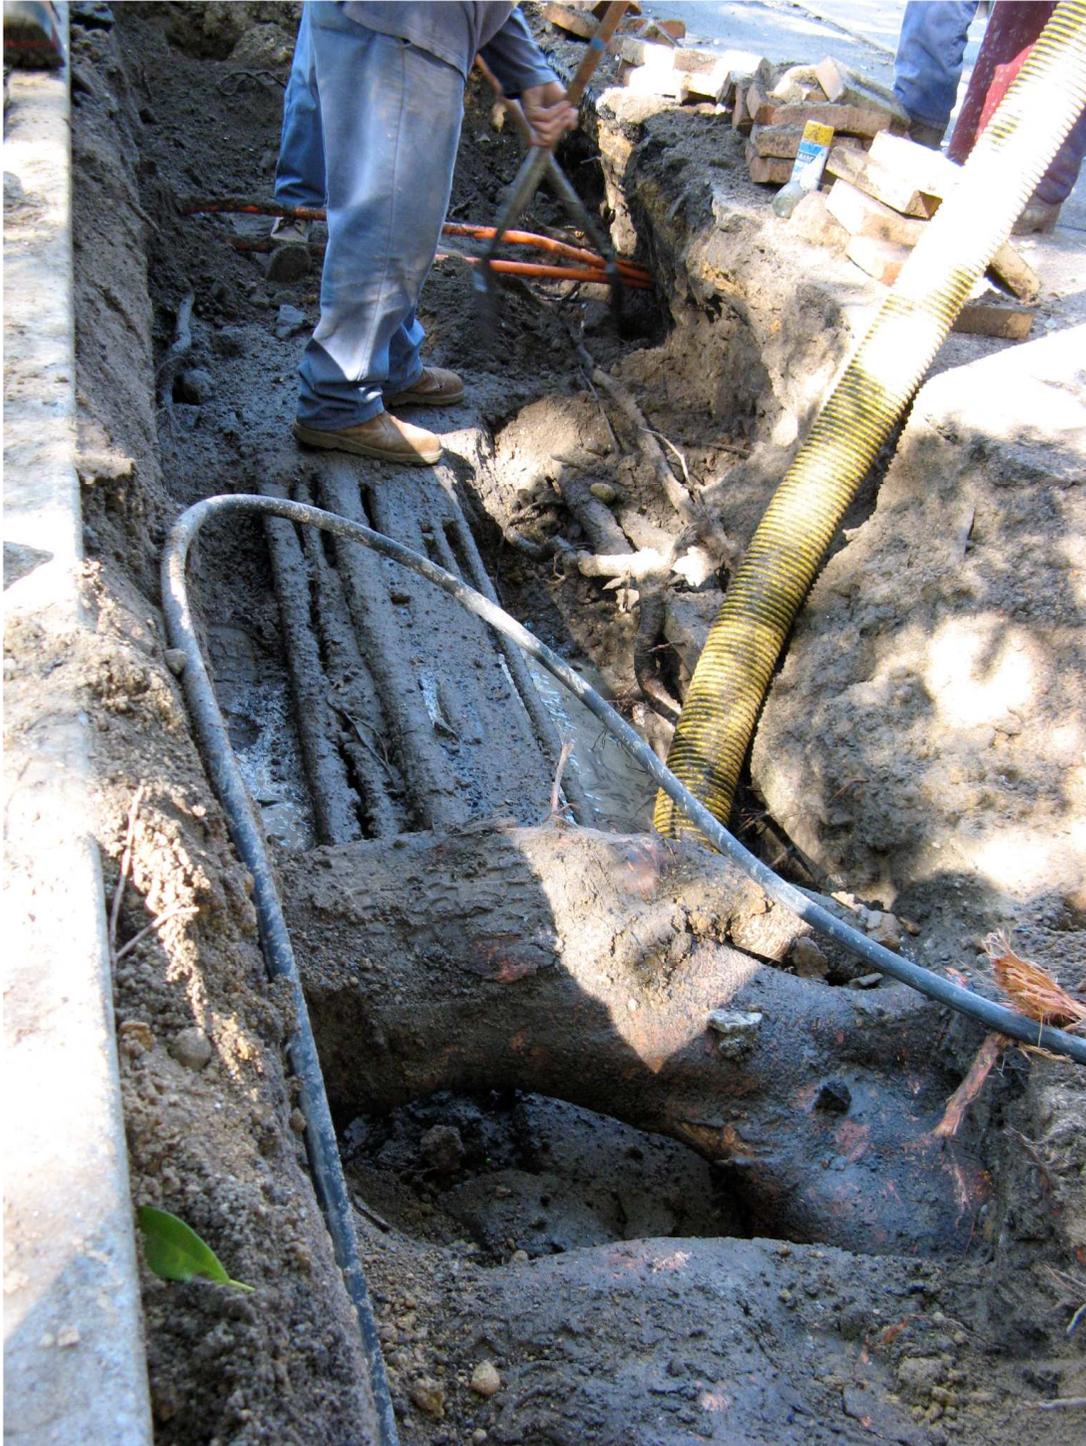
High voltage  
electricity cables

Third footpath  
Opening since 2005

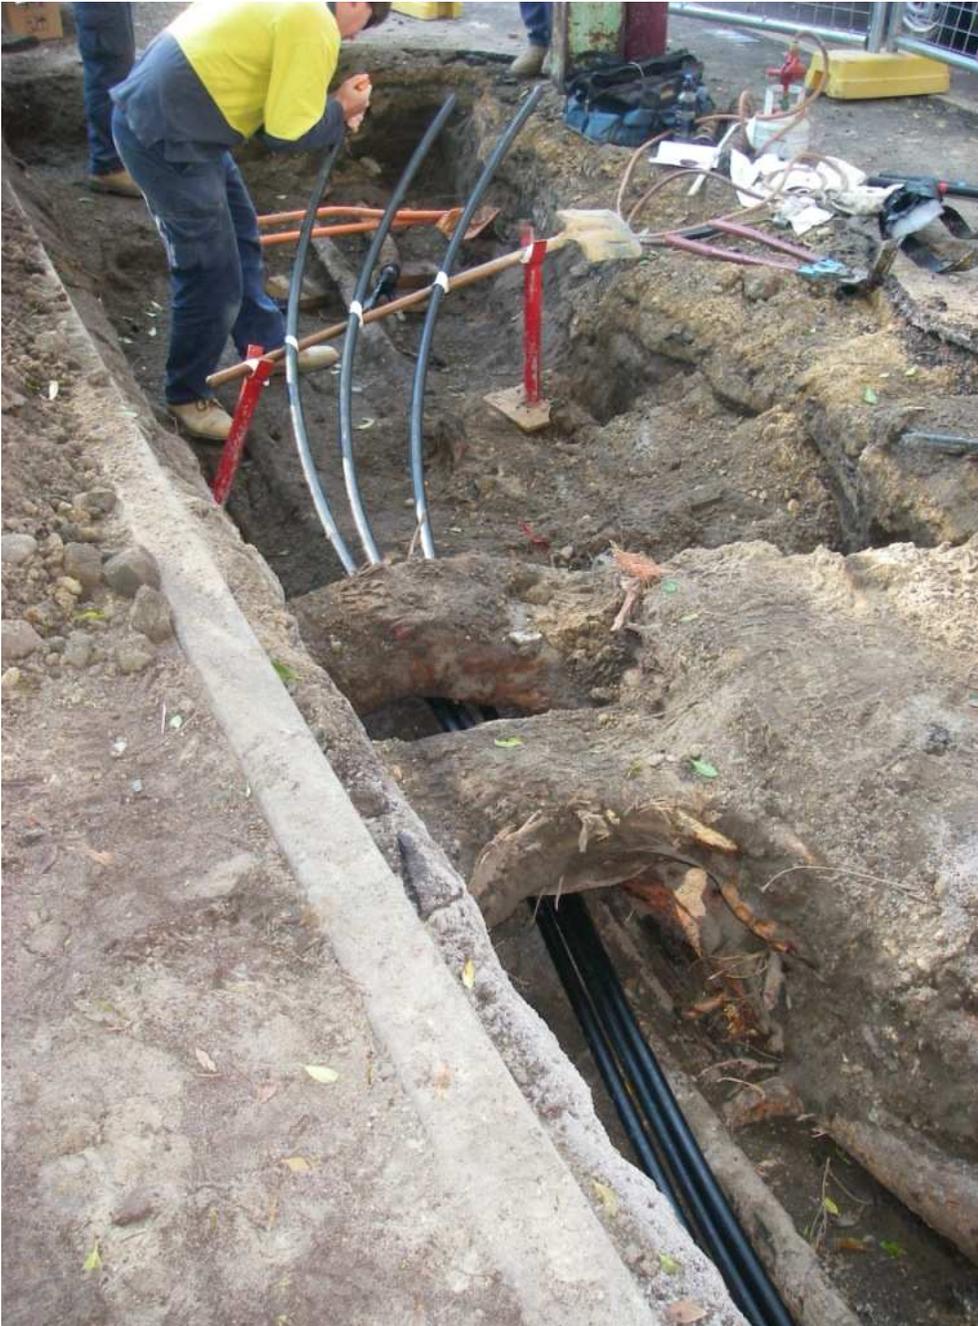
Cable  
realignment  
passed around  
the tree and  
under the  
exposed roots.

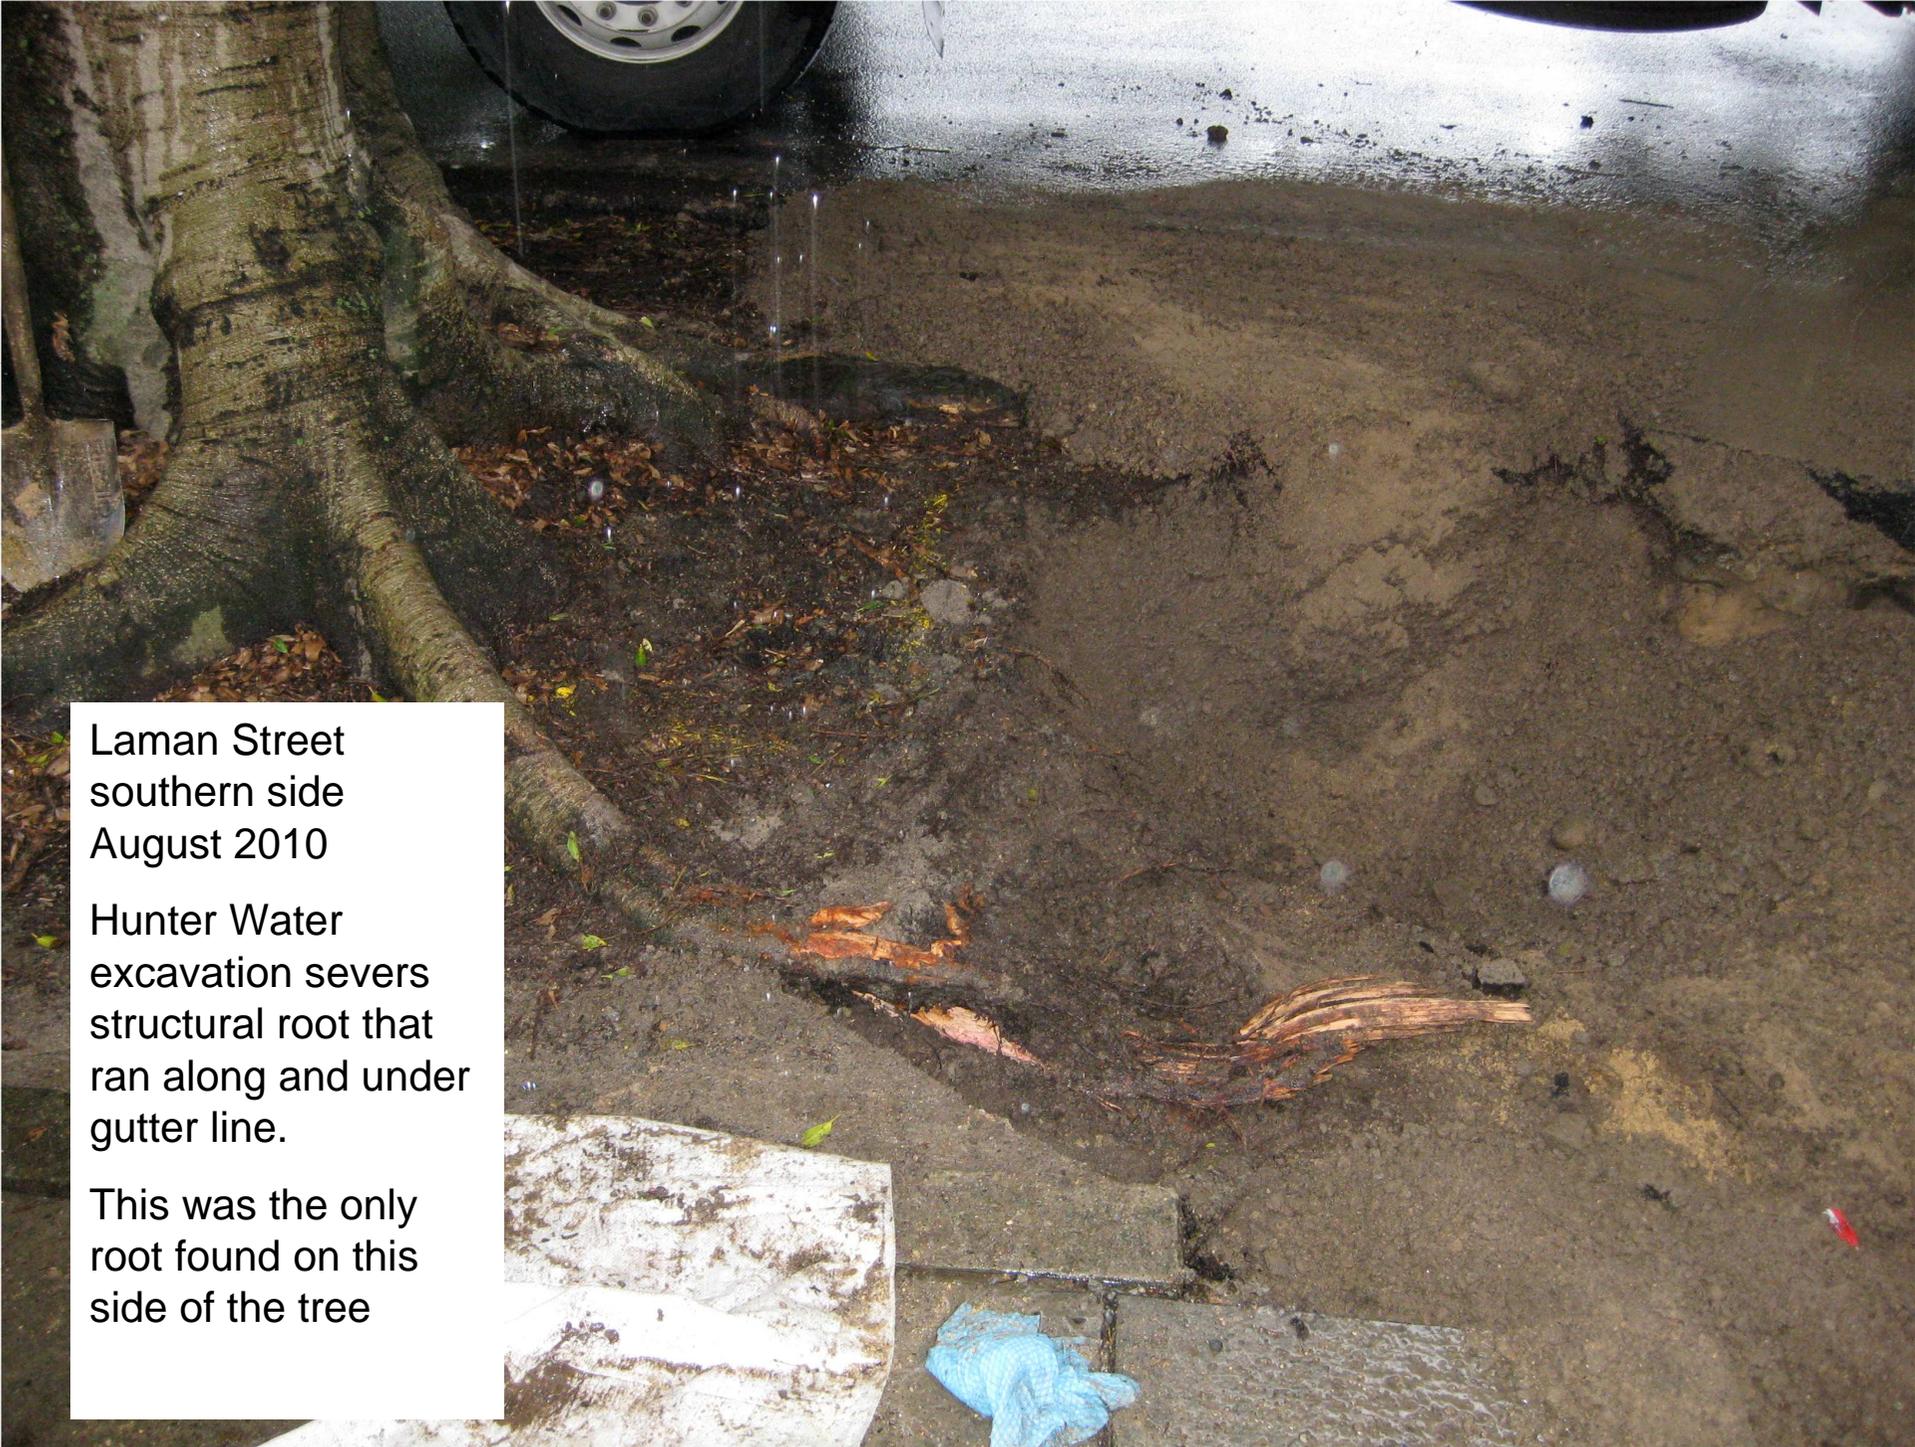
Laman Street  
southern side  
August 2010

Hunter Water  
excavation severs  
structural root that  
ran along and under  
gutter line.

This was the only  
root found on this  
side of the tree
