Investigation into Stability of three Hill's Weeping Figs Along Laman Street Newcastle

City of Newcastle

Dennis Marsden, MAIH, MISA, MNAAA
Consulting Arborist

11 July 2007

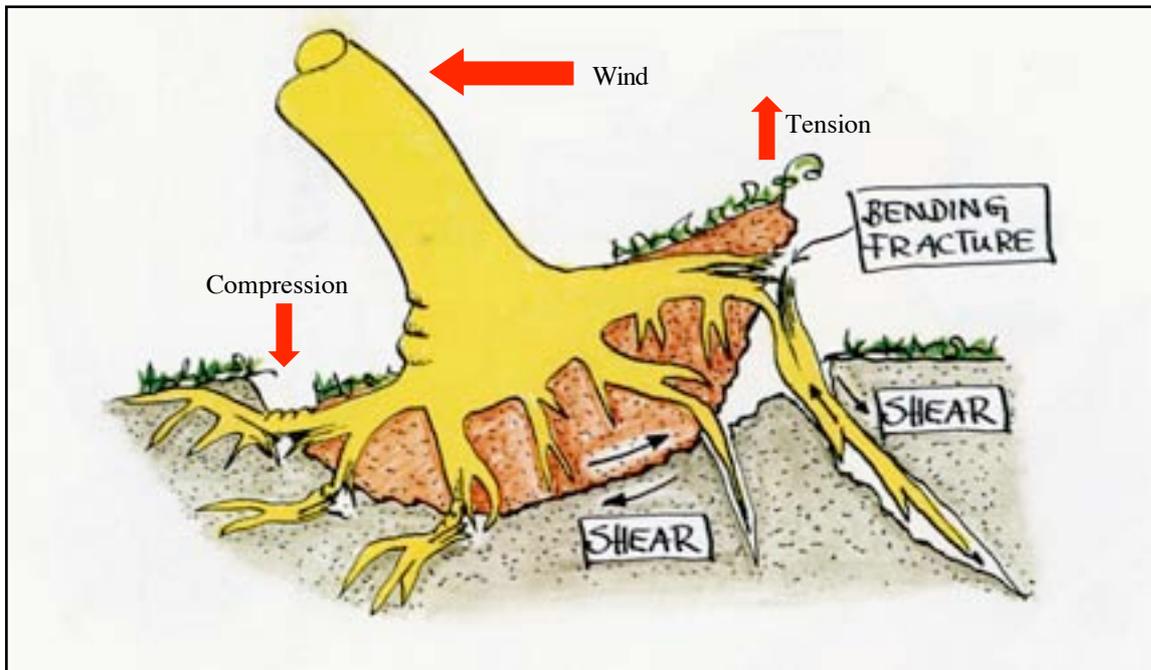
While there can be some variations in modes of windthrow, root-plate failure generally follows the theme of the root-plate lifting on the side under tension, i.e. the windward side, and subsiding on the side under compression^{vi} (figure B, below).

Figure B. Root-plate failure (Mattheck, 2004).
