# Community Update

The Local Recovery Committee is continuing the recovery effort following the Wickham Wool Store fire on 1 March.

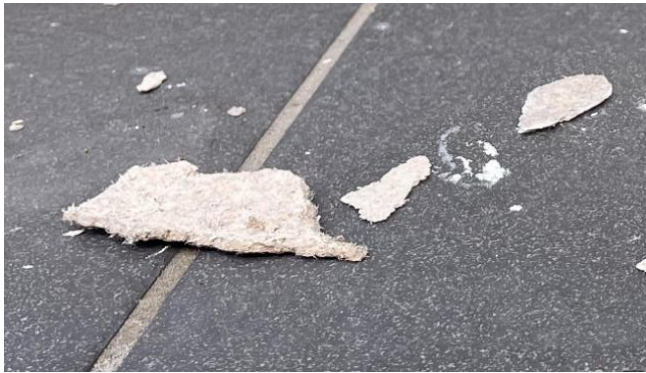
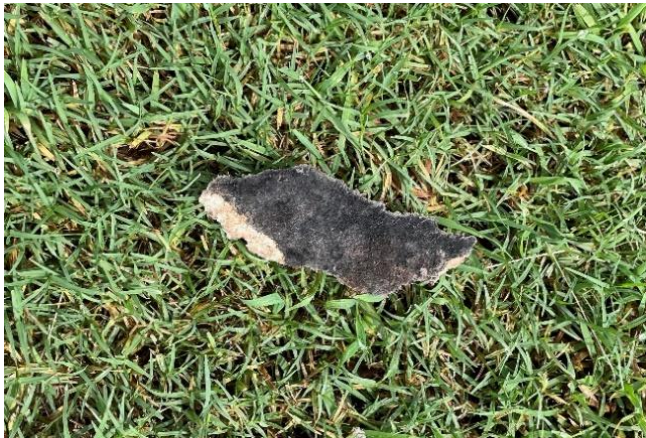
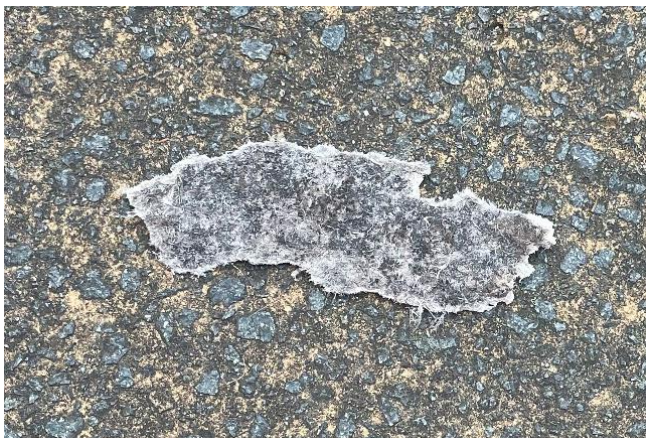
Asbestos specialists have advised that the asbestos is likely to be Super Six, which was previously a commonly used construction material in older buildings and is now banned. The images on page two show some of the asbestos debris from the Wickham fire.

Asbestos debris from the fire. Photo: Hazmat Services

During and since the fire, there has been prolonged rainfall, which has helped prevent fibres from becoming airborne. Information from Fire and Rescue NSW rapid assessment reports indicates that asbestos-containing debris from the fire that landed on properties were fragments of non-friable asbestos cement debris, with some loose fibres.

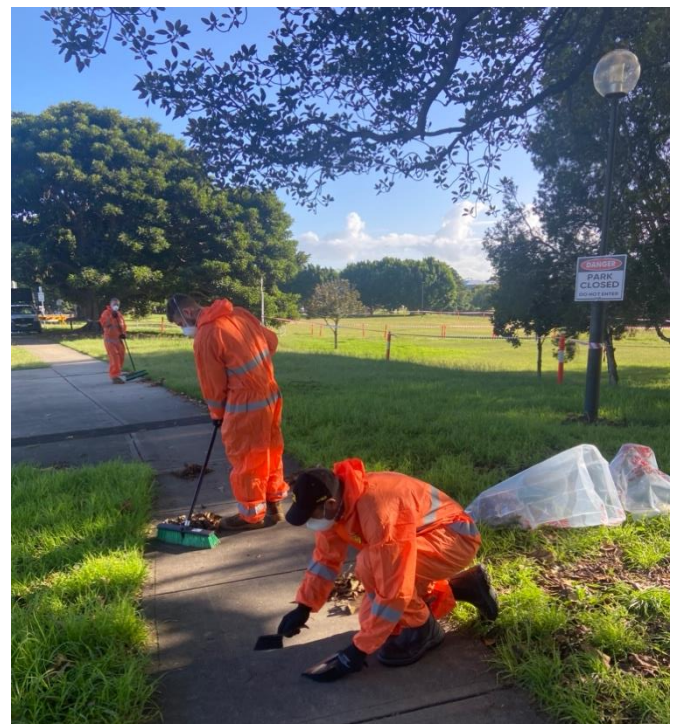
Specialist asbestos contractor cleaning at Islington Park.

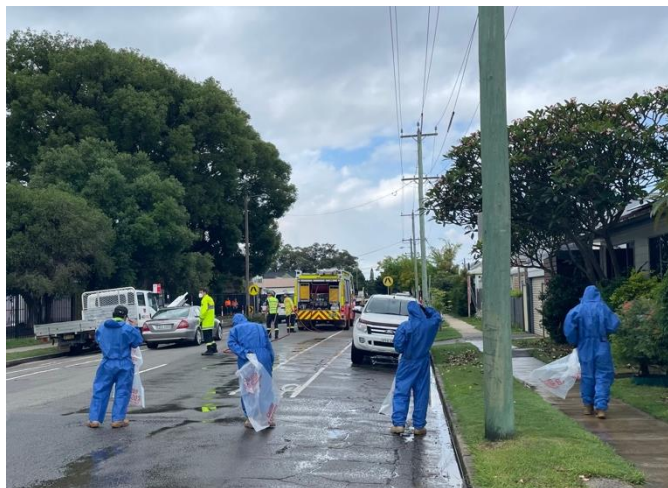
Specialist asbestos contractors cleaning up an impacted street.
